## Storm Babet, the Angus grouse moors and the flood destruction in Brechin

## **How much rainfall caused the unprecedented flooding in Brechin?**

## **Not all the water levels on the River South Esk exceeded previous records**

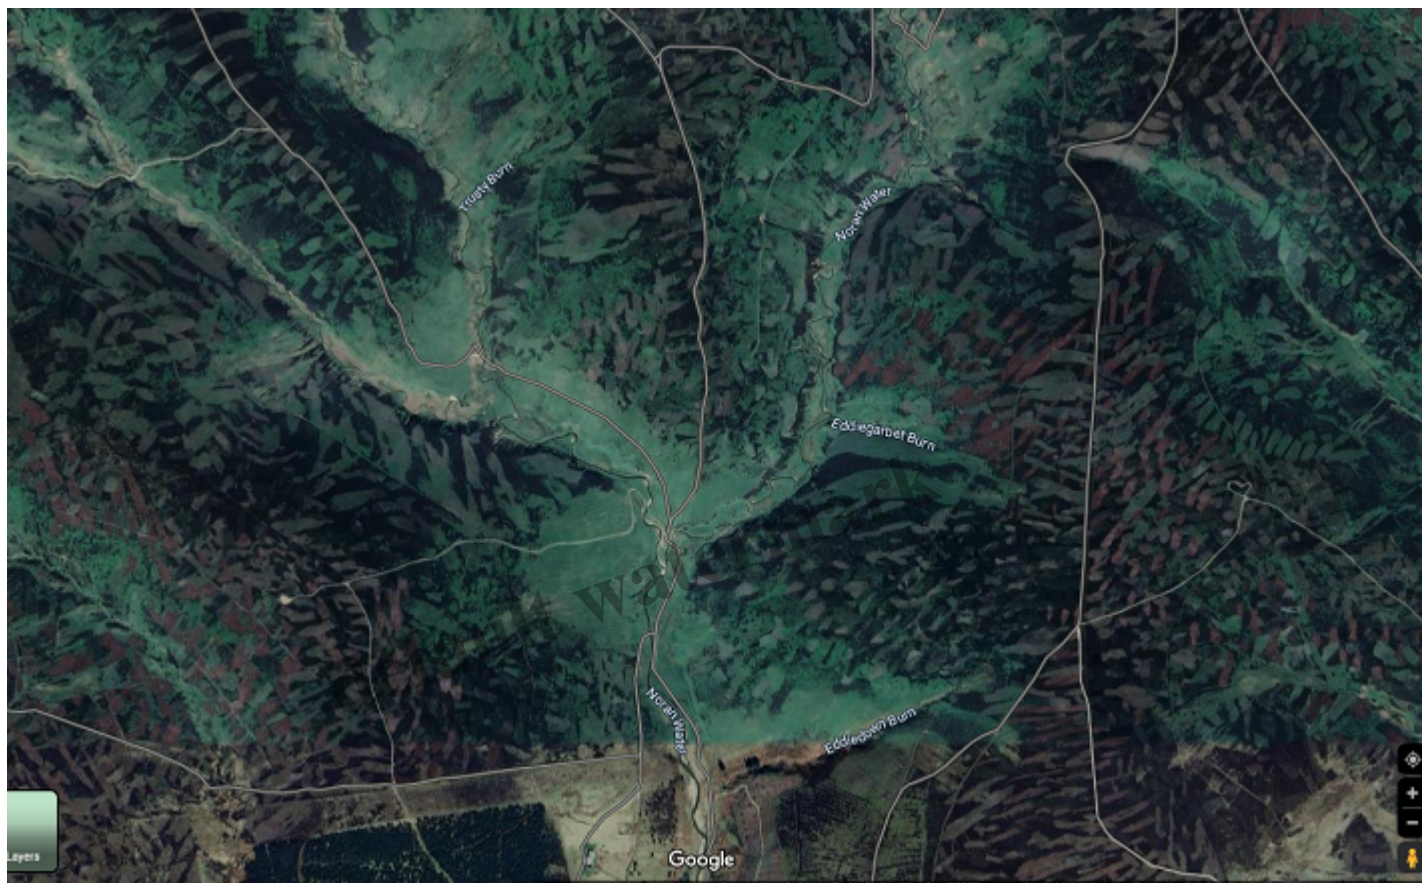
Muirburn around the catchment of the Noran Water, one of the main tributaries of the River South Esk, which joins it south the the Highland Boundary Fault upstream of Brechin. Photo credit google maps.

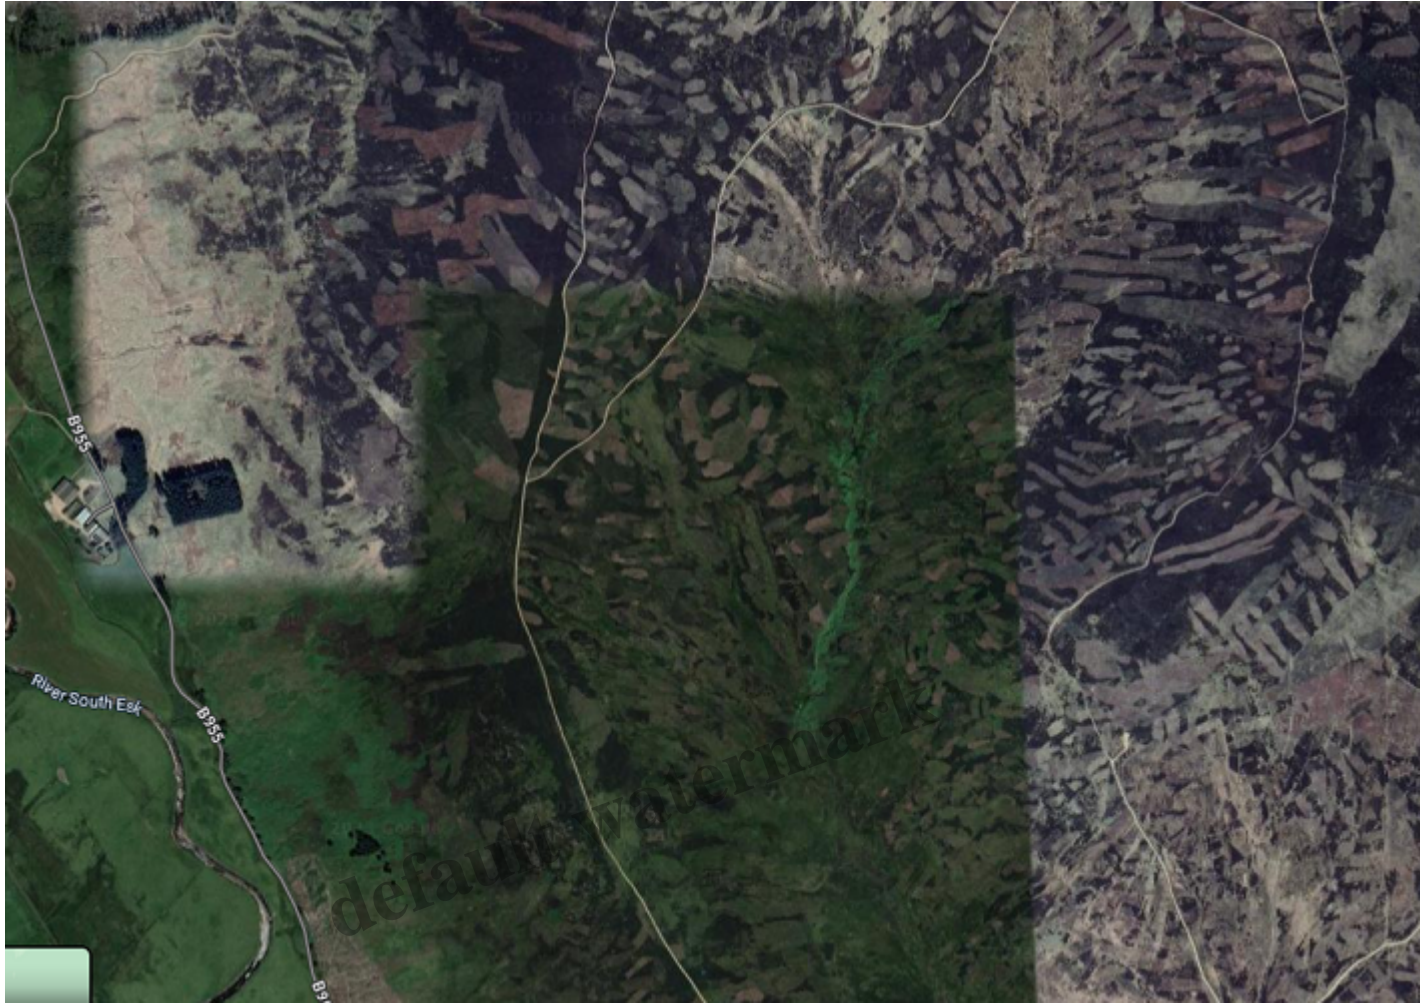
Muirburn on the eastern side of Glen Clova south of the Cairngorms National Park. Photo Credit google maps

The muirburn, besides destroying peat which helps absorb rainfall, also removes surface vegetation, including plant litter, which helps slow the flow of water downhill. The rate of water run-off is almost certainly sped up further where the burned strips are oriented downhill, rather than across slopes.

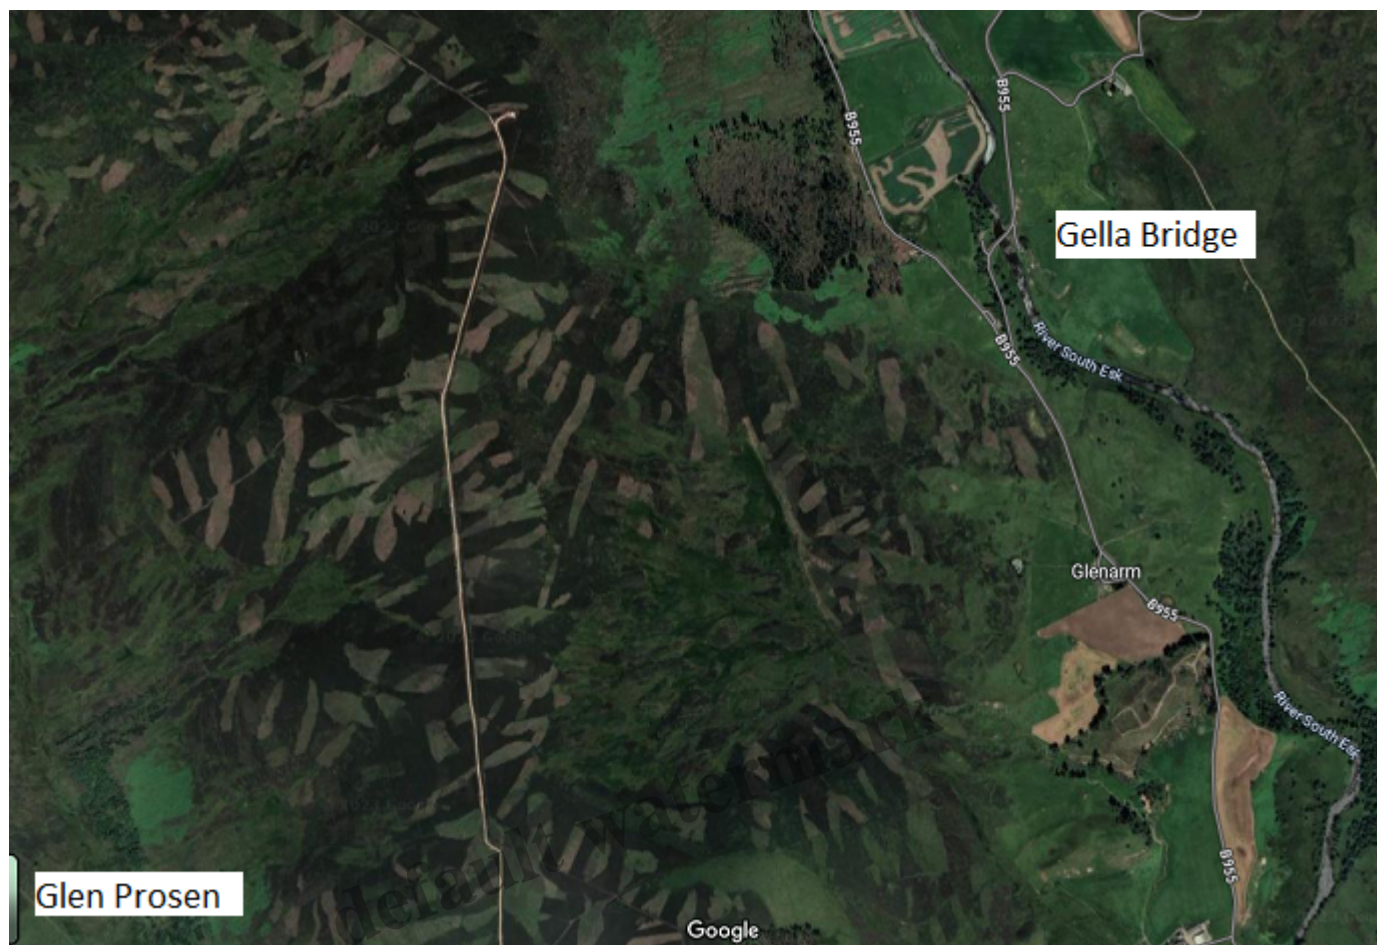
Water running off the muirburn strips on the left of the photo will have drained into the River Prosen contributing to the record levels recorded at Prosen Bridge

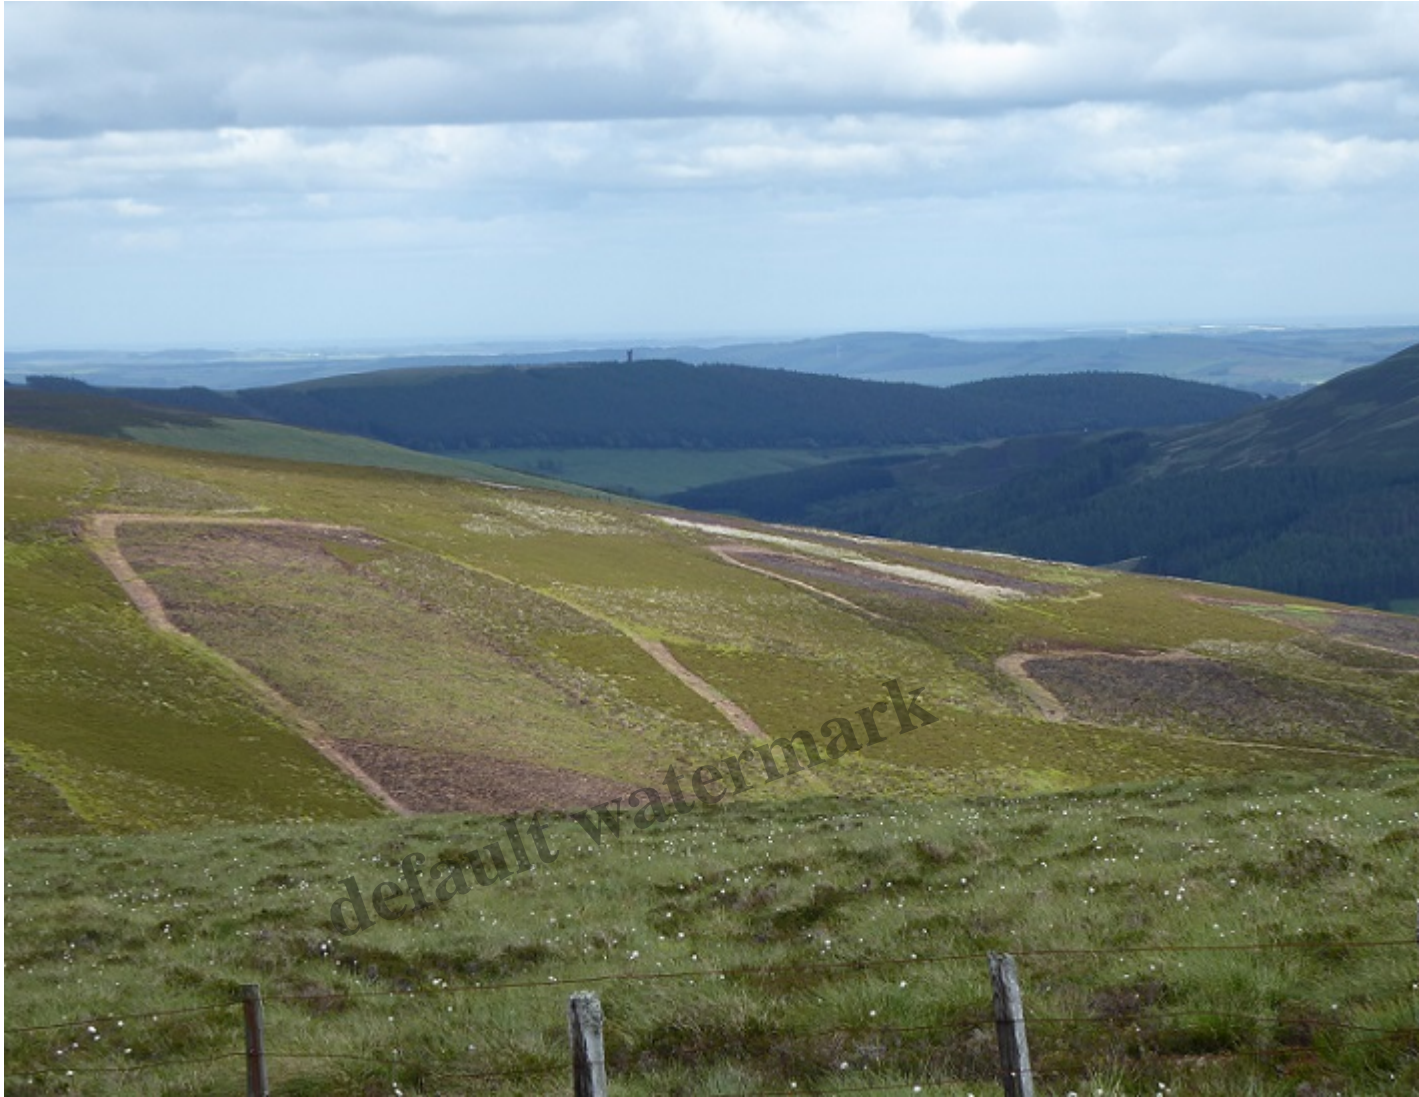
Muirburn Glen Prosen 2016. The difference between the water retention capacity of the slope in the foreground, covered with bog cotton, compared with the burned areas, surrounded by mowed rings, opposite is obvious

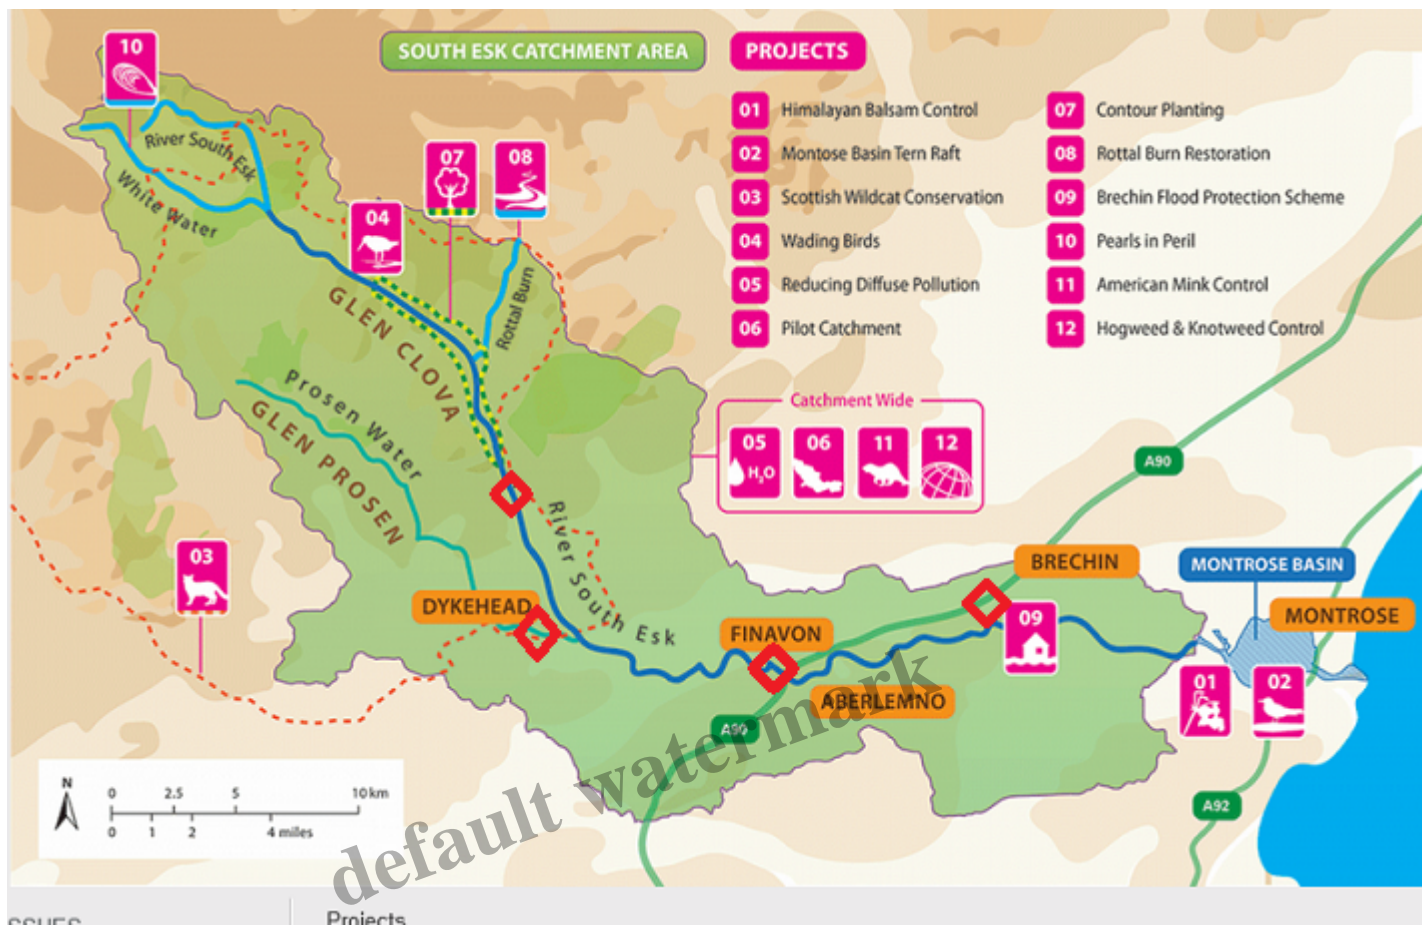
Map annotated with red diamonds showing, from left to right, approx position of SEPA's water monitoring stations at Gella bridge, Prosen Bridge, Tannadice and Brechin. Map Credit River South Esk Catchment Management Plan Review 2017

SEPA has just one rainfall guage for the whole of the River South Esk catchment above the Montrose Basin. It is located in the lower part of Glen Clova at Gella Bridge (top diamond flat above)

SEPA operate more river level guages than rainfall guages. There are four on the South River Esk (map above). Those at Brechin and Tannadice were inundated and stopped functioning but not before the one at Tannadice registered water 0.5m above the previous record. There is general agreement that the level of the water in Brechin was unprecedented.

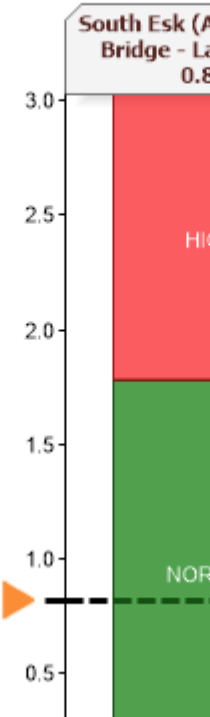
By contrast the river level guage upstream at Gella Bridge showed water levels 0.5m BELOW the record set in December 2015:

Station Name	South Esk (Angus)@Gella Bridge	?
Level Data (.csv, .json, .xml)	CSV   JSON   XML	?
Gauge Datum (mAOD)	213.63	?
Catchment Area (km2)	130	?
Record Start Date	December 1990	?
Highest Level on Record	3.031 at 2015-12-30 13:30:00	?
Lowest Level on Record (m)	0.049	?
National River Flow Archive Link	Click here	?

This data also suggests that the 80mm rainfall recorded at the same location was not a record
