Storm Babet, the Angus grouse moors and the flood destruction in Brechin

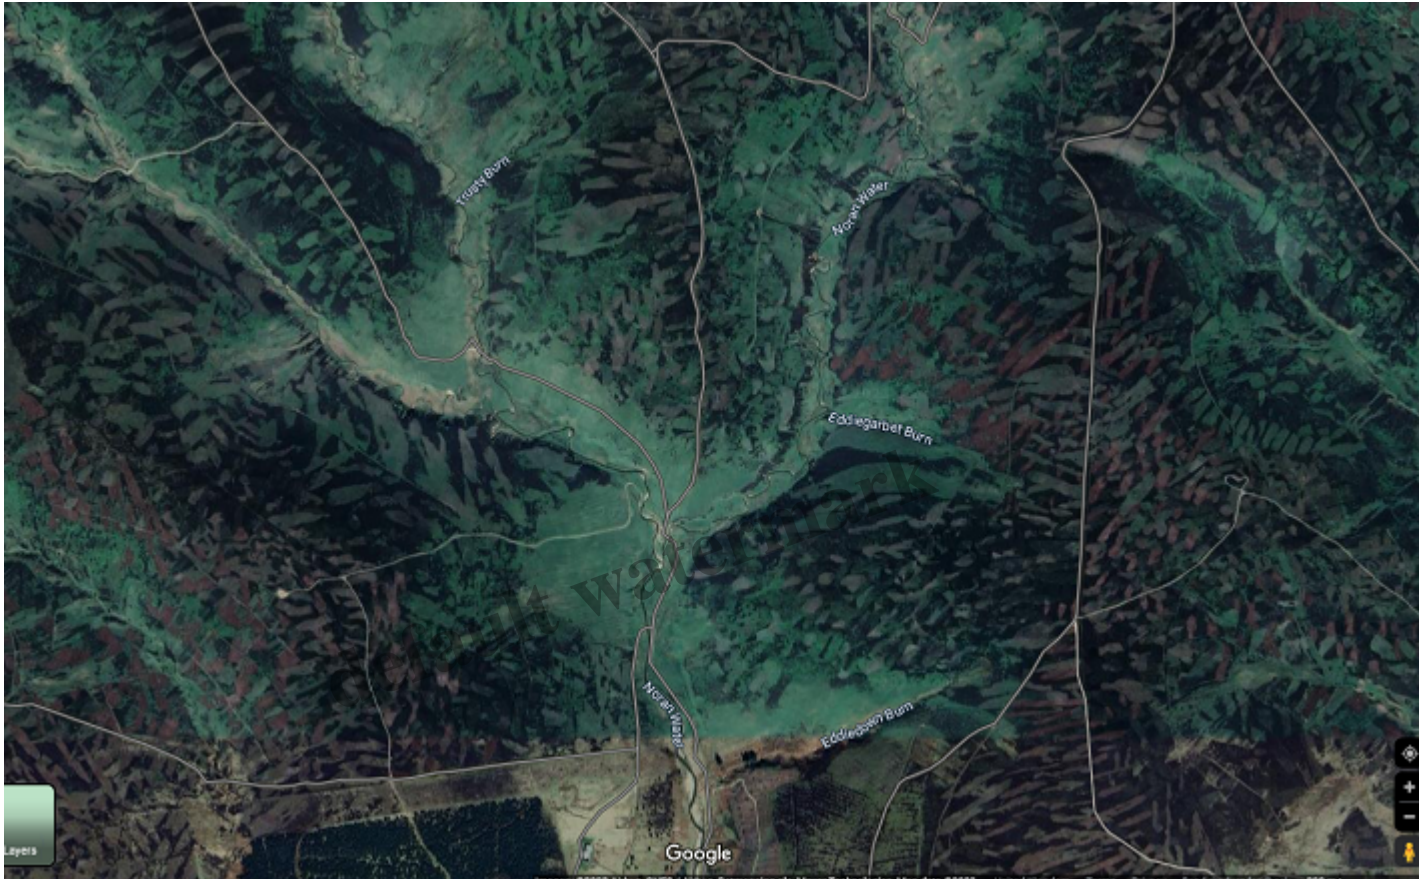
Muirburn around the catchment of the Noran Water, one of the main tributaries of the River South Esk, which joins it south the the Highland Boundary Fault upstream of Brechin. Photo credit google maps.

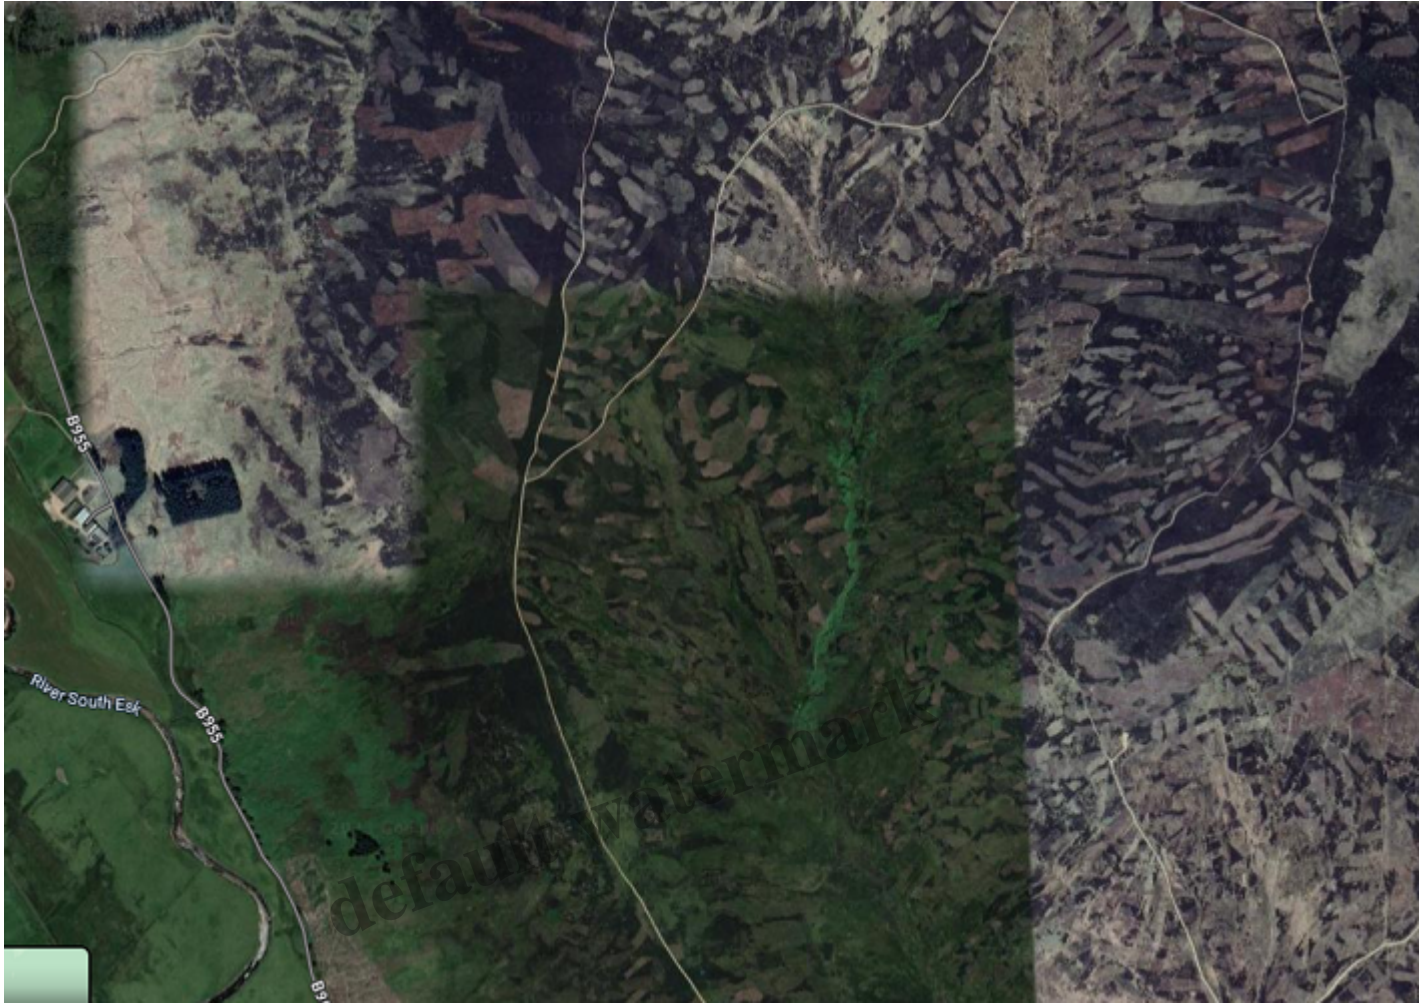
Muirburn on the eastern side of Glen Clova south of the Cairngorms National Park. Photo Credit google maps

The muirburn, besides destroying peat which helps absorb rainfall, also removes surface vegetation, including plant litter, which helps slow the flow of water downhill. The rate of water run-off is almost certainly sped up further where the burned strips are oriented downhill, rather than across slopes.

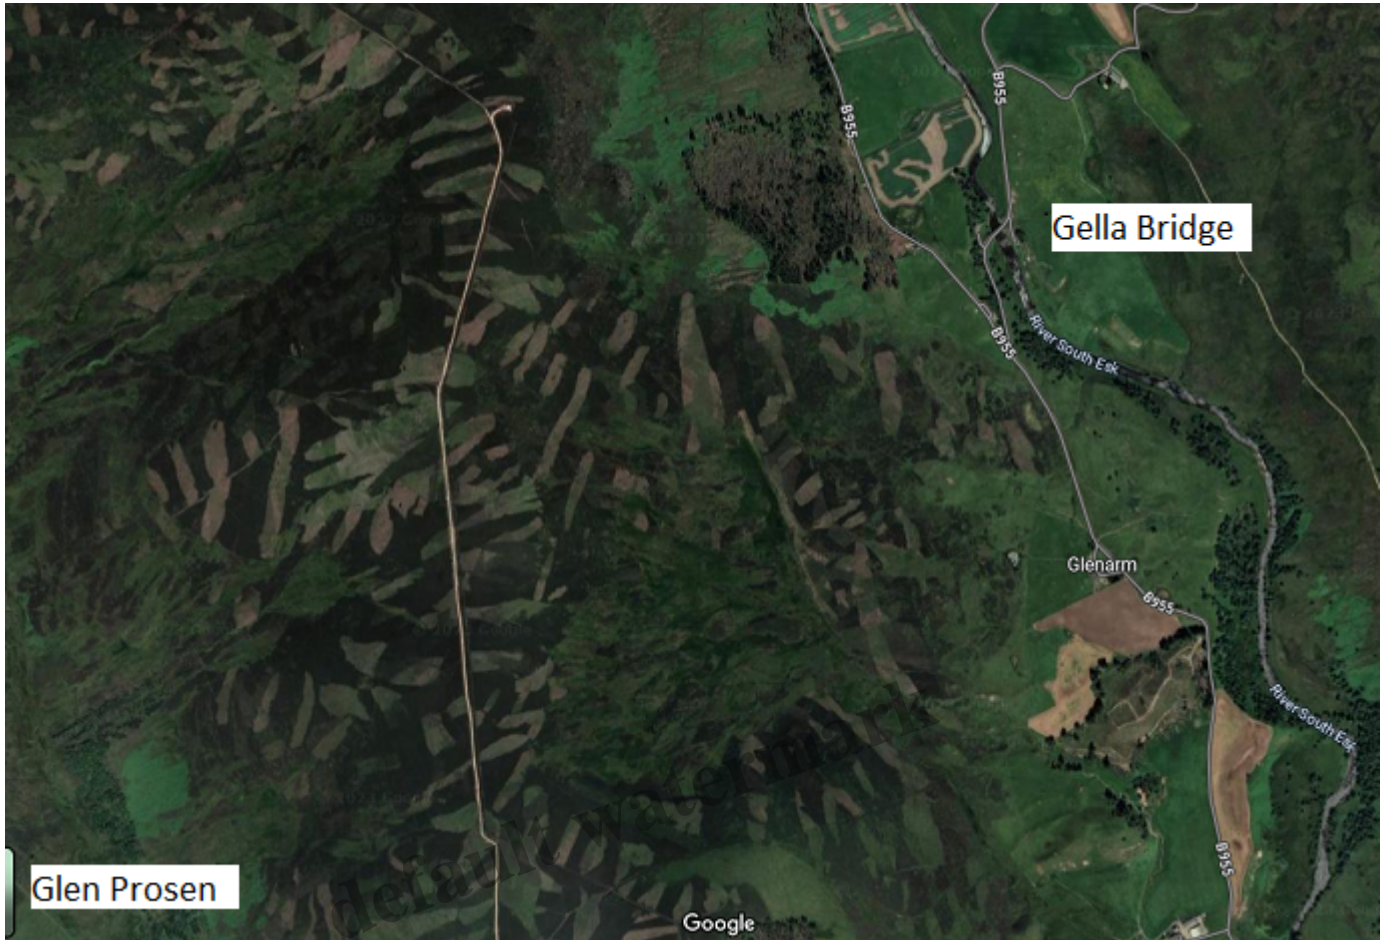
Water running off the muirburn strips on the left of the photo will have drained into the River Prosen contributing to the record levels recorded at Prosen Bridge

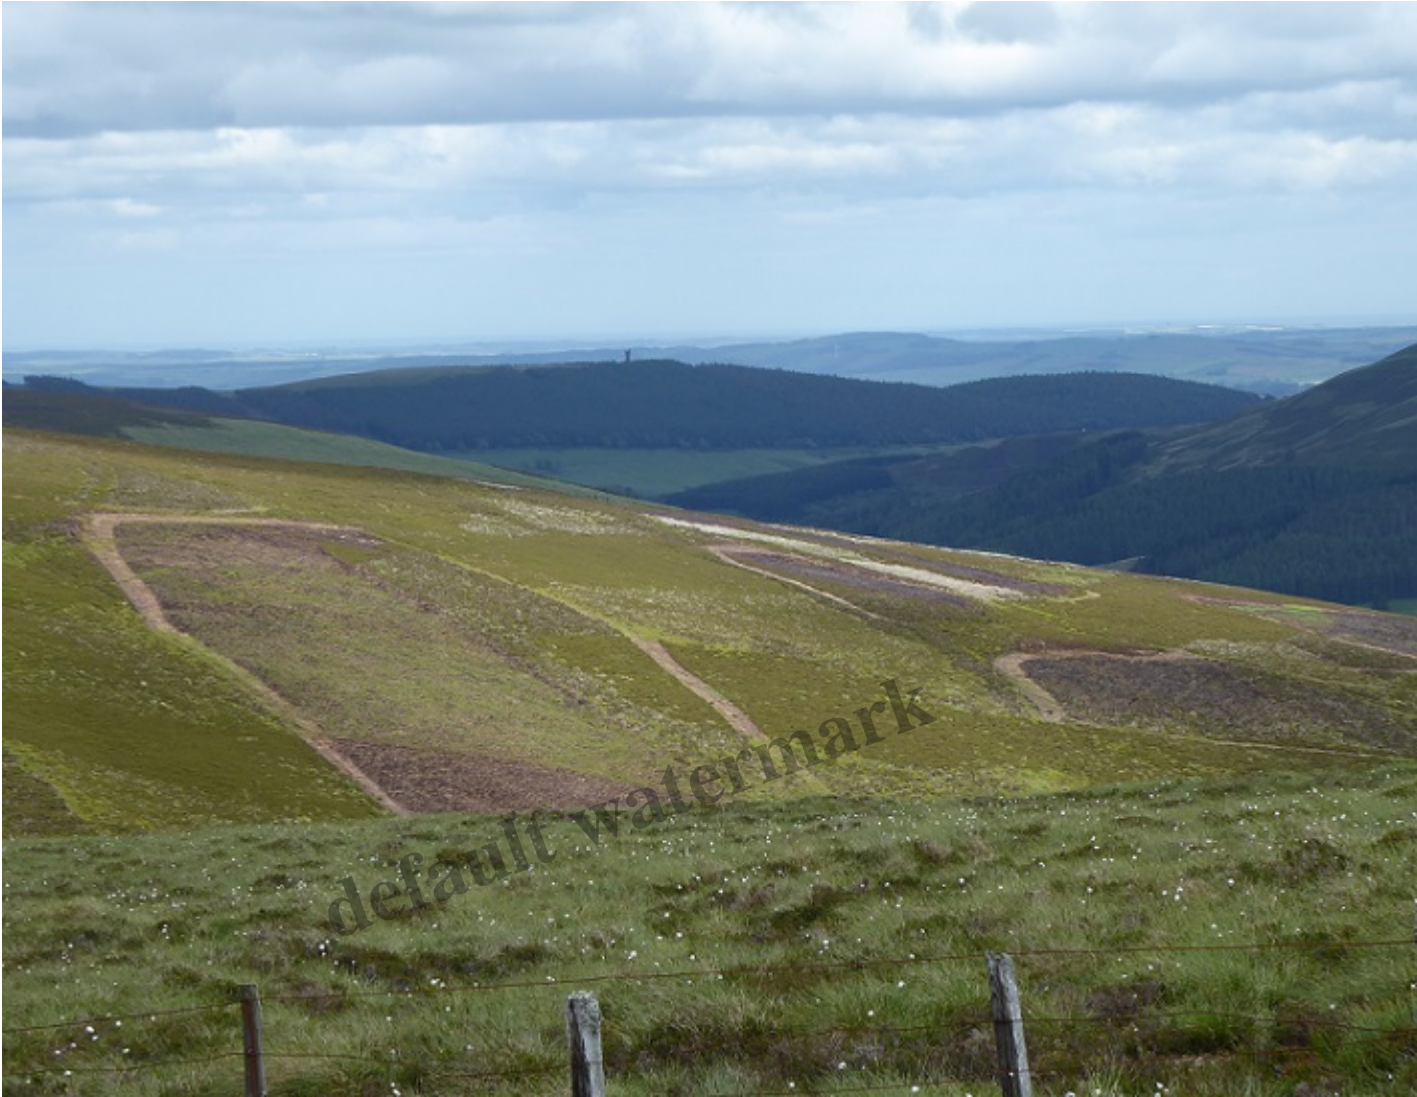
Muirburn Glen Prosen 2016. The difference between the water retention capacity of the slope in the foreground, covered with bog cotton, compared with the burned areas, surrounded by mowed rings, opposite is obvious

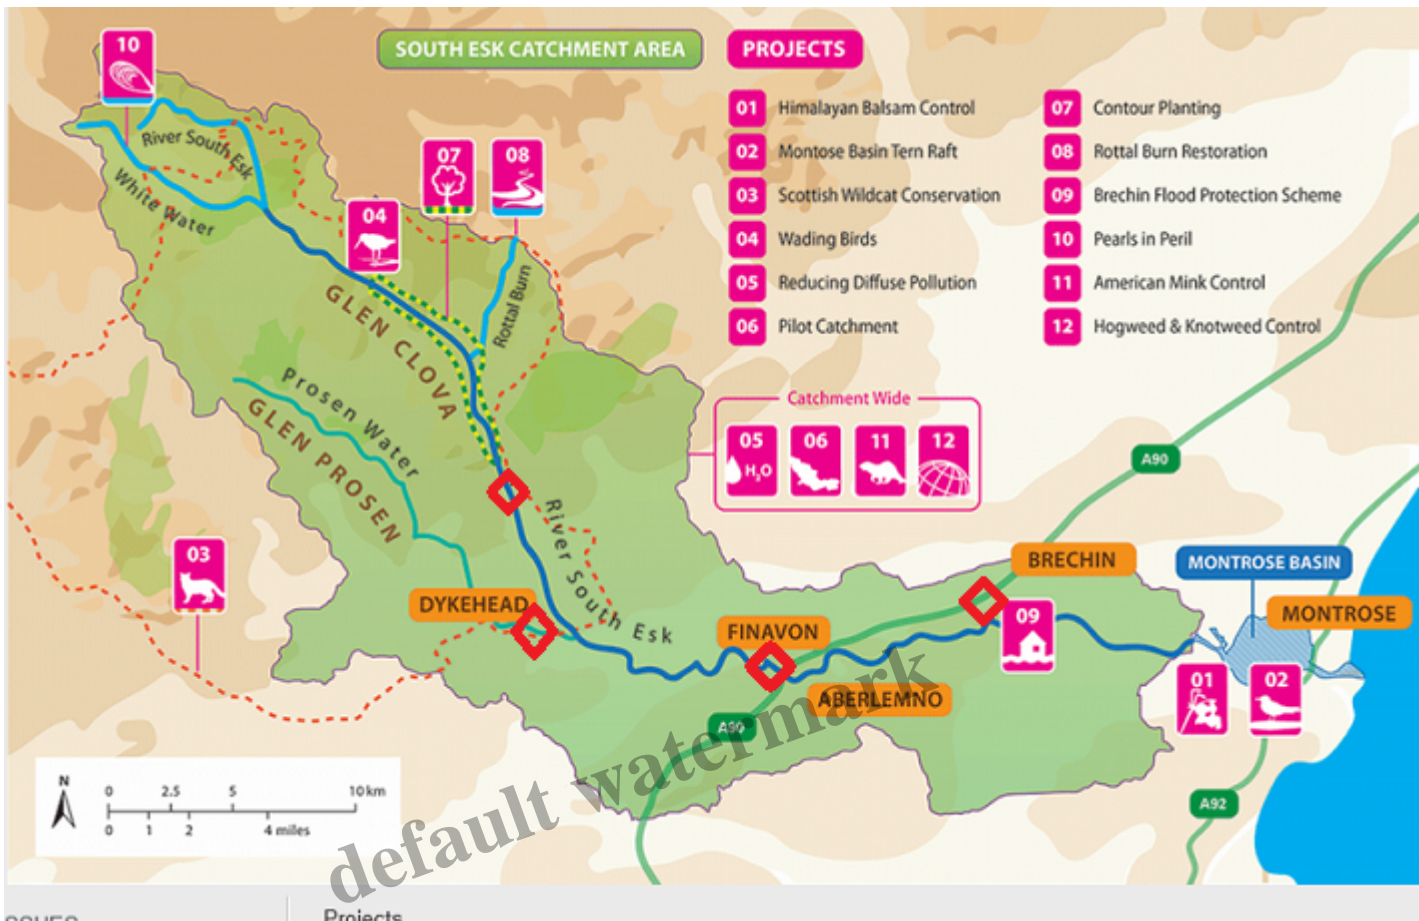
Map annotated with red diamonds showing, from left to right, approx position of SEPA's water monitoring stations at Gella bridge, Prosen Bridge, Tannadice and Brechin. Map Credit River South Esk Catchment Management Plan Review 2017

SEPA has just one rainfall guage for the whole of the River South Esk catchment above the Montrose Basin. It is located in the lower part of Glen Clova at Gella Bridge (top diamond flat above)

SEPA operate more river level gauges than rainfall gauges. There are four on the South River Esk (map above). Those at Brechin and Tannadice were inundated and stopped functioning but not before the one at Tannadice registered water 0.5m above the previous record. There is general agreement that the level of the water in Brechin was unprecedented.

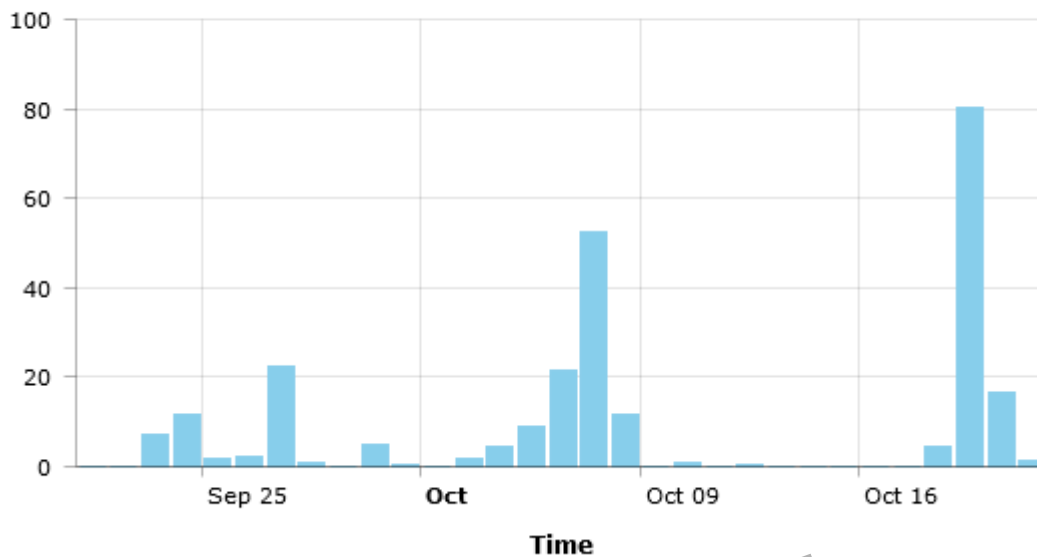
Daily Rainfall in mm at Gella Bridge

The monthly data shows just over 200mm have fallen this month, so far still c80mm below the previous record for the last ten years set in December 2014

The 80mm which fell on 19th October and just under 100mm in 36 hours compares to the 160mm which fell in many parts of Argyll two weeks earlier. Unfortunately, the records for daily rainfall on the SEPA only go back a month so its not possible to tell whether the 80mm was near previous records or not. However, if the rain guage is correct, claims in the media that Storm Babet brought a month of rain in a day should be taken with a large glass of salt water. The lack of further rain guages makes it impossible to say how much rain might have fallen elsewhere in the catchment except for the Montrose basin, where the River South Esk flows out to the sea and 60mm fell in 24 hours..

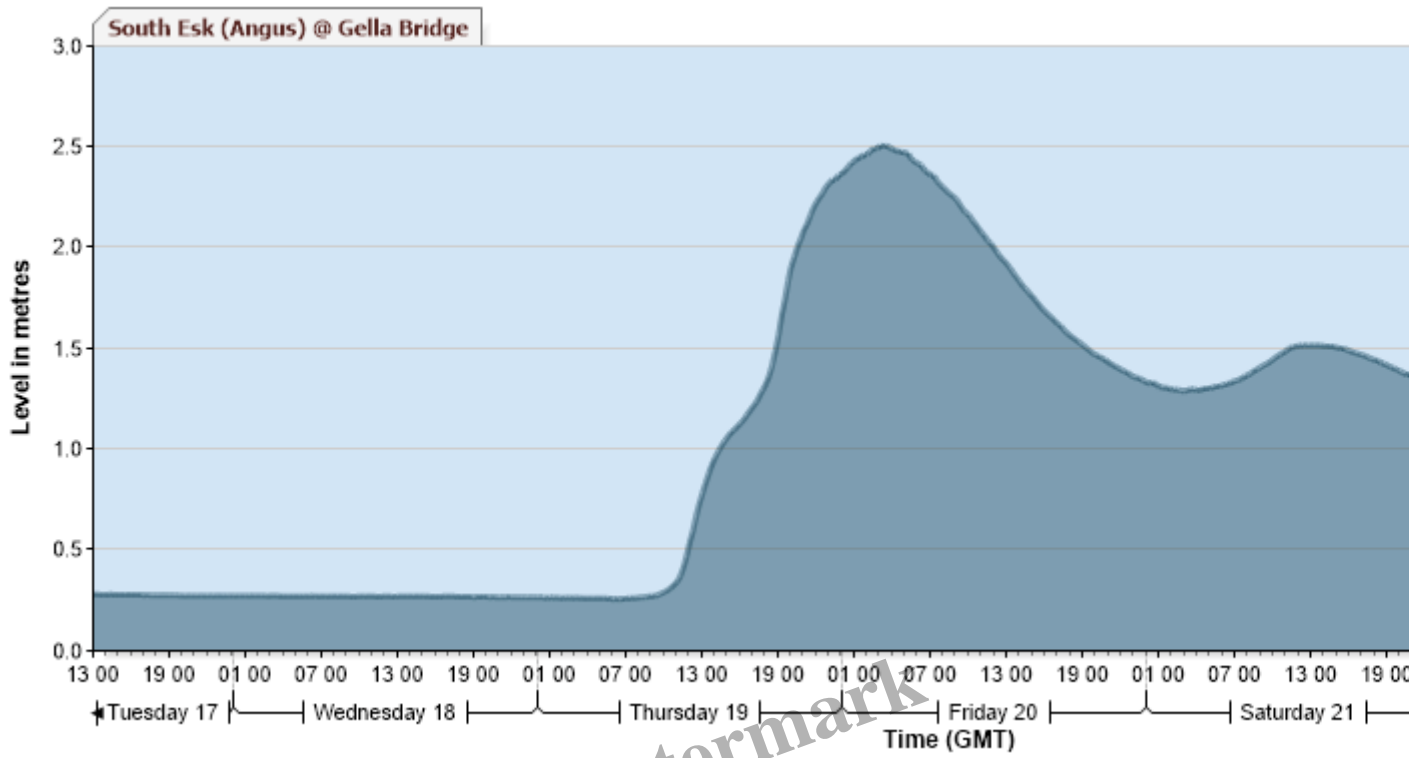
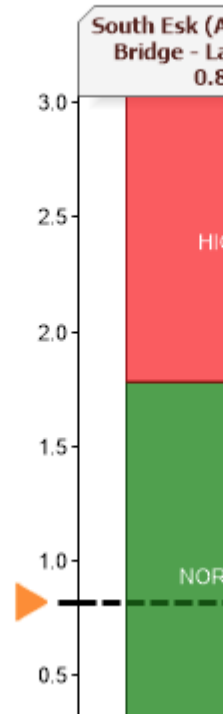
By contrast the river level gauge upstream at Gella Bridge showed water levels 0.5m BELOW the record set in December 2015:

Station Name	South Esk (Angus)@Gella Bridge
Level Data (.csv, .json, .xml)	CSV JSON XML
Gauge Datum (mAOD)	213.63
Catchment Area (km2)	130
Record Start Date	December 1990
Highest Level on Record	3.031 at 2015-12-30 13:30:00
Lowest Level on Record (m)	0.049
National River Flow Archive Link	Click here

This data also suggests that the 80mm rainfall recorded at the same location was not a record

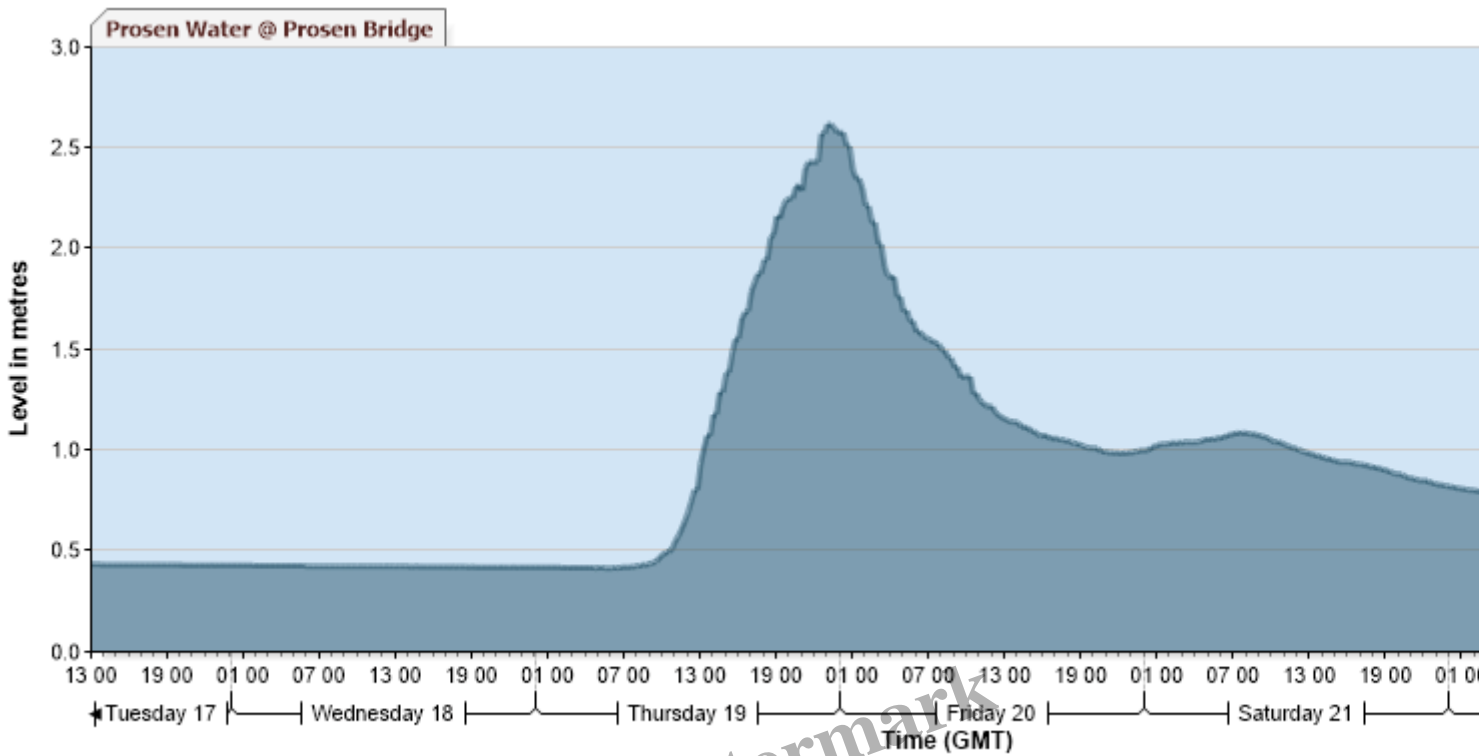
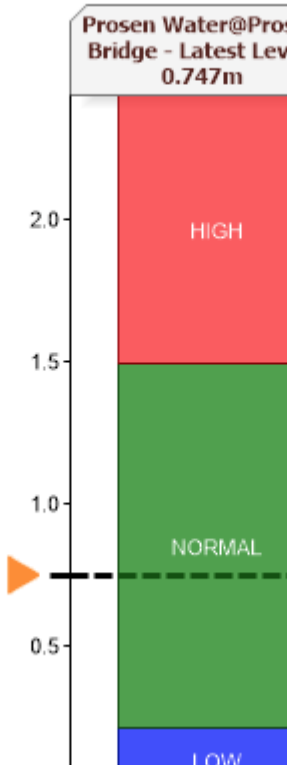
The guage on the River Prosen, which enters the South River Esk a little downstream, however did show that water levels had breached previous records – but not by that much:

Station Name	Prosen Water@Prosen Bridge	?
Level Data (.csv, .json, .xml)	CSV JSON XML	?
Gauge Datum (mAOD)	109.3	?
Catchment Area (km2)	104	?
Record Start Date	November 1984	?
Highest Level on Record	2.436 at 2014-11-14 17:00:00	?
Lowest Level on Record (m)	0.018	?
National River Flow Archive Link	Click here	?

This data strongly suggests that MORE of the water that was responsible for the the record floods levels in Brechin entered the River South Esk downstream from the upper part of Glen Clova. This

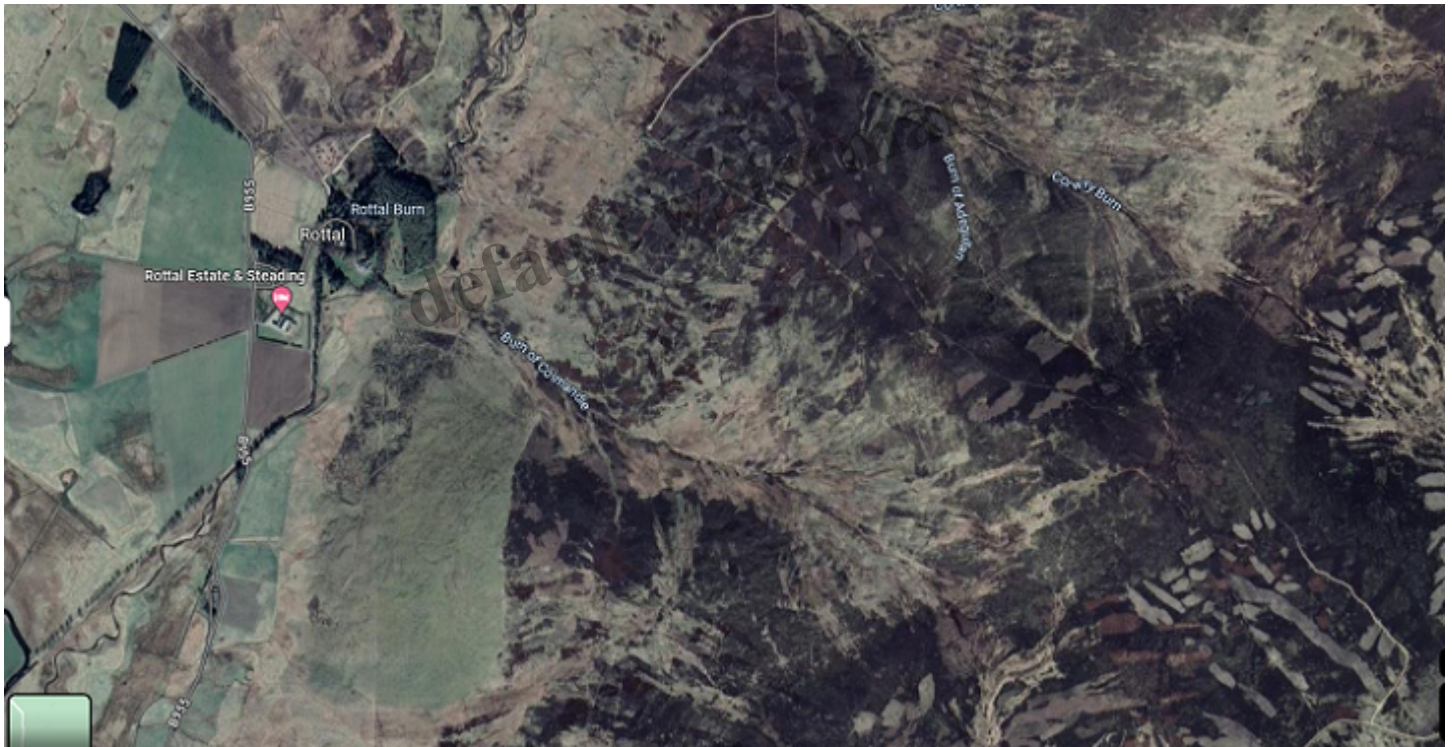
Great stuff but meantime the muirburn on the hillsides above the Rottal Burn appears to have continued unabated:

Perhaps that muirburn could help explain why a bridge on the Rottal Estate was swept away by Storm Babet ([see here](#)) despite the river being re-engineered? How the roaring river shown in that link fits with the the river levels recorded at Gella Bridge downstream is unclear. Perhaps the Gella Bridge guage was malfunctioning or perhaps the Rottal Estate received the brunt of the rainfall or perhaps more water drained off its hillsides than elsewhere in the upper part of Glen Clova? Someone in government should be asking these questions and trying to ascertain the answers.

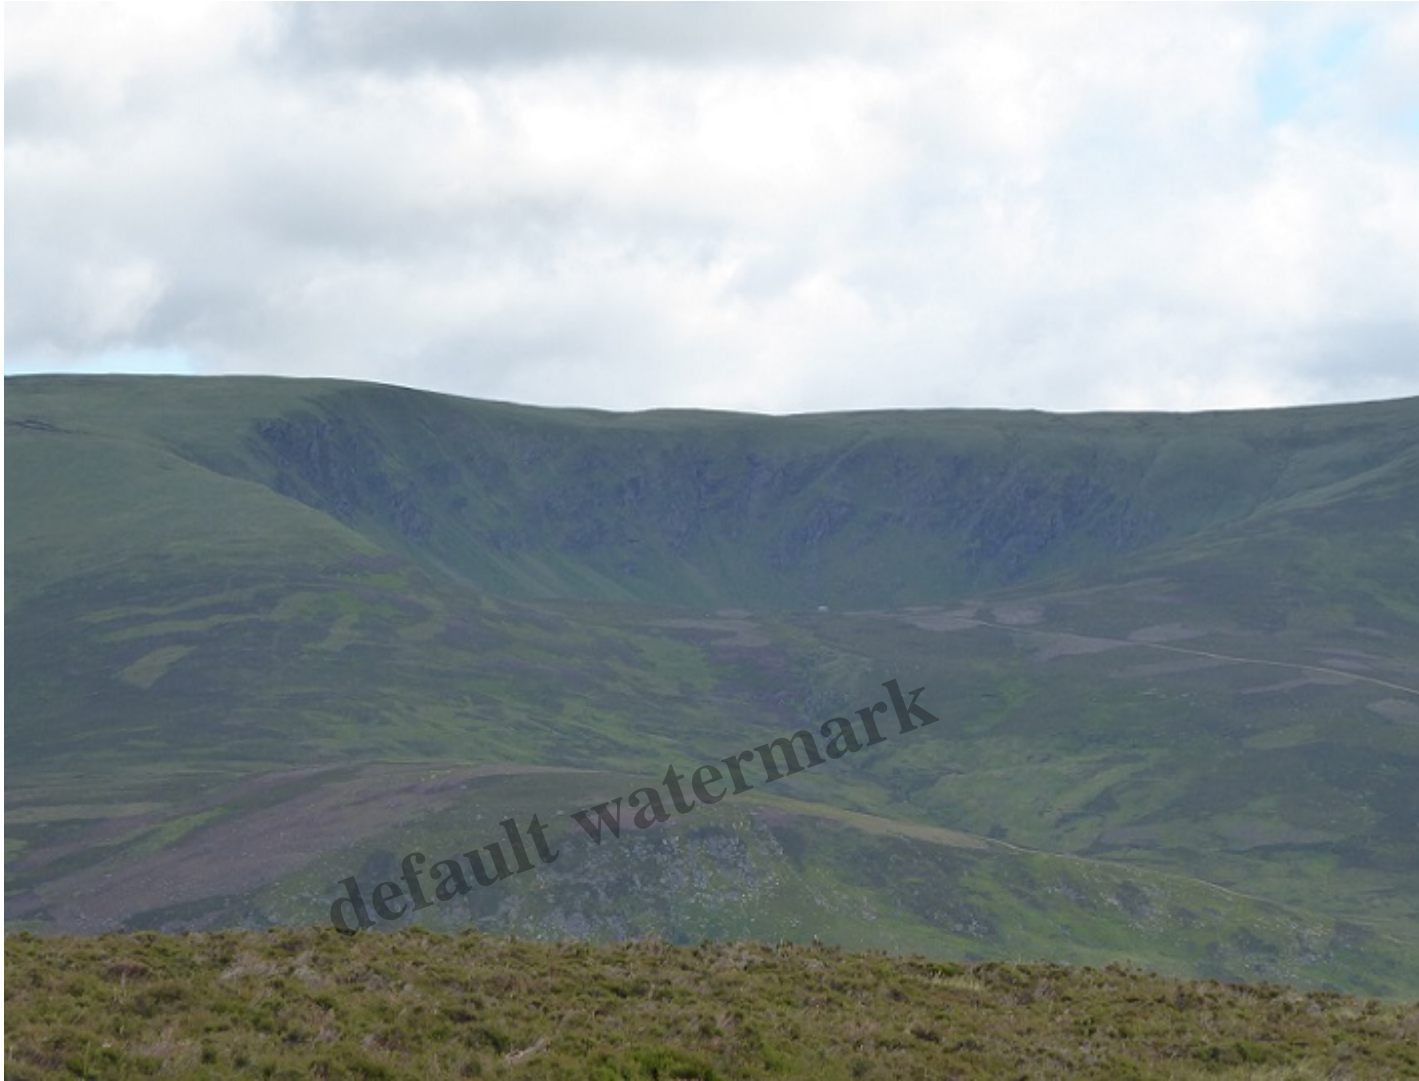
Muirburn below Craigs of Loch Wharral on the east side of Glen Clova and in the National Park viewed from Coremachy 2016
