The end of the Cononish goldmine – what will be the environmental and financial costs?

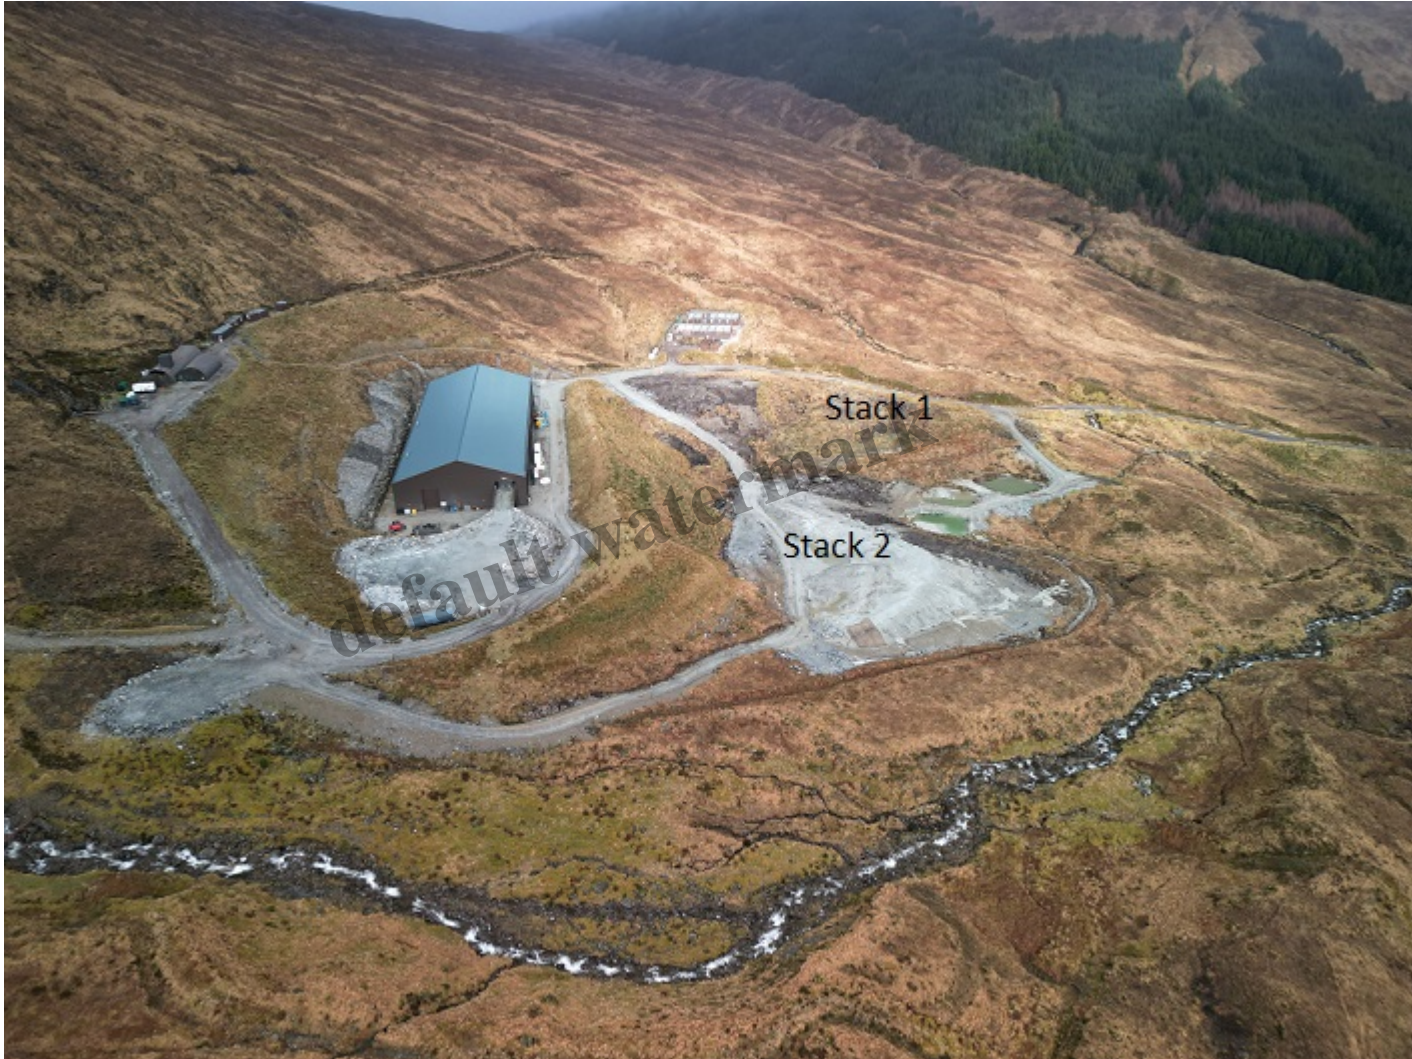
Overview of main part of Cononish goldmine mid-February 2024 showing the production shed and tailings stacks. The containers behind stack 1 give a sense of scale. Photo credit Harry Barnes.

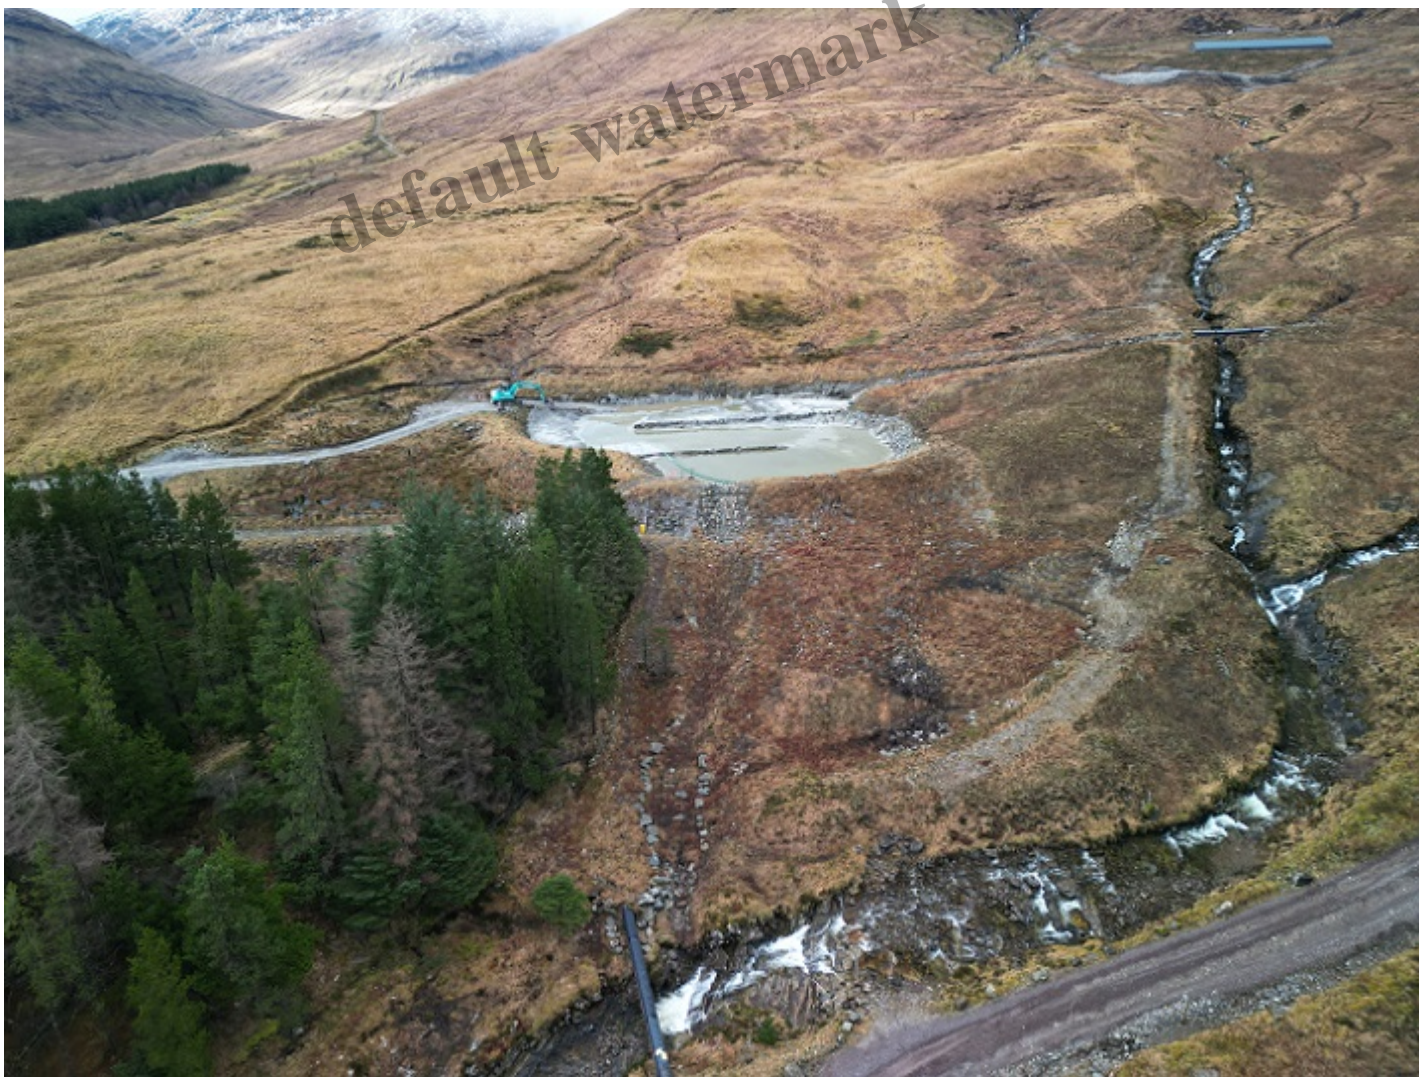
The largest settlement pond with tailings stack 2 and mine shed visible top right, The pipe, centre

foreground, takes the “clean” water from the pond and discharges it in the River Cononish which is a Special Area of Conservation. After a period of heavy rain in January I had heard this pond was overflowing and sediment washing down in the river system. Photo credit Harry Barnes.

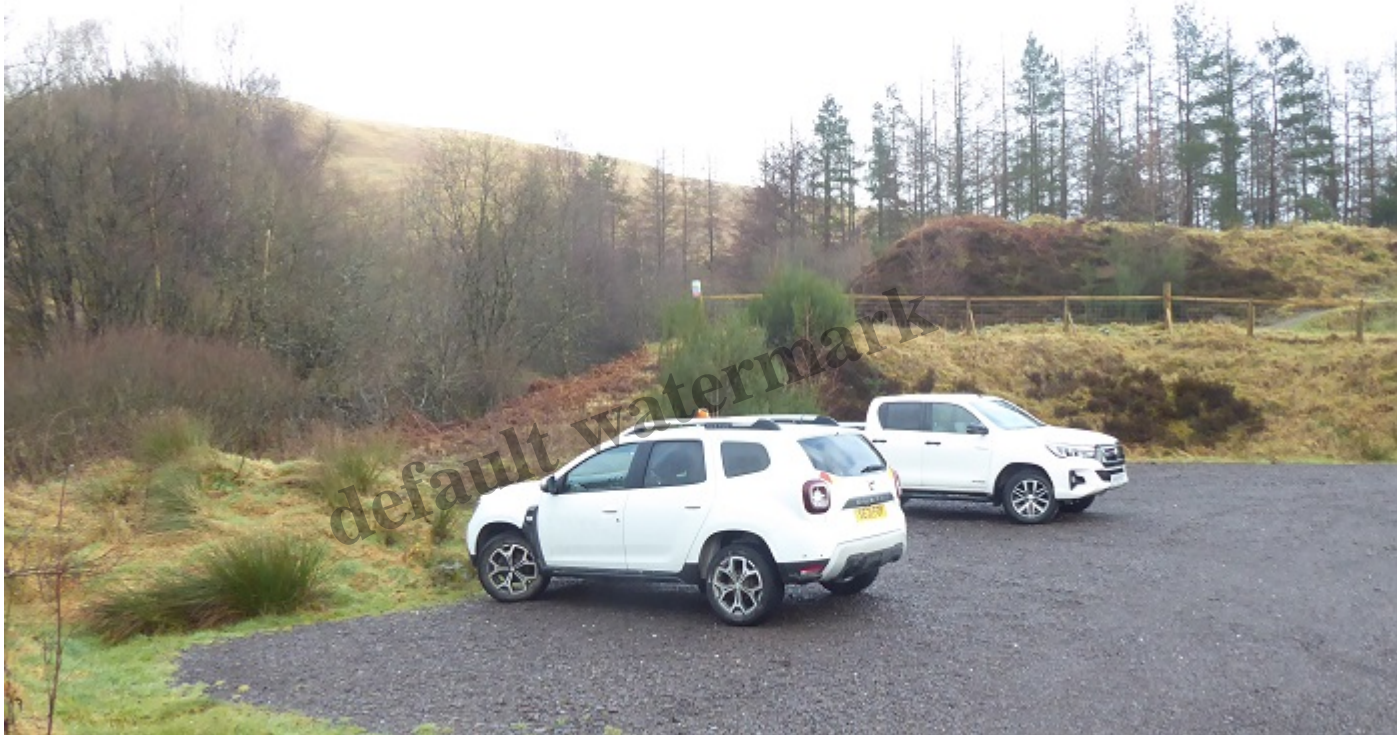
The former car park for mine staff. The most recent planning monitoring report from last August published on 22nd February indicated that the local community development trust was taking over this car park so the vehicles were probably not connected with the mine.

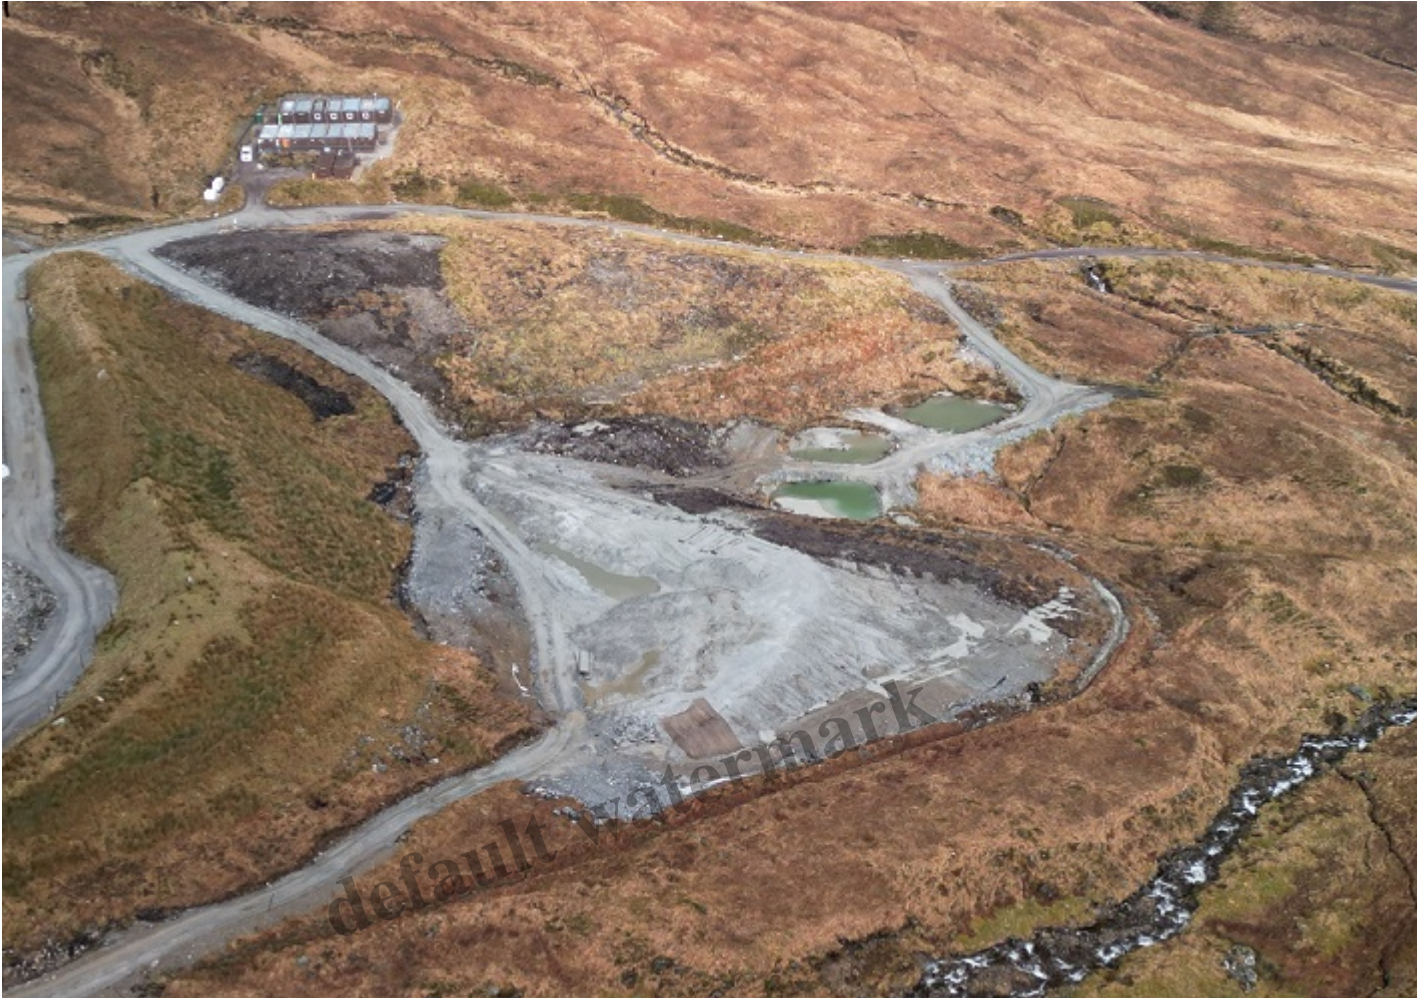
The stacks were supposed to be restored as they went along, reducing the landslip and pollution risks but stack 2 has now been exposed to the weather for over 6 months. Note the drainage ditch on the right which is designed to take take silty run-off to the small settling ponds behind. Photo credit Harry Barnes.

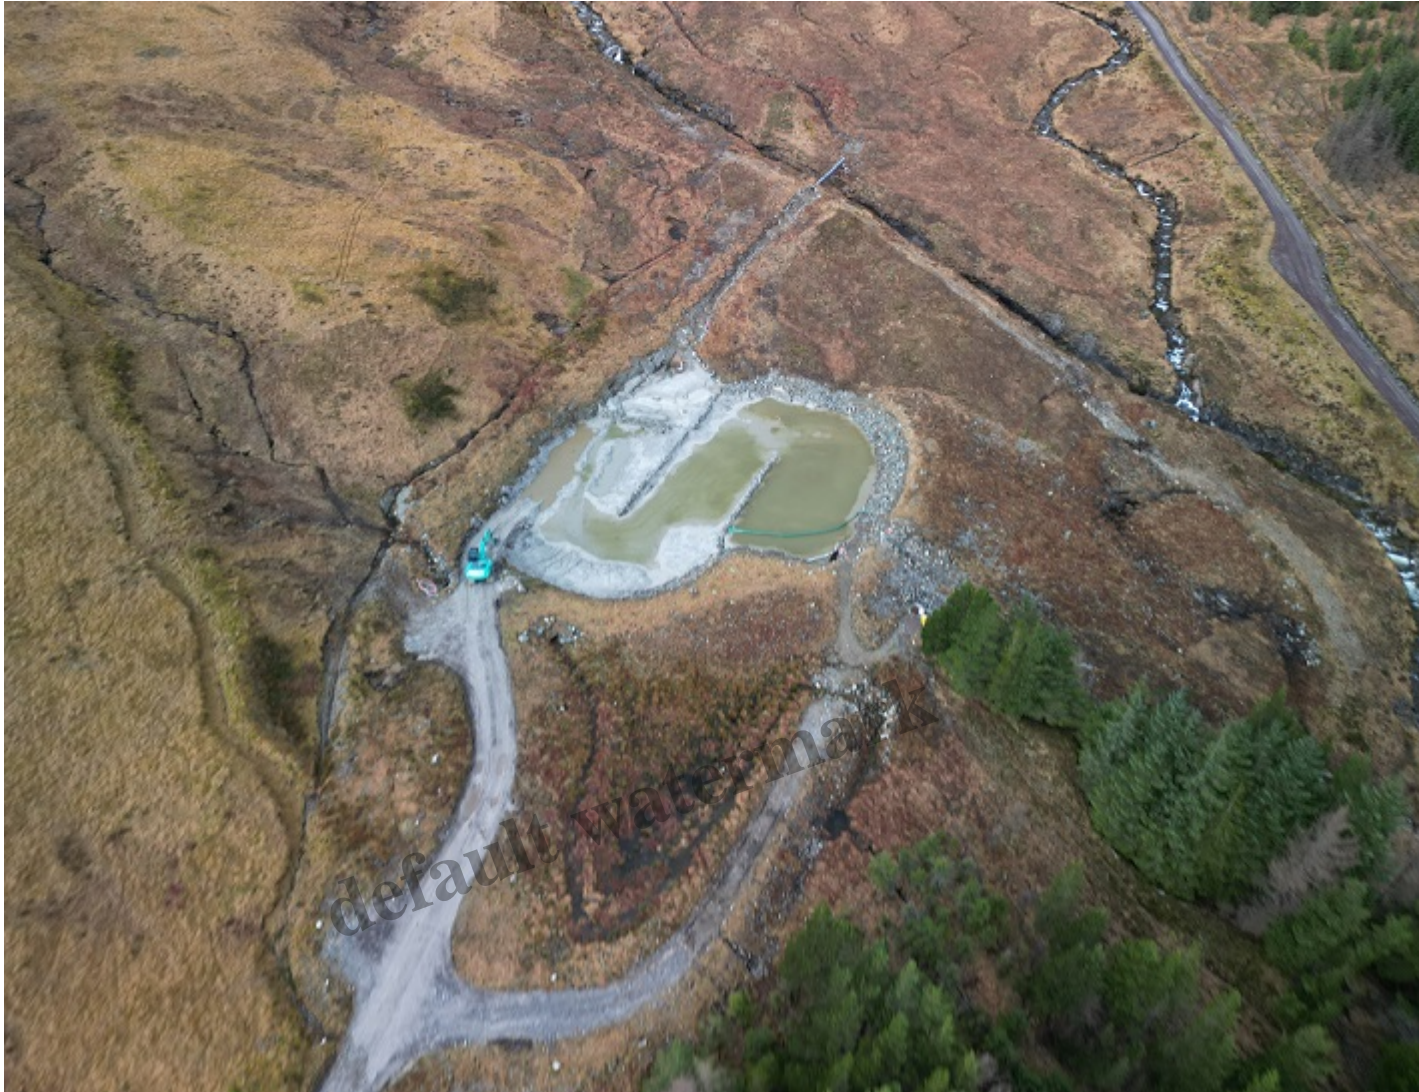
Lower settlement pond still full of sediment six months after the mine ceased to operate. Photo credited to Harry Barnes.

It appears that some arrangements may still be in place to care and maintain the mine site. In the photo above the presence of the digger and the green boom, designed to protect the outflow from the pond and in the right place, suggests some maintenance has been taking place. The pond, however, is not being emptied of sediment as it should be and there was little other machinery visible on site (another contrast to my visit in October). It is possible therefore that maintenance is being provided by contractors on a needs be basis rather than staff permanently based on the site who can see what is going on. If so, it is not clear who is paying for this.

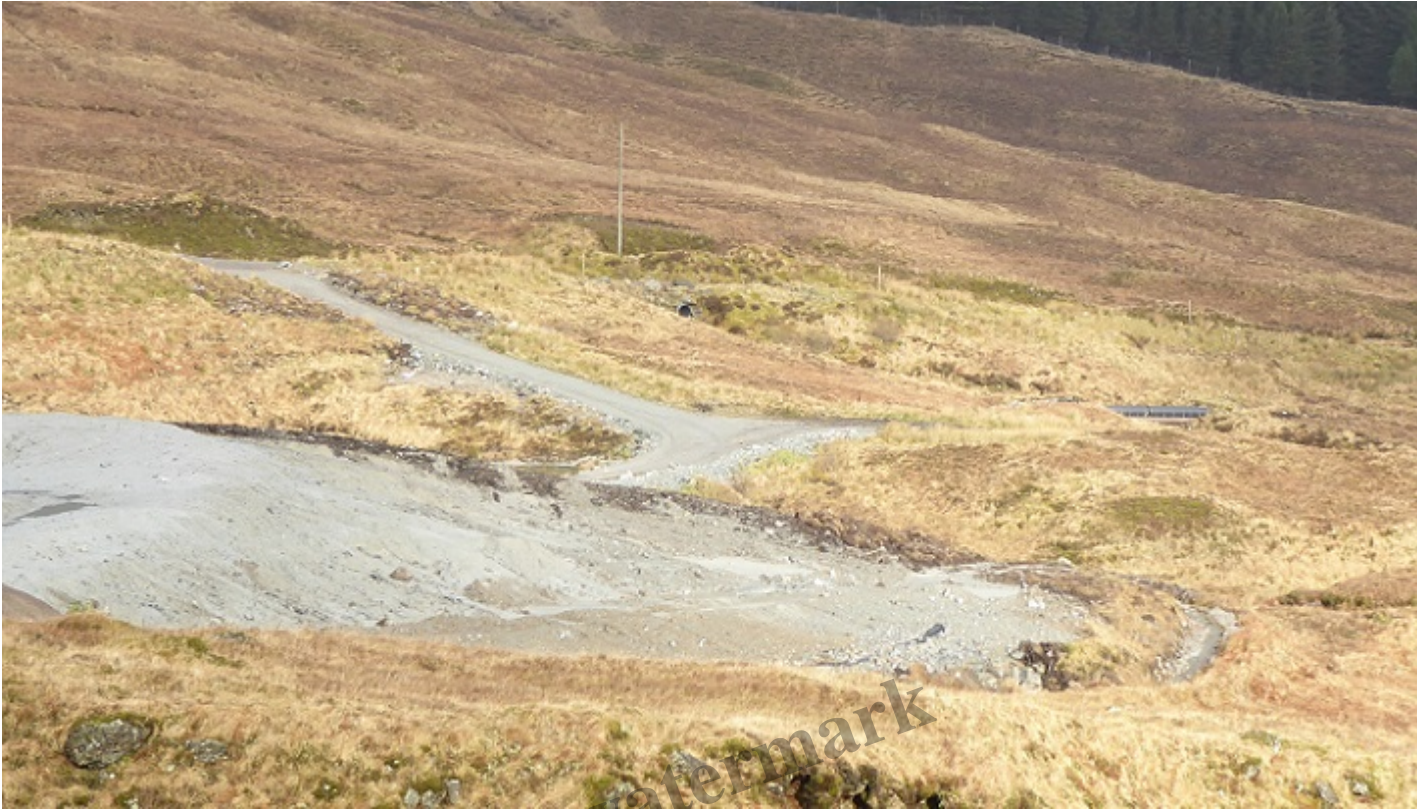
Tailings stack 2 with the drainage ditch designed to catch run-off visible below. The side of the main heap has clearly been eroded by water.

The main short-term risk at present is the “new” tailings stack that was started last year and the significant amounts of silt that are visible across the site. On a dry day and in a dry period, such as when we visited, this is not a problem. The issue is when the site is very wet and it then rains heavily.

The Mine Monitoring reports published on the LLTNPA’s planning portal record a history of sediment laden discharges into the River Cononish after heavy rainfall, a breach of planning conditions. For example, the most recent report dated 23rd August 2023 and published last week reports:

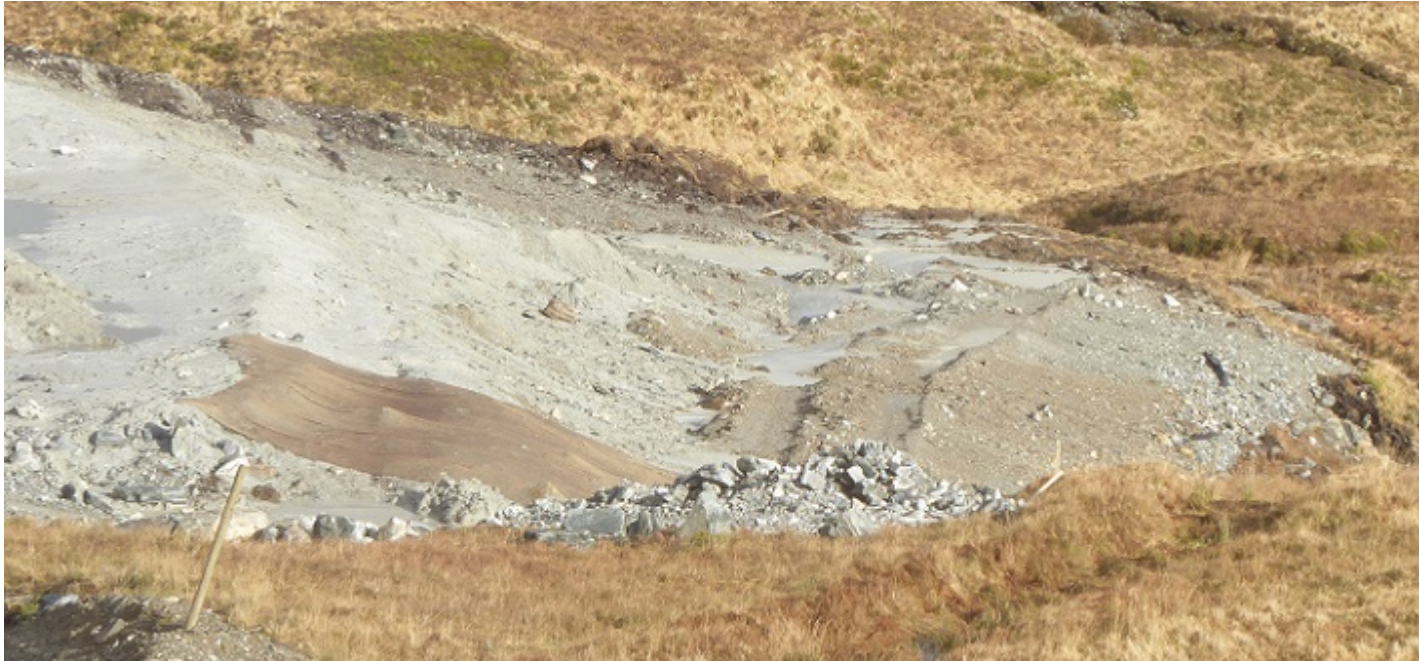
Note the matting, an attempt to stop a section of the tailings stack eroding away, and how rubble and sediment has been moving over the edge of the stack known as the shear key.

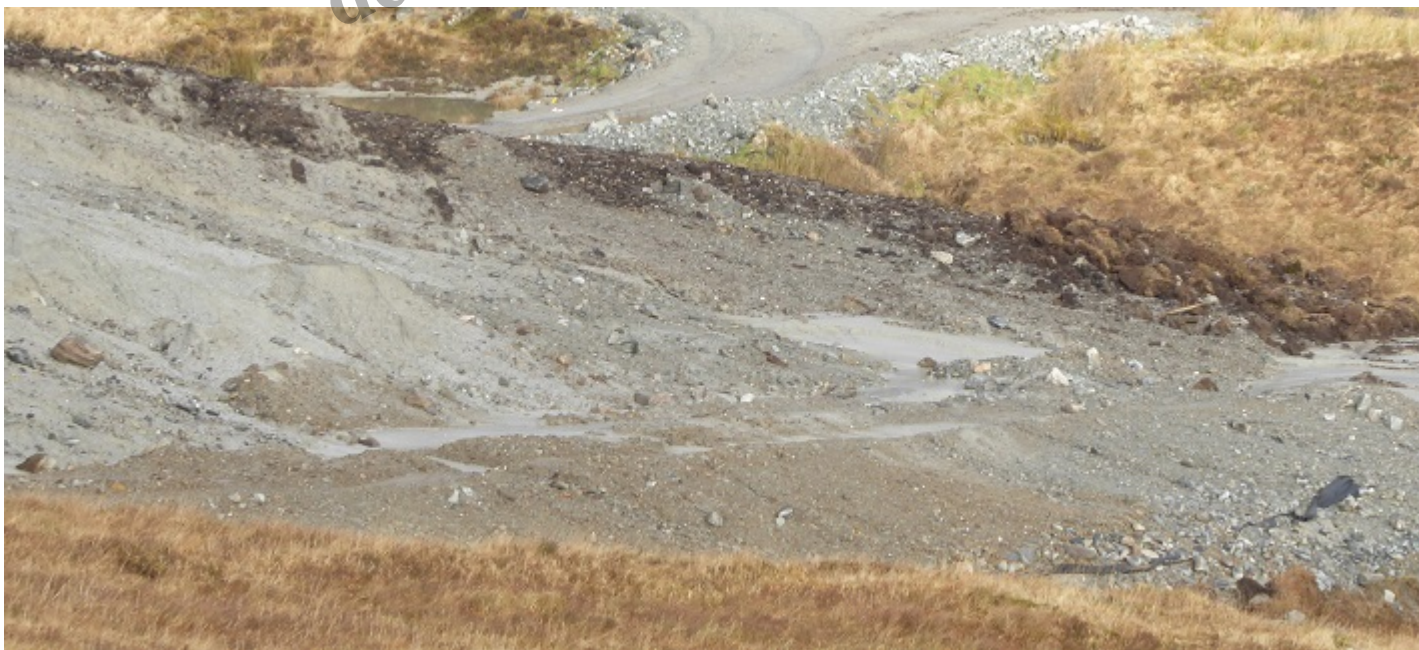
A slightly different angle showing how silt (left and far right) has been running off the side of the stack into the drainage ditch. Also note the failing work to revegetate/re-turf the far side of the stack.

While Stack 2 is clearly eroding away at present, in breach of planning conditions and basic good environmental practice, it may be that the quantity of tailings is insufficient to cause a landslide or for the amount of sediment being washed into the River Cononish Special Area of Conservation to have

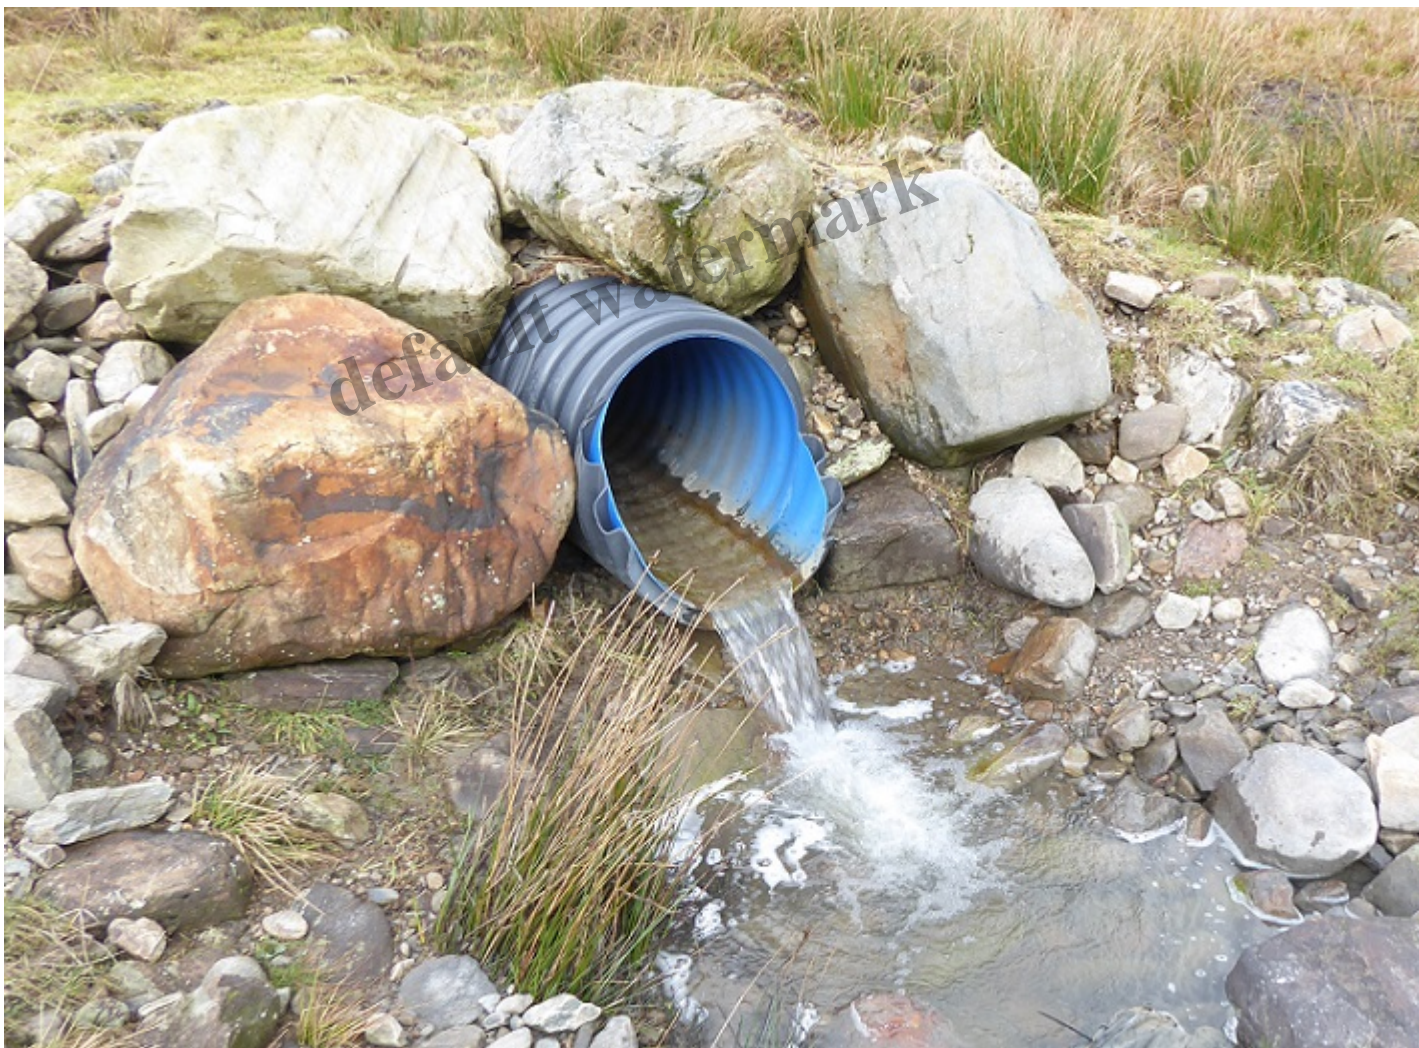
The outflow into the River Cononish

There was not much water flowing out of the pipe from the lower settlement pond and while not laden with sediment it was not as clear the river above. One would have been a fool to drink it.

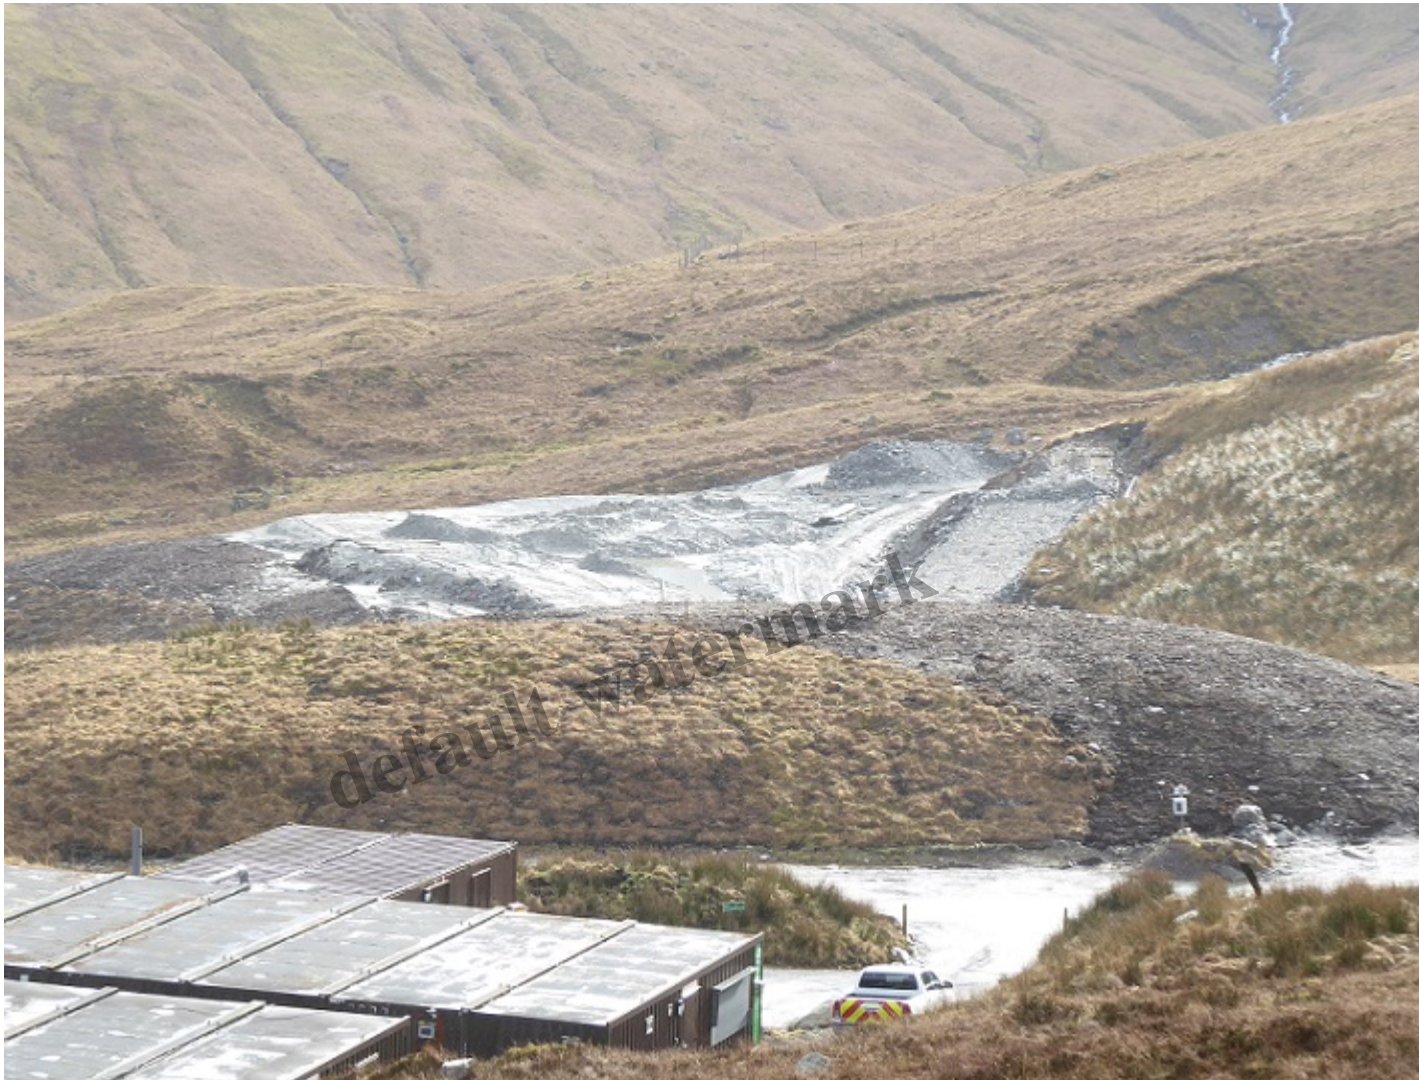
View over Stack 1 to Stack 2 from the north showing how the tailings stack is saturated with water even after a relatively dry spell. The vehicle in the foreground was the only one we saw on our visit. A planning application was submitted in Feb 2023 to retain the containers, which were not part of the original development, as office and welfare facilities. The LLTNPA has never taken a decision on this but is now likely to be left with the responsibility of removing them.

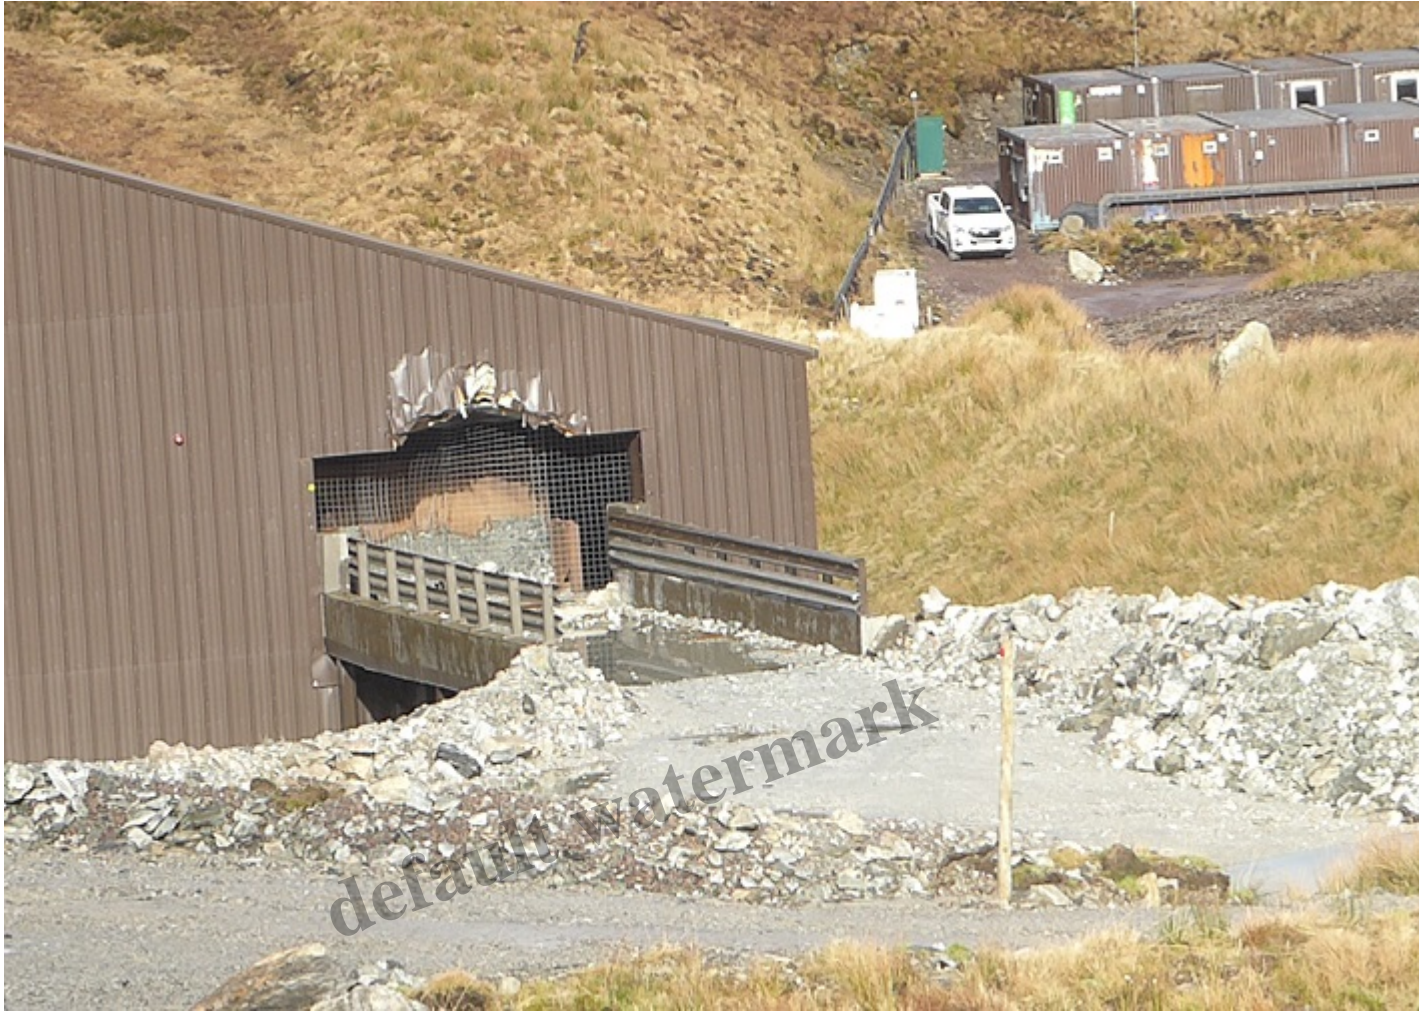
Entrance to the production shed – how did that happen?

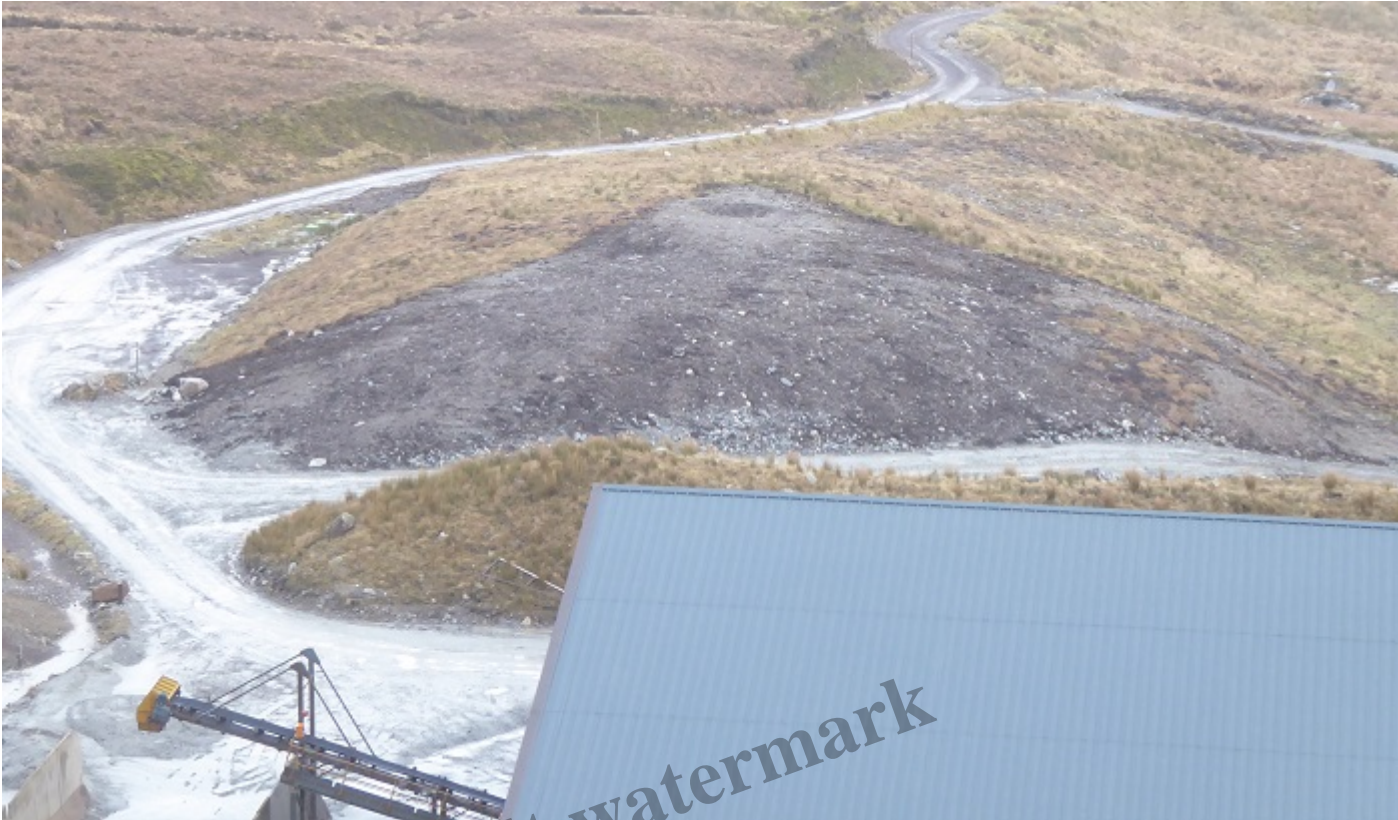
View over roof of production shed showing unrestored area on Stack 1 and the amount of silt on site six months after production ceased and all the winter rain

The August monitoring report records that the bare area of Stack 1 had been returfed and according to SGZ Cononish re-seeded. There is not much sign of that now and meantime the bare peaty soil has been leaking carbon into the atmosphere and gradually eroding. Scotgold claimed they did not have enough turf to cover this stack, as per the planning conditions, so where is the LLTNPA going to get the turf to cover Stack 2?
