The reconstructed Gynack overflow about Kingussie – how long will it last?

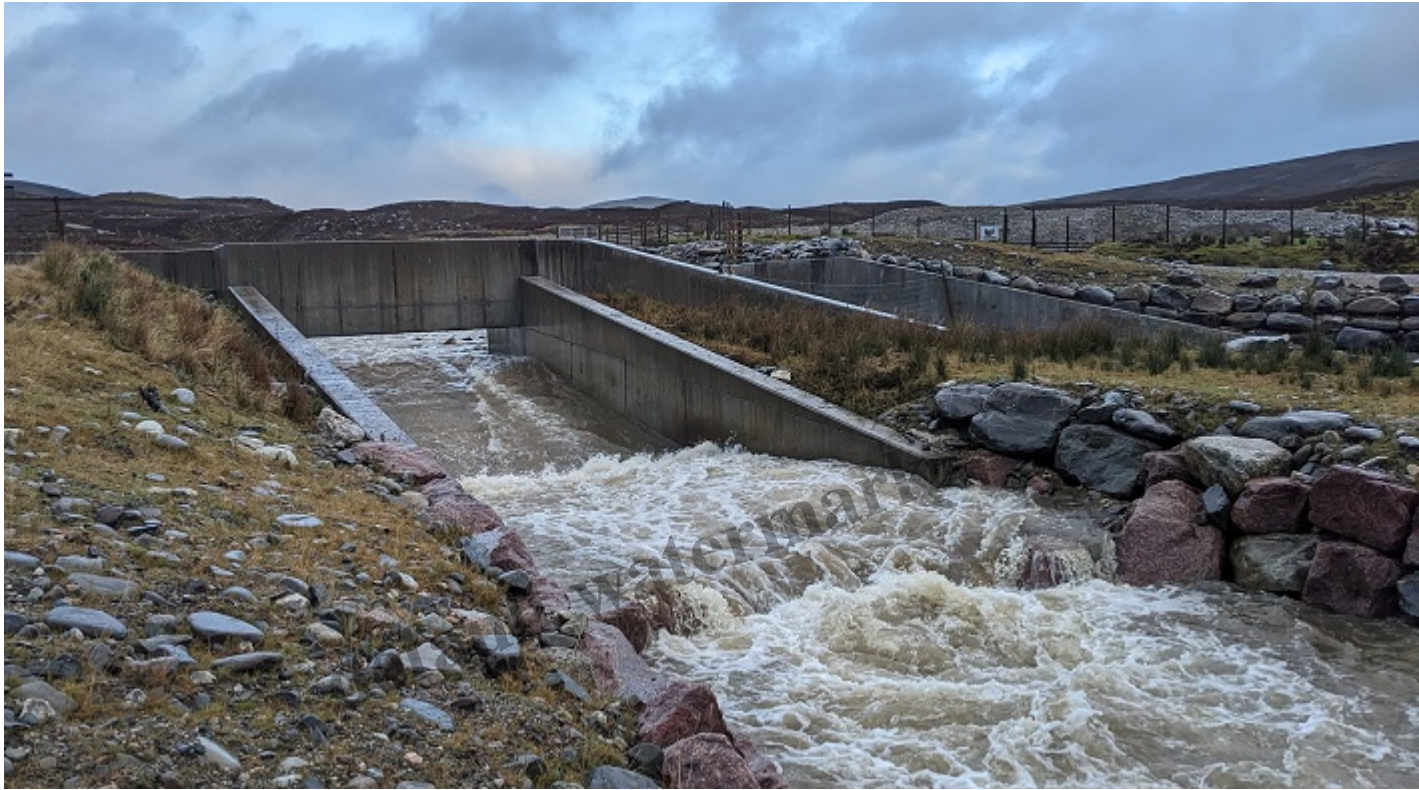
The intake to the Gynack overflow from below 31st Dec 2024

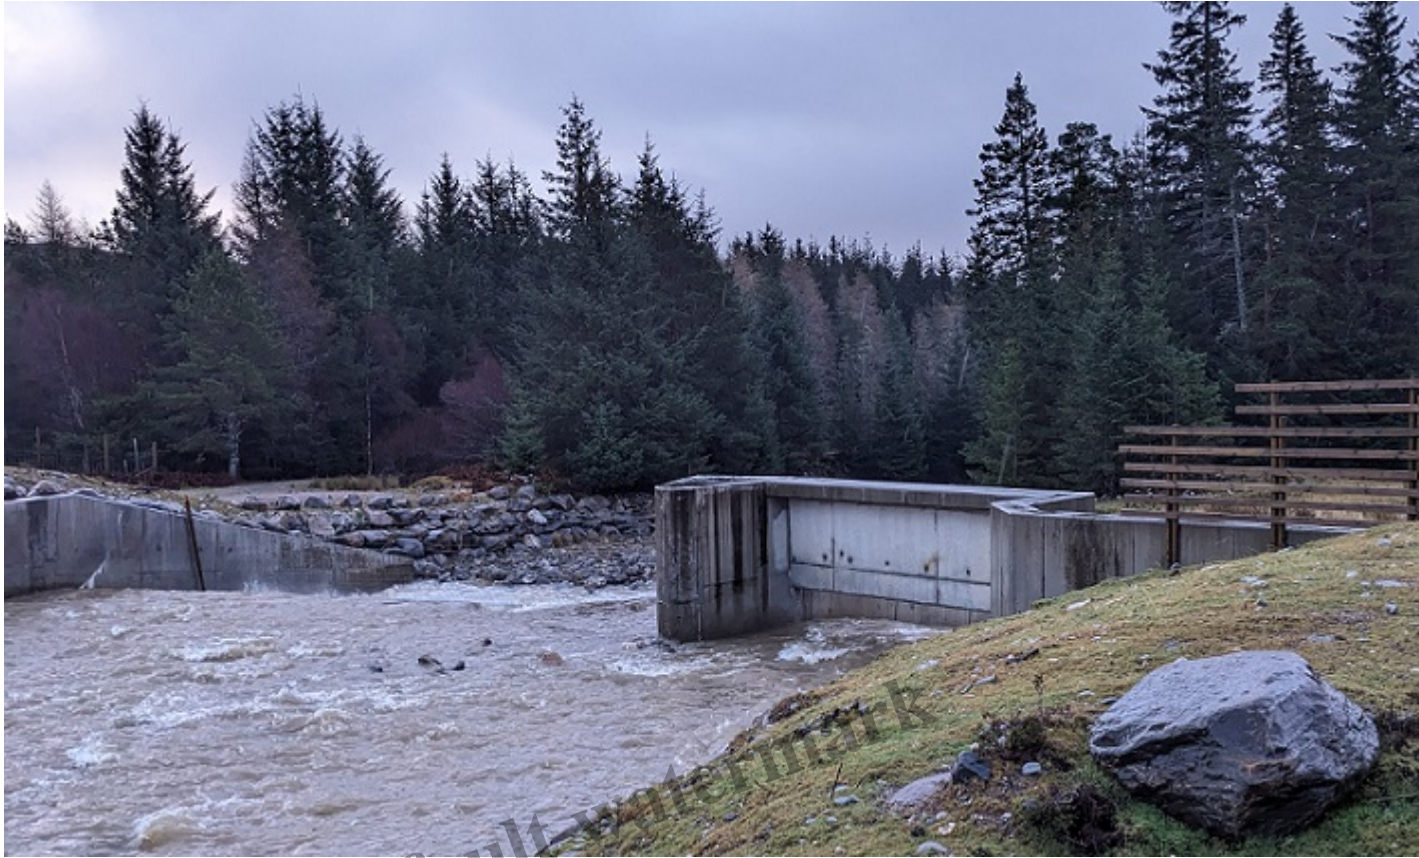
The intake to the Gynack overflow from below. 31st Dec 2024

My estimate from looking at the volume of water flowing through the intake was that the overflow was working at less than half of its maximum capacity. Even so, around the time I visited, the level of water in the River Gynack was sufficiently high for trains on the Perth-Inverness line to be cancelled because of the risk to the railway bridge in Kingussie below [\(see here\)](#).

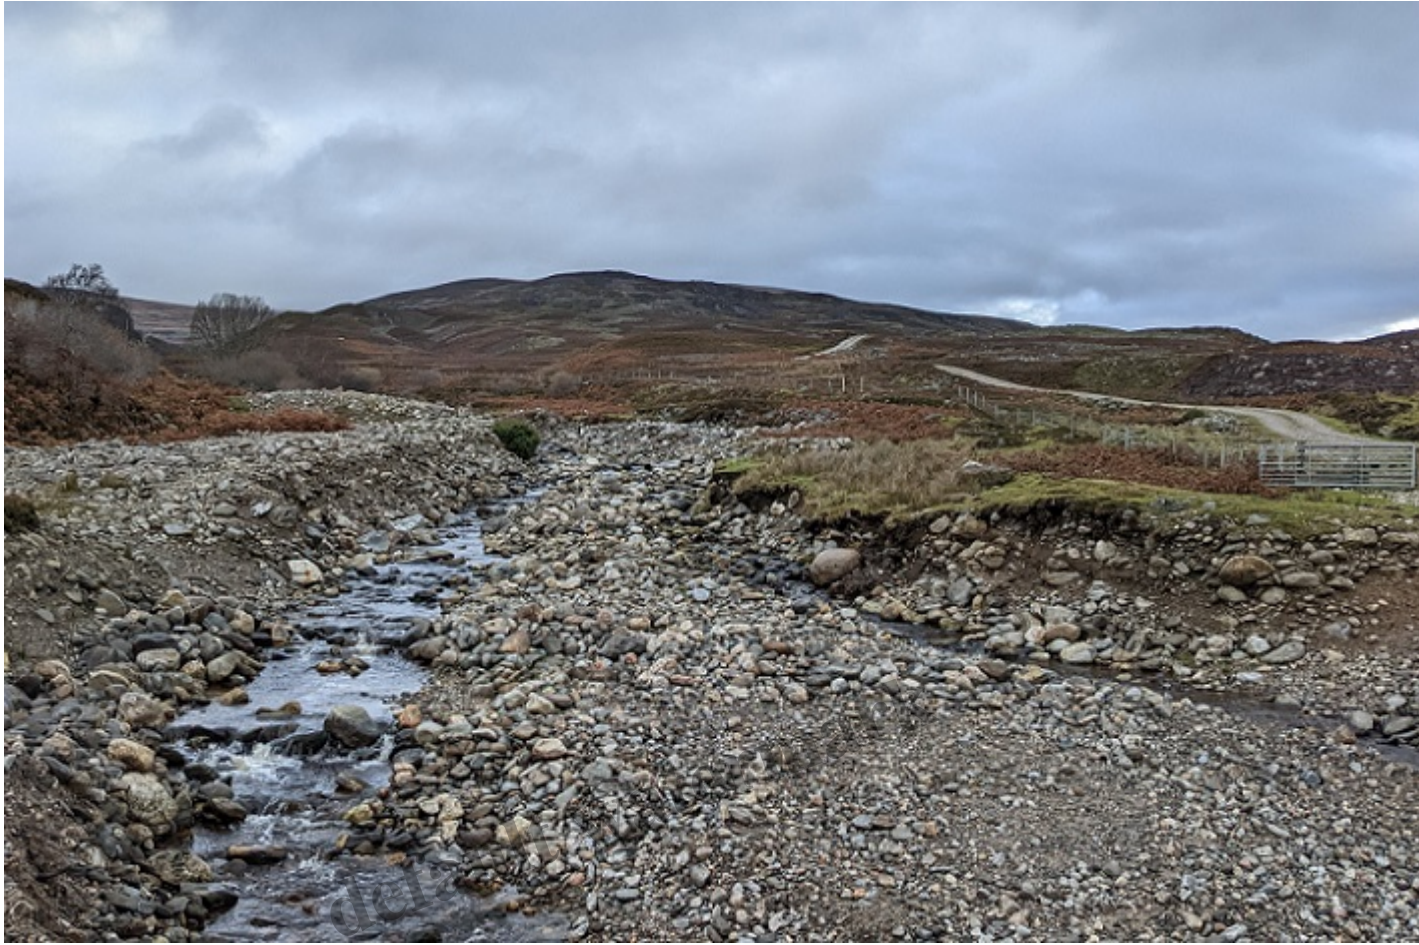
The River Gynack just above the overflow November 2022 with muirburn visible from just behind the gate on the right to the top of the hill in the distance

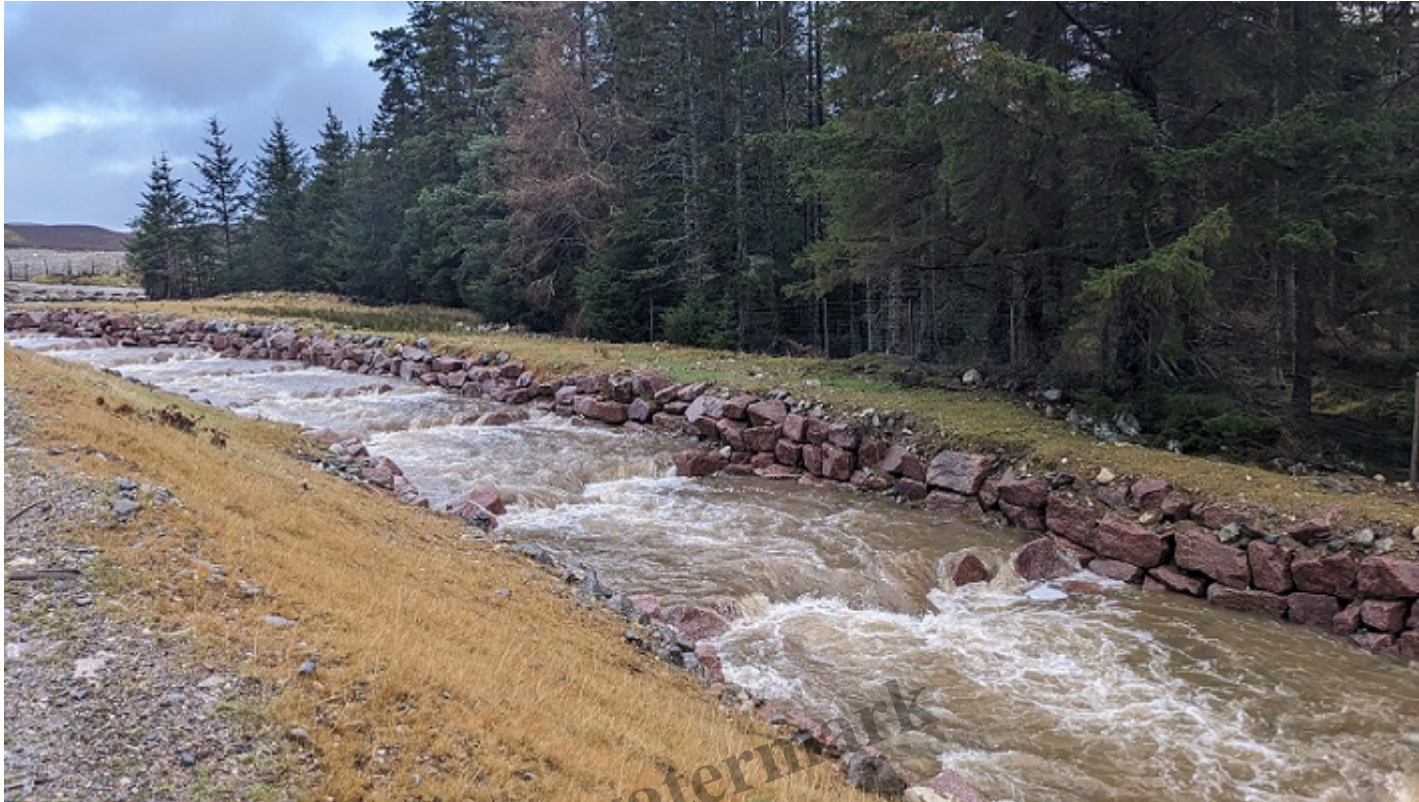
The top section of the channel. Note the width of the bank on the far side at this point.

The top part of the re-designed overflow appeared to be working more effectively. The rock steps were directing the main flow away from the banks while the much larger replacement rocks used for the rip-rap bouldering appeared to have been unaffected by the flood.

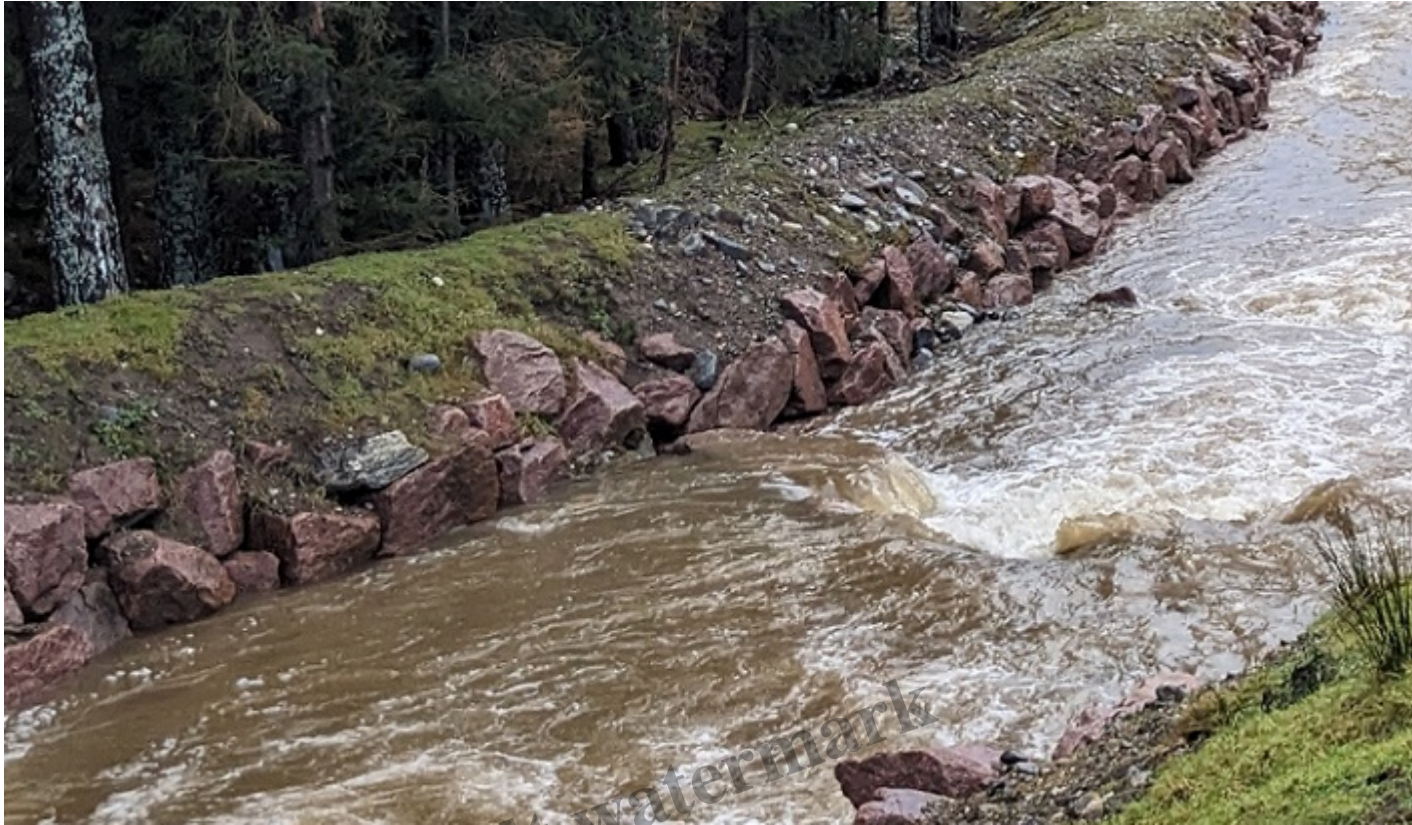
Note how the earth heaped on top of the rip rap bouldering has been eroding just to the right of the tree and along the bare area which starts by the bottom step

The embankment at the bottom of the stepped section appeared far more vulnerable, being narrower and there were a couple of places with exposed soils 18 inches or so above the water. Indeed, looking at the photo – I did not spot this when out – it looks as though a boulder may have been dislodged from what is now the lowest point of the rip rap bouldering just to the right of the tree. If the overflow was to operate full capacity these weak points look extremely vulnerable to erosion which could potentially result in the channel failing catastrophically.

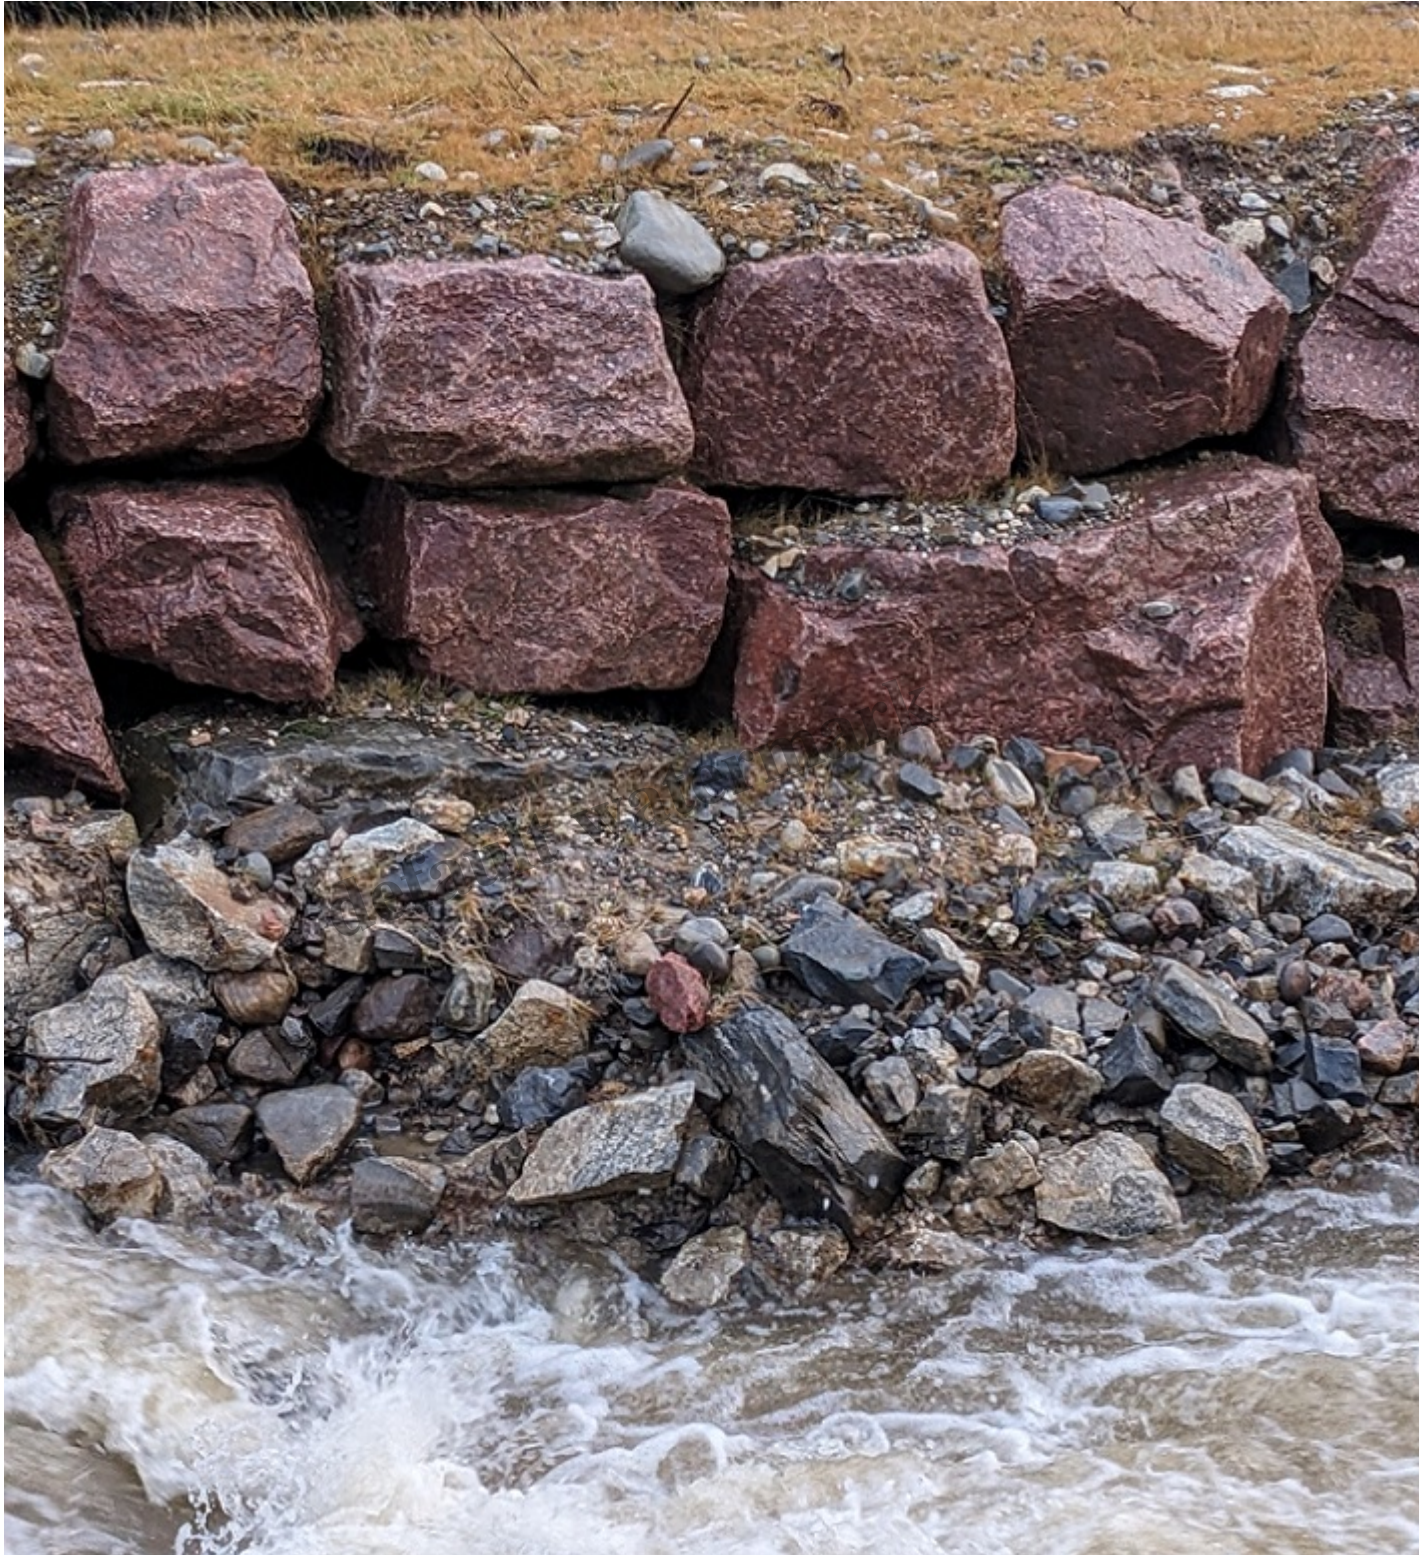
A section of rip rap bouldering that has now been partially buried

Since returning to use, the force of the water in the overflow channel has redeposited rocks large and small. This has strengthened the embankment at some points but could potentially undercut it in others.

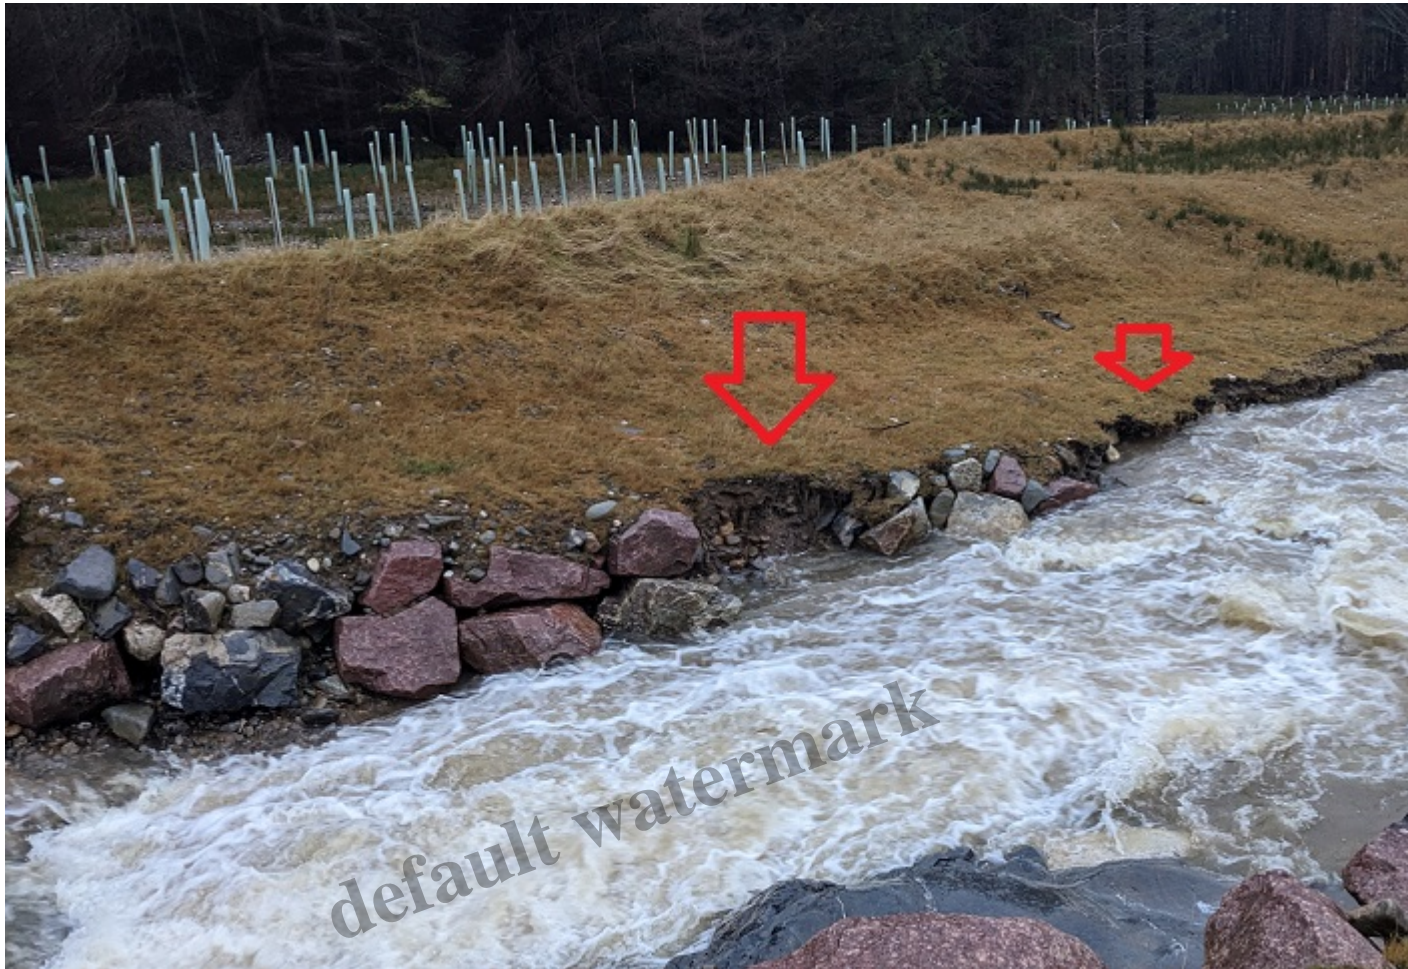
The gap in the protection was probably filled with two or more smaller boulders. Note how the gently sloping earth embankment downstream has started to erode.

The one clear example I observed of a failure in rip rap bouldering was at the very bottom of the steep section of the overflow where the embankment changes from rock to earth. Some of the smaller rocks used for the rip rap bouldering had been swept away just as happened with the first version of the channel. The trees planted behind will do nothing to strengthen it.

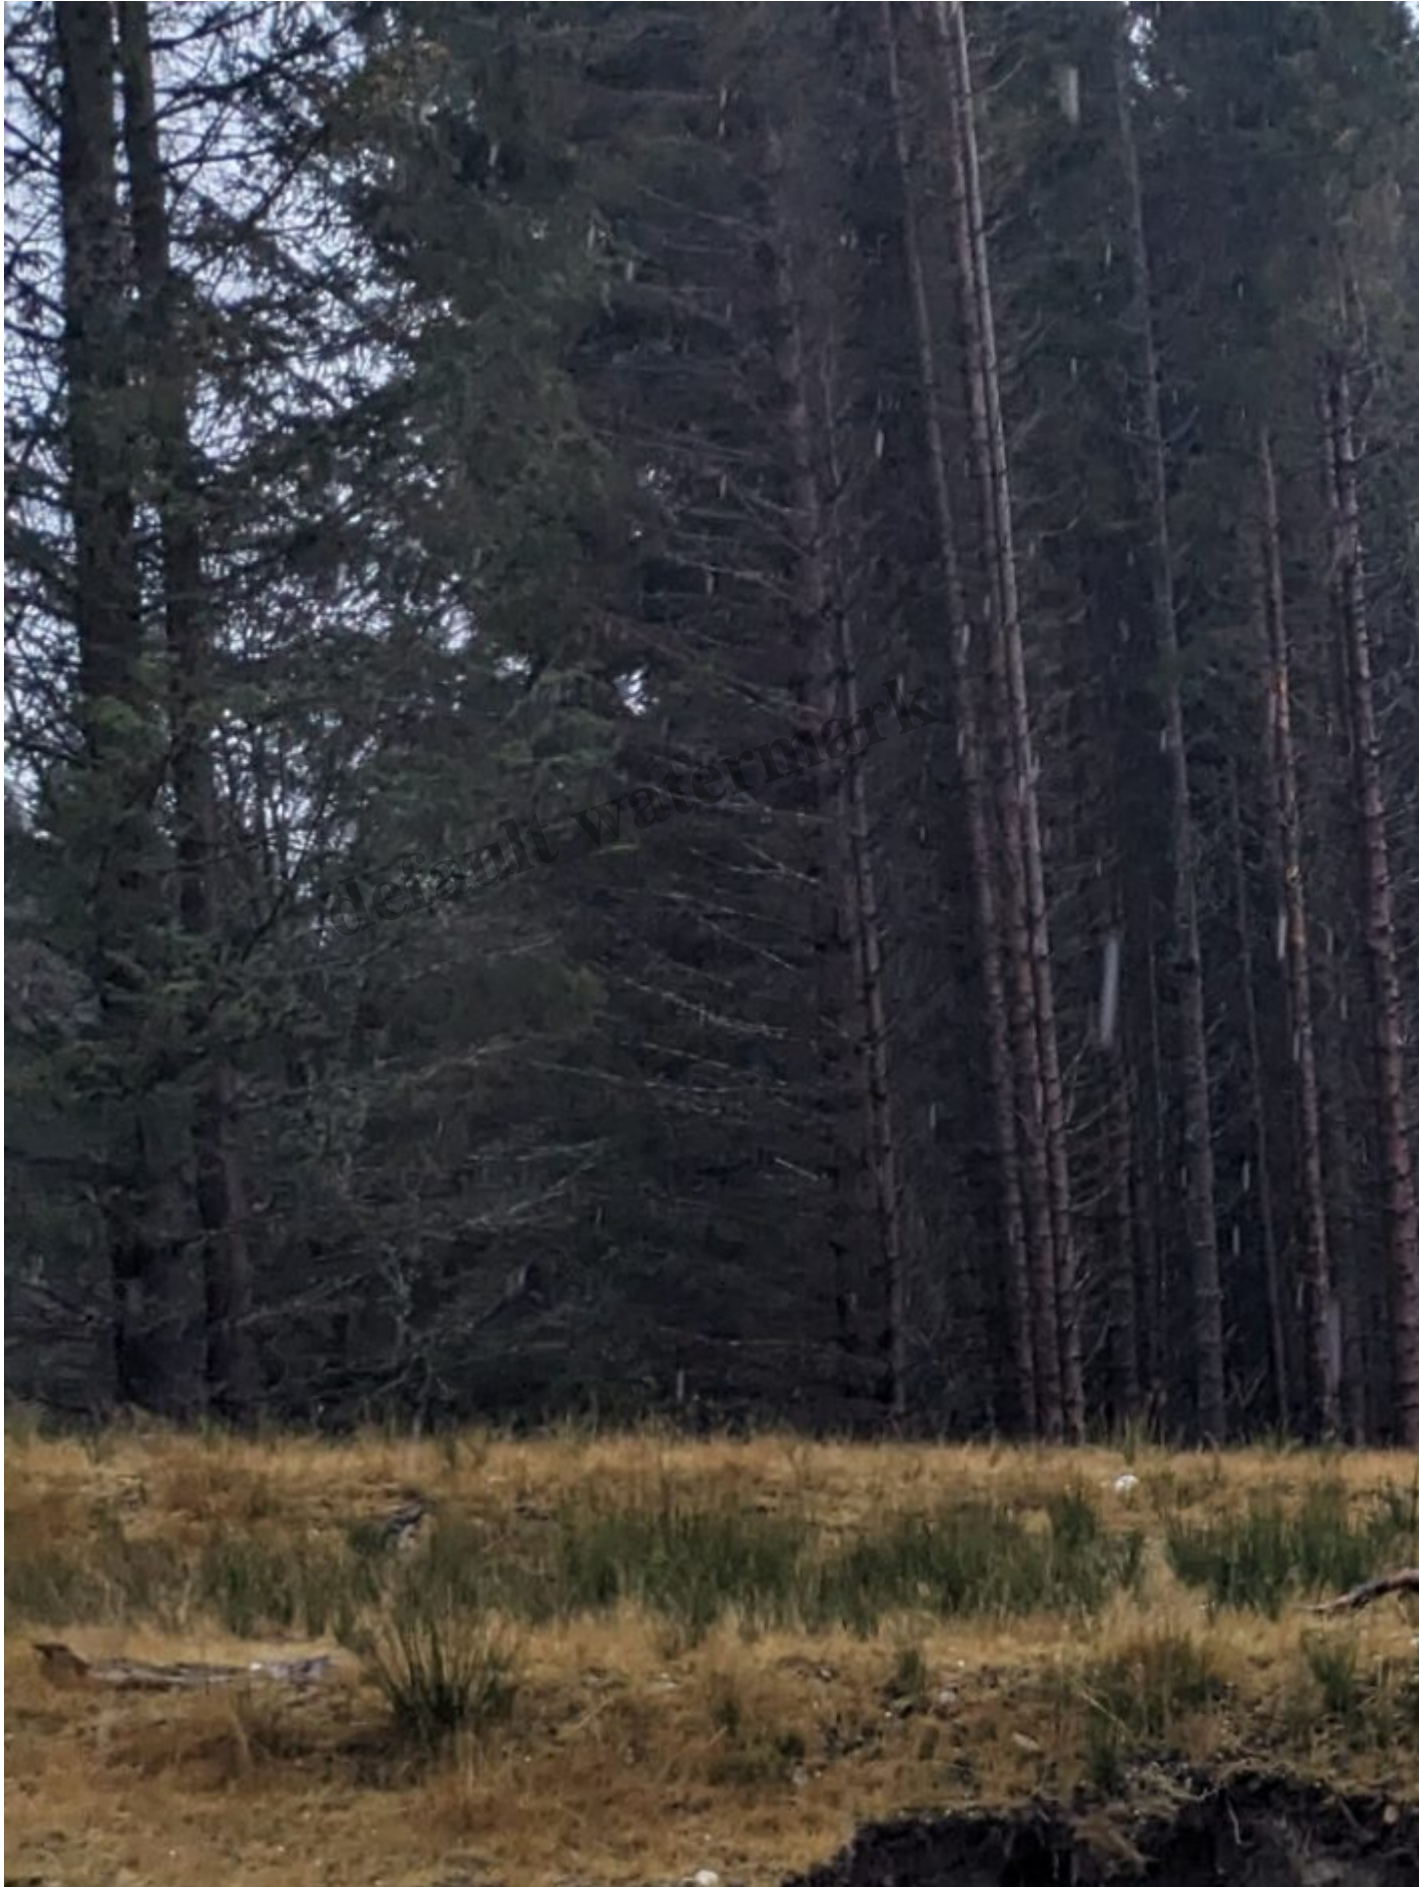
Near the start of the new earth embankment below the rip rap bouldering showing the two “steps”

Despite the reconstructed overflow being blocked initially to allow time for grass to cover the exposed earth it has already started to erode away. Once this erosion process has begun it is difficult to see why it should stop unless there is a hidden line of boulders within the embankment.

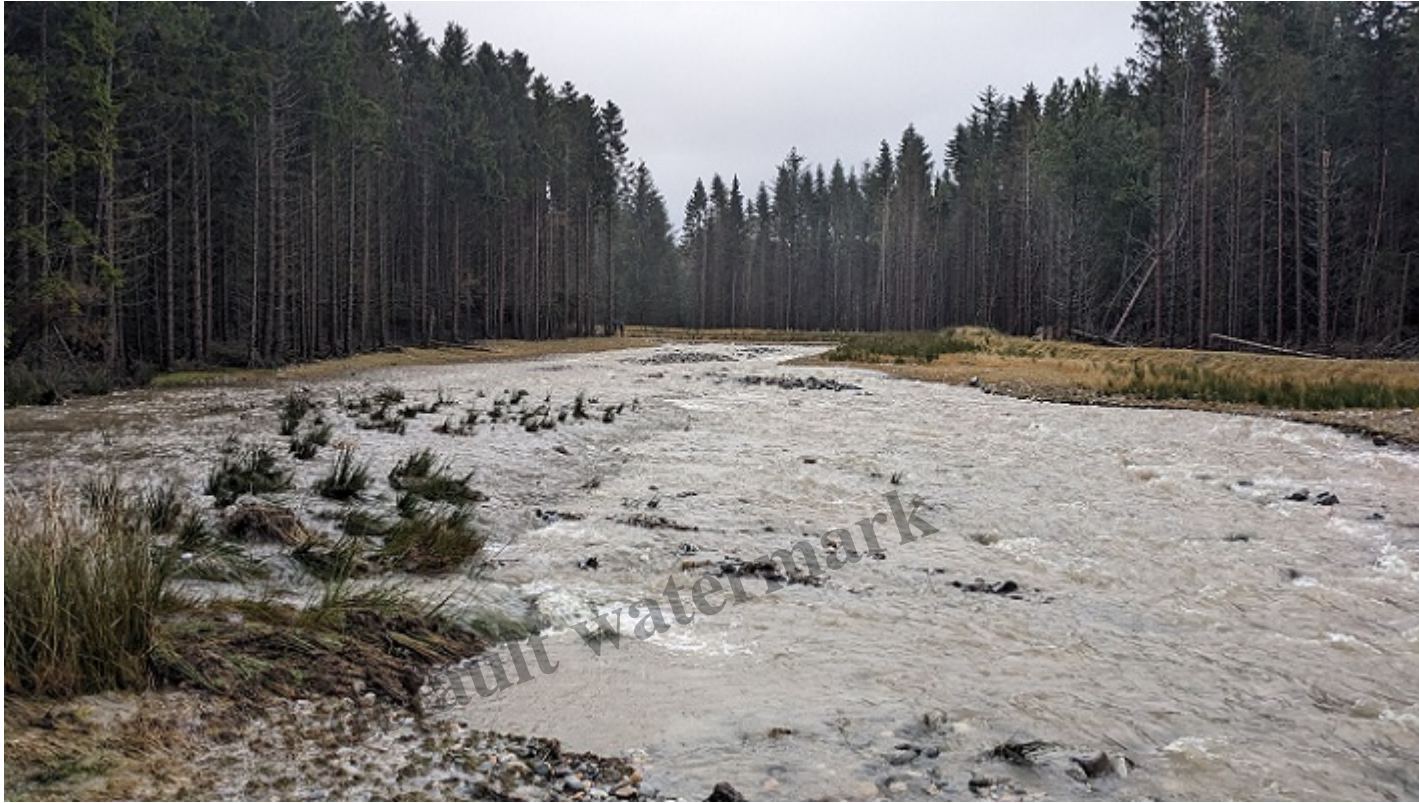
Looking up the broadest section of the channel with the earth embankment on the right

Along the broadest section of the channel the earth embankment is very low. At present the water is eroding a course away from the embankment to the edge of the trees but the question is what will happen when it starts to meander? That process might be accelerated if the water undercuts some of the trees causing them to fall into the channel and diverting the flow. Will the bank then be sufficiently covered in vegetation to withstand the flow of the water or will it too start to erode?

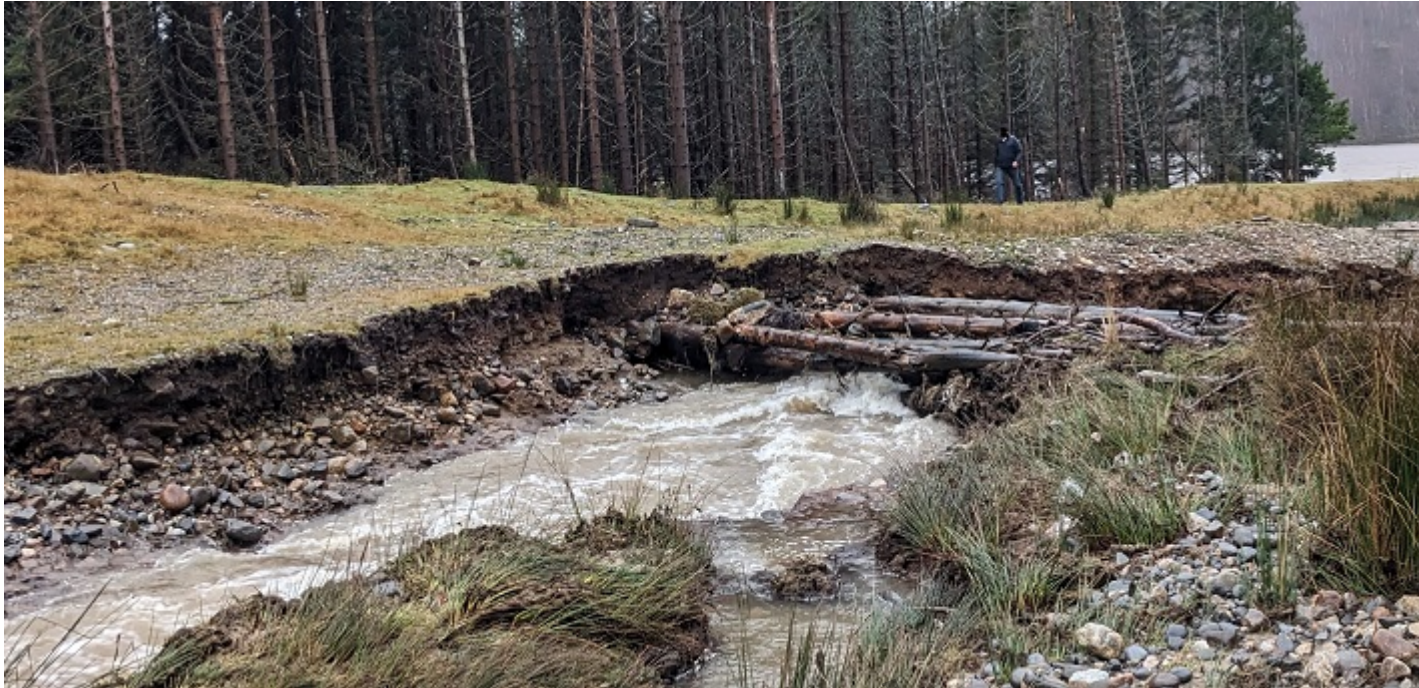
Near the bottom of the channel, with Loch Gynack visible behind. Note how the bank at this point has been built constructed with shingle, washed down by the previous overflow channel, not earth.

Near the bottom of the channel trees had been placed across the other side, possibly in an attempt to reduce erosion The shingle section of the embankment is broad enough that it is unlikely to fail catastrophically but again the question is why should the obvious erosion processes stop this time?

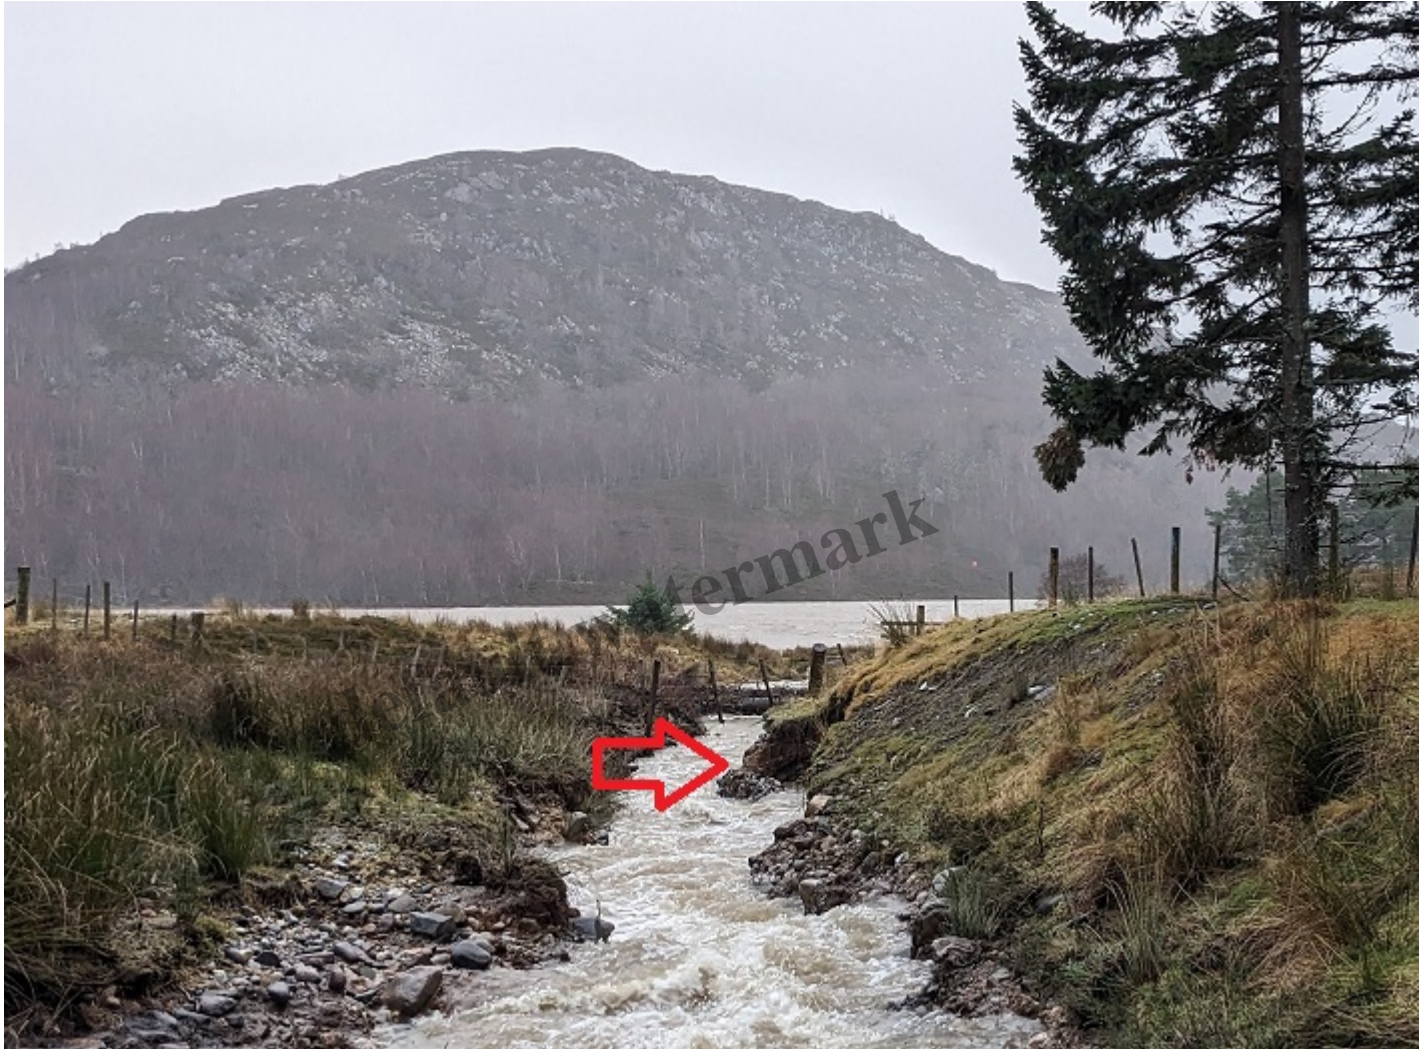
The lowest section of the channel is surprising narrow (and deep) and looks certain to sweep away a further section of the embankment on the right.

Rush had started to colonise both sides of the lower part of the embankment. That is likely to offer better protection against erosion than the bare section of bank.

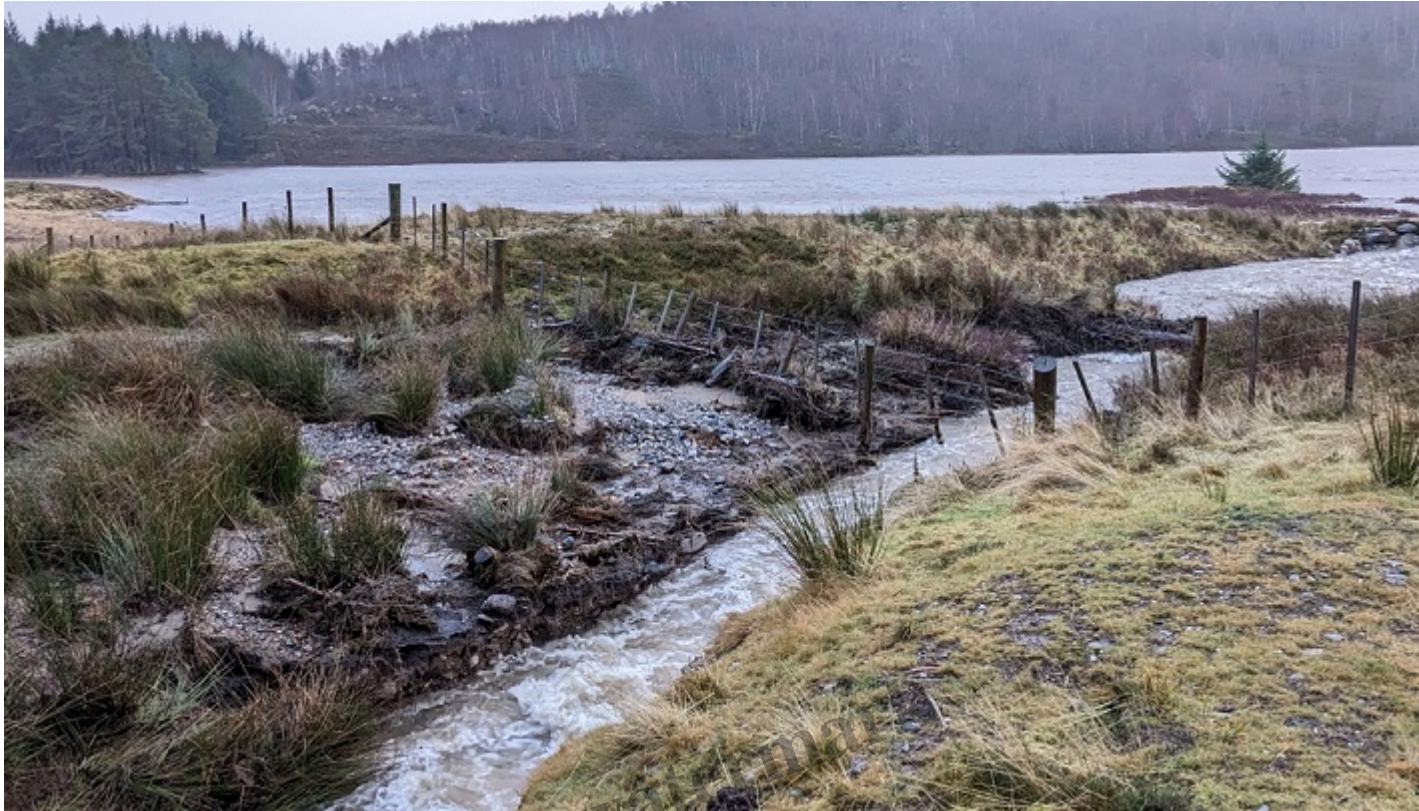
The outflow of the overflow channel viewed from the eroding section of bank. Note the difference between the still half bare bank in the foreground with the heavily vegetated bank beyond

Perhaps the upper section of the earth and shingle embankments should have been left another couple of years to allow more profuse protective vegetation to develop?
