## The reconstructed Gynack overflow about Kingussie – how long will it last?

The intake to the Gynack overflow from below 31st Dec 2024

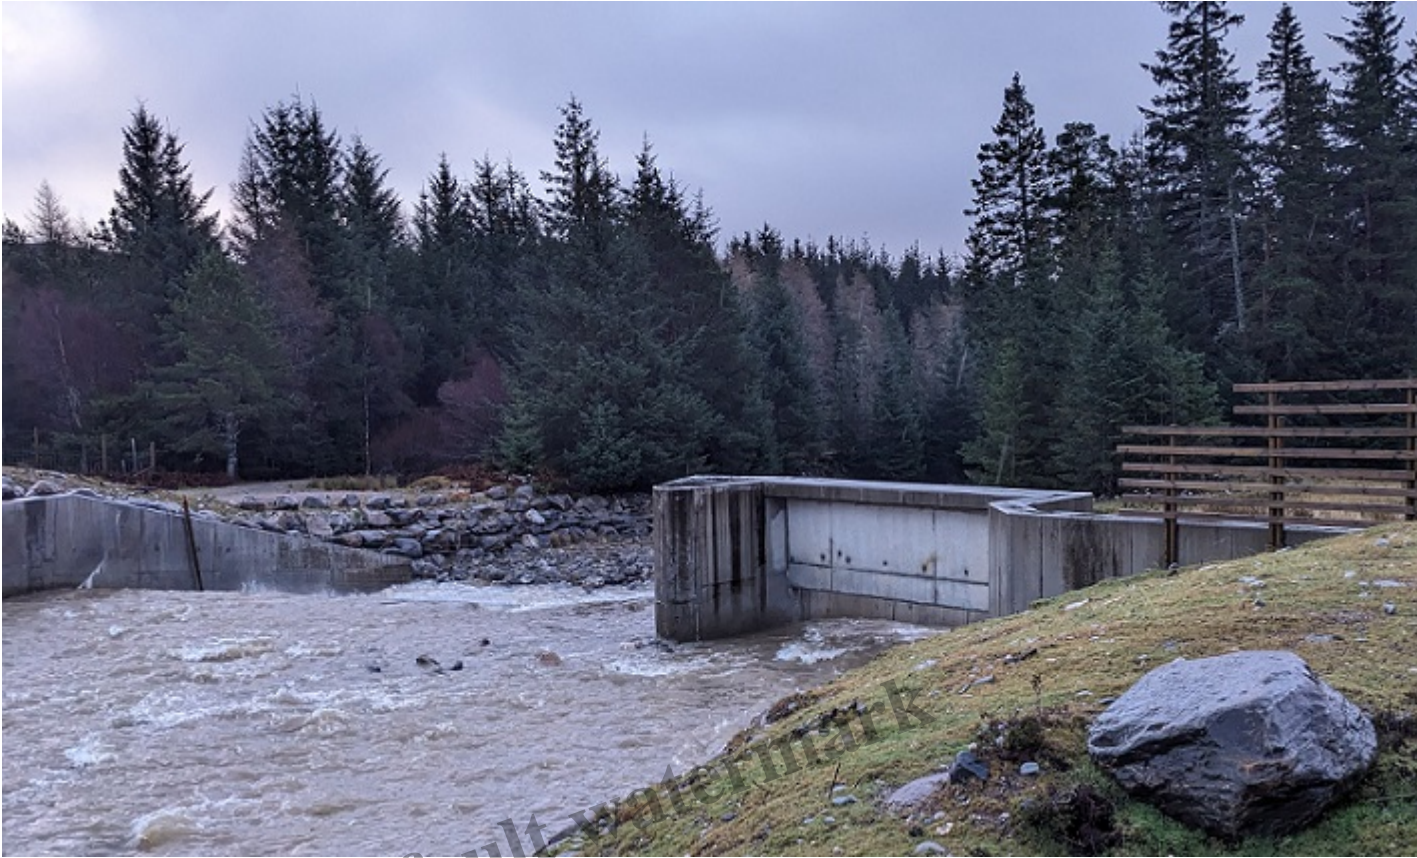
The intake to the Gynack overflow from below. 31st Dec 2024

My estimate from looking at the volume of water flowing through the intake was that the overflow was working at less than half of its maximum capacity. Even so, around the time I visited, the level of water in the River Gynack was sufficiently high for trains on the Perth-Inverness line to be cancelled because of the risk to the railway bridge in Kingussie below [\(see here\)](#).

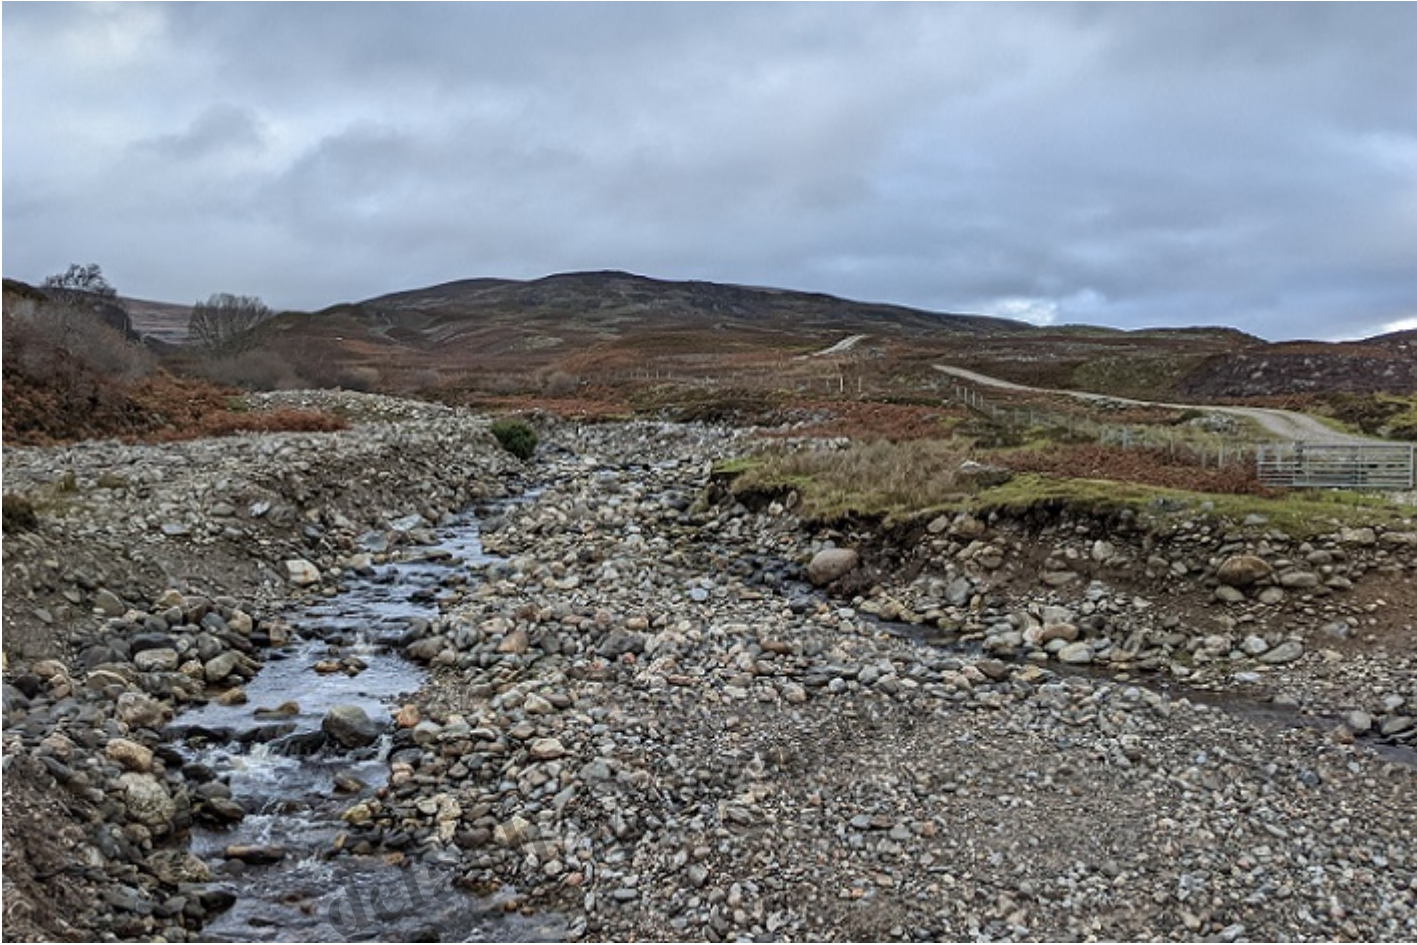
The River Gynack just above the overflow November 2022 with muirburn visible from just behind the gate on the right to the top of the hill in the distance

The overflow diverts water from the River Gynack when levels are high to Loch Gynack before it flows back into the main river. The overflow serves to delay/reduce the flood risks in Kingussie not to solve them. The only way for that to happen would be to ban the extensive muirburn undertaken by the Pitman Estate within the Gynack catchment and reduce grazing levels so that vegetation holds back water on the hillside instead of it rapidly draining into the river system as it does at present.

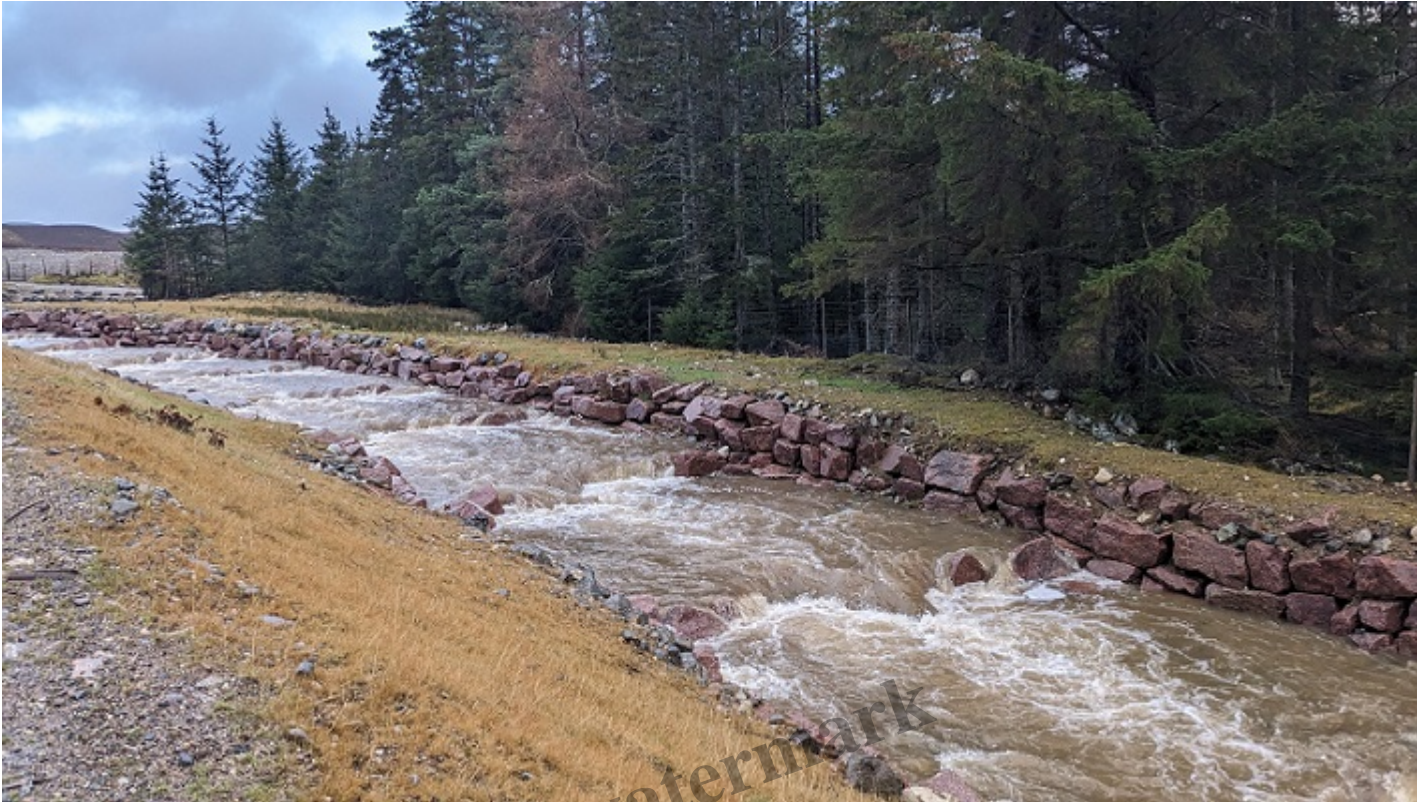
The top section of the channel. Note the width of the bank on the far side at this point.

The top part of the re-designed overflow appeared to be working more effectively. The rock steps were directing the main flow away from the banks while the much larger replacement rocks used for the rip-rap bouldering appeared to have been unaffected by the flood.

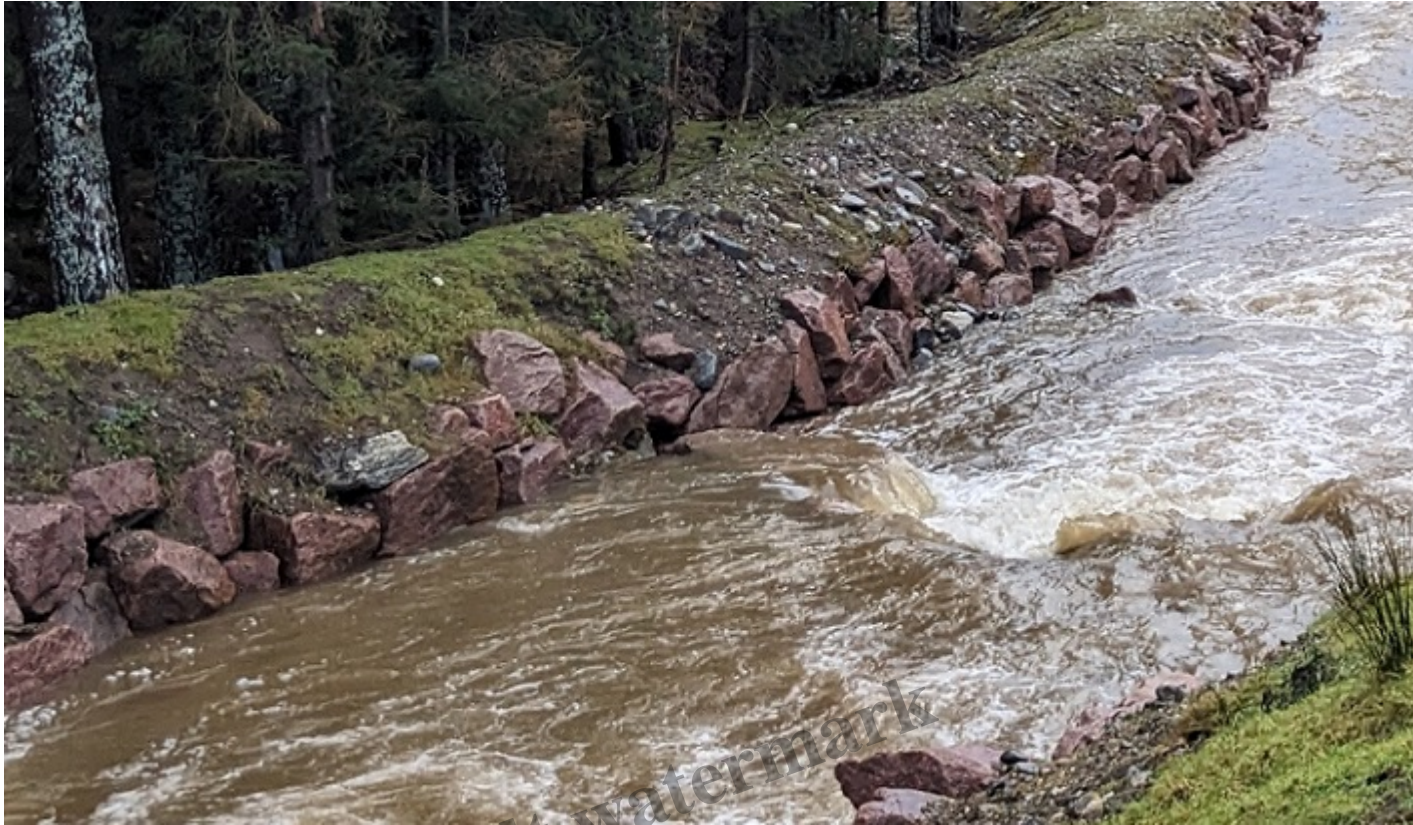
Note how the earth heaped on top of the rip rap bouldering has been eroding just to the right of the tree and along the bare area which starts by the bottom step

The embankment at the bottom of the stepped section appeared far more vulnerable, being narrower and there were a couple of places with exposed soils 18 inches or so above the water. Indeed, looking at the photo – I did not spot this when out – it looks as though a boulder may have been dislodged from what is now the lowest point of the rip rap bouldering just to the right of the tree. If the overflow was to operate full capacity these weak points look extremely vulnerable to erosion which could potentially result in the channel failing catastrophically.

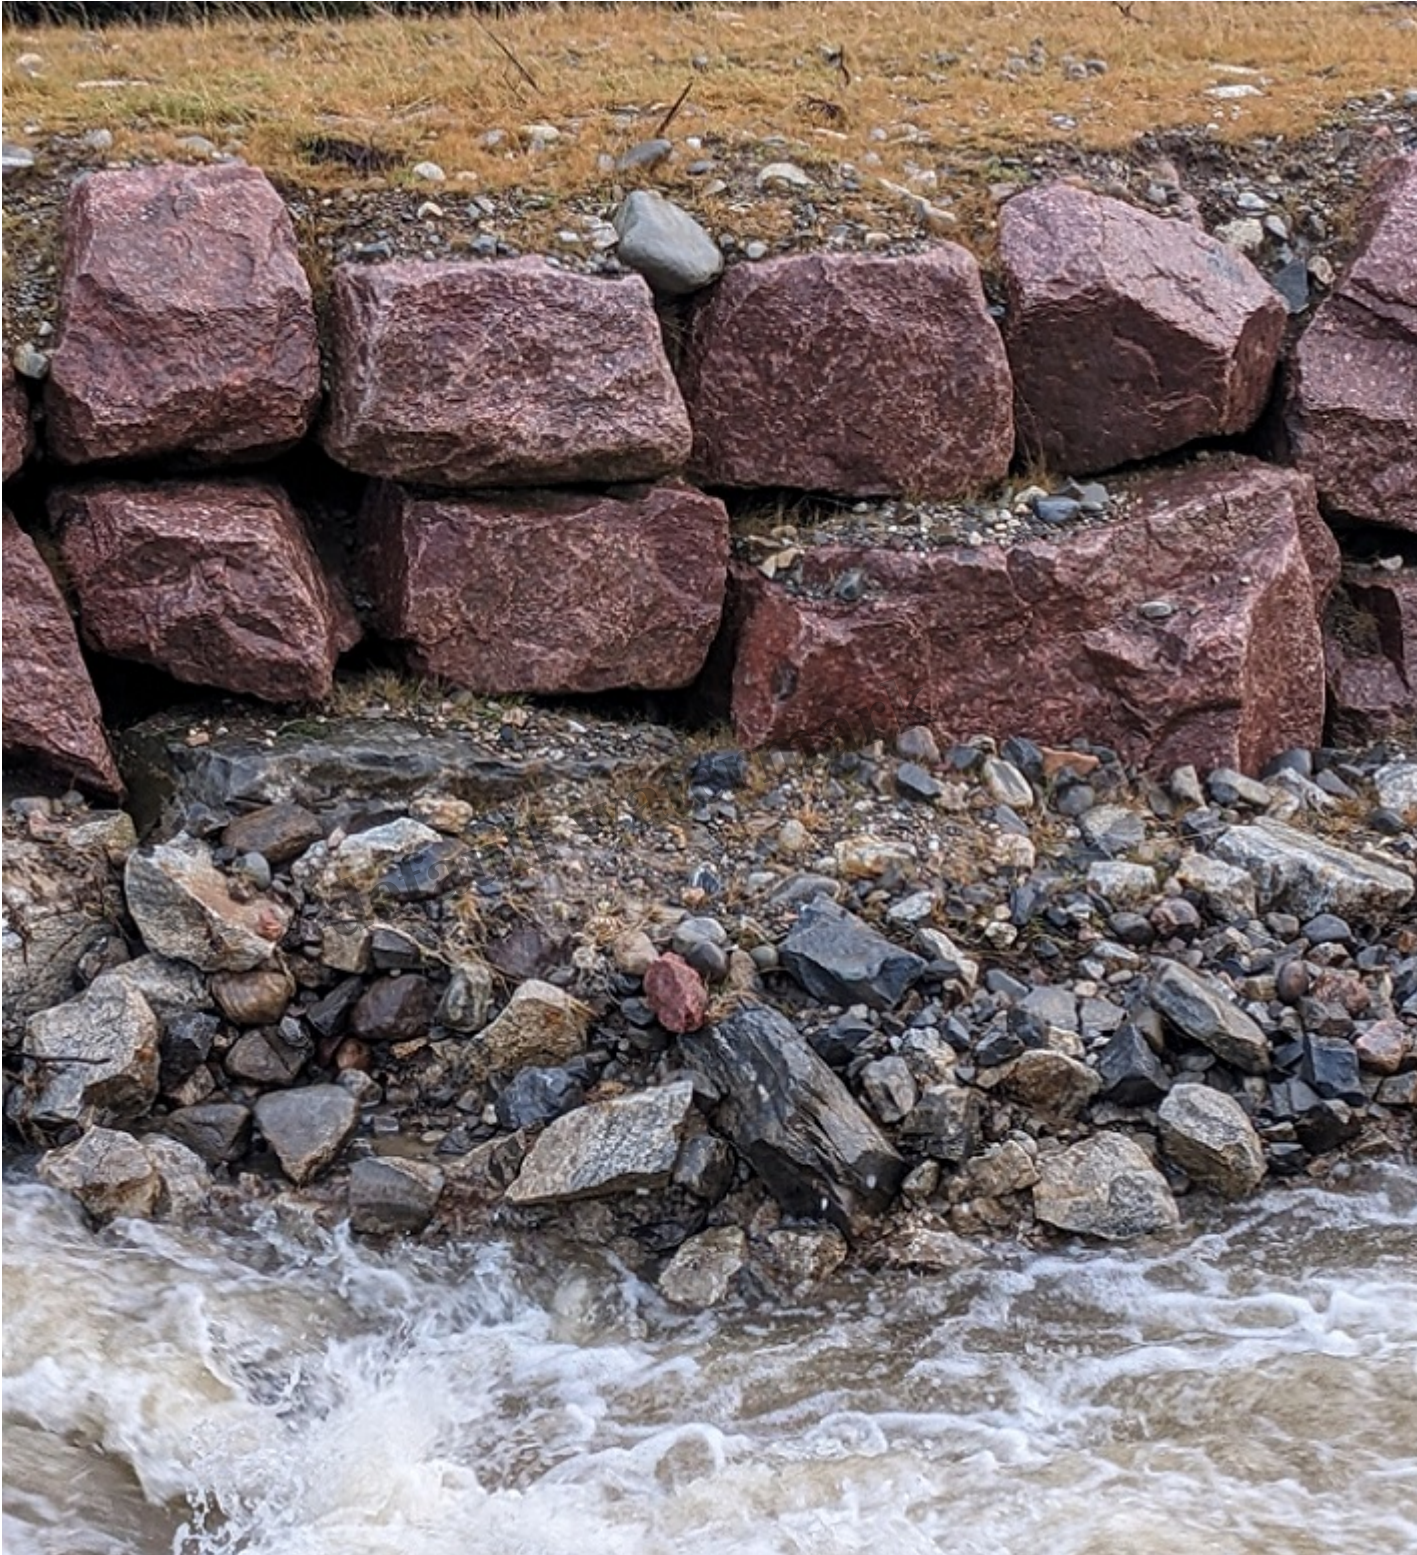
A section of rip rap bouldering that has now been partially buried

Since returning to use, the force of the water in the overflow channel has redeposited rocks large and small. This has strengthened the embankment at some points but could potentially undercut it in others.

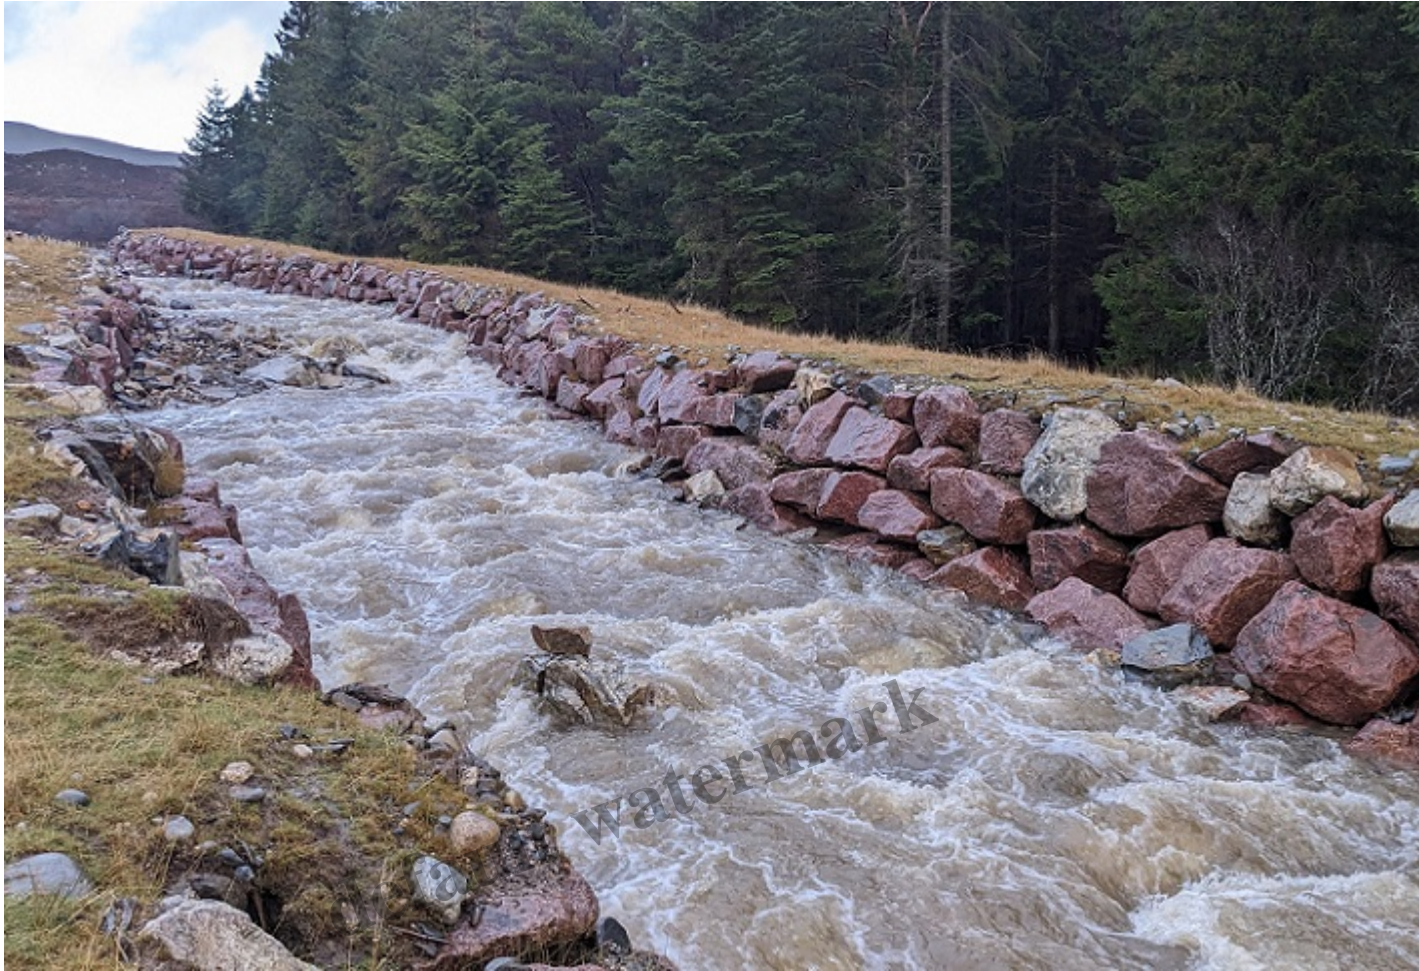
Stranded rock on boulder in foreground with differential erosion of the base of the channel evident from the “dry” area behind.

As it flows down and across the hillside the channel narrows significantly constraining the water and increasing its force. While the rip rap bouldering on the right appeared to me quite robust again I wondered what would happen if the overflow was running at full capacity?

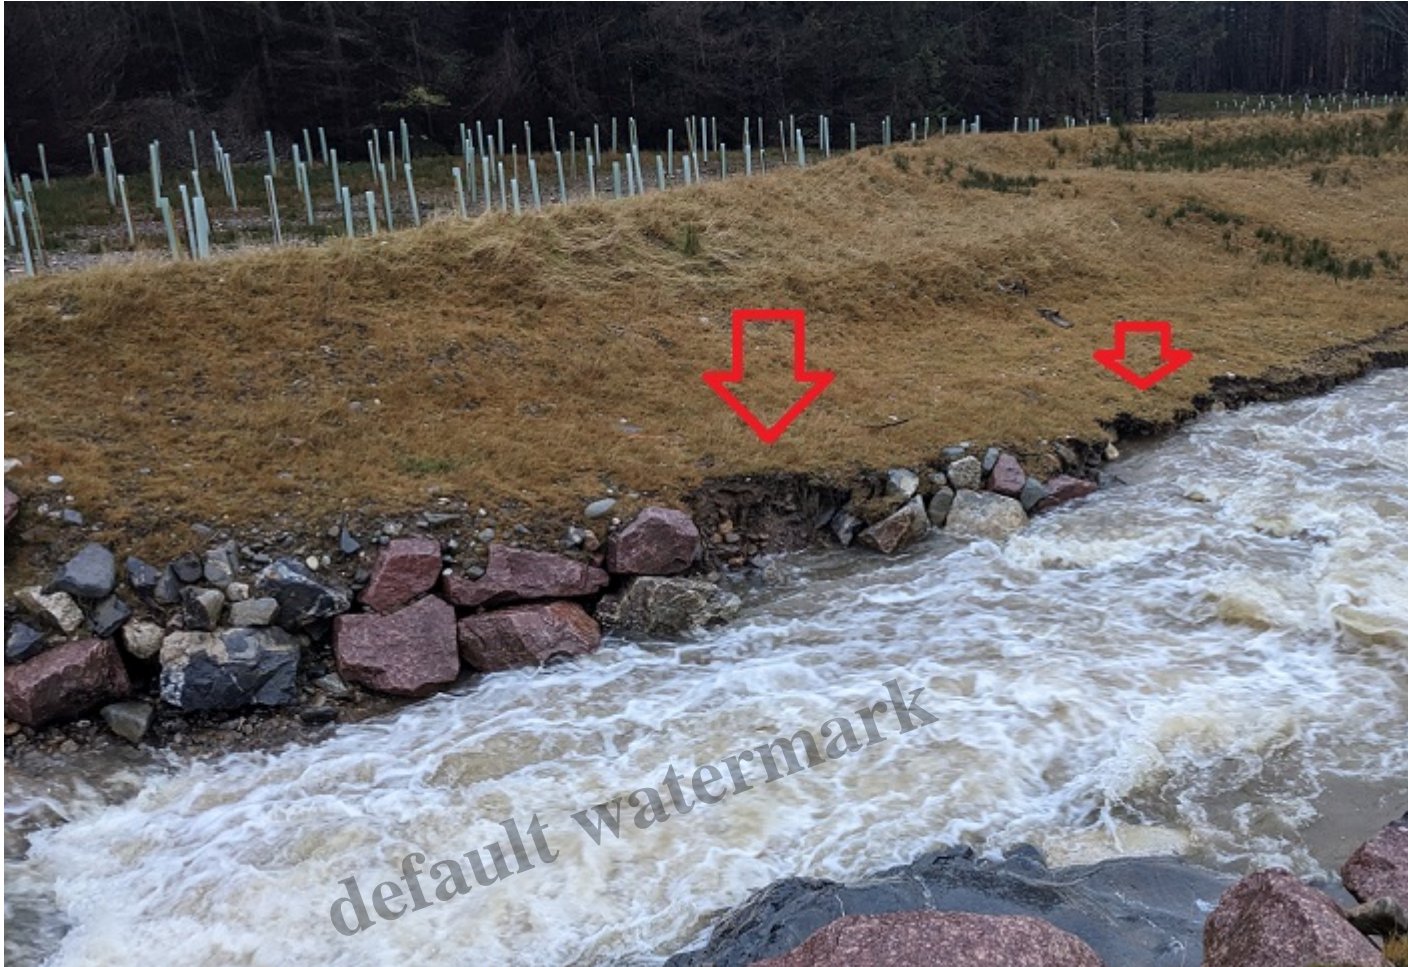
The gap in the protection was probably filled with two or more smaller boulders. Note how the gently sloping earth embankment downstream has started to erode.

The one clear example I observed of a failure in rip rap bouldering was at the very bottom of the steep section of the overflow where the embankment changes from rock to earth. Some of the smaller rocks used for the rip rap bouldering had been swept away just as happened with the first version of the channel. The trees planted behind will do nothing to strengthen it.

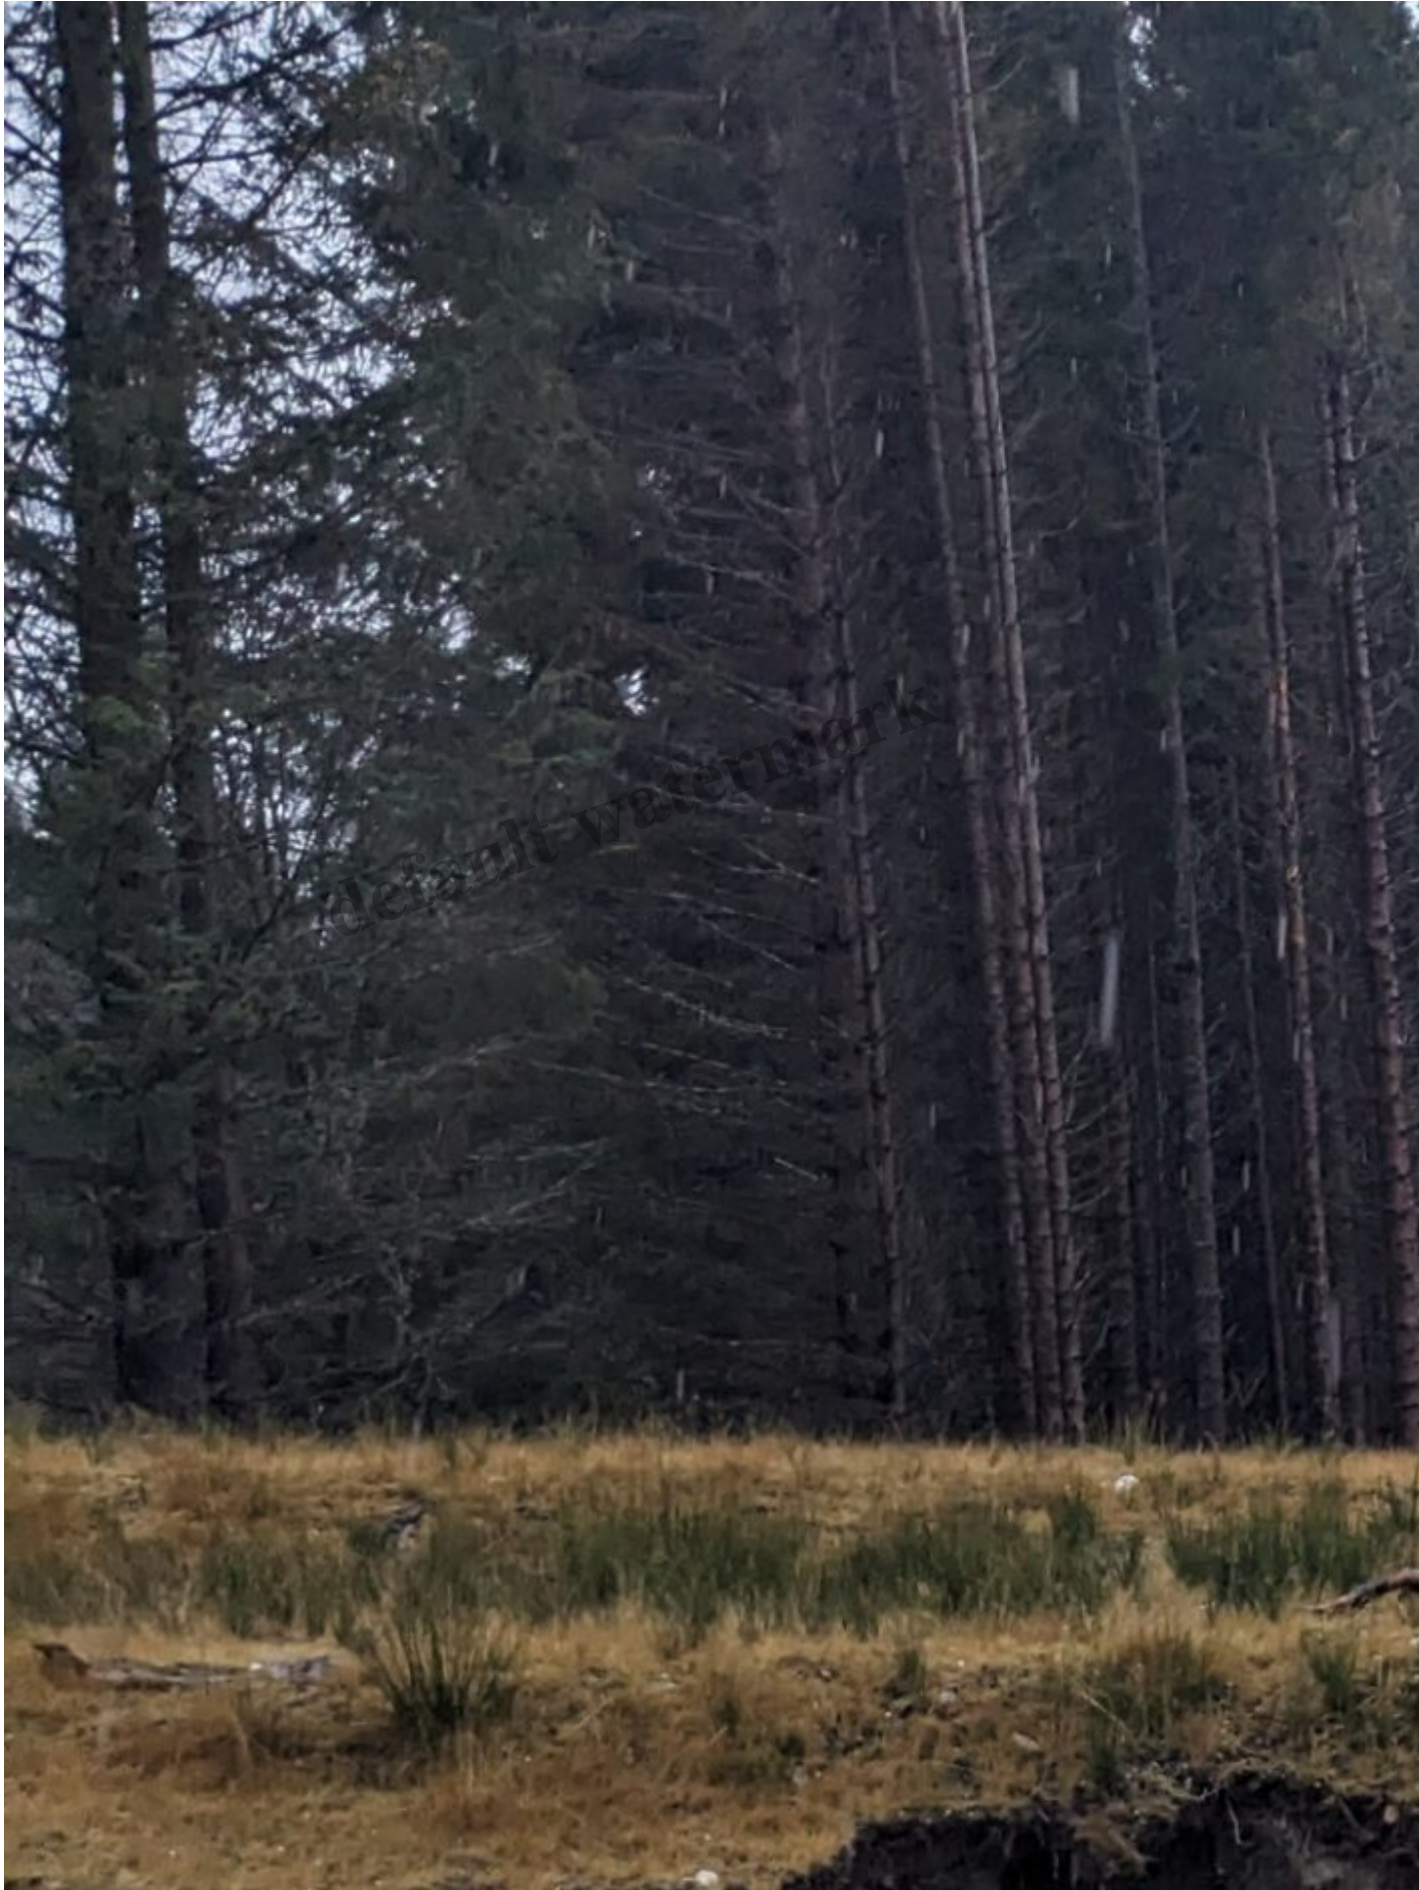
Near the start of the new earth embankment below the rip rap bouldering showing the two “steps”

Despite the reconstructed overflow being blocked initially to allow time for grass to cover the exposed earth it has already started to erode away. Once this erosion process has begun it is difficult to see why it should stop unless there is a hidden line of boulders within the embankment.

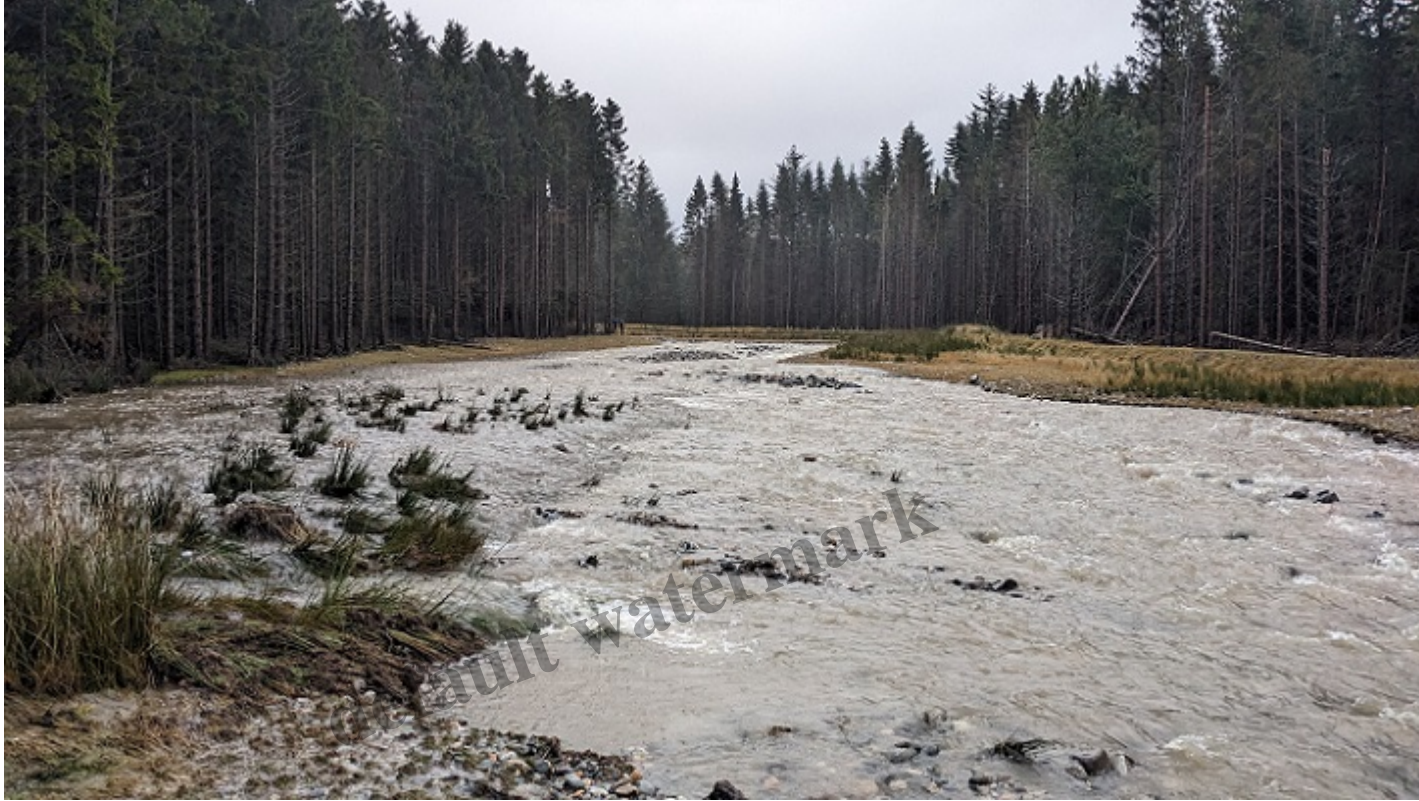
Looking up the broadest section of the channel with the earth embankment on the right

Along the broadest section of the channel the earth embankment is very low. At present the water is eroding a course away from the embankment to the edge of the trees but the question is what will happen when it starts to meander? That process might be accelerated if the water undercuts some of the trees causing them to fall into the channel and diverting the flow. Will the bank then be sufficiently covered in vegetation to withstand the flow of the water or will it too start to erode?

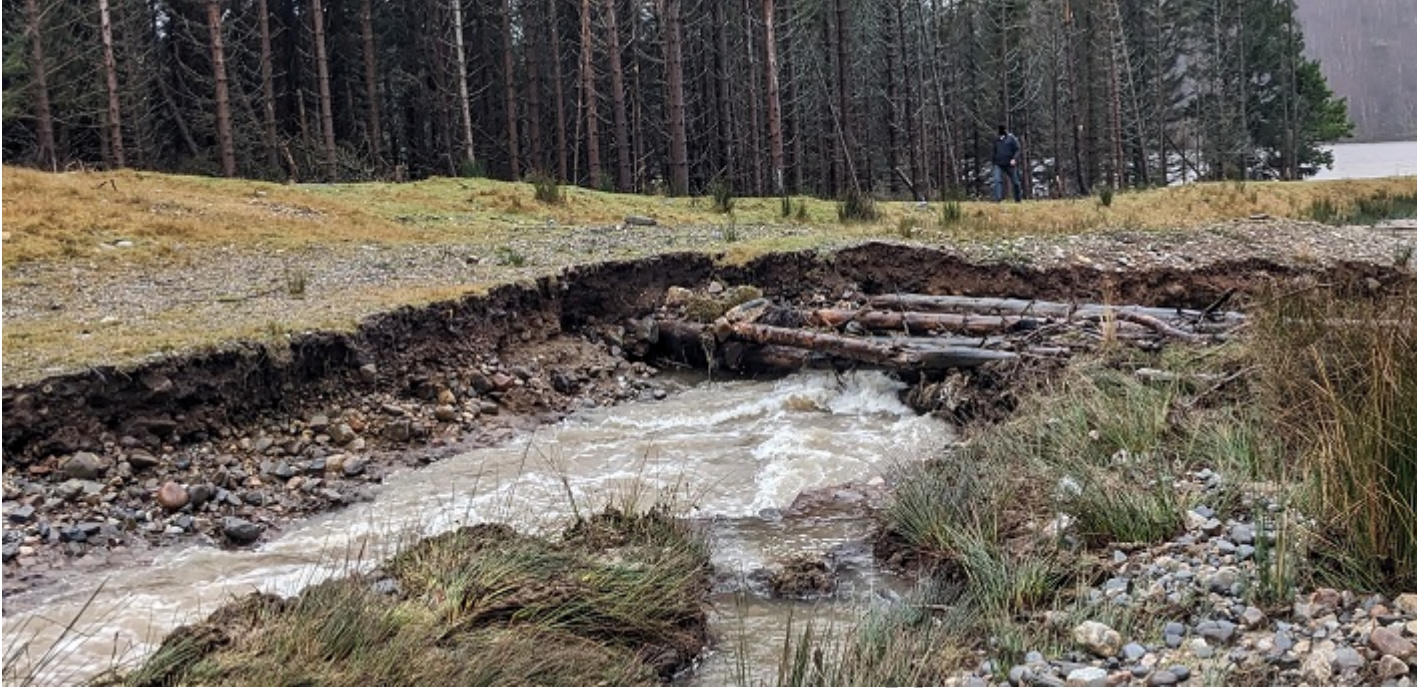
Near the bottom of the channel, with Loch Gynack visible behind. Note how the bank at this point has been built constructed with shingle, washed down by the previous overflow channel, not earth.

Near the bottom of the channel trees had been placed across the other side, possibly in an attempt to reduce erosion. The shingle section of the embankment is broad enough that it is unlikely to fail catastrophically but again the question is why should the obvious erosion processes stop this time?

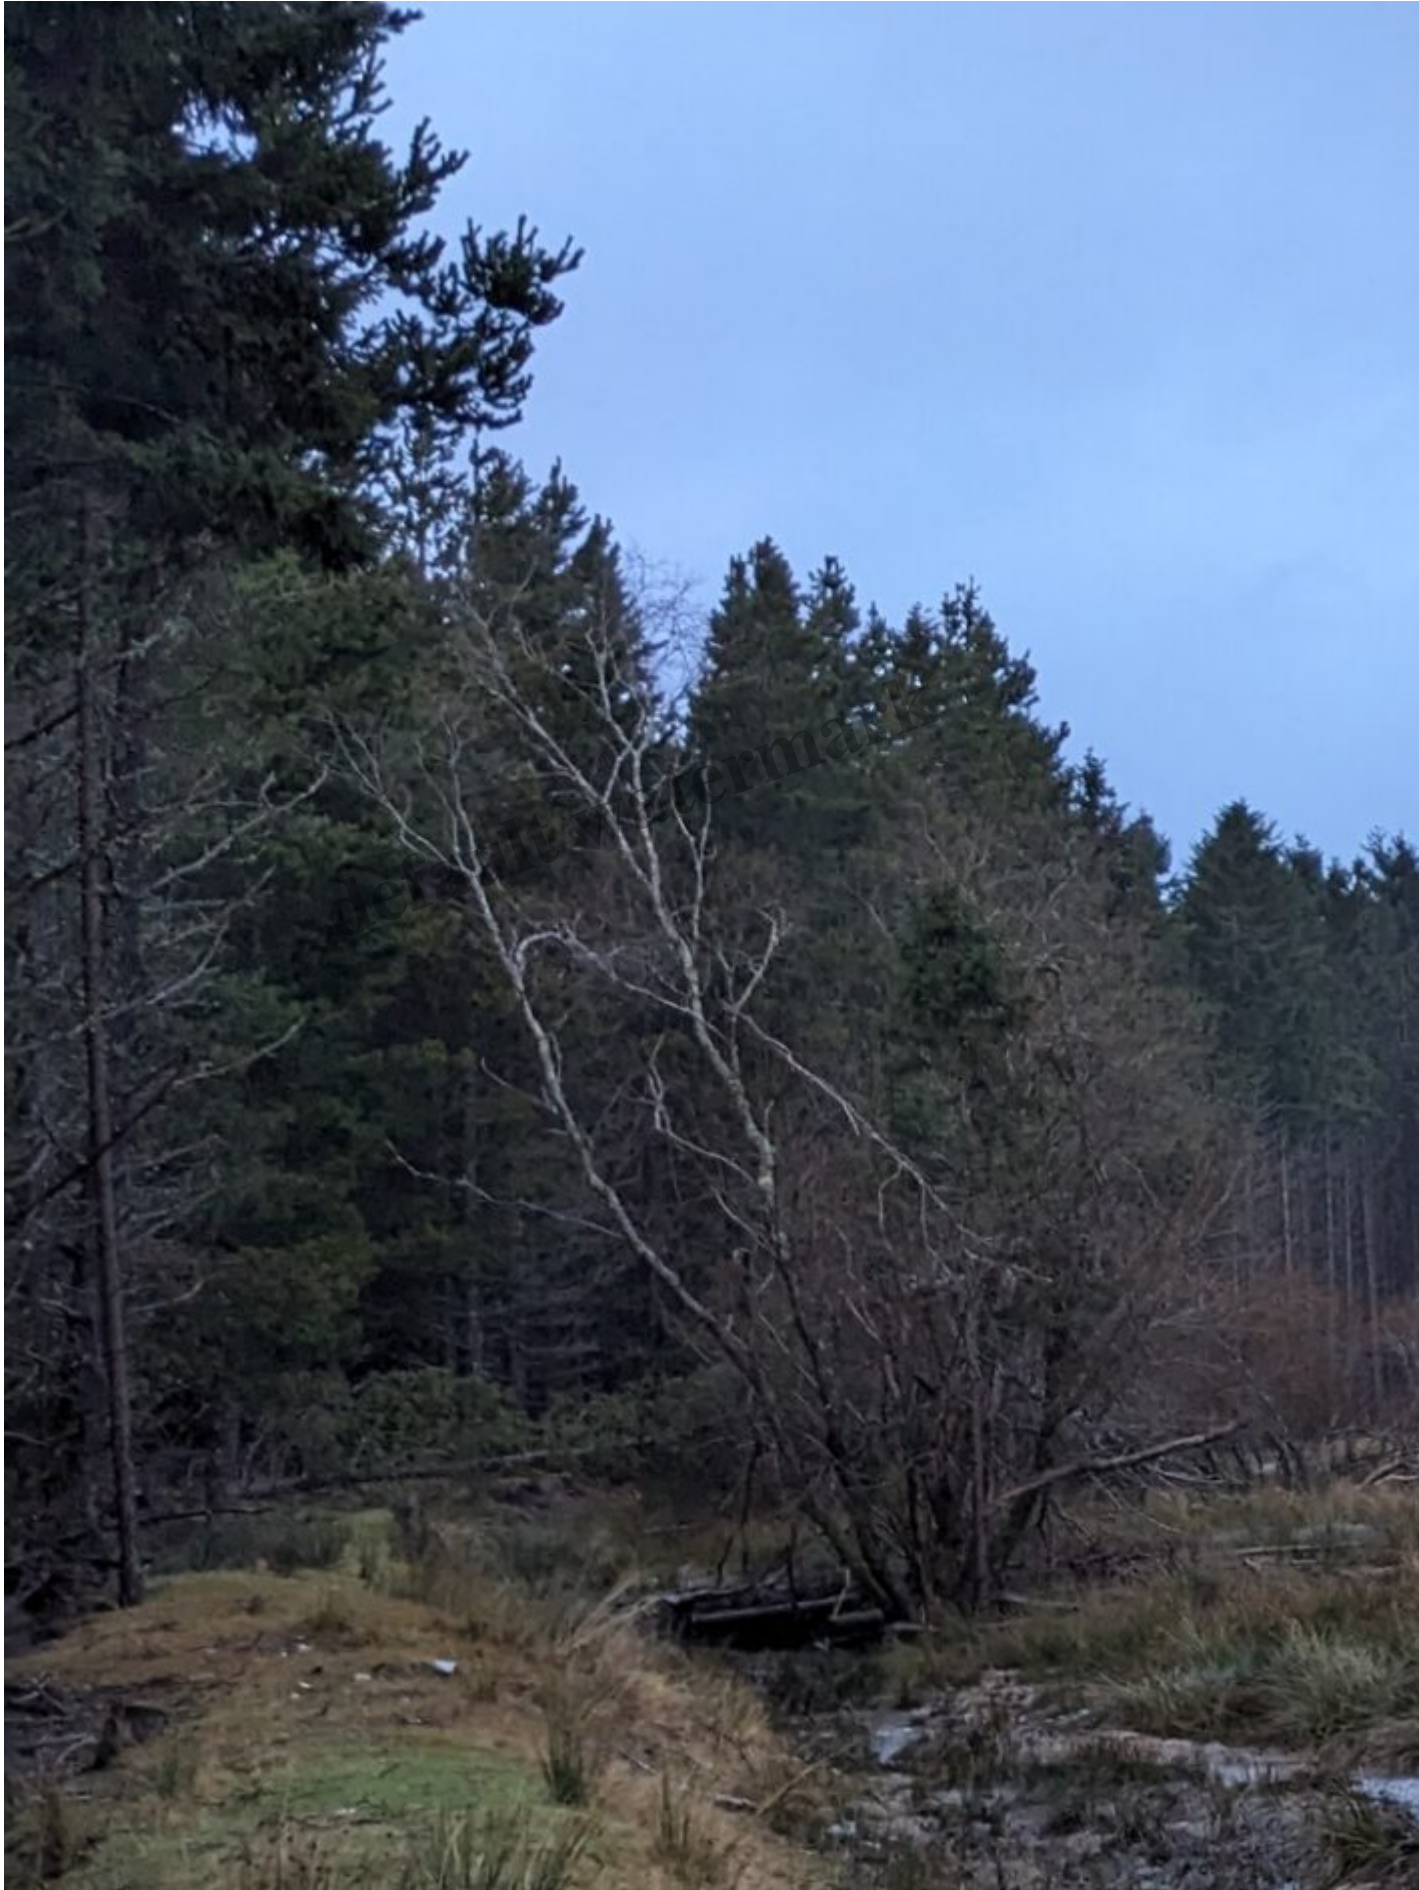
View back up to the tree dam showing how the water is already meandering significantly. Note the s

One wonders too what will happen to this channel if the beavers, released into the Spey, start to work their miracles. Along natural watercourses that normally holds back the flow and reduces flood damage but in the overflow channel it could direct the water to the vulnerable earth embankments

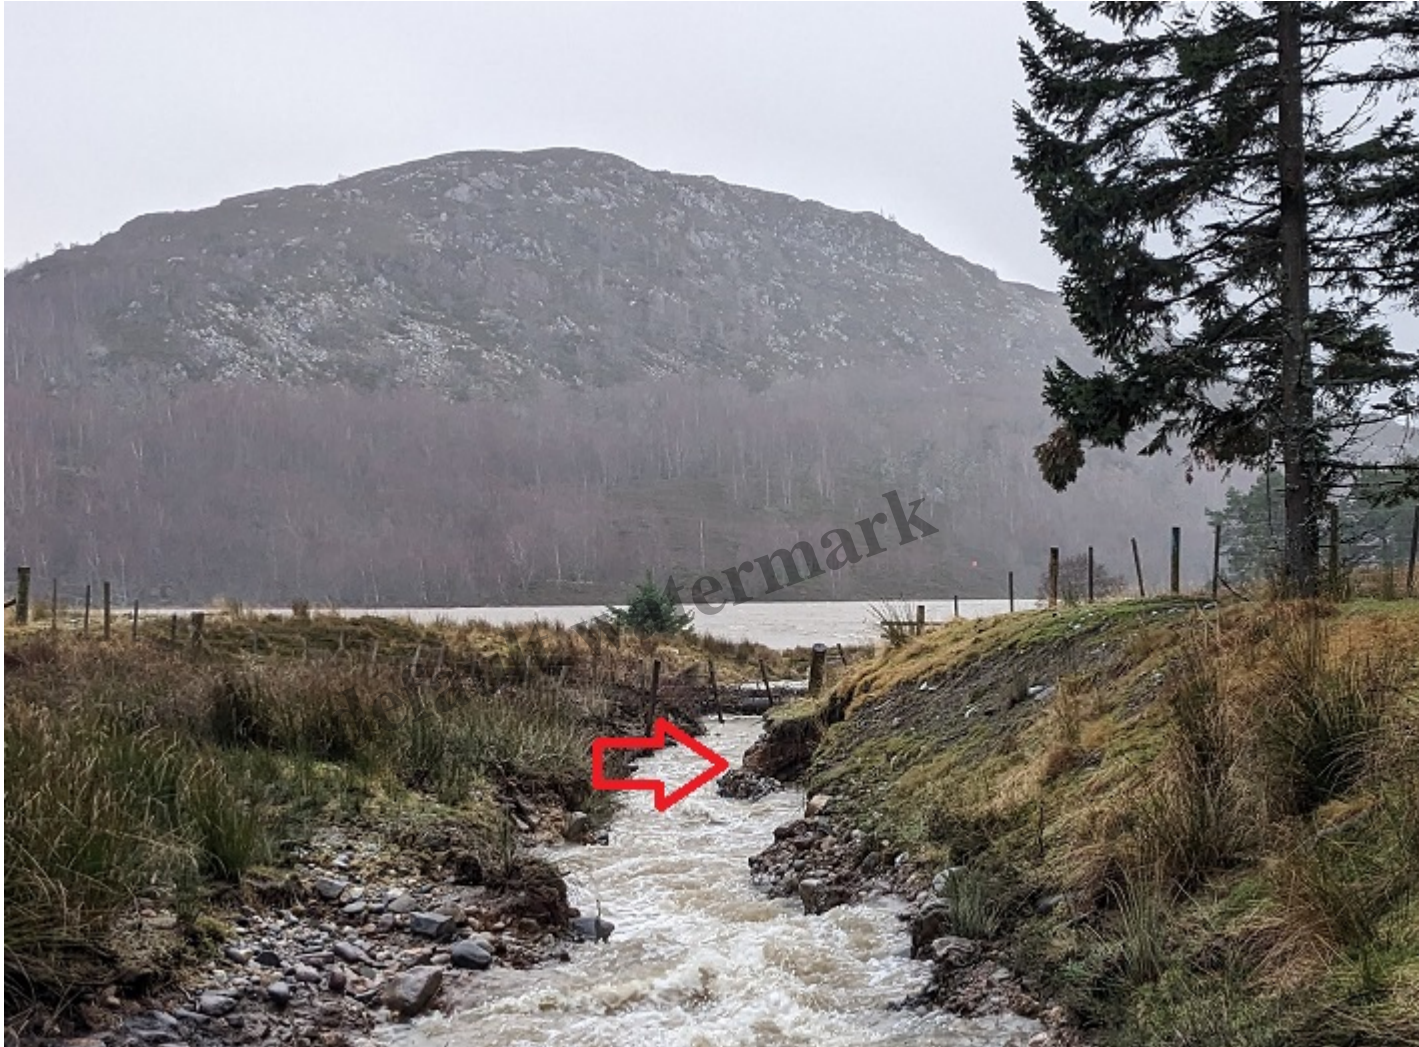
The lowest section of the channel is surprising narrow (and deep) and looks certain to sweep away a further section of the embankment on the right.

Rush had started to colonise both sides of the lower part of the embankment. That is likely to offer better protection against erosion than the bare section of bank.

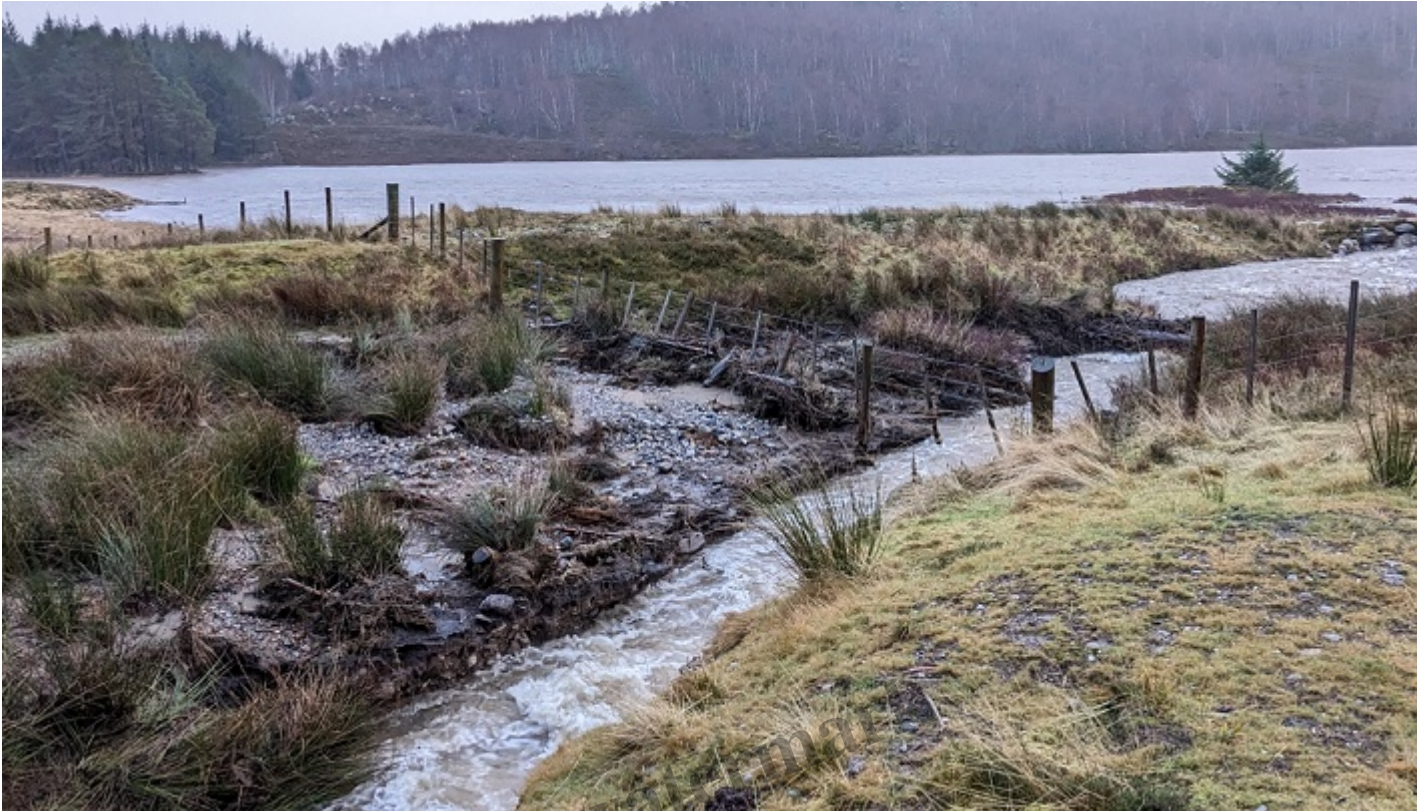
The outflow of the overflow channel viewed from the eroding section of bank. Note the difference between the still half bare bank in the foreground with the heavily vegetated bank beyond

Perhaps the upper section of the earth and shingle embankments should have been left another couple of years to allow more profuse protective vegetation to develop?
