The reconstructed Gynack overflow about Kingussie â?? how long will it last?

Hogmanay was forecast to be a wet day and Strathspey was flooded so I thought I would take a look at the River Gynack overflow, which had been reconstructed after being almost washed away in 2017 ([see here](#)), to see if it was operational and, if so, how the revised design was working.

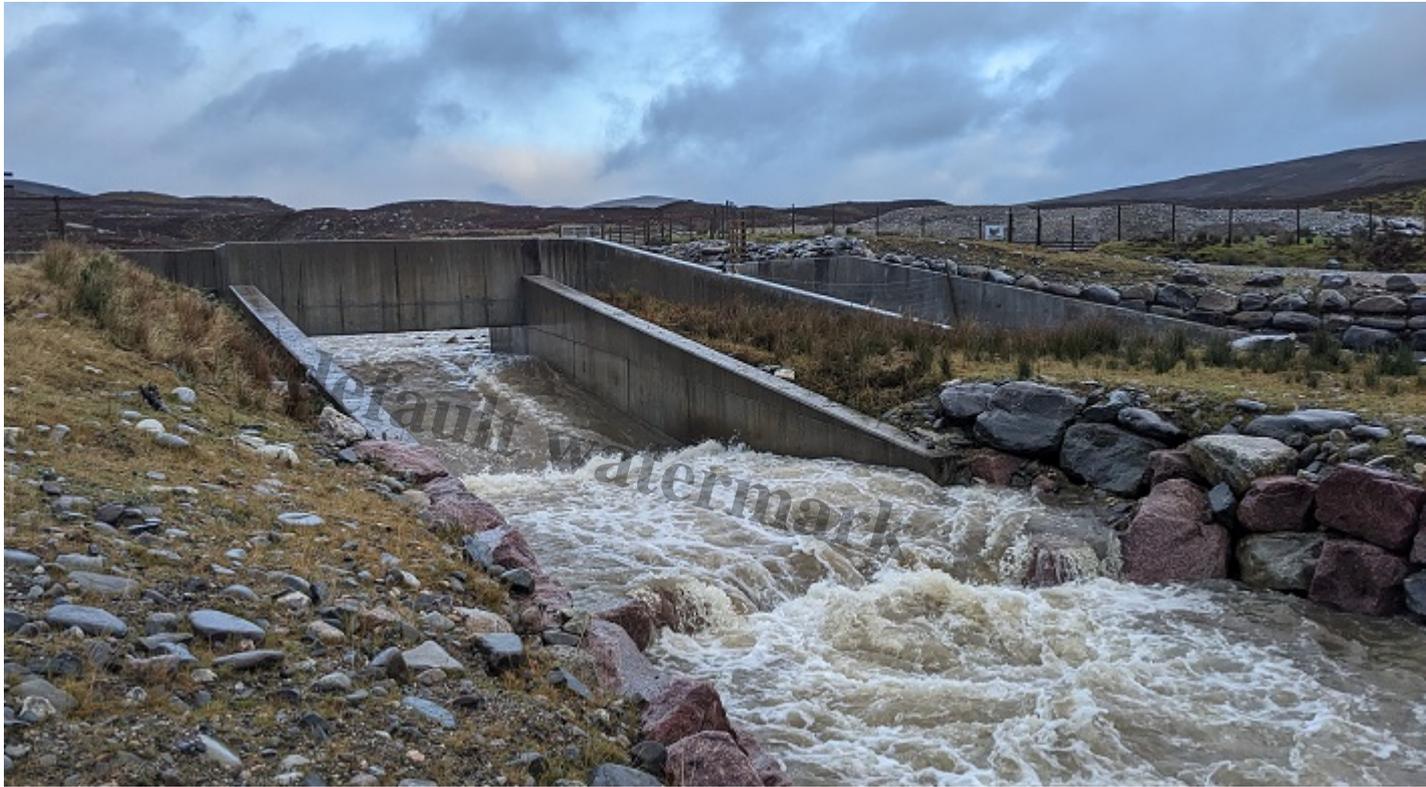
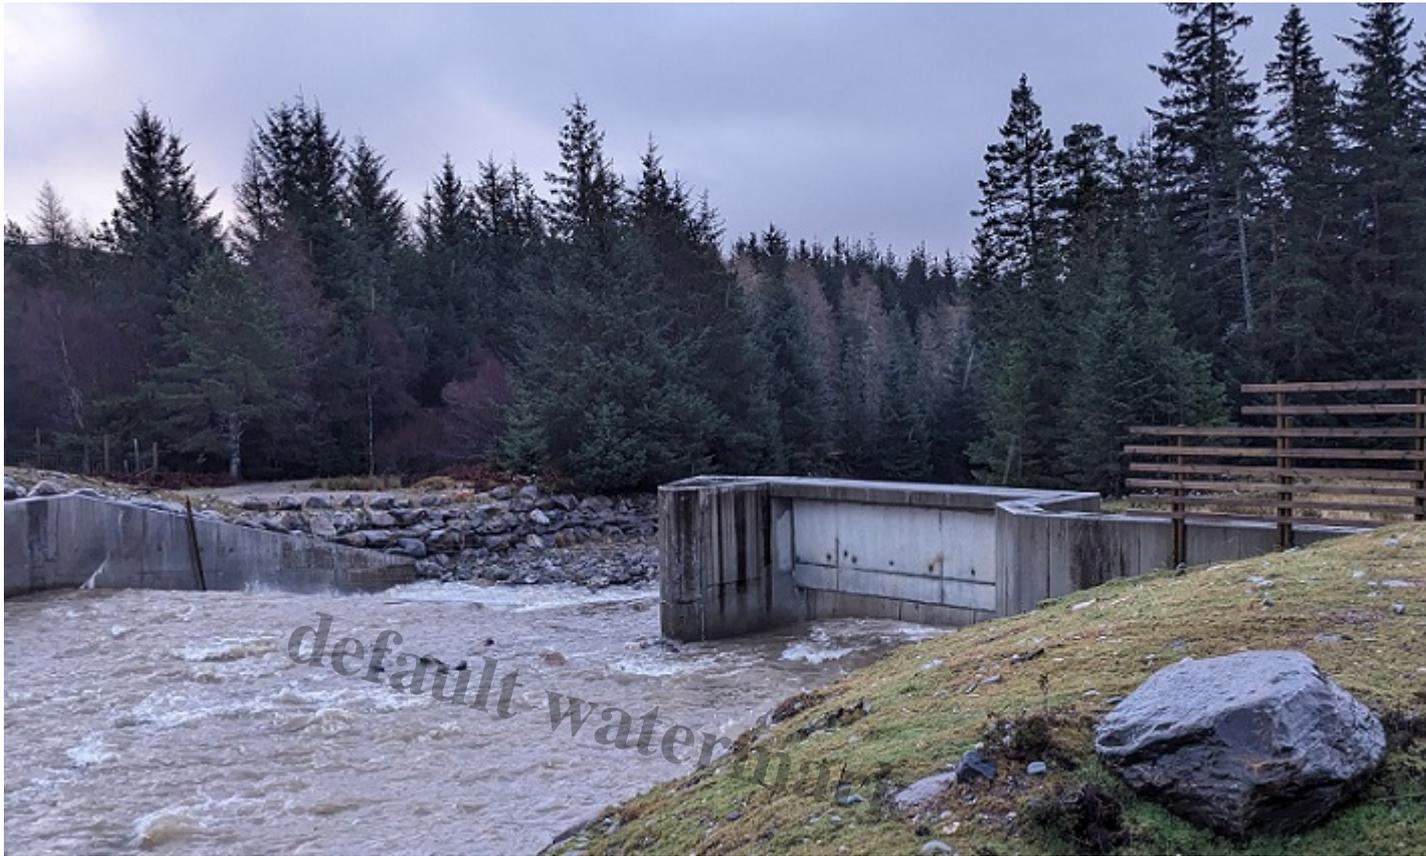
The intake to the Gynack overflow from below 31st Dec 2024

The intake to the Gynack overflow from below. 31st Dec 2024

My estimate from looking at the volume of water flowing through the intake was that the overflow was working at less than half of its maximum capacity. Even so, around the time I visited, the level of water in the River Gynack was sufficiently high for trains on the Perth-Inverness line to be cancelled because of the risk to the railway bridge in Kingussie below [\(see here\)](#).

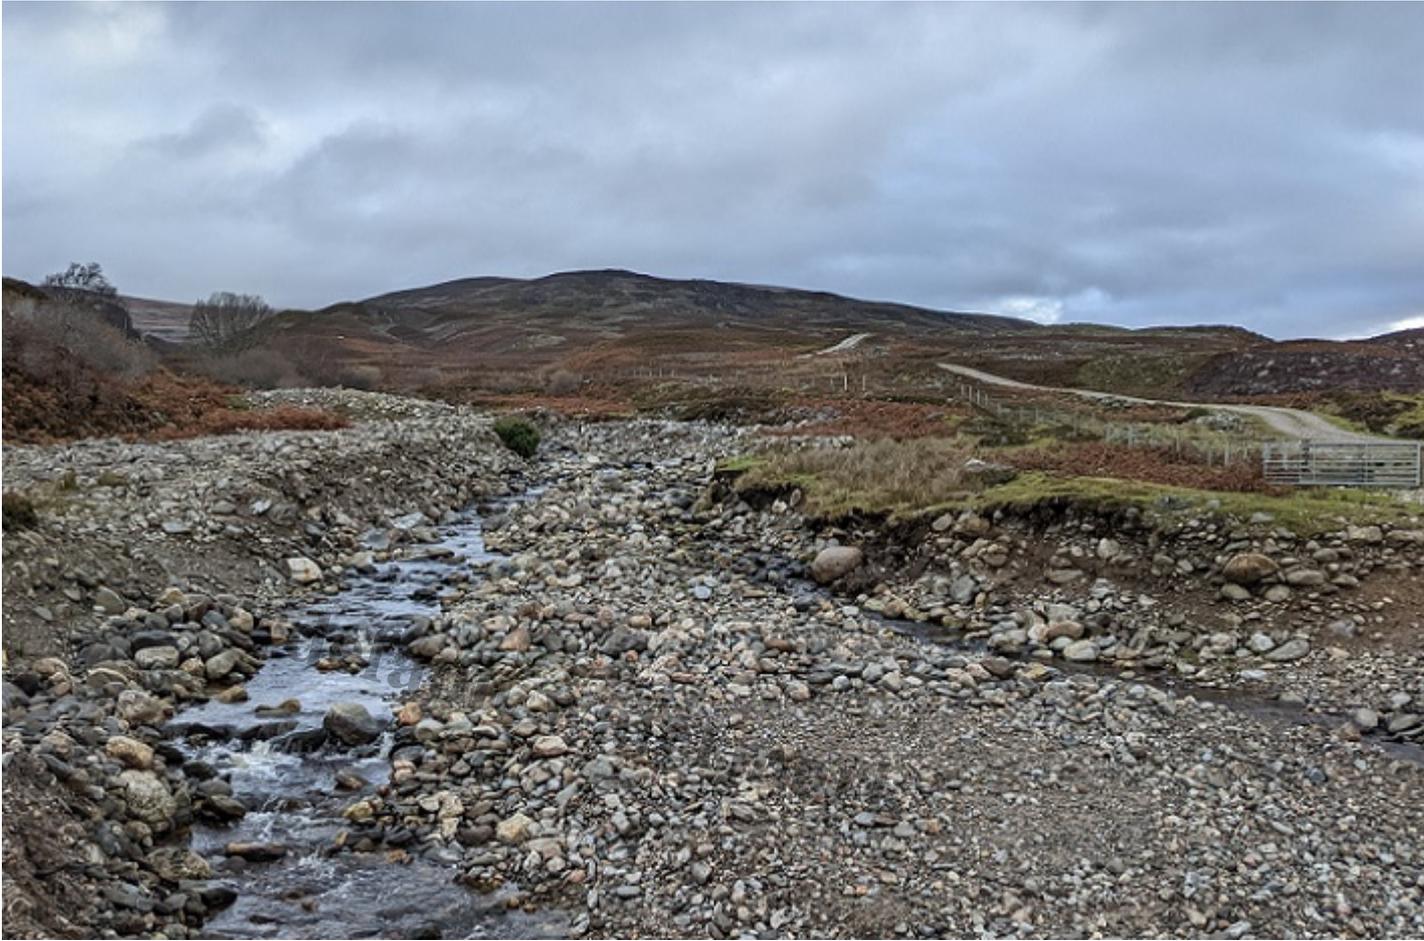
The River Gynack just above the overflow November 2022 with muirburn visible from just behind the gate on the right to the top of the hill in the distance

The overflow diverts water from the River Gynack when levels are high to Loch Gynack before it flows back into the main river. The overflow serves to delay/reduce the flood risks in Kingussie not to solve them. The only way for that to happen would be to ban the extensive muirburn undertaken by the Pitman Estate within the Gynack catchment and reduce grazing levels so that vegetation holds back water on the hillside instead of it rapidly draining into the river system as it does at present.

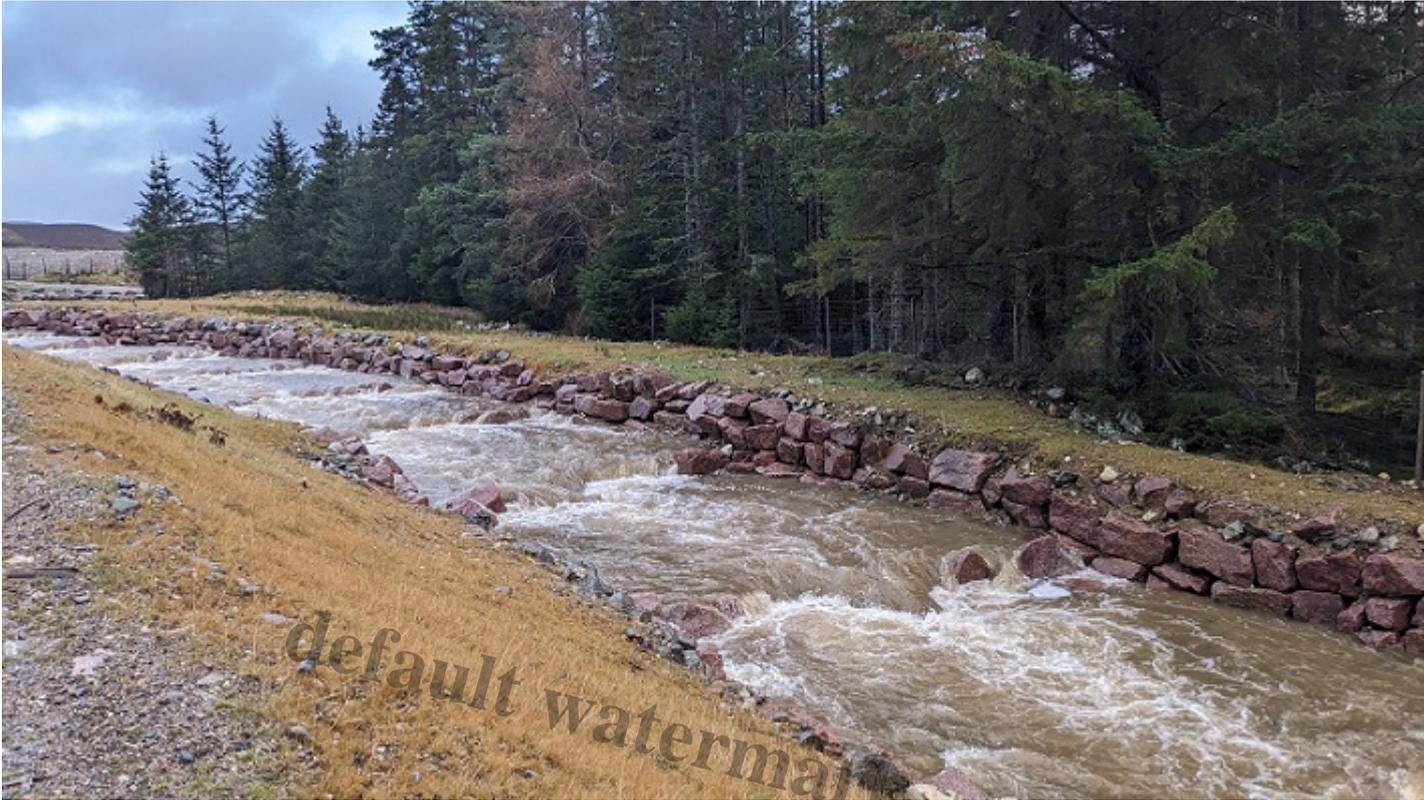
The top section of the channel. Note the width of the bank on the far side at this point.

The top part of the re-designed overflow appeared to be working more effectively. The rock steps were directing the main flow away from the banks while the much larger replacement rocks used for the rip-rap bouldering appeared to have been unaffected by the flood.

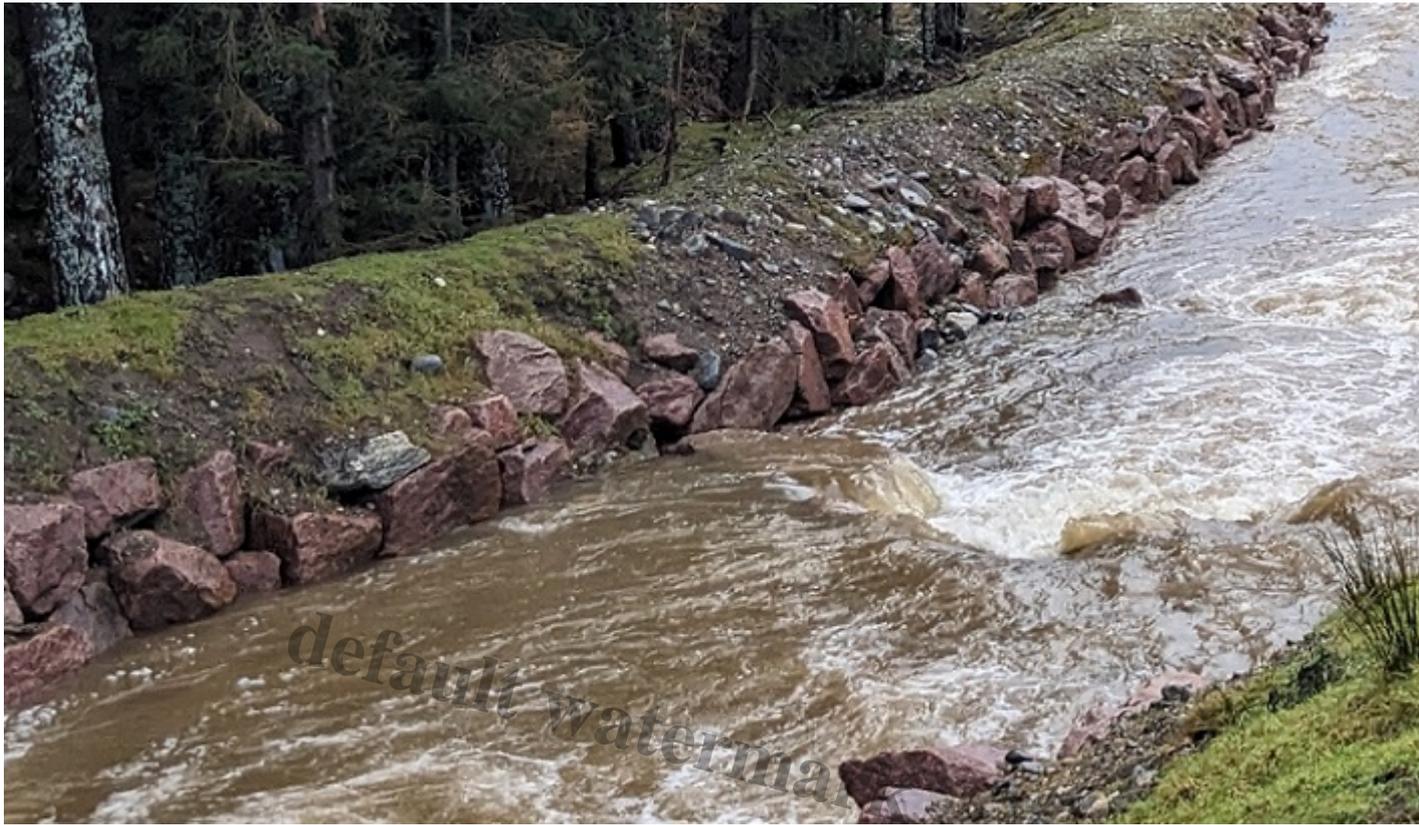
Note how the earth heaped on top of the rip rap bouldering has been eroding just to the right of the tree and along the bare area which starts by the bottom step

The embankment at the bottom of the stepped section appeared far more vulnerable, being narrower and there were a couple of places with exposed soils 18 inches or so above the water. Indeed, looking at the photo I did not spot this when out it looks as though a boulder may have been dislodged from what is now the lowest point of the rip rap bouldering just to the right of the tree. If the overflow was to operate full capacity these weak points look extremely vulnerable to erosion which could potentially result in the channel failing catastrophically.

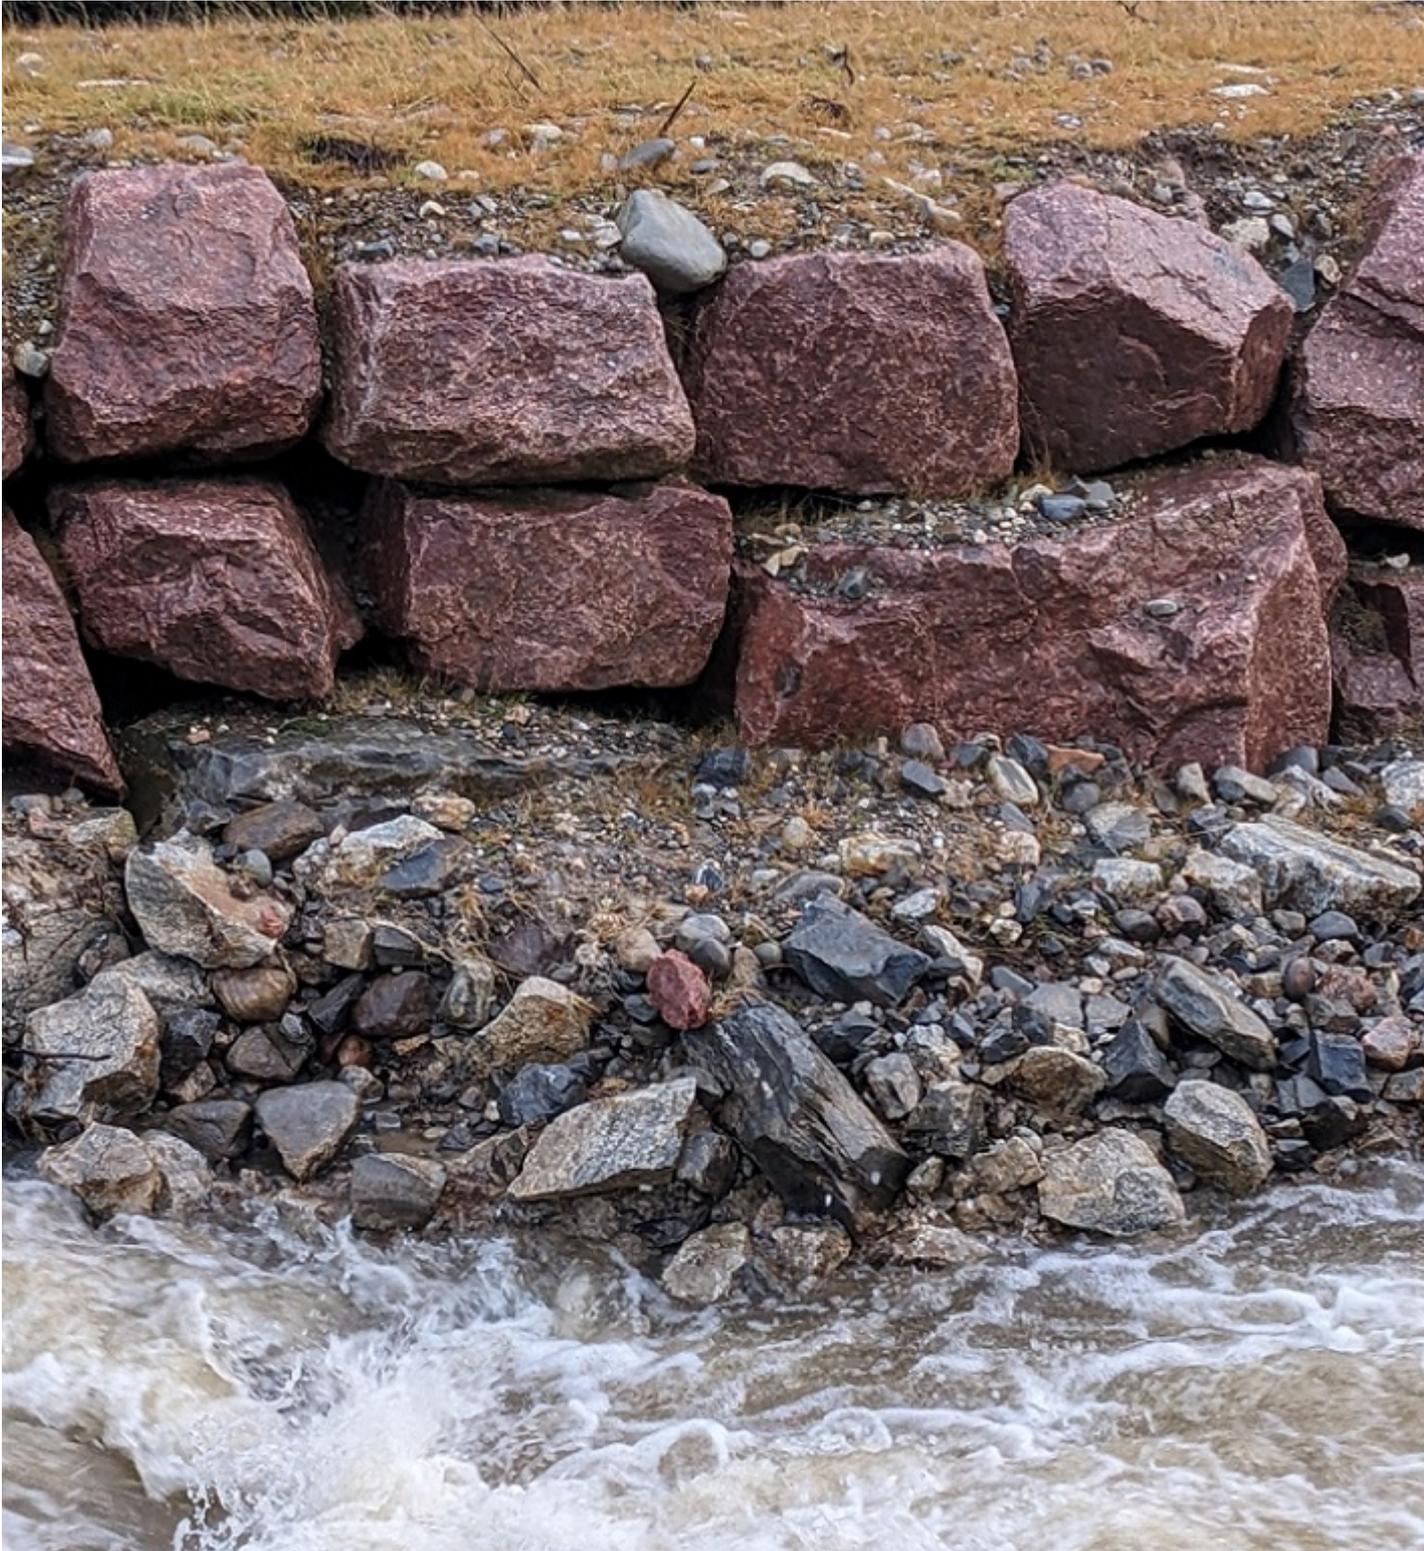
A section of rip rap bouldering that has now been partially buried

Since returning to use, the force of the water in the overflow channel has redeposited rocks large and small. This has strengthened the embankment at some points but could potentially undercut it in others.

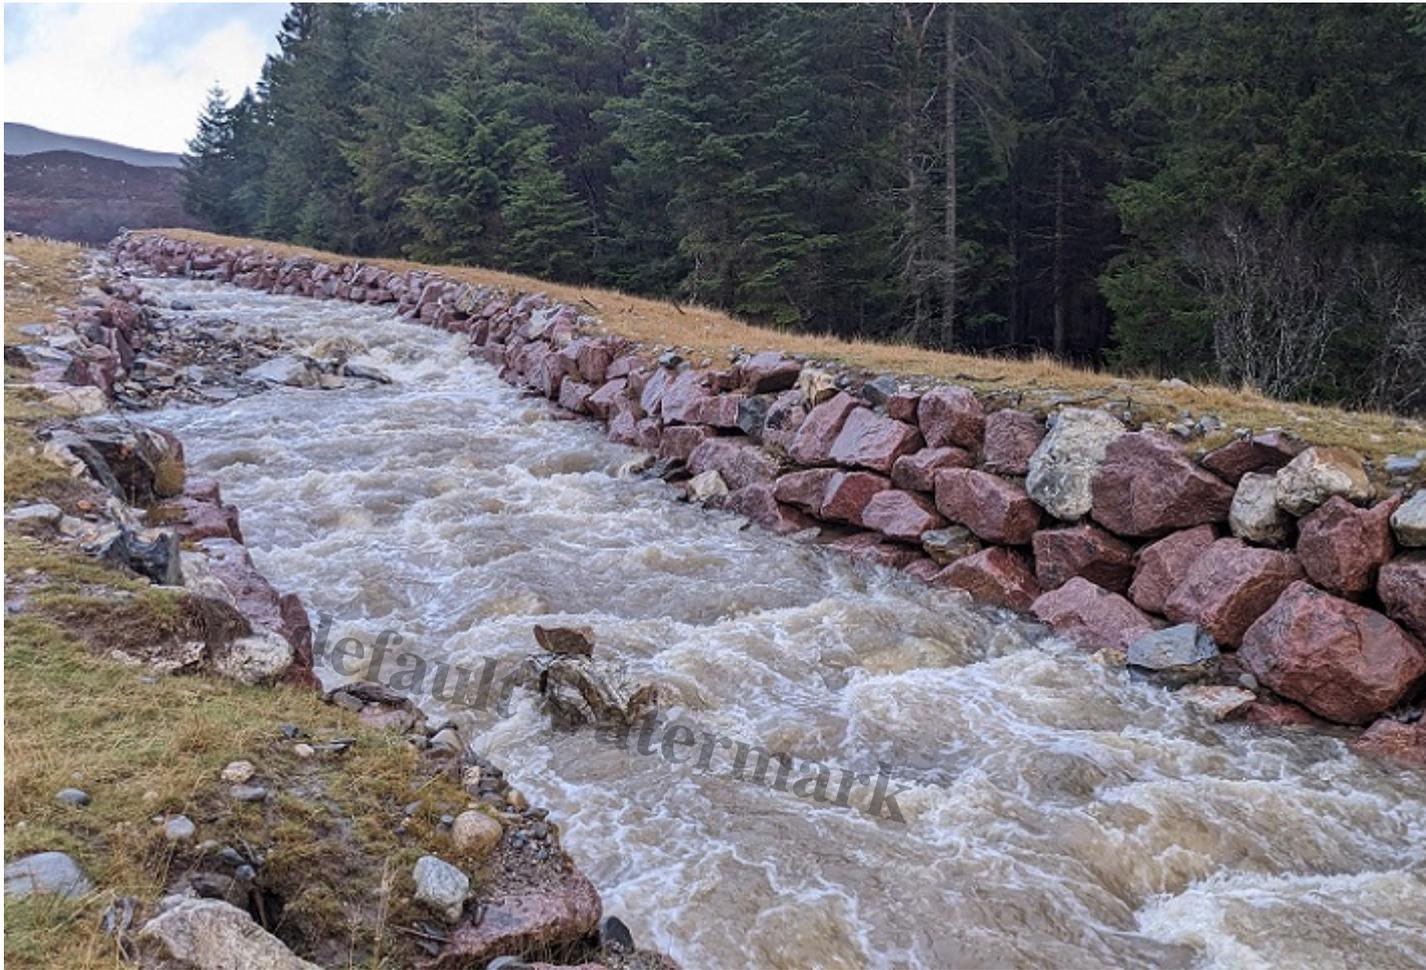
Stranded rock on boulder in foreground with differential erosion of the base of the channel evident from the "dry" area behind.

As it flows down and across the hillside the channel narrows significantly constraining the water and increasing its force. While the rip rap bouldering on the right appeared to me quite robust again I wondered what would happen if the overflow was running at full capacity?

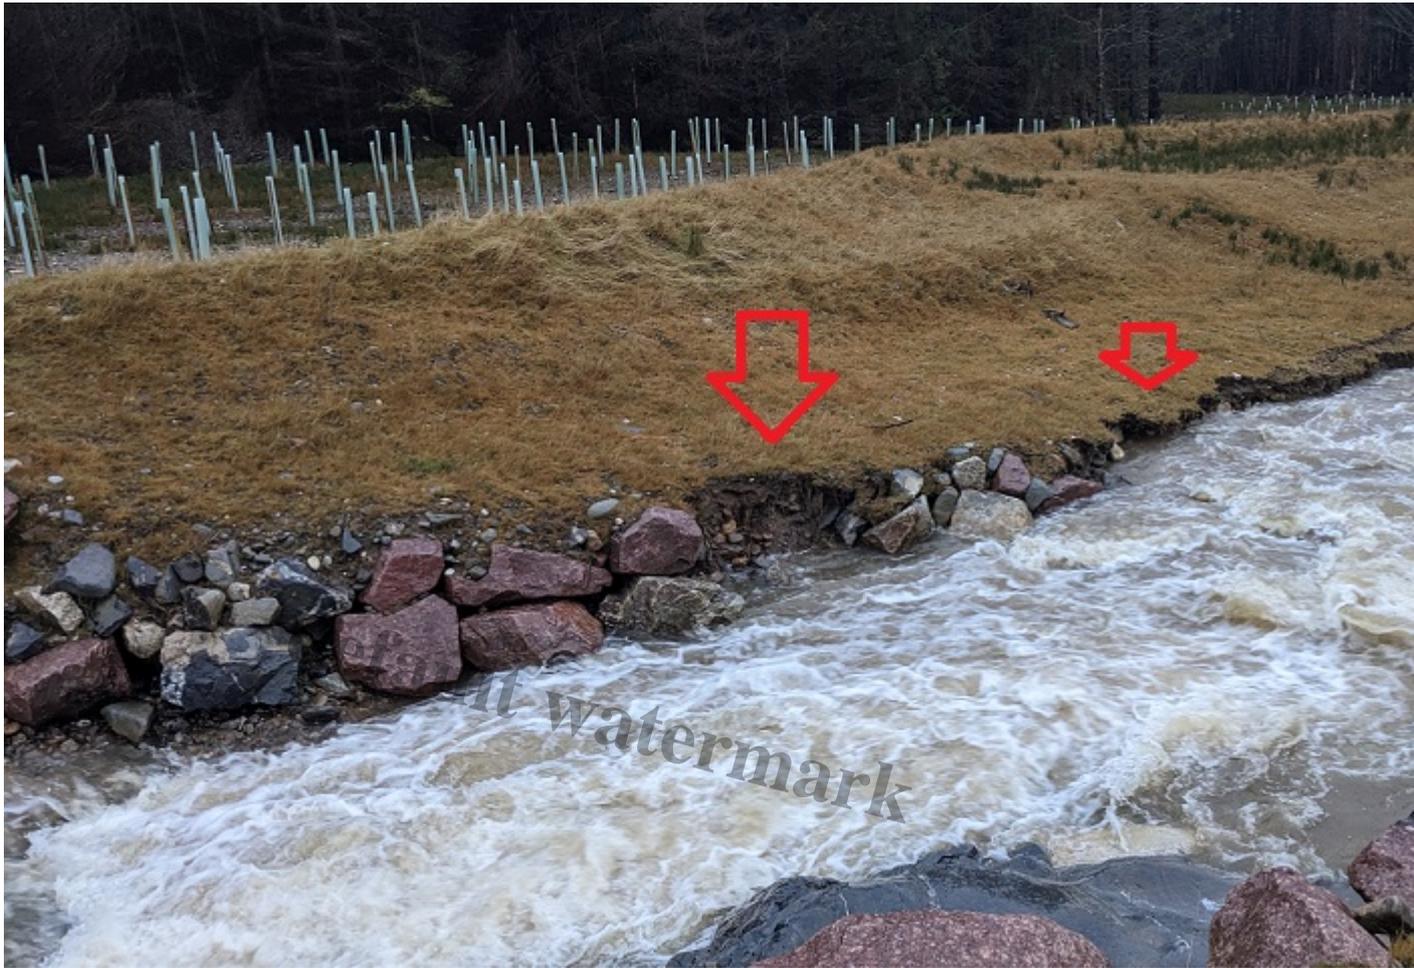
The gap in the protection was probably filled with two or more smaller boulders. Note how the gently sloping earth embankment downstream has started to erode.

The one clear example I observed of a failure in rip rap bouldering was at the very bottom of the steep section of the overflow where the embankment changes from rock to earth. Some of the smaller rocks used for the rip rap bouldering had been swept away just as happened with the first version of the channel. The trees planted behind will do nothing to strengthen it.

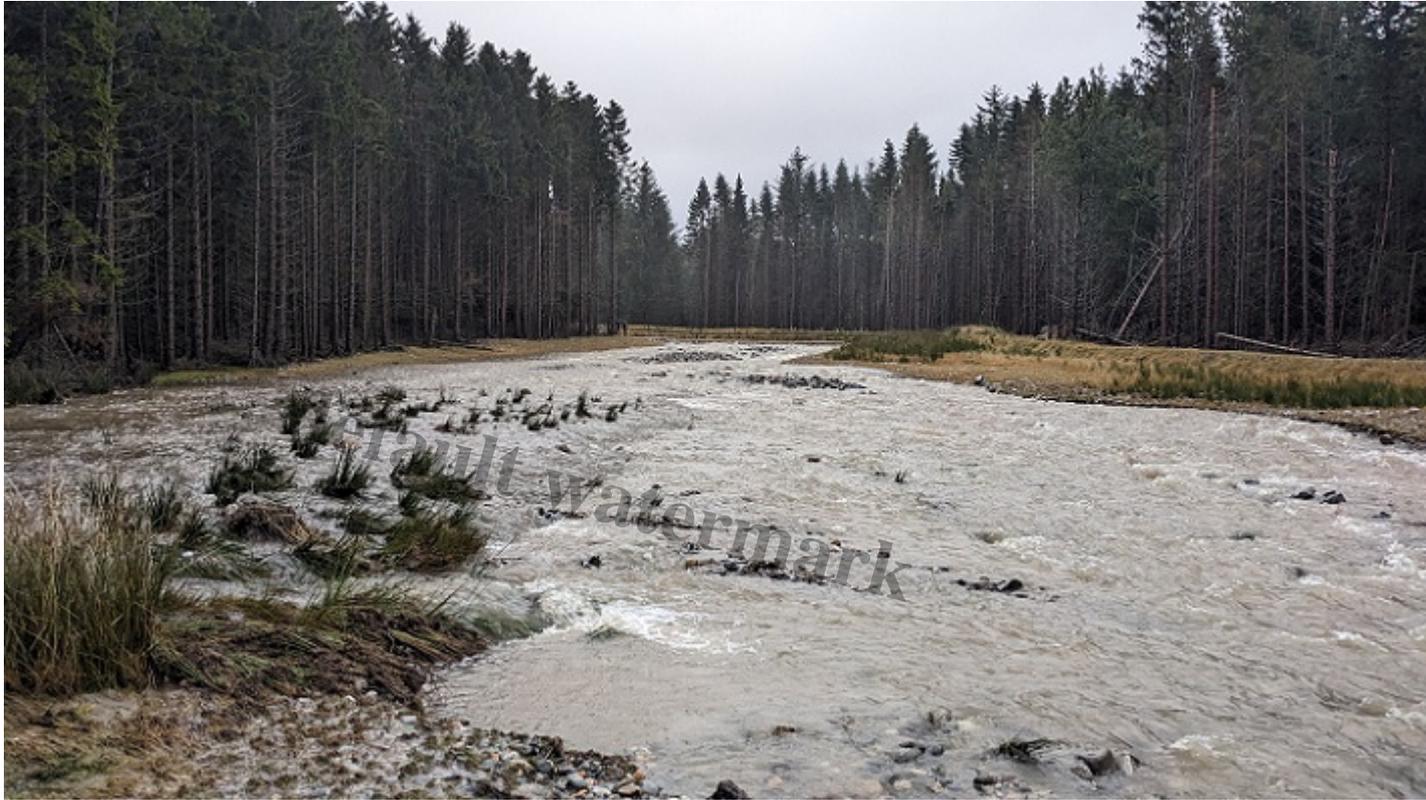
Looking up the broadest section of the channel with the earth embankment on the right

Along the broadest section of the channel the earth embankment is very low. At present the water is eroding a course away from the embankment to the edge of the trees but the question is what will happen when it starts to meander? That process might be accelerated if the water undercuts some of the trees causing them to fall into the channel and diverting the flow. Will the bank then be sufficiently covered in vegetation to withstand the flow of the water or will it too start to erode?

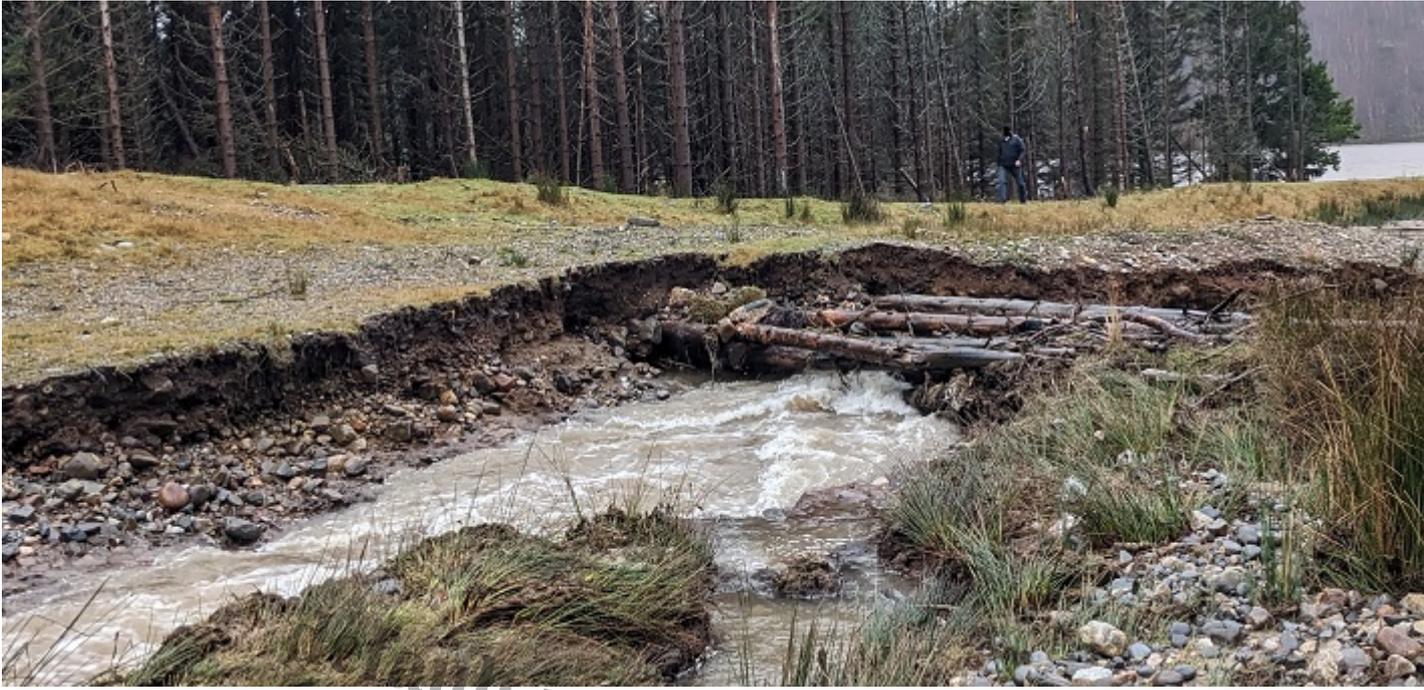
Near the bottom of the channel, with Loch Gynack visible behind. Note how the bank at this point has been built constructed with shingle, washed down by the previous overflow channel, not earth.

Near the bottom of the channel trees had been placed across the other side, possibly in an attempt to reduce erosion. The shingle section of the embankment is broad enough that it is unlikely to fail catastrophically but again the question is why should the obvious erosion processes stop this time?

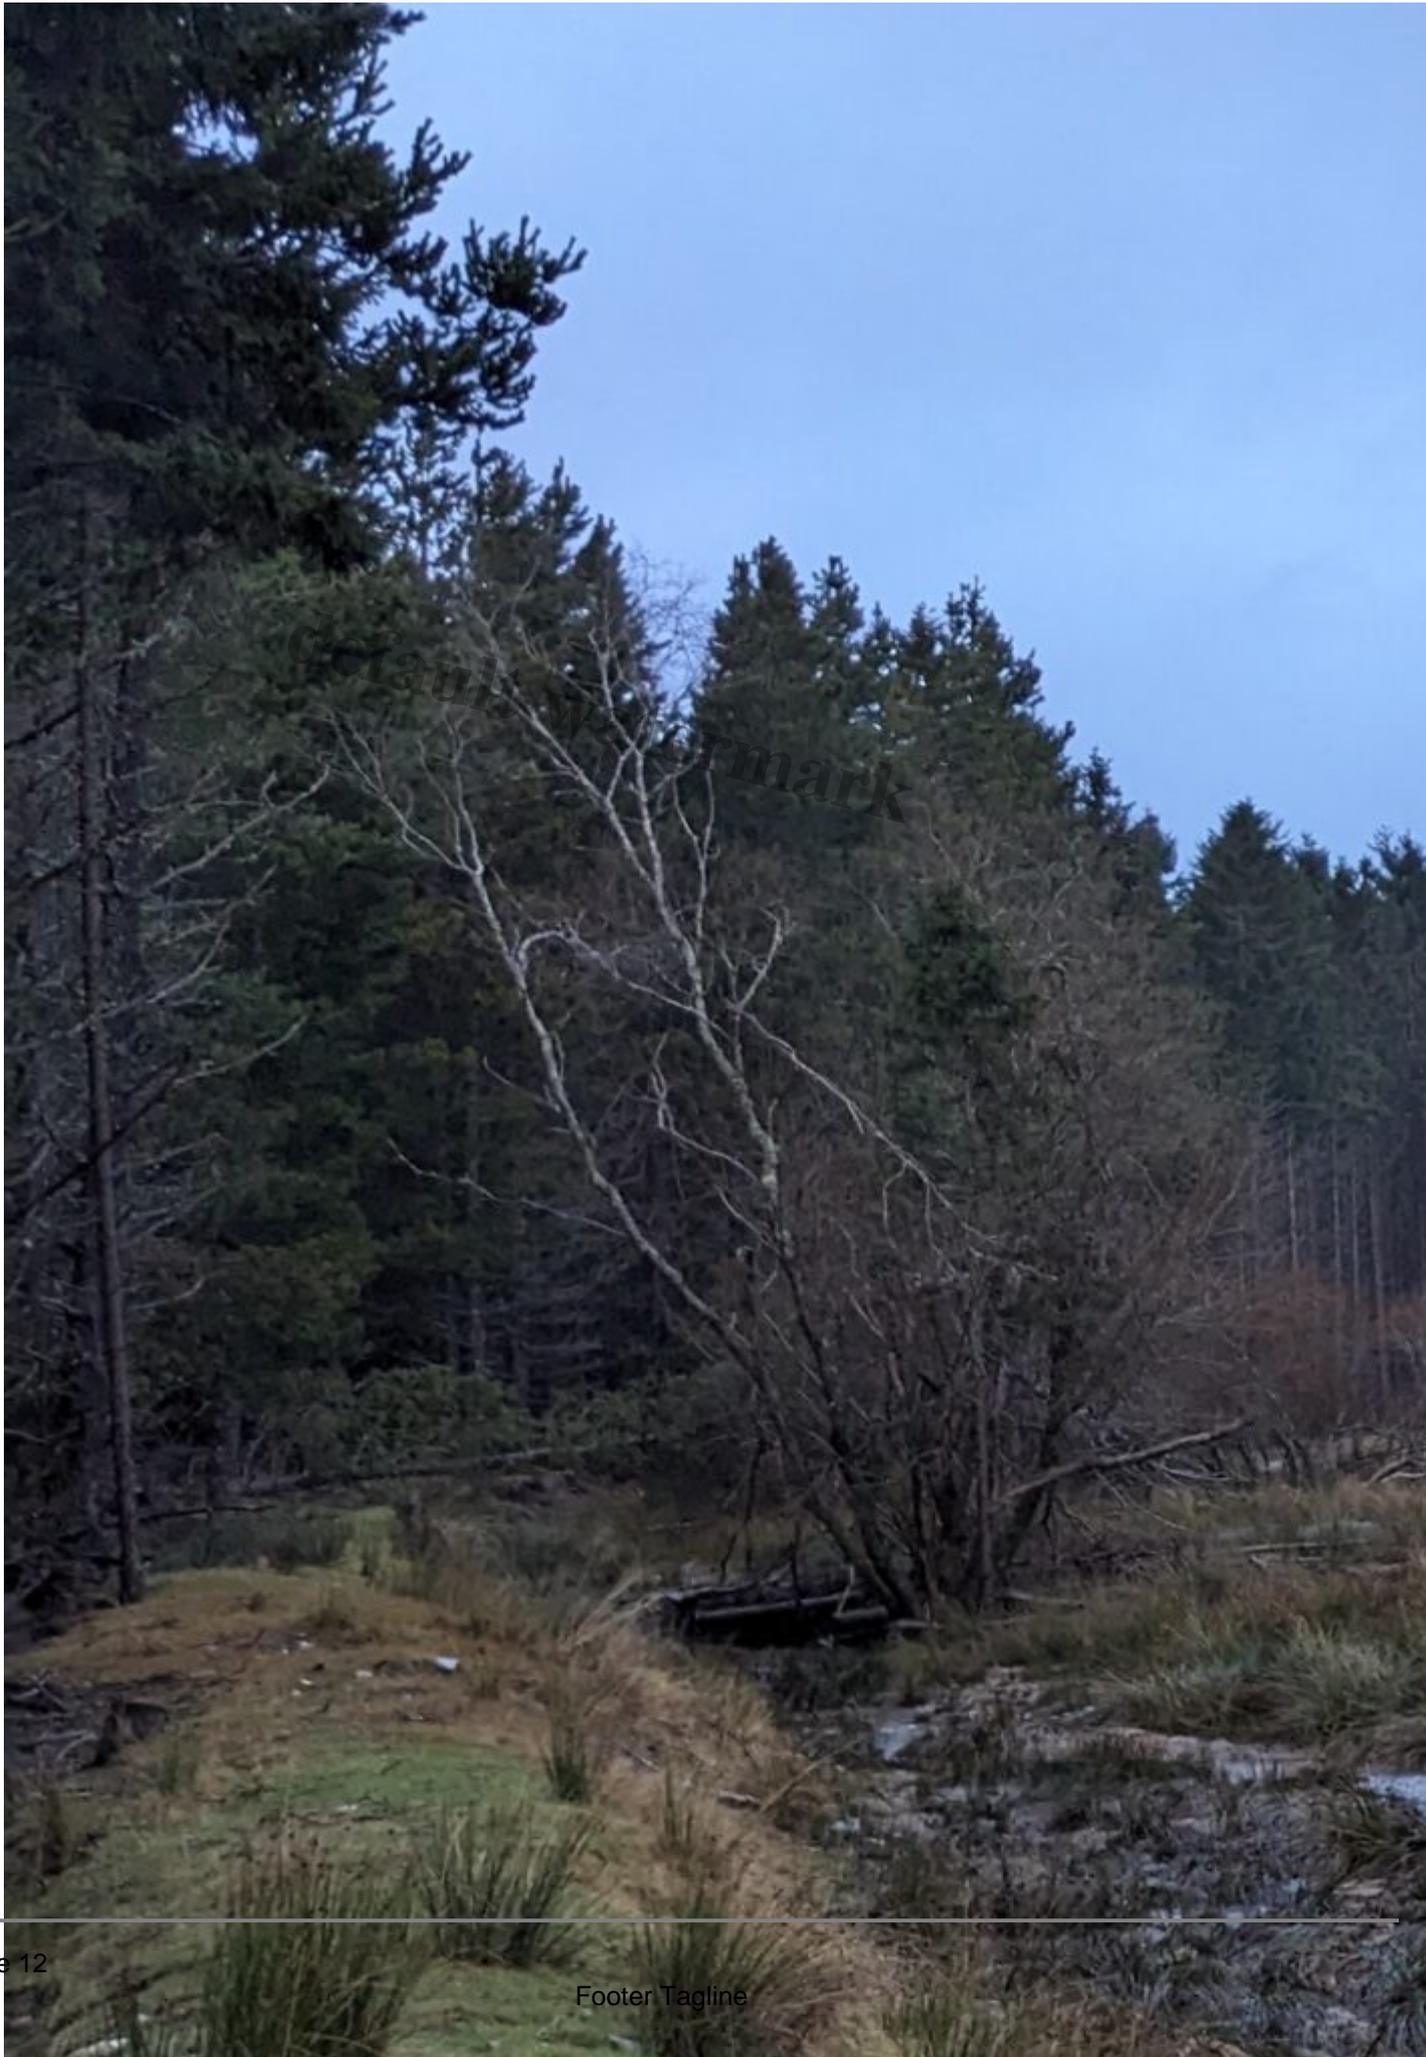
View back up to the tree dam showing how the water is already meandering significantly. Note the s

One wonders too what will happen to this channel if the beavers, released into the Spey, start to work their miracles. Along natural watercourses that normally holds back the flow and reduces flood damage but in the overflow channel it could direct the water to the vulnerable earth embankments

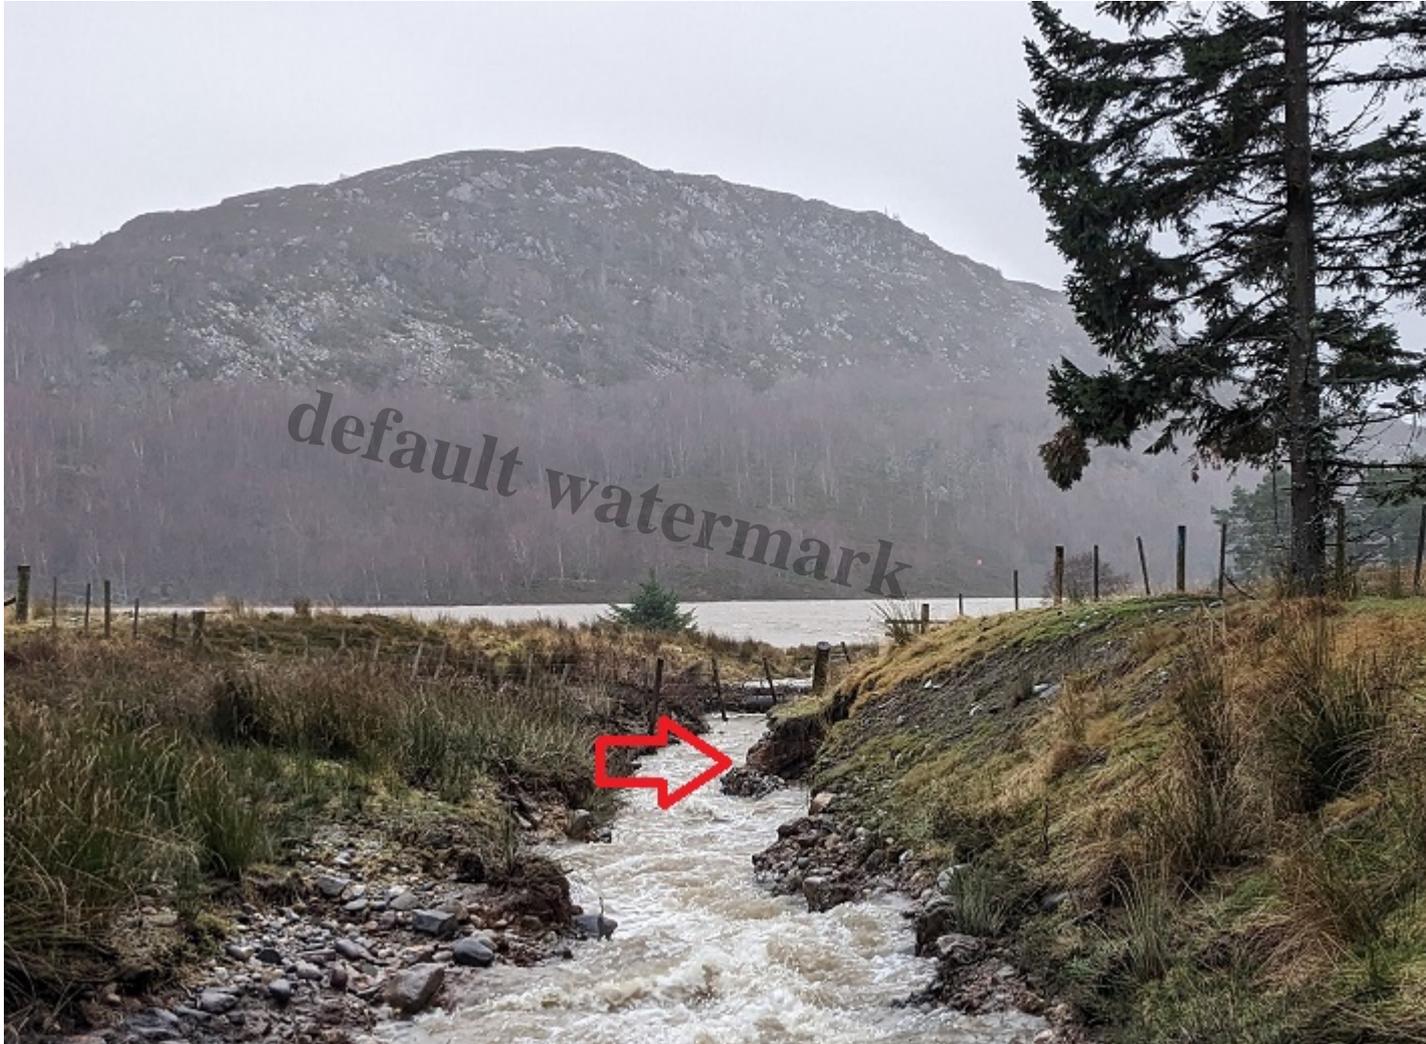
The lowest section of the channel is surprising narrow (and deep) and looks certain to sweep away a further section of the embankment on the right.

Rush had started to colonise both sides of the lower part of the embankment. That is likely to offer better protection against erosion than the bare section of bank.

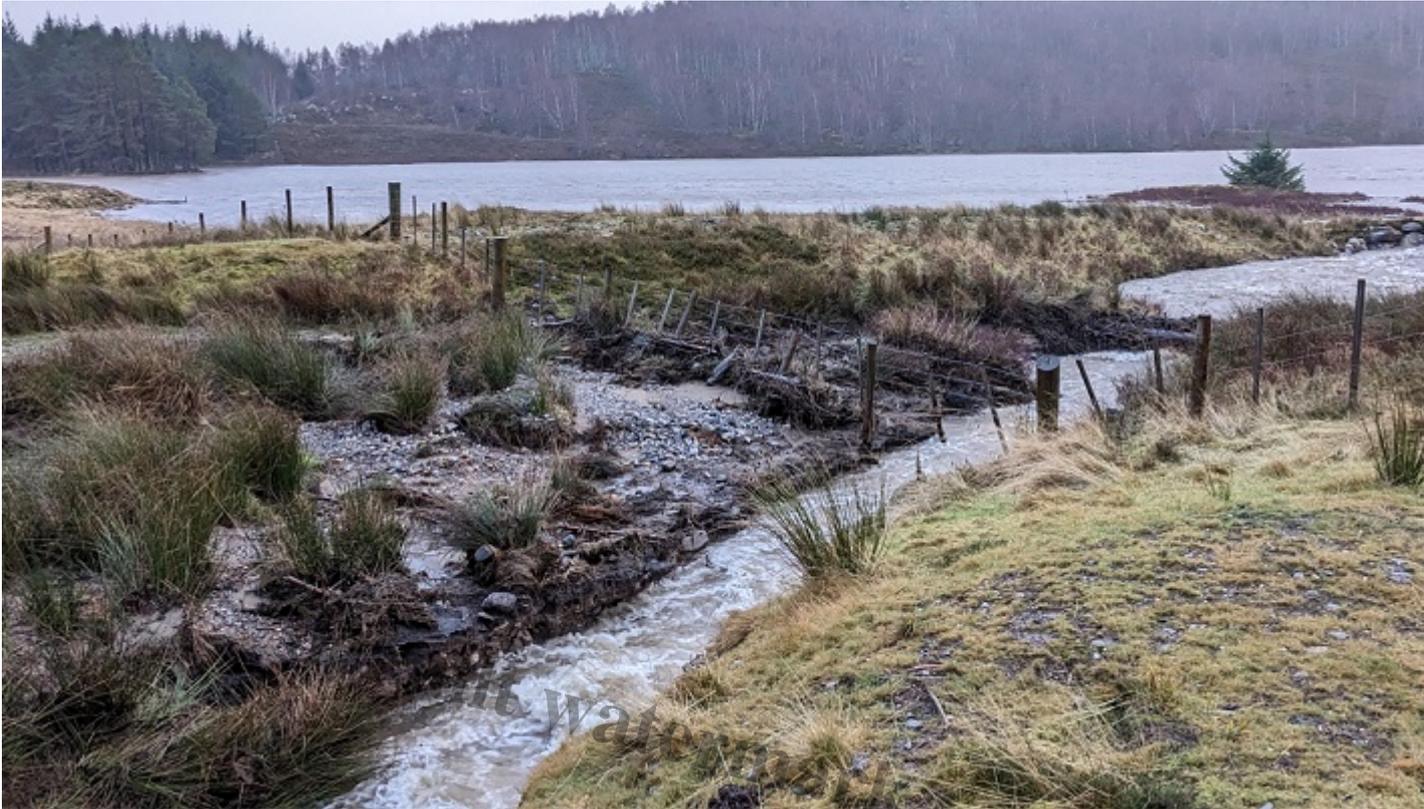
The outflow of the overflow channel viewed from the eroding section of bank. Note the difference between the still half bare bank in the foreground with the heavily vegetated bank beyond

Perhaps the upper section of the earth and shingle embankments should have been left another couple of years to allow more profuse protective vegetation to develop?
