Forest and Land Scotland's mismanagement of Strathyre - the Ben Ledi footpath

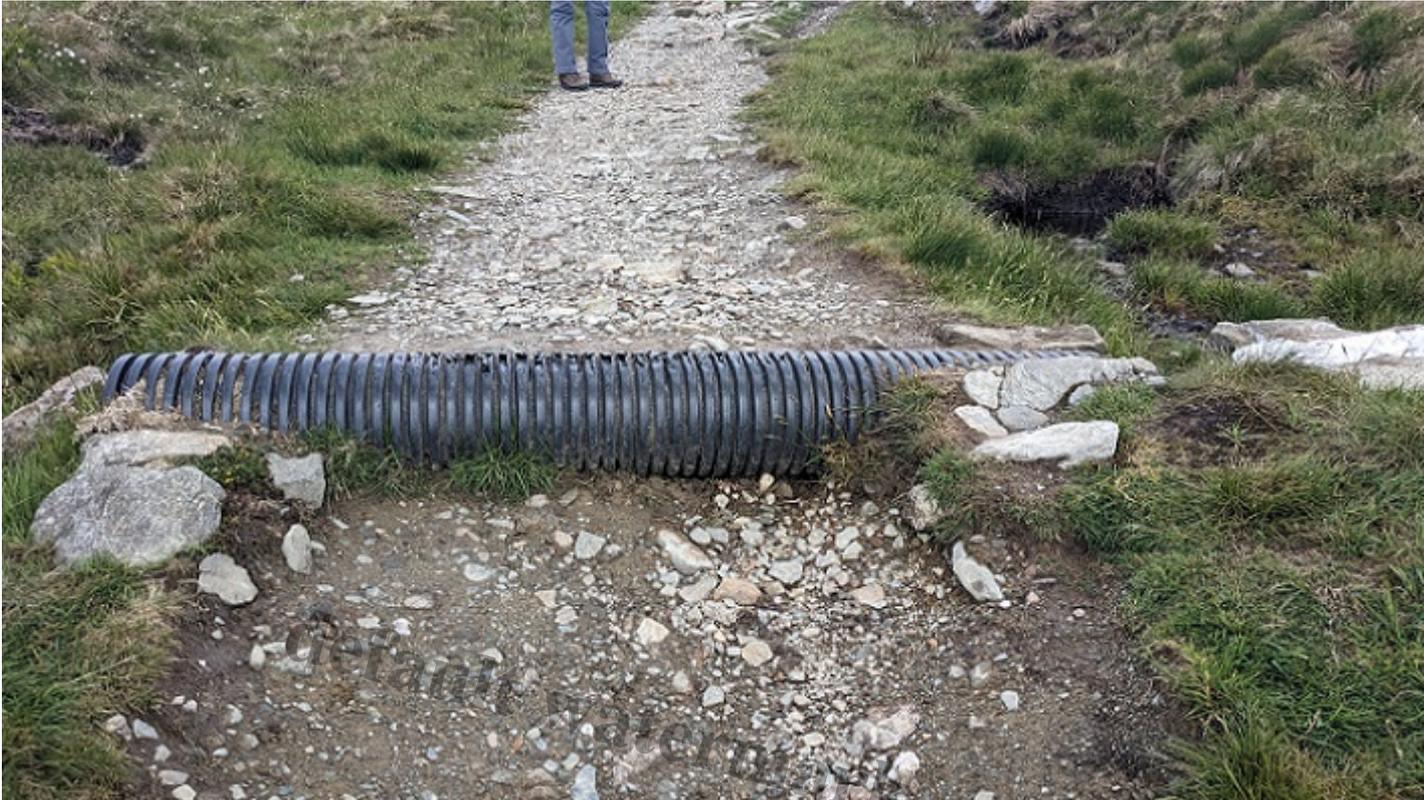
The original surface on this section of path, constructed sometime between 2016 and 2018, has completely eroded away exposing the plastic culvert which is now disintegrating

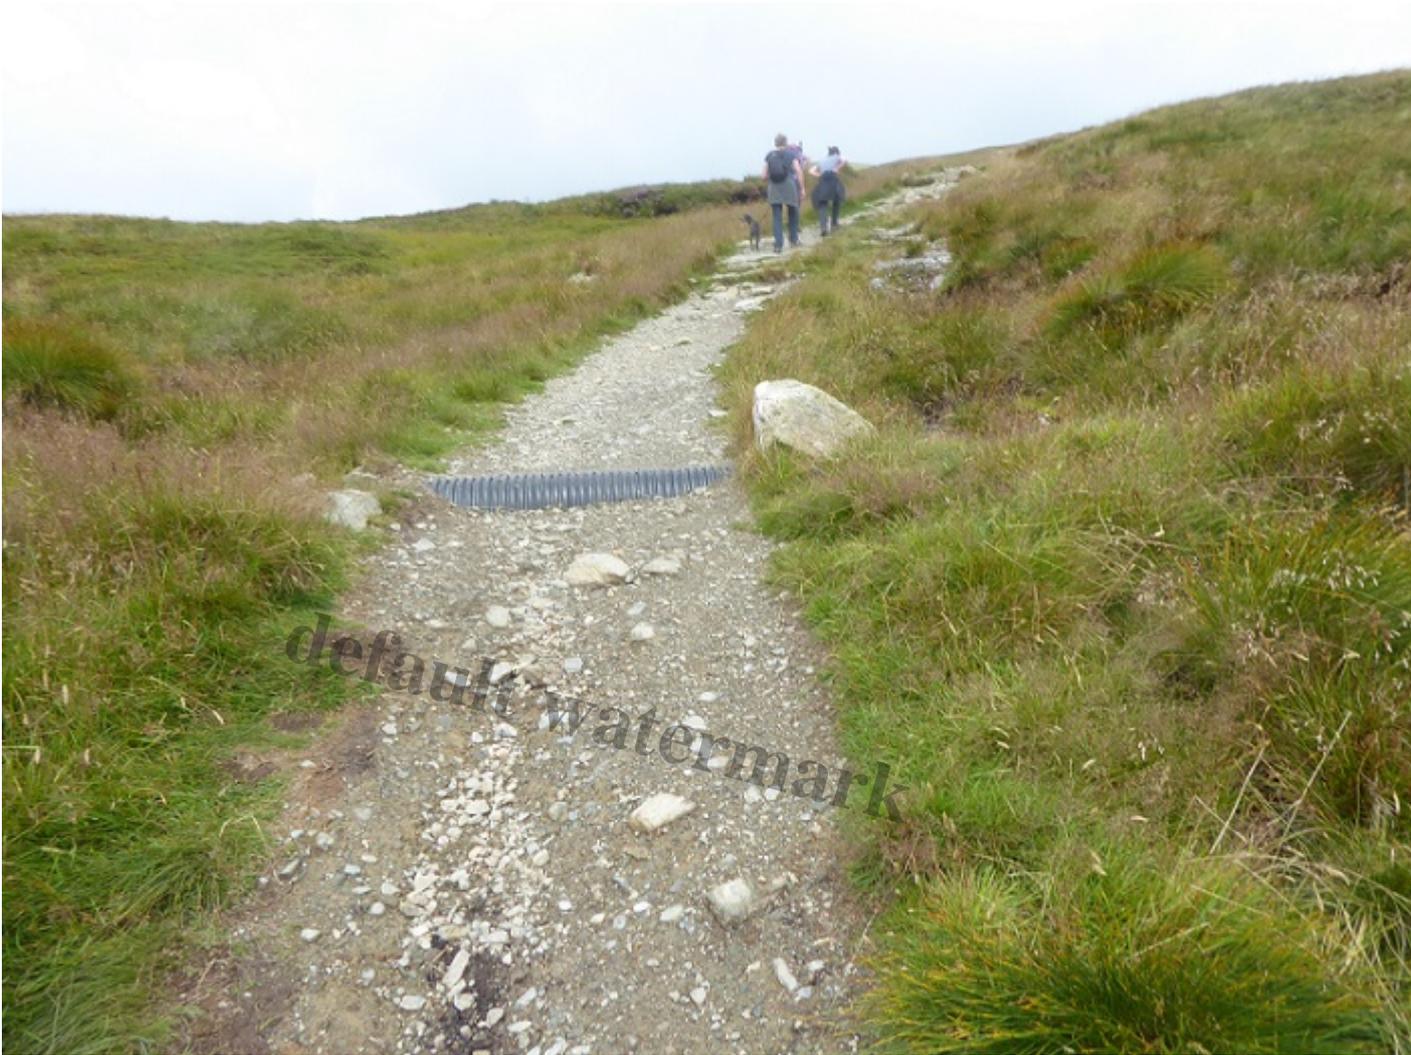
Photo September 2021 illustrating just how much more of the path surface has washed away in the last three and a half years

While the path was already seriously eroding in 2021, that process has continued. A couple of plastic culverts which were half exposed in 2021 are now totally exposed (see above) while more are emerging as the path surface has been washed away:

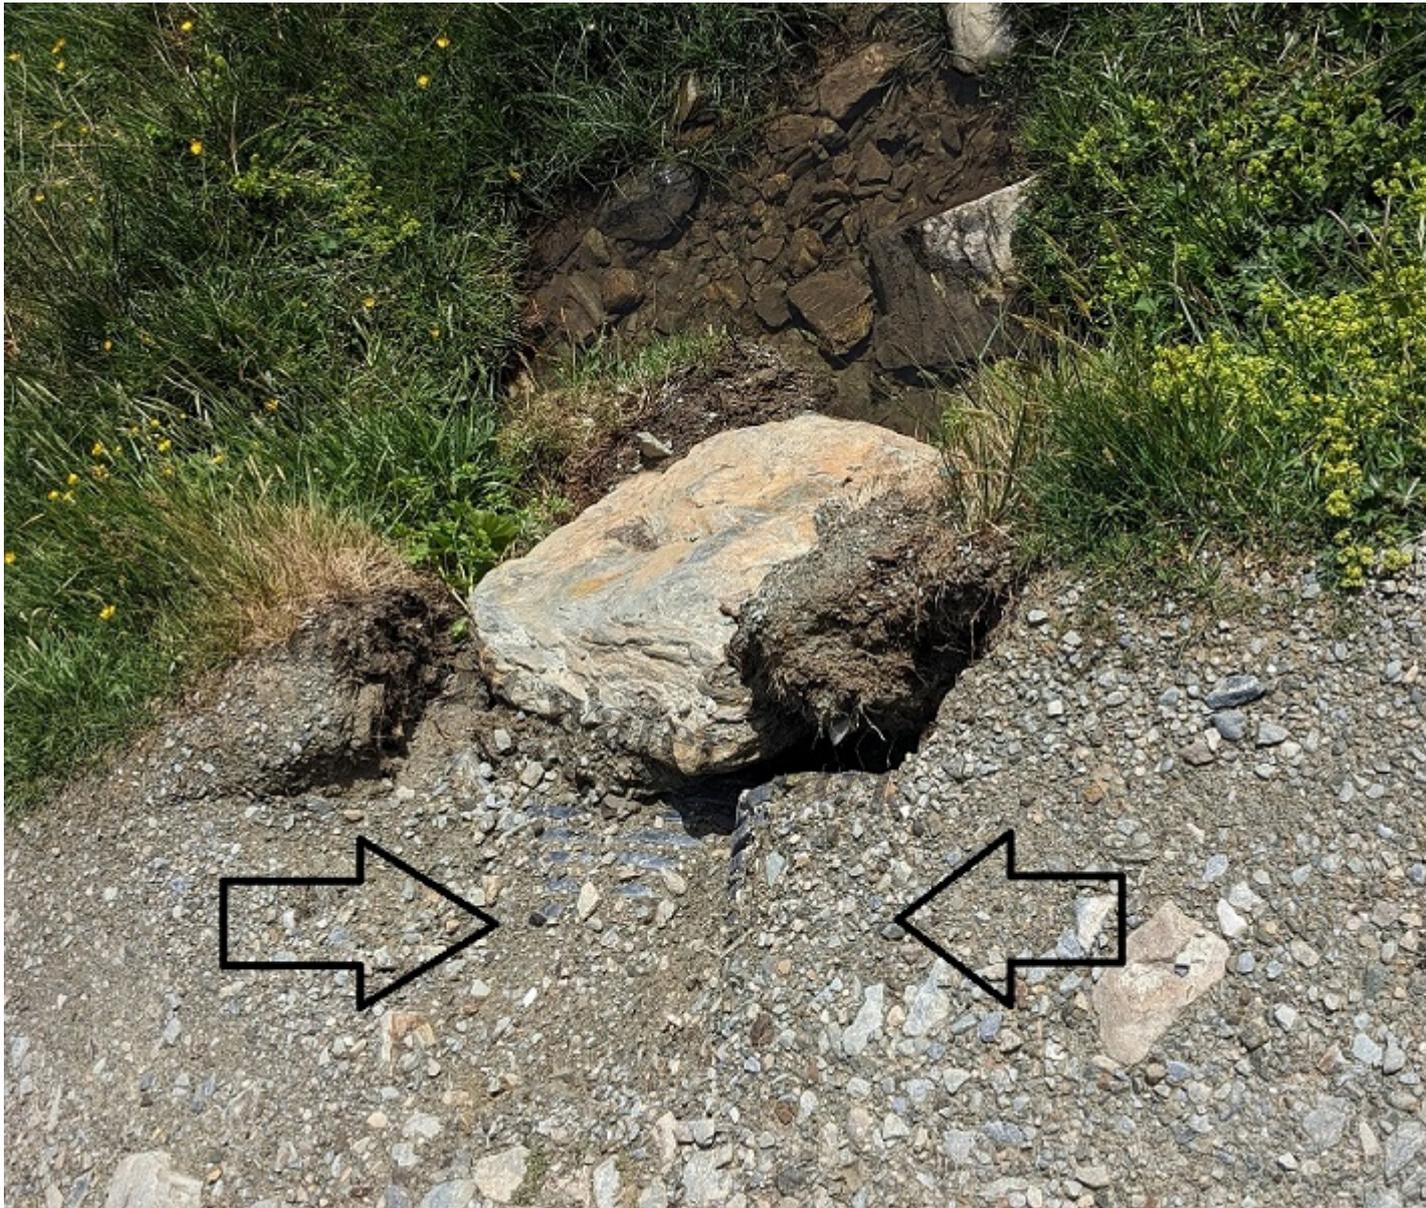
Collapsed topping stone over culvert with path surface eroded down to reveal two plastic pipes

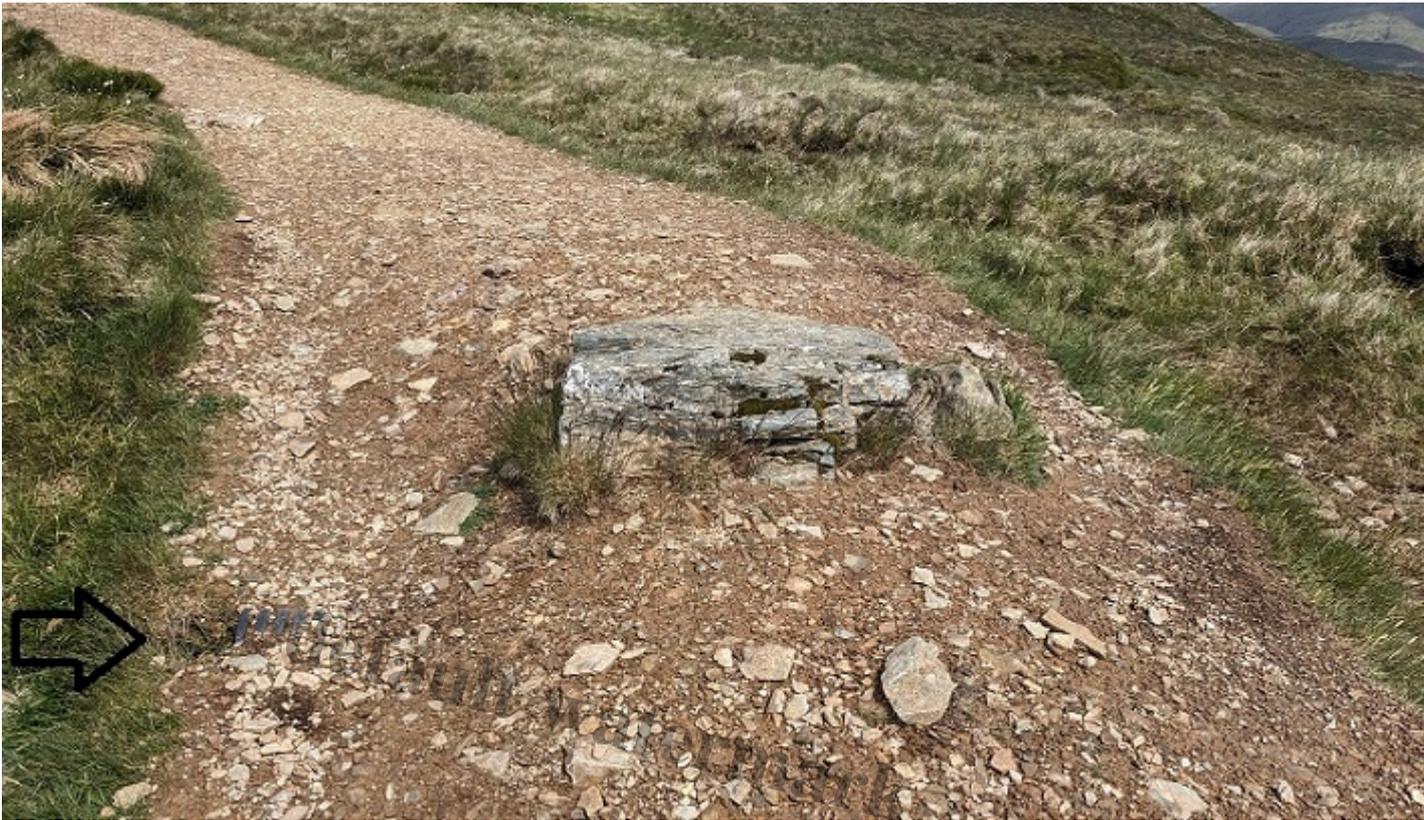
Culvert appearing by a step, stranded by erosion.

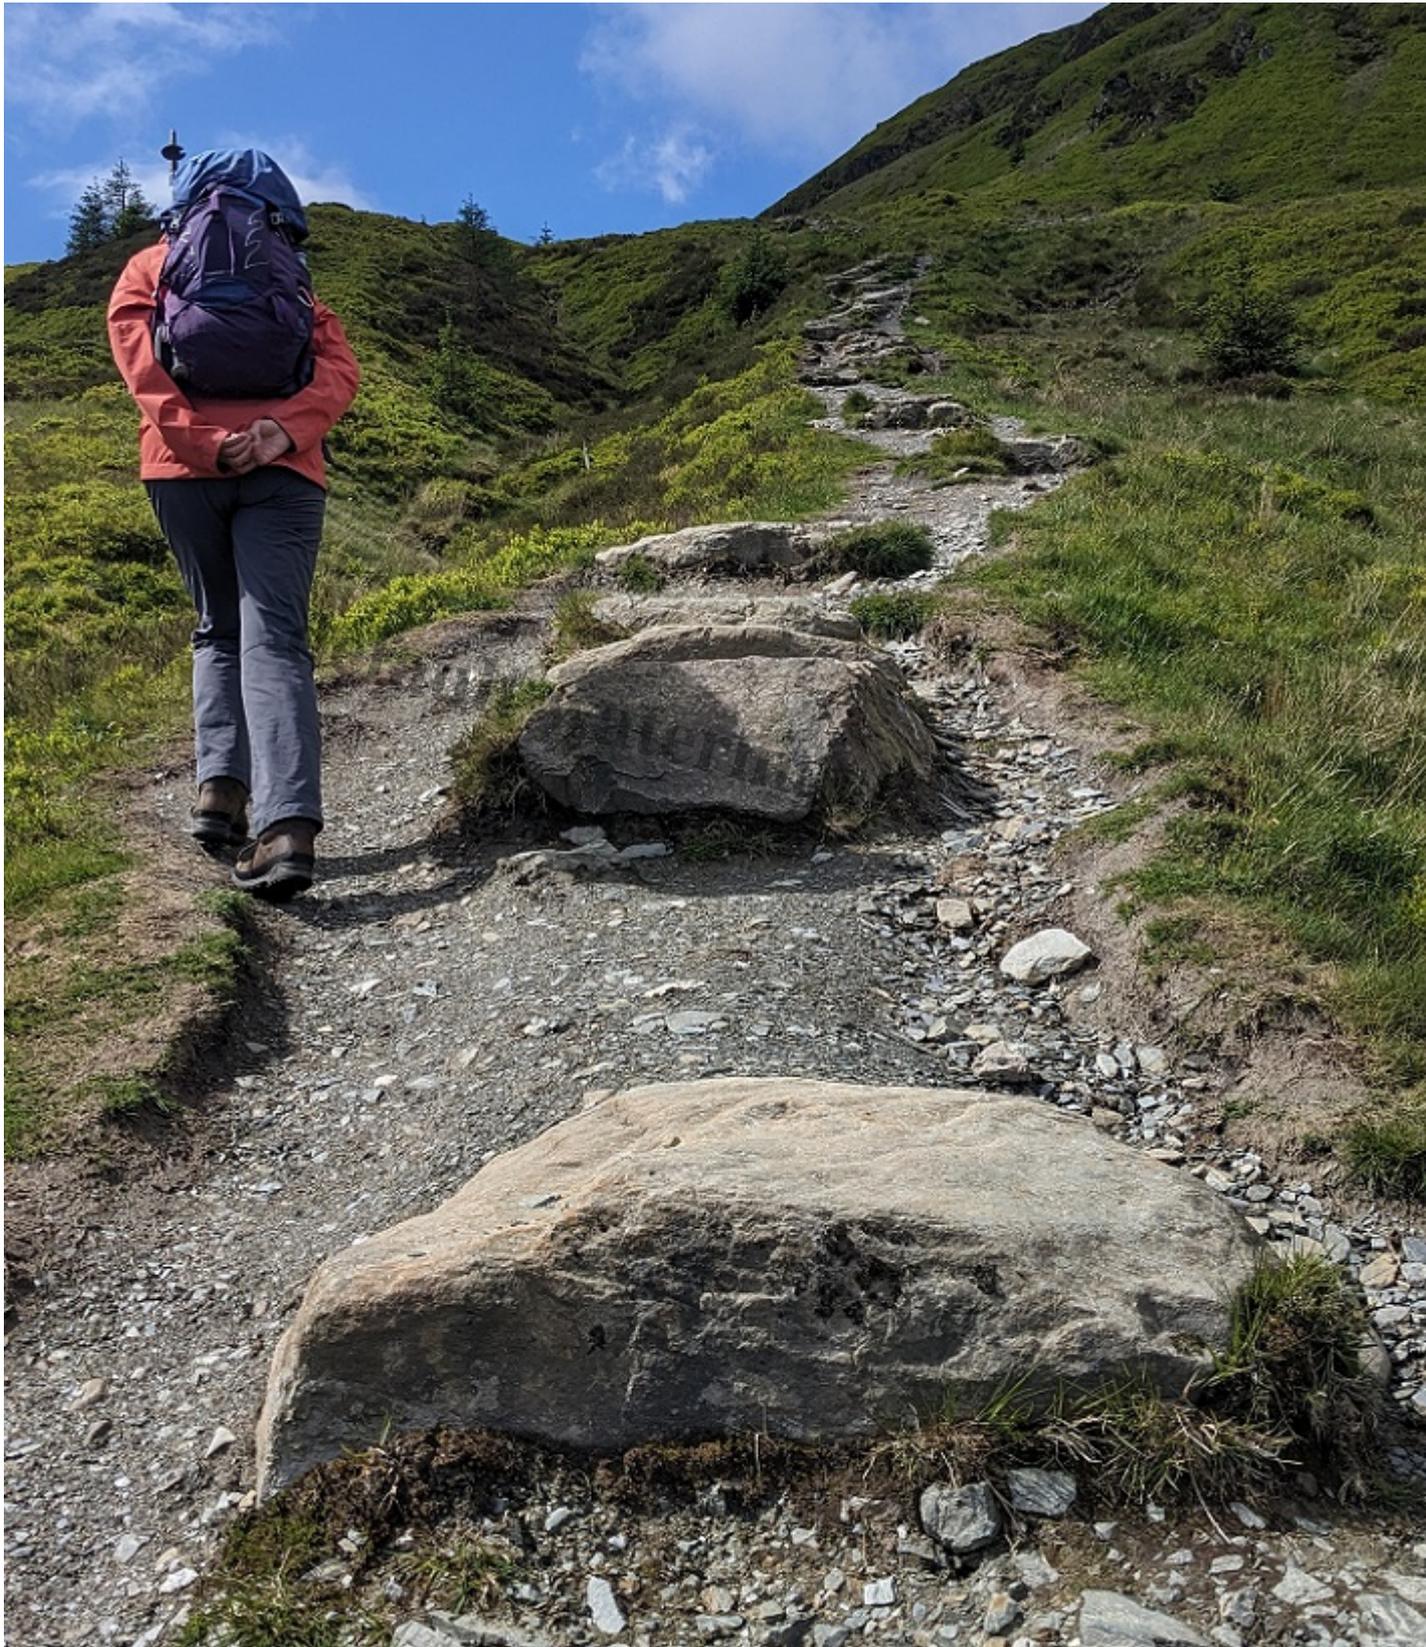
As the surface of the path below stone steps, the erosion becomes worse as people try and get round what becomes a barrier rather than an aid to progress (research has shown the average person avoids steps which are more than c8 inches high):

A section of path where the stone steps have become barriers- built by contractors engaged by the Mountains for People Project. Note how the right side of the path has now become a drainage channel where all the finer material has washed away.

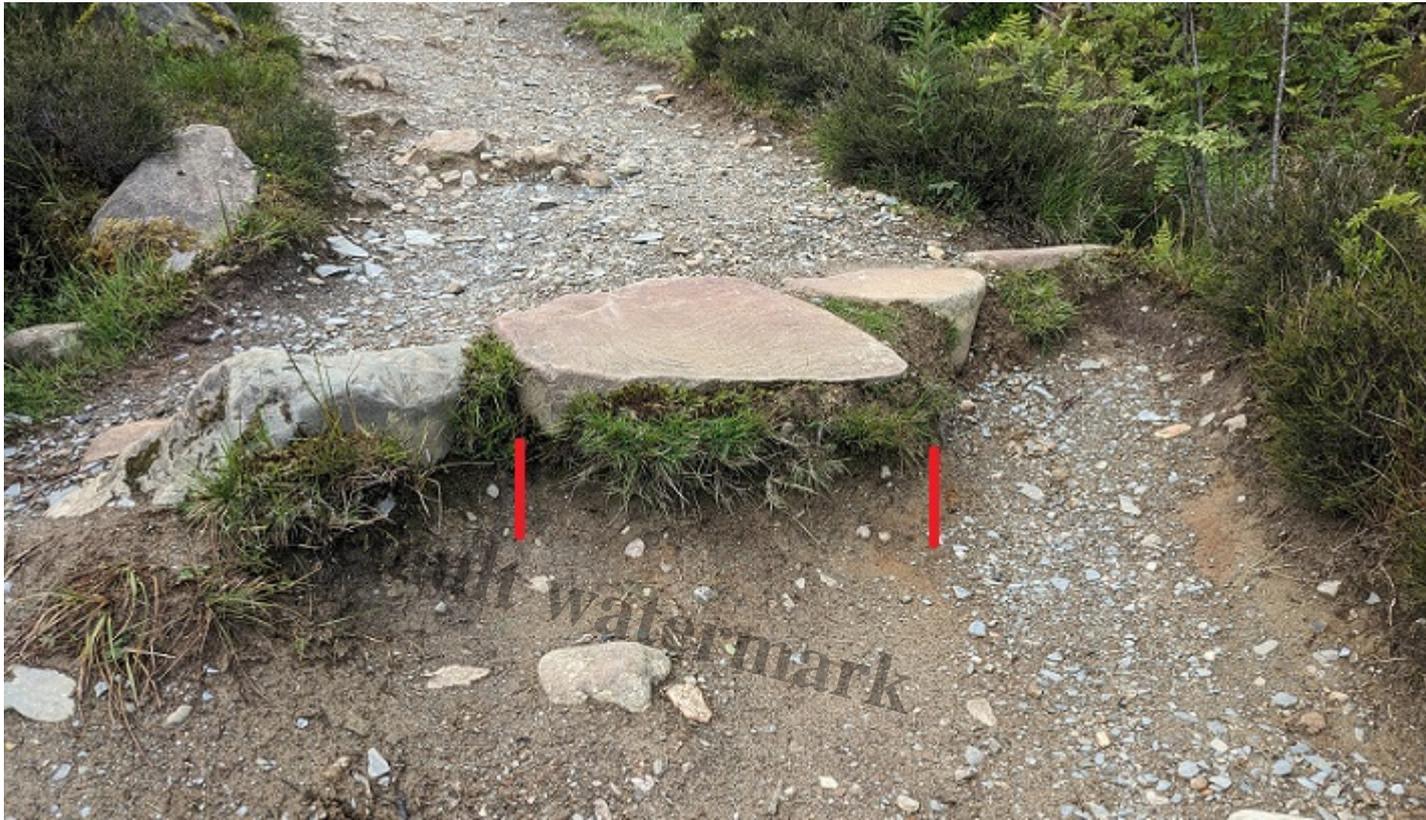
What happens is that as the surface of the path below and between steps is eroded, steps which were in some cases quite low become higher and people start to go round them.

Red lines show just how much ground has eroded out below step

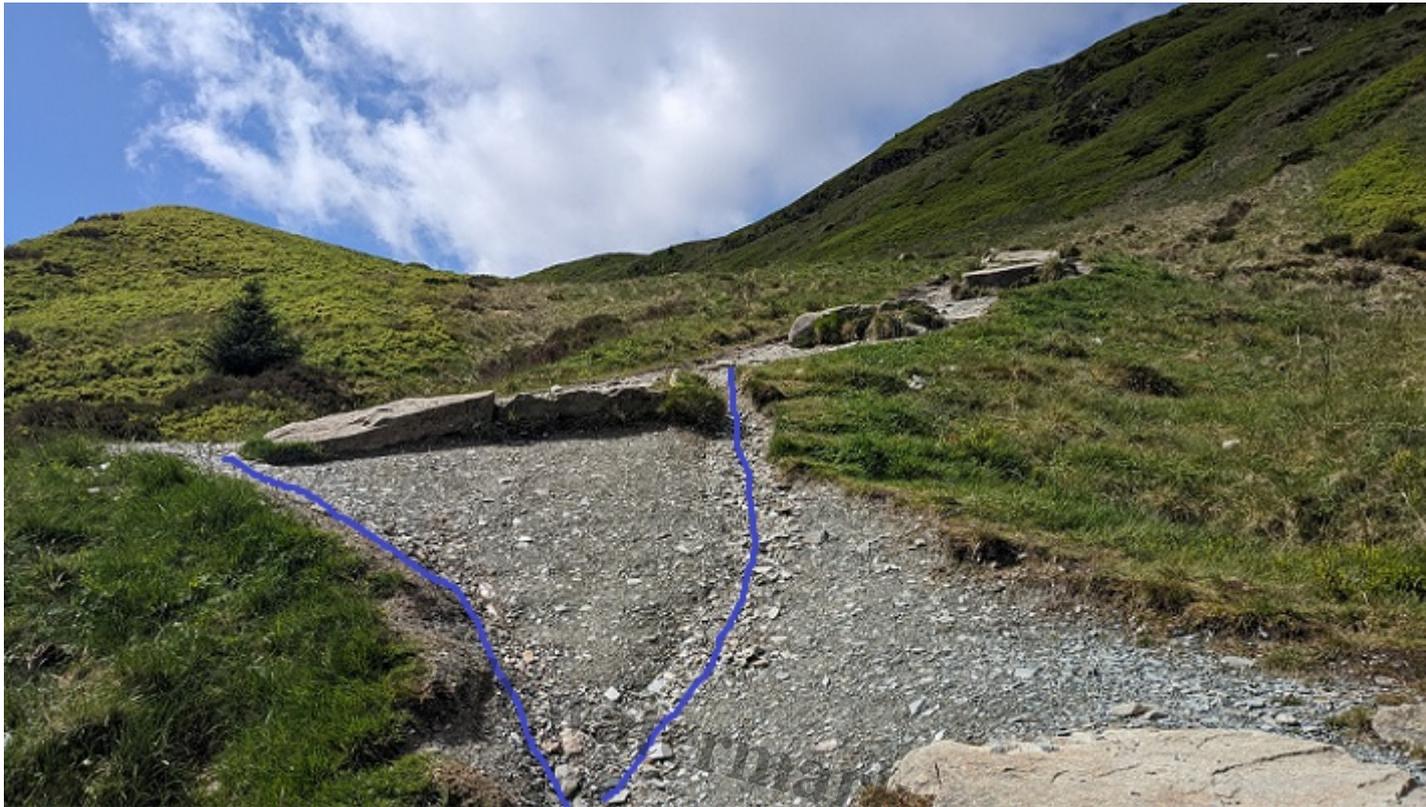
The new routes round the steps then become drainage channels which speeds up the rate of erosion further:

The spreading path around and below the first in a series of isolated steps (there is a photo taken just above this step in my 2021 post)

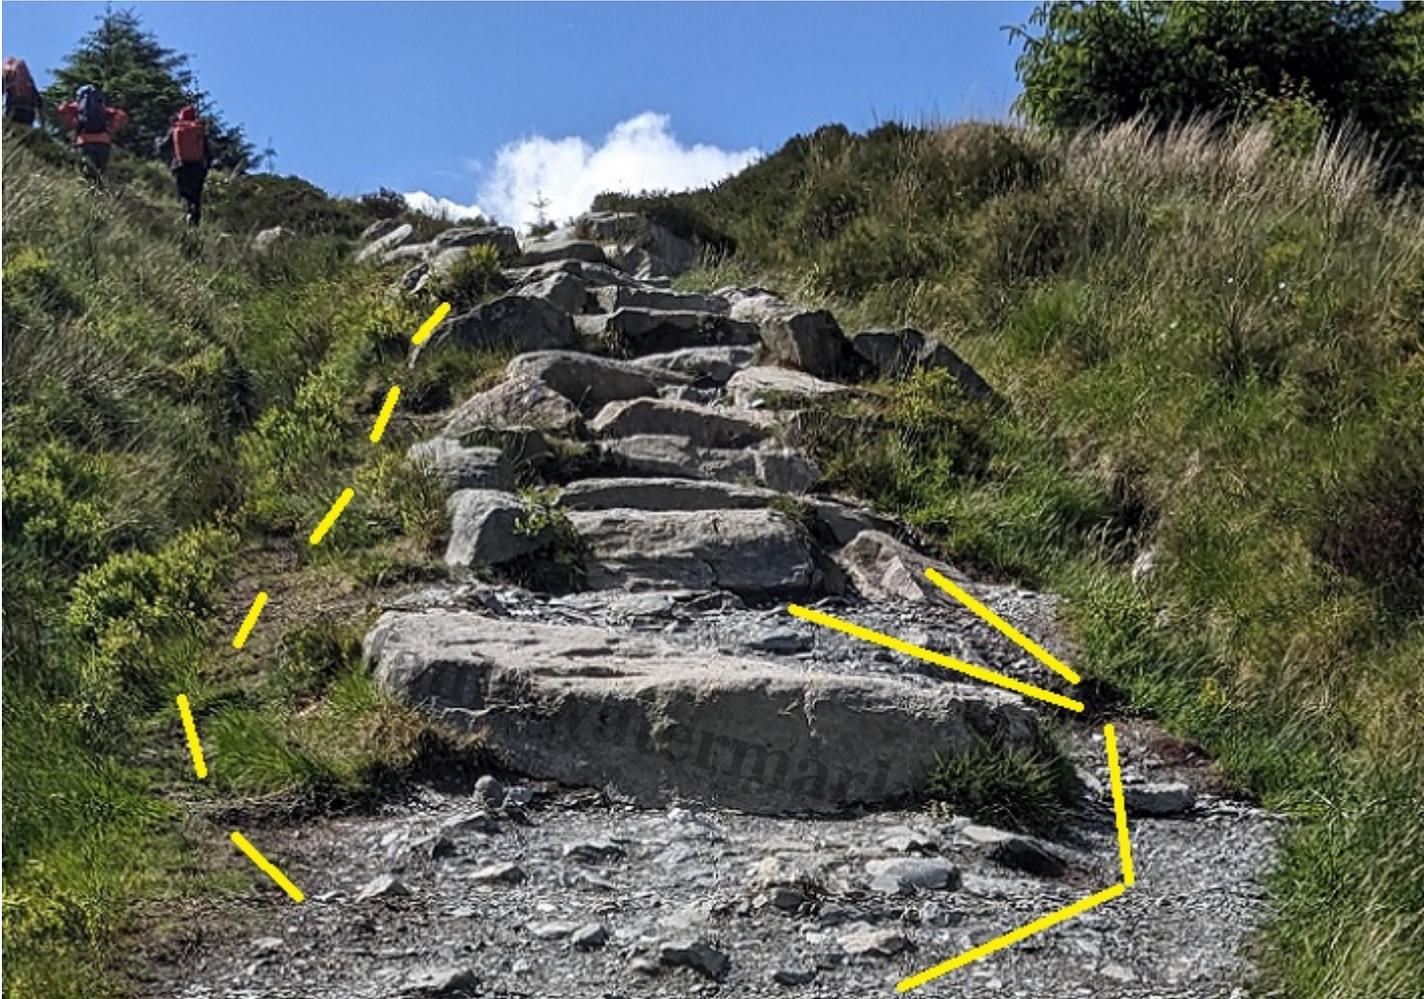
The yellow indicates lines people have taken to avoid the steps

While boulders have been placed on either side of what was intended as a stone staircase to keep people on the path, people have avoided the too-high steps where-ever they can. In my view this is a fundamental design flaw. While more boulders at the side of the lower section of the path in this photo could have forced people to keep to it, the more fundamental problem is the path is too steep: it should, as in the Alps or on the fine old stalkers tracks, have been designed to take a more zig zag course.

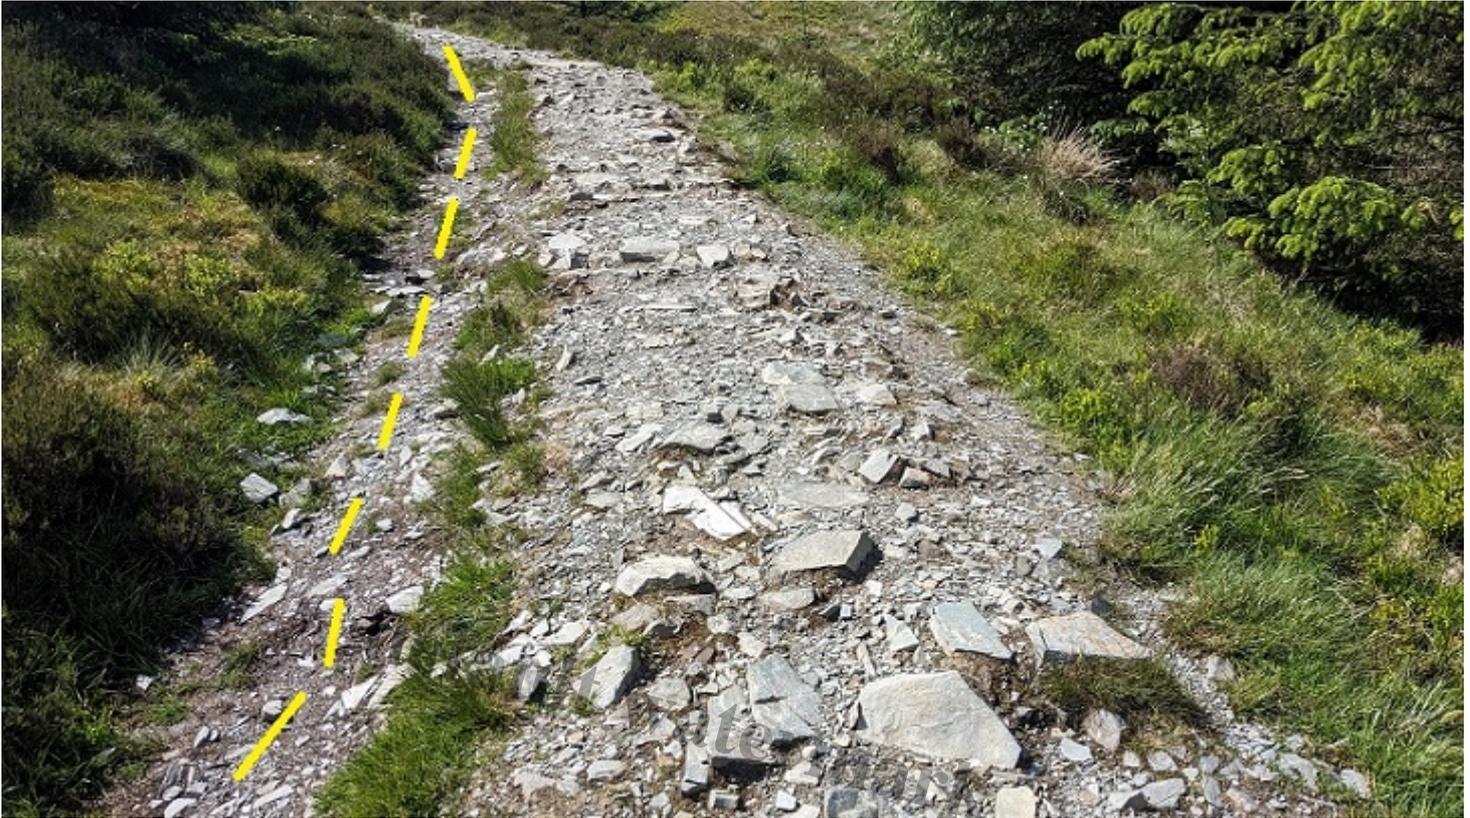
There are similar design failures on some of the flatter sections of path. Much of the fine material on this section had already washed away in 2021 (see below) leaving an uneven surface that was difficult and uncomfortable to walk on. As a result people soon started to walk along the ground between the edge of the path and what was a drainage ditch.

A comparison between the photos shows that in the last three years more fine material has been eroded from the surface of the path, making it even rougher and difficult to walk on, that the desire line (yellow) has spread but is now itself eroding (there are signs of bare earth in top photo) and interestingly that the line of vegetation along the former edge of the path, which is too steep to walk along, has developed significantly into a thicker and more continuous green line.

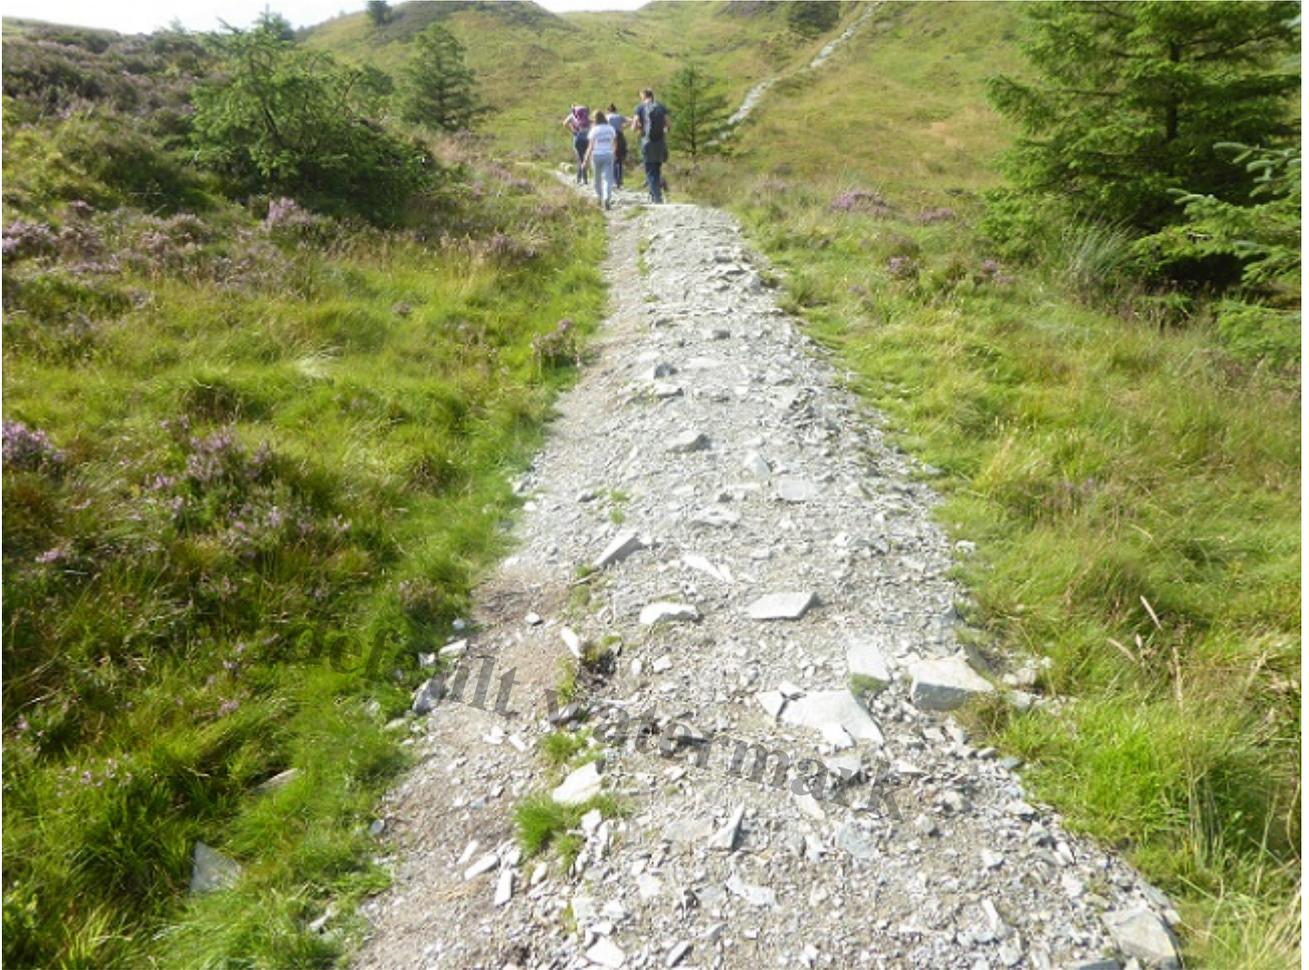
The same section of path in 2021, showing the drainage ditch on the left (already filling in with vegetation).

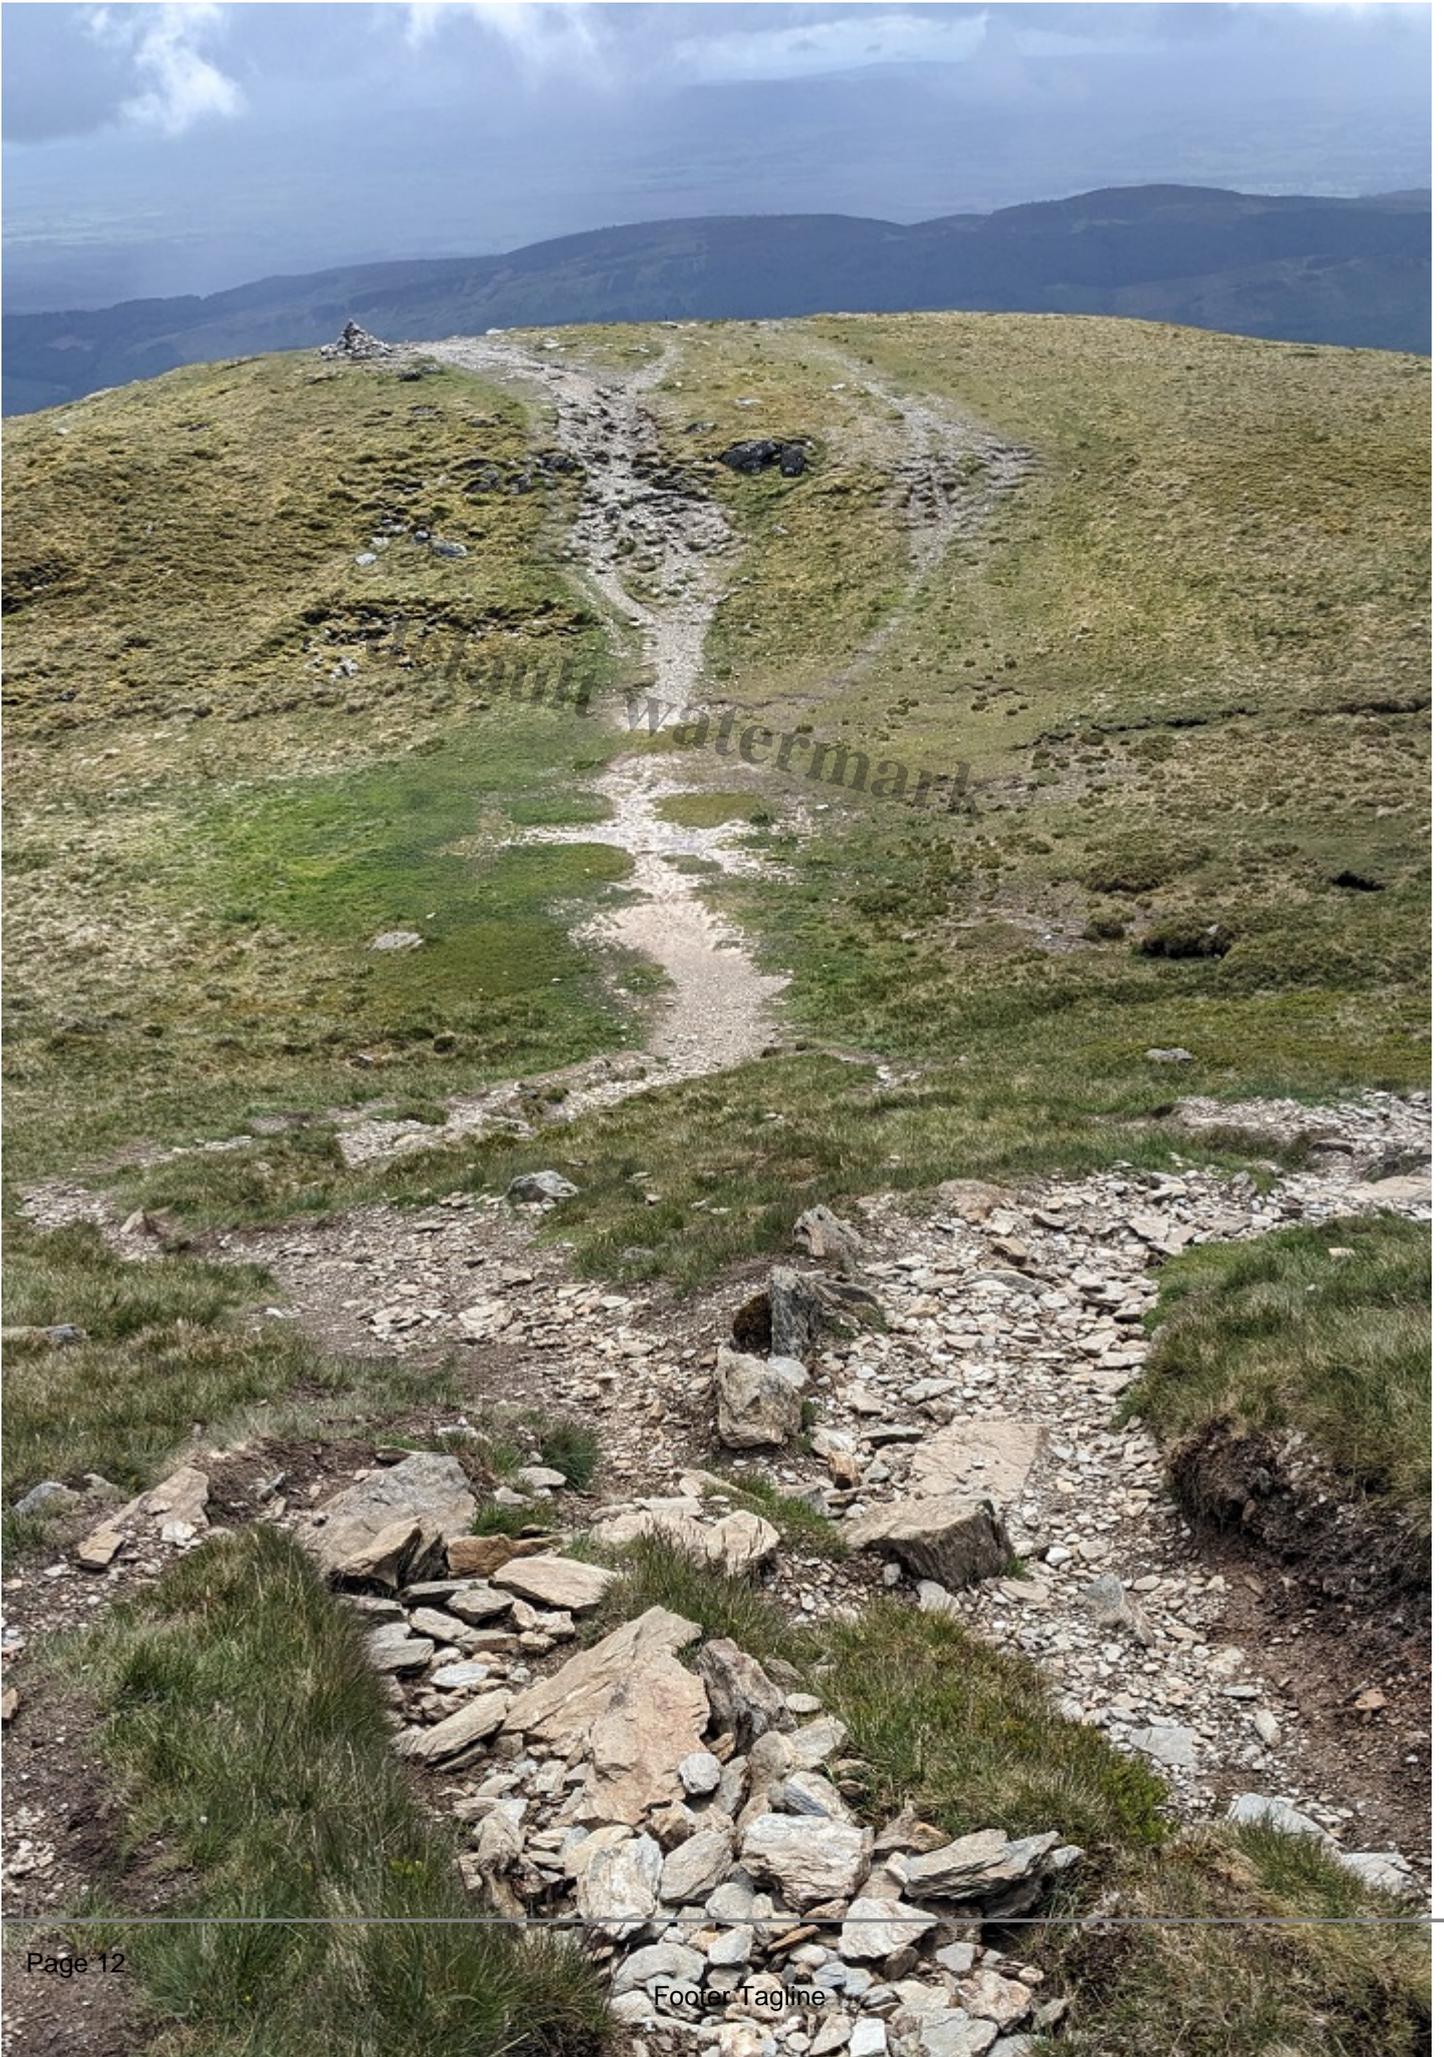
The top section of the path onto the summit of Ben Ledi, which I understand was not included in the Mountains for People Project is in an even worse state and illustrates just how little senior management at FLS, whose primary care is timber sales, care about facilitating outdoor recreation and protecting the landscape:

This upper section of the path had, like the lower section of path, been subject to repairs/construction work before the Mountains and the People Project and, in 2021, at the time of my last visit the remains of stone steps were still visible on this section. Without ongoing maintenance, much of the path work undertaken by the Mountains for People Project could end up looking like this.

While some of the erosion problems illustrated above would require the path to be redesigned, others could have been prevented or addressed if the path had been maintained properly.

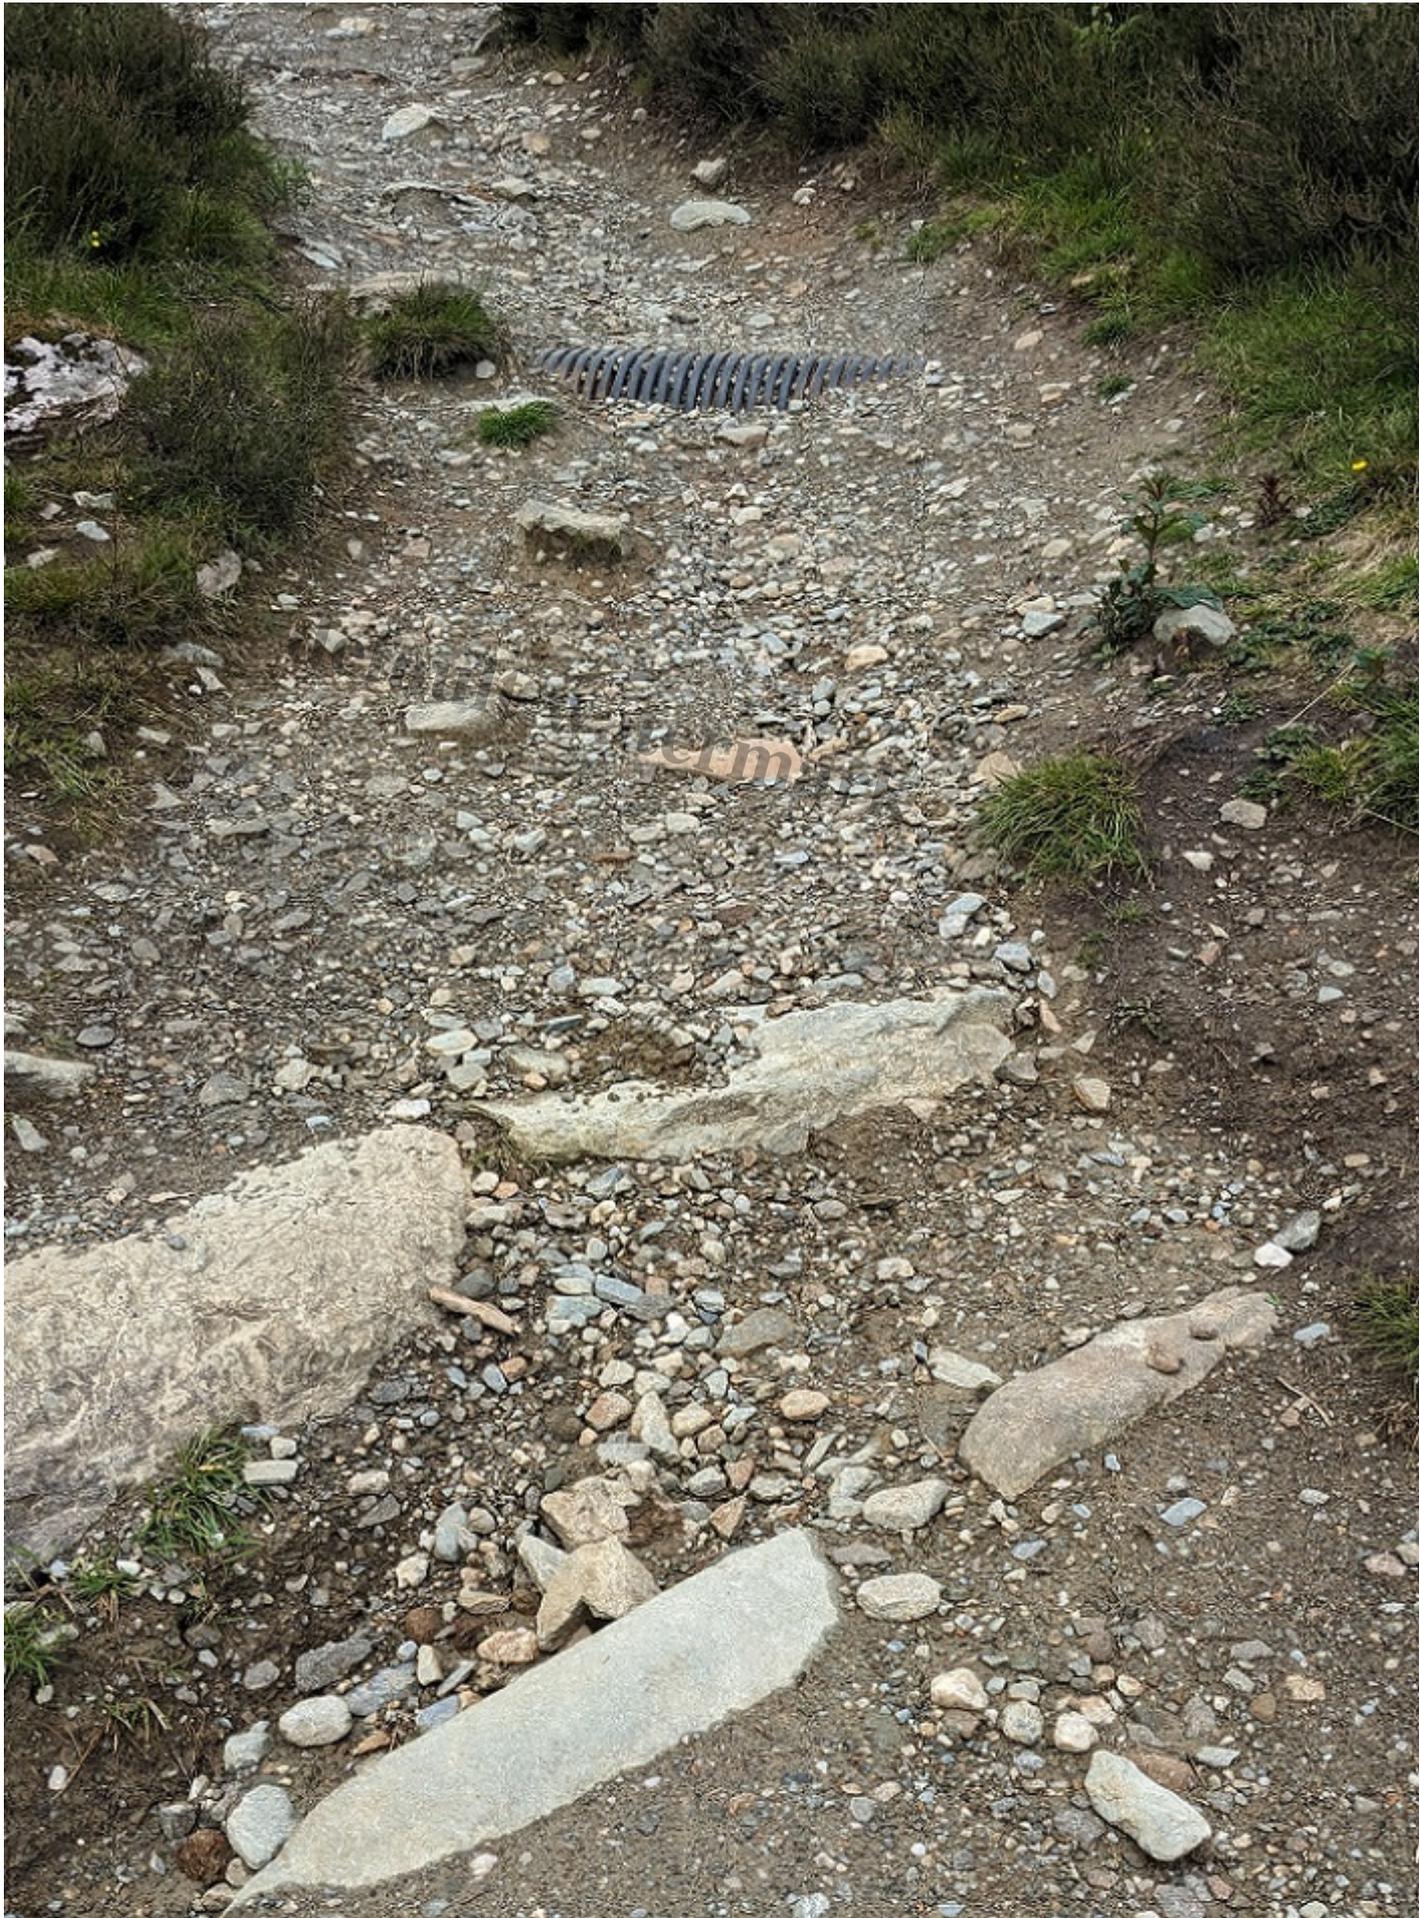
In-filled cross drain with emerging culvert behind. The material blocking the drain could be used to help cover up the plastic pipe above.

Some of these maintenance tasks are very simple. Ensuring cross drains, which are designed to drain water off the path, or side drains are kept free of material is a simple job which would enable them to continue to fulfil their intended function but FLS does not appear to have even done that.
