Forest and Land Scotland's mismanagement of Strathyre – the Ben Ledi footpath

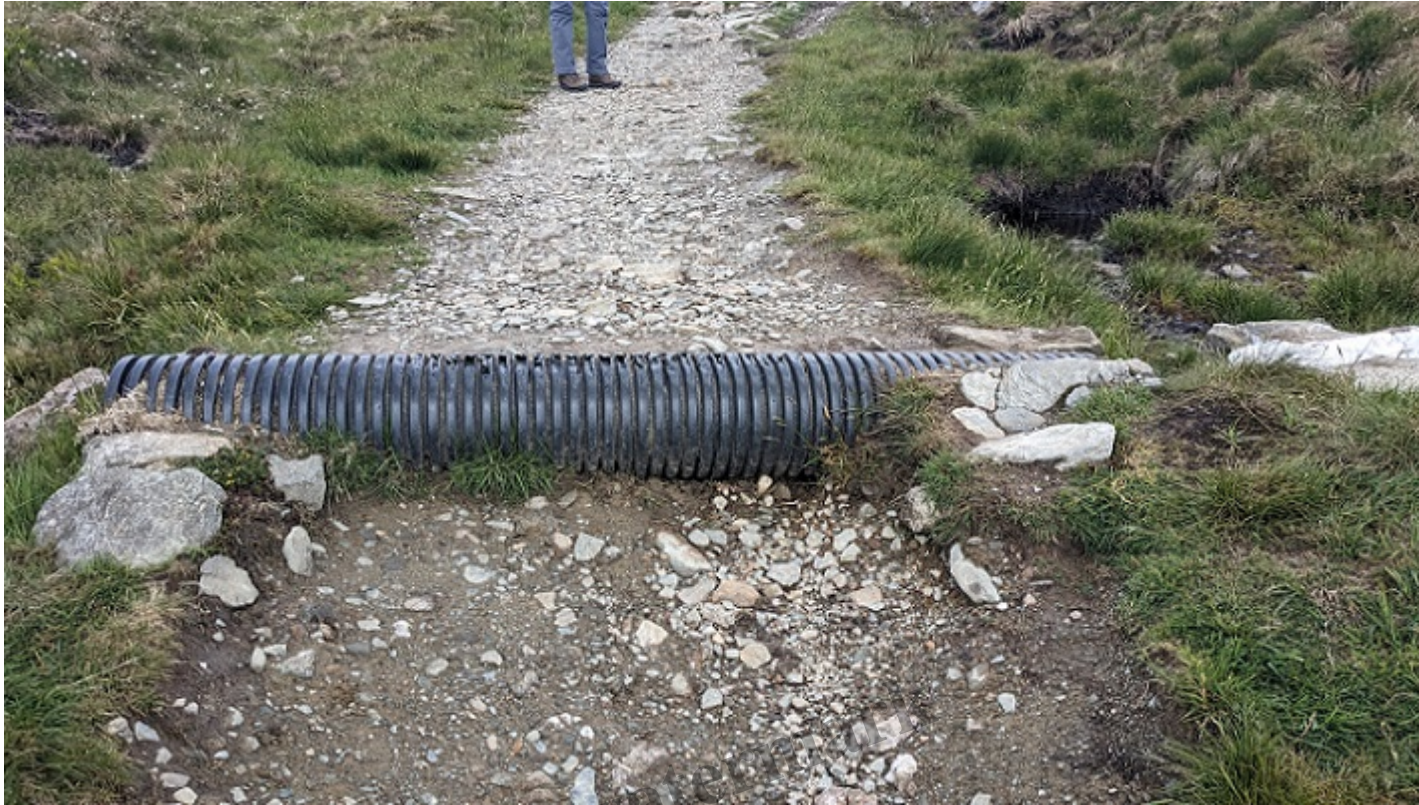
The original surface on this section of path, constructed sometime between 2016 and 2018, has completely eroded away exposing the plastic culvert which is now disintegrating

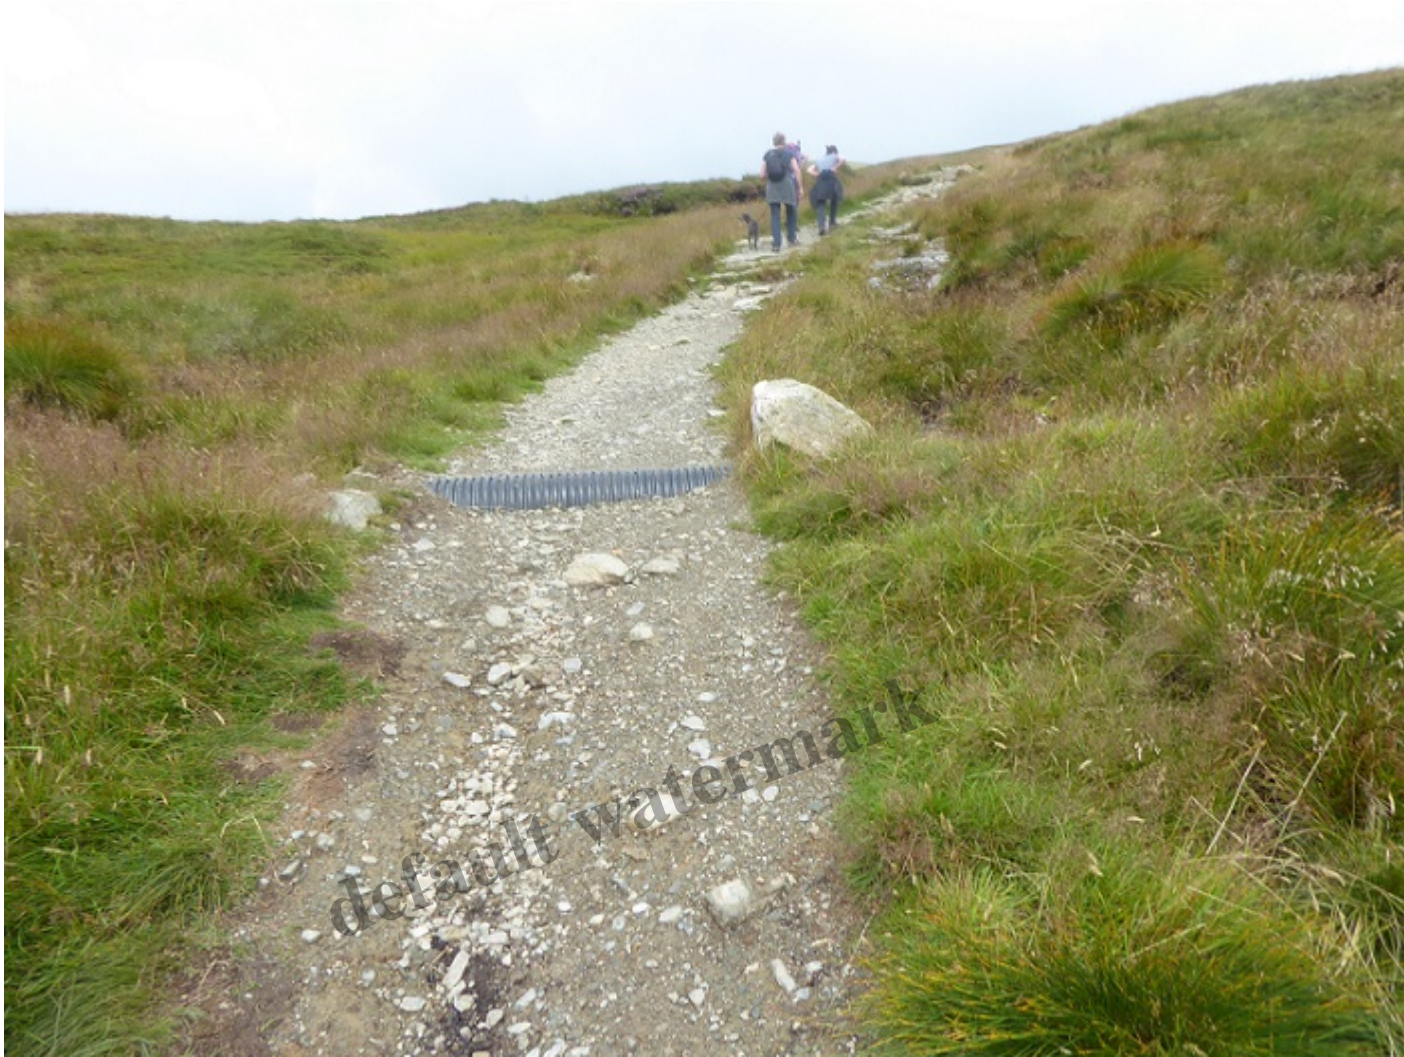
Photo September 2021 illustrating just how much more of the path surface has washed away in the last three and a half years

While the path was already seriously eroding in 2021, that process has continued. A couple of plastic culverts which were half exposed in 2021 are now totally exposed (see above) while more are emerging as the path surface has been washed away:

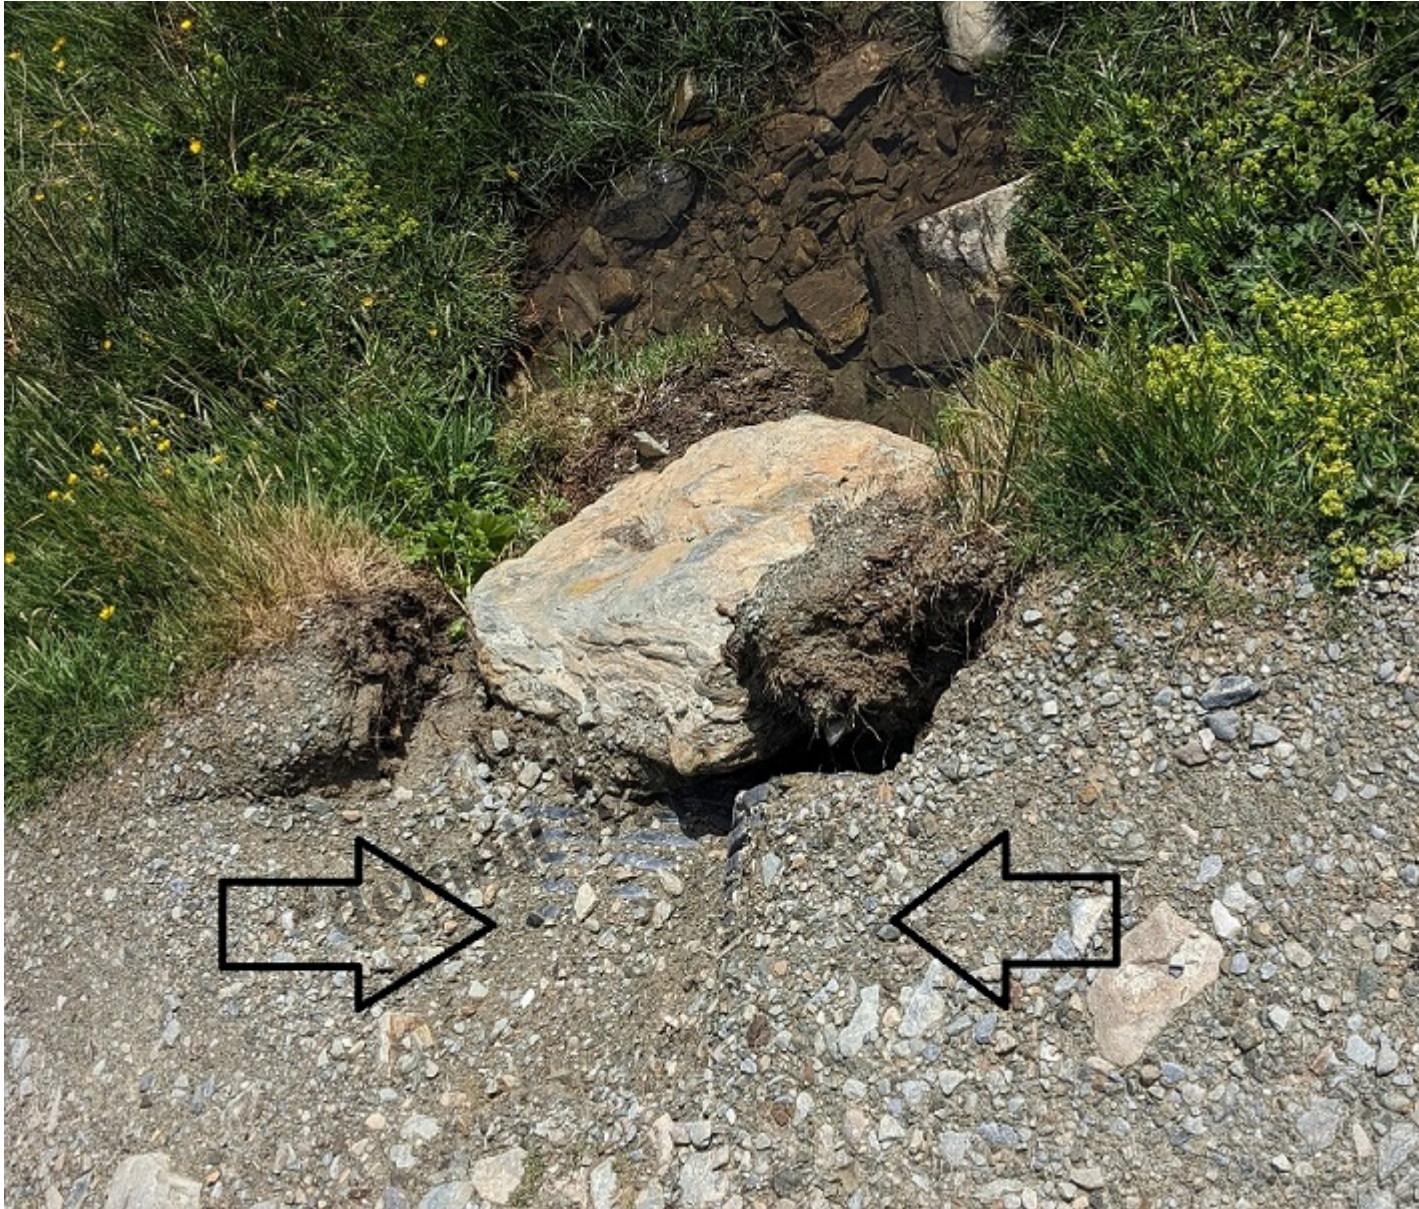
Collapsed topping stone over culvert with path surface eroded down to reveal two plastic pipes

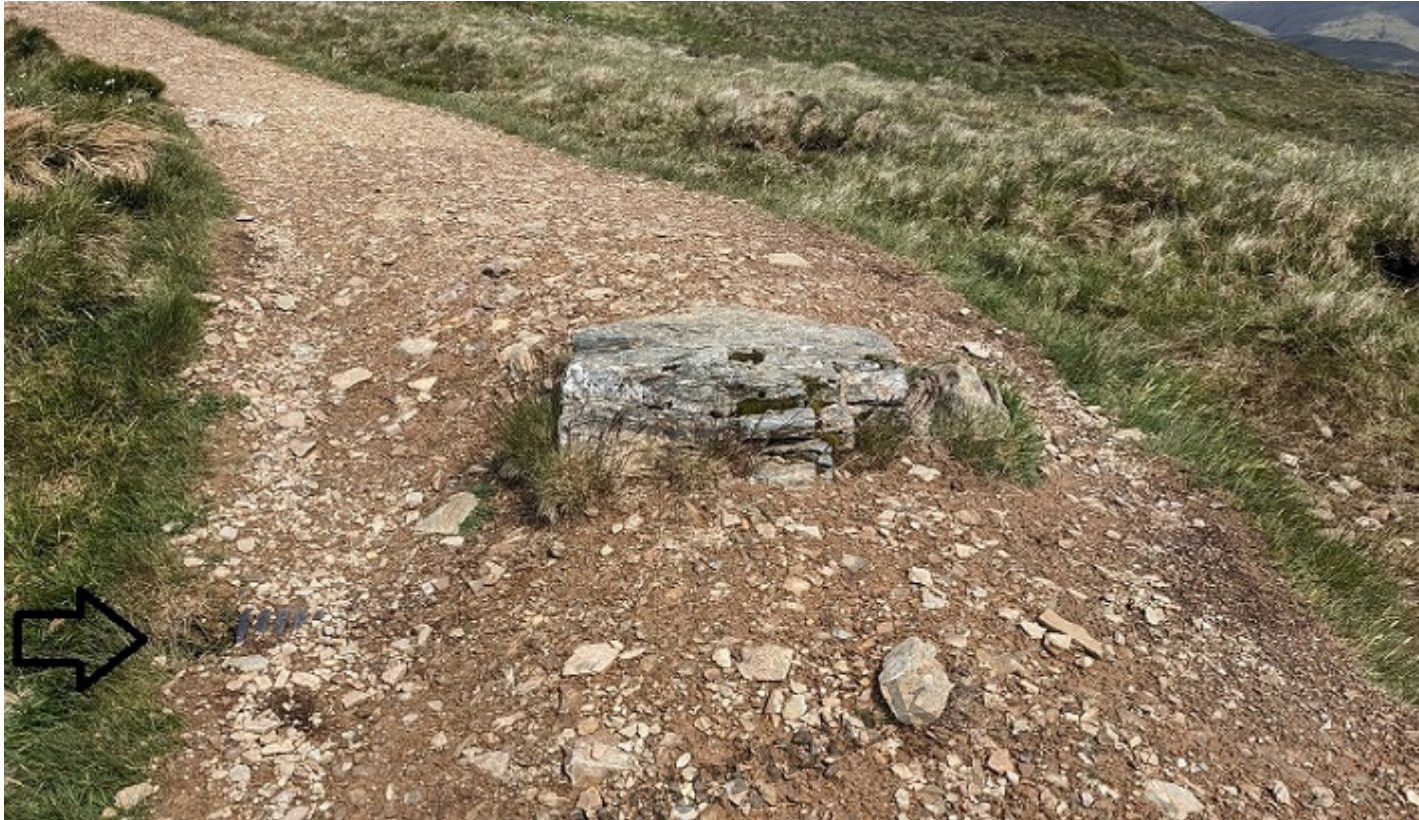
Culvert appearing by a step, stranded by erosion.

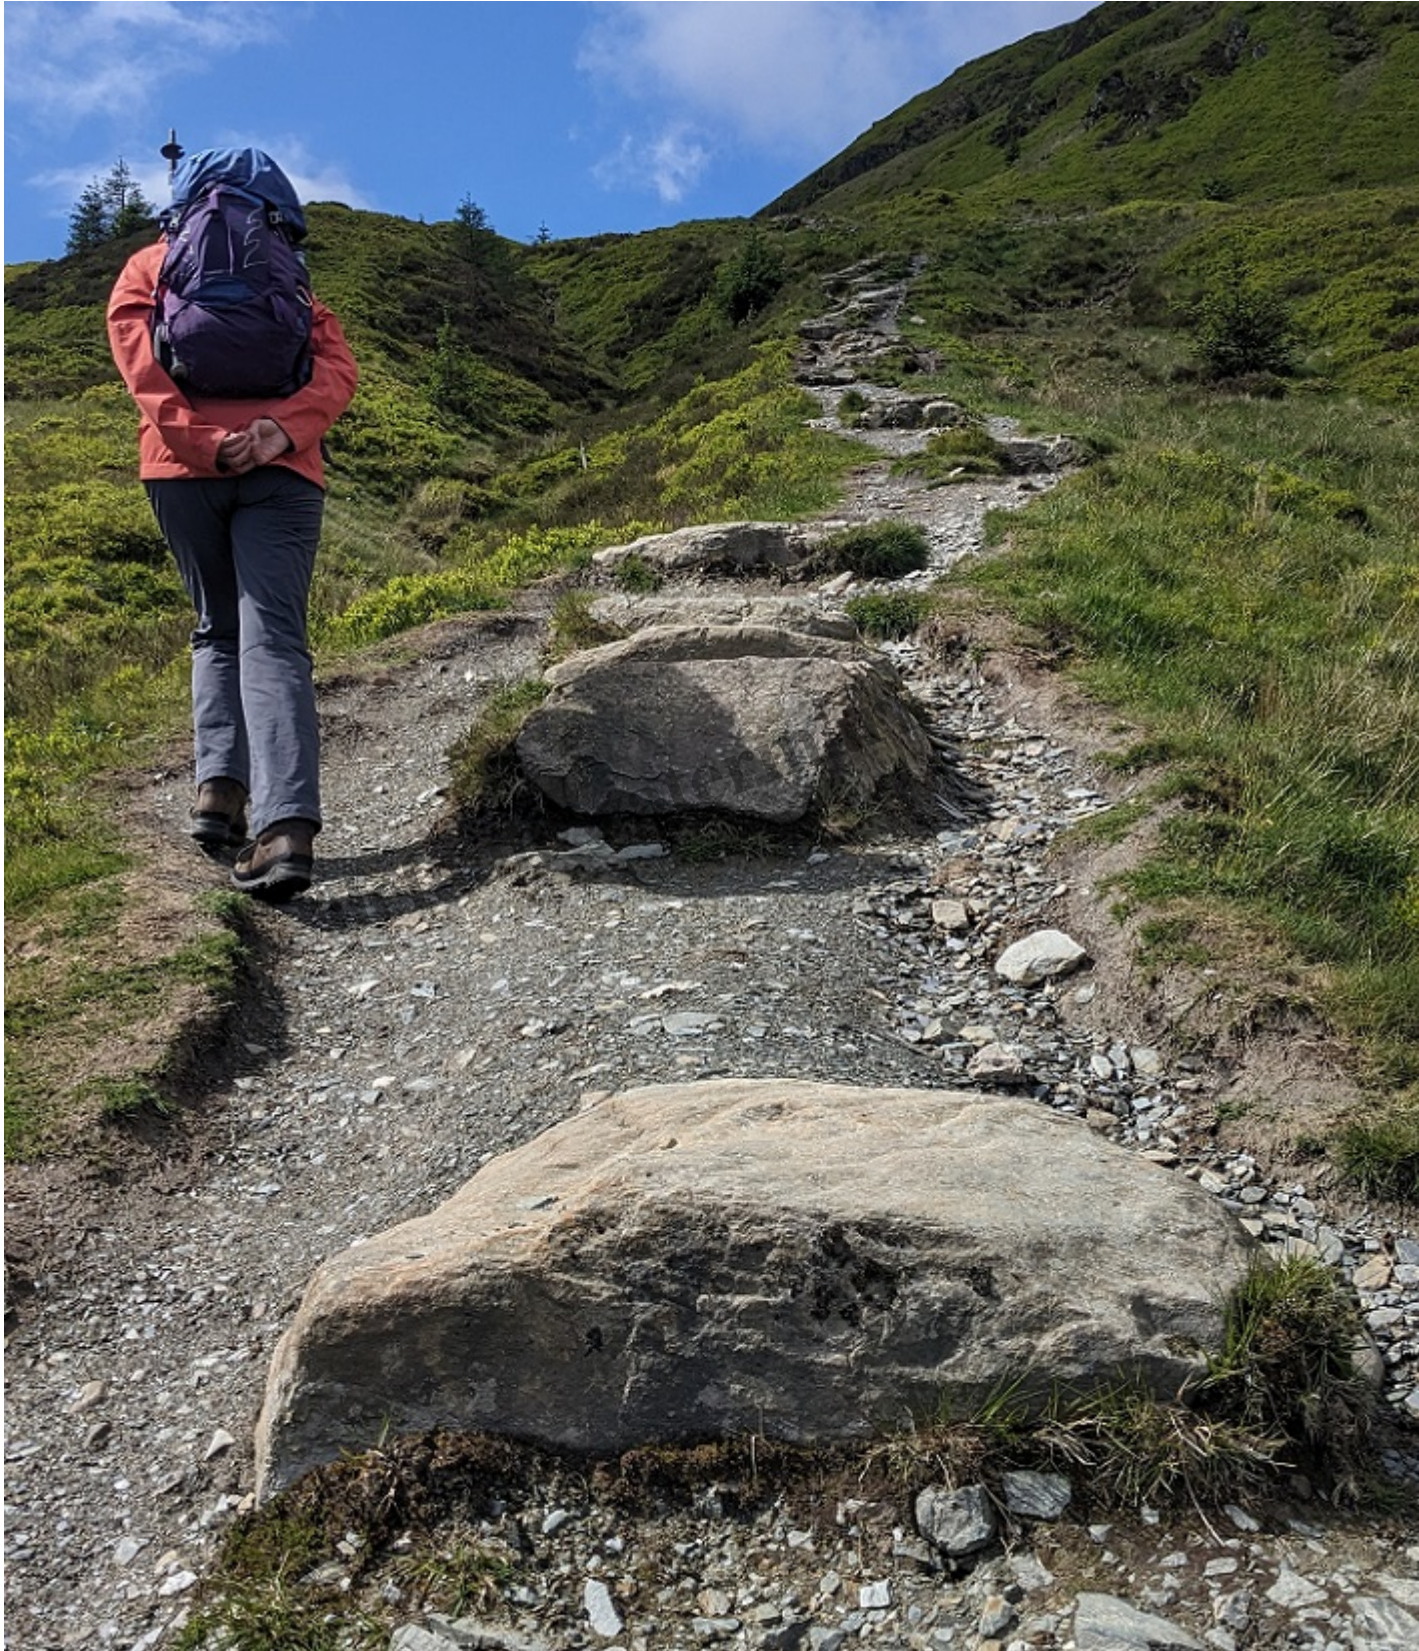
As the surface of the path below stone steps, the erosion becomes worse as people try and get round what becomes a barrier rather than an aid to progress (research has shown the average person avoids steps which are more than c8 inches high):

A section of path where the stone steps have become barriers- built by contractors engaged by the Mountains for People Project. Note how the right side of the path has now become a drainage channel where all the finer material has washed away.

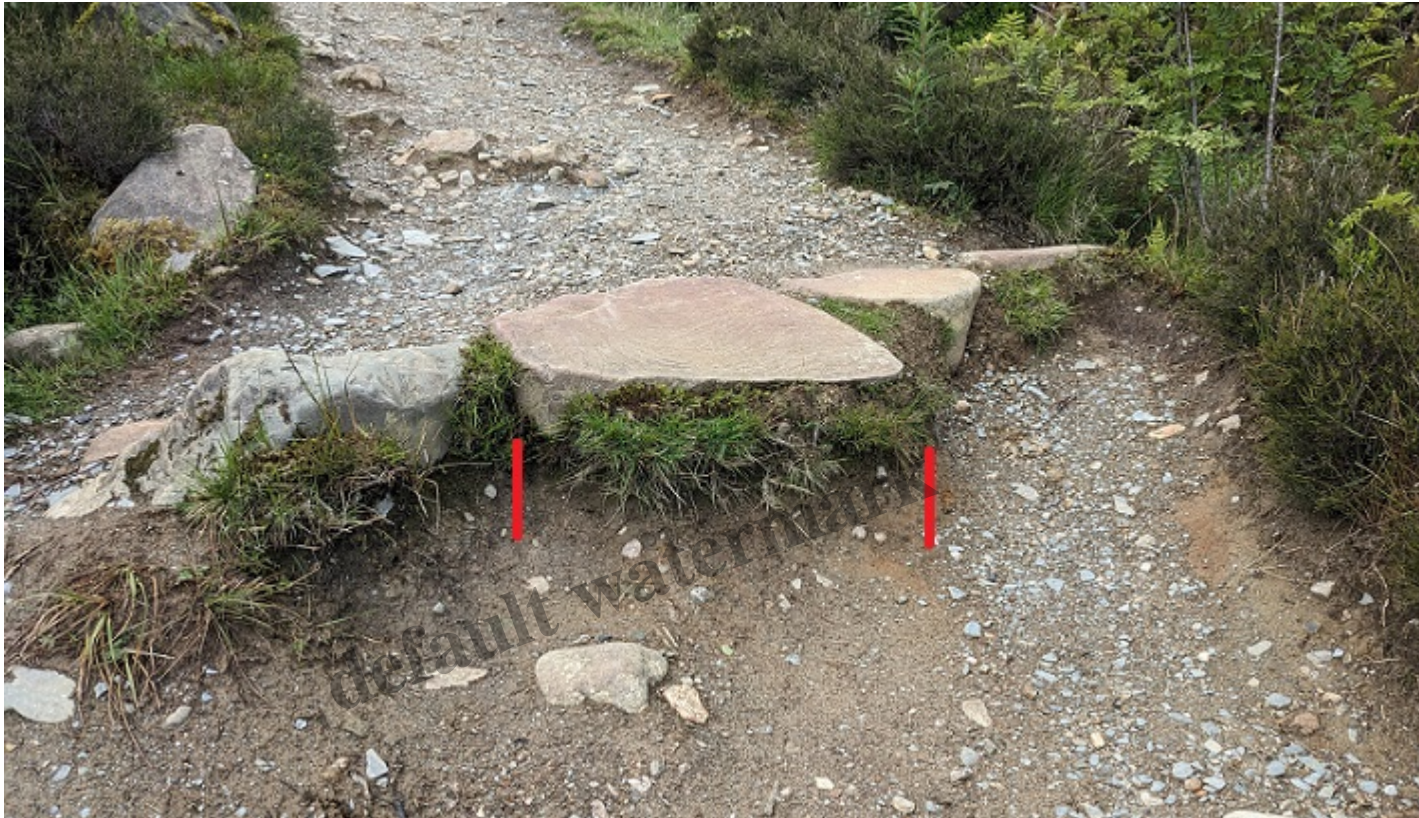
What happens is that as the surface of the path below and between steps is eroded, steps which were in some cases quite low become higher and people start to go round them.

Red lines show just how much ground has eroded out below step

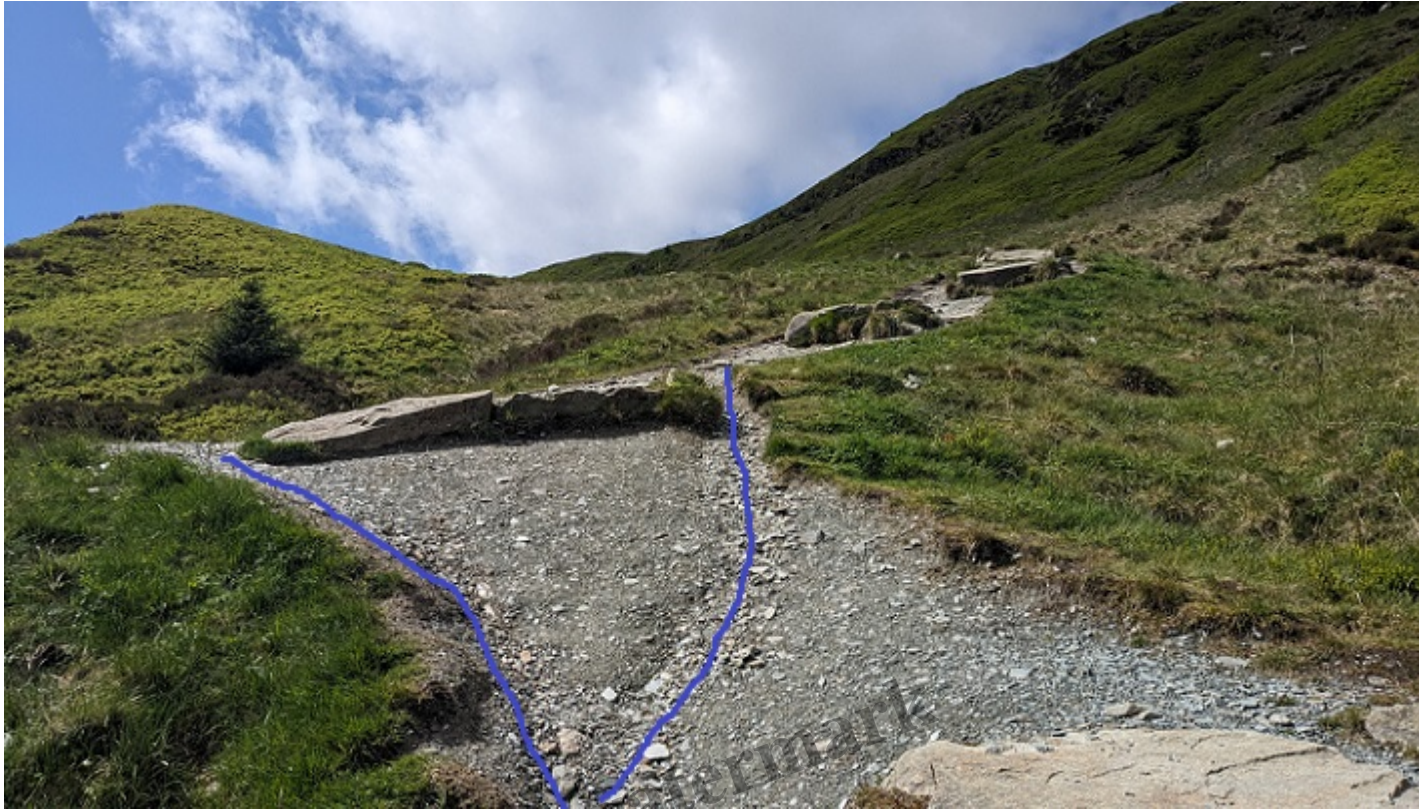
The new routes round the steps then become drainage channels which speeds up the rate of erosion further:

The spreading path around and below the first in a series of isolated steps (there is a photo taken just above this step in my 2021 post)

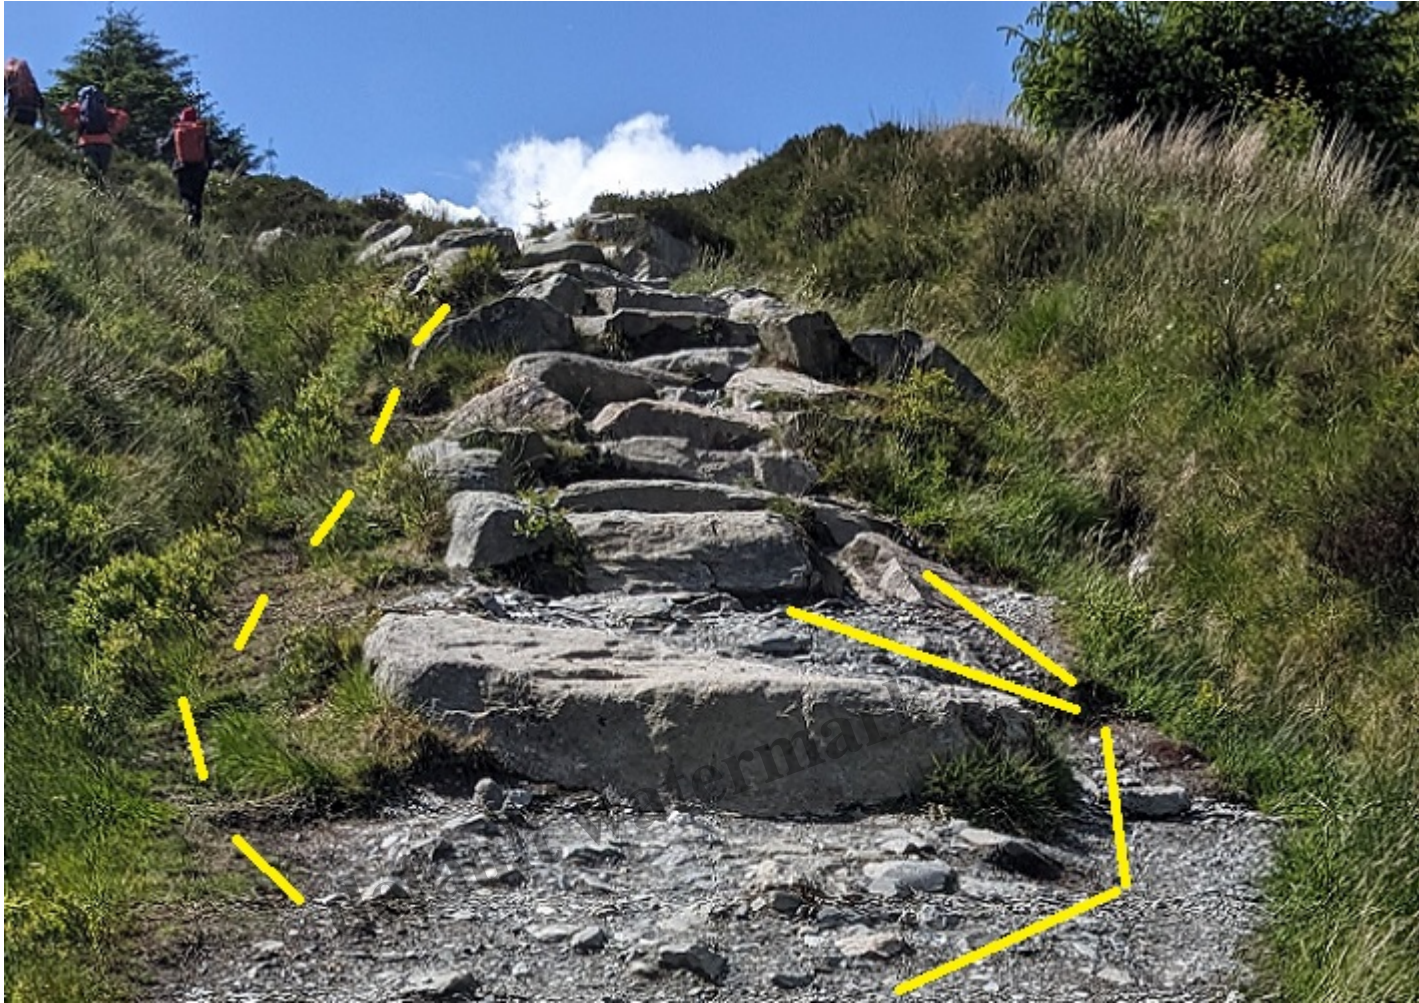
The yellow indicates lines people have taken to avoid the steps

While boulders have been placed on either side of what was intended as a stone staircase to keep people on the path, people have avoided the too-high steps where-ever they can. In my view this is a fundamental design flaw. While more boulders at the side of the lower section of the path in this photo could have forced people to keep to it, the more fundamental problem is the path is too steep: it should, as in the Alps or on the fine old stalkers tracks, have been designed to take a more zig zag course.

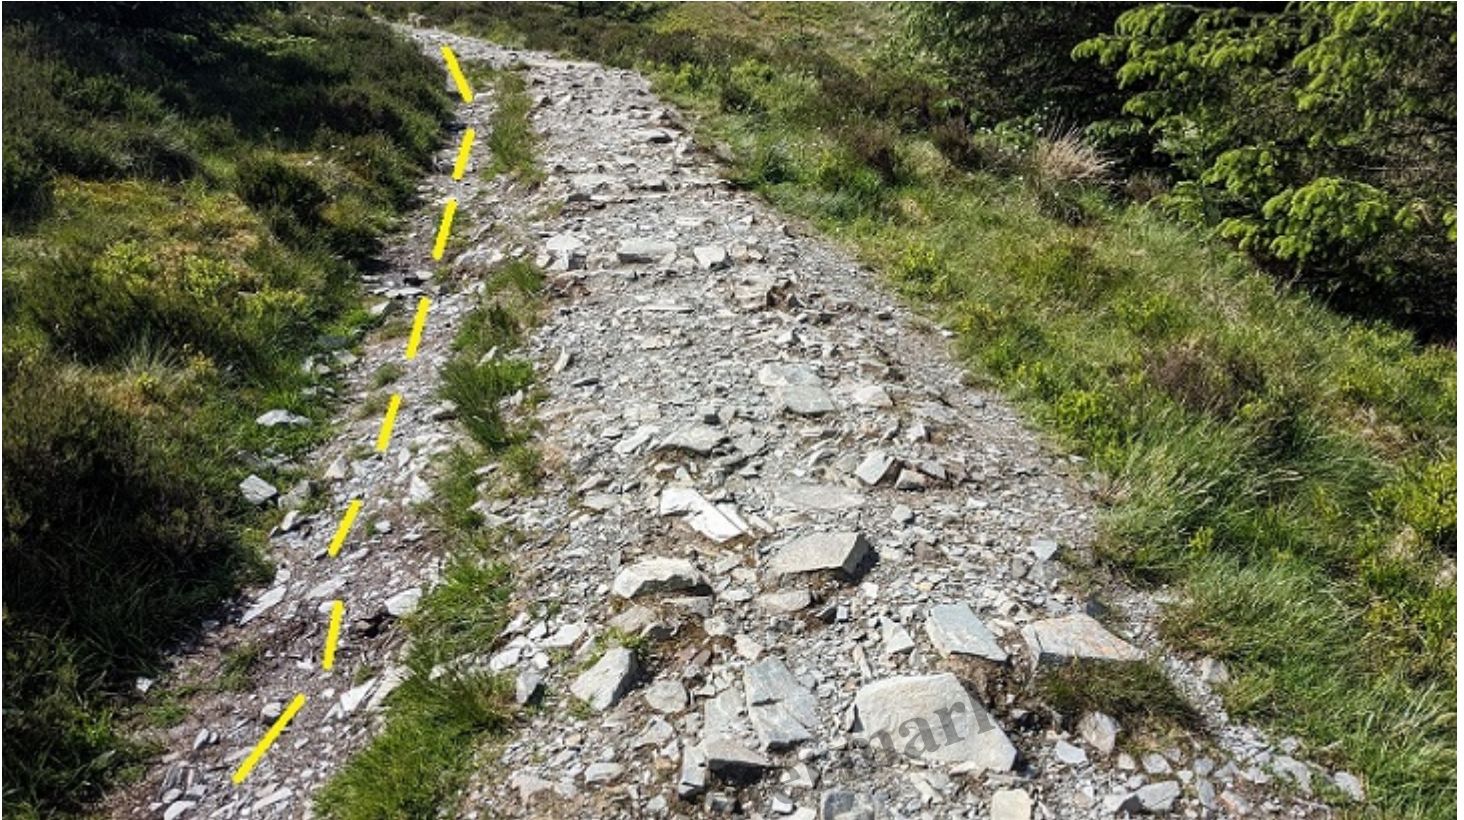
There are similar design failures on some of the flatter sections of path. Much of the fine material on this section had already washed away in 2021 (see below) leaving an uneven surface that was difficult and uncomfortable to walk on. As a result people soon started to walk along the ground between the edge of the path and what was a drainage ditch.

A comparison between the photos shows that in the last three years more fine material has been eroded from the surface of the path, making it even rougher and difficult to walk on, that the desire line (yellow) has spread but is now itself eroding (there are signs of bare earth in top photo) and interestingly that the line of vegetation along the former edge of the path, which is too steep to walk along, has developed significantly into a thicker and more continuous green line.

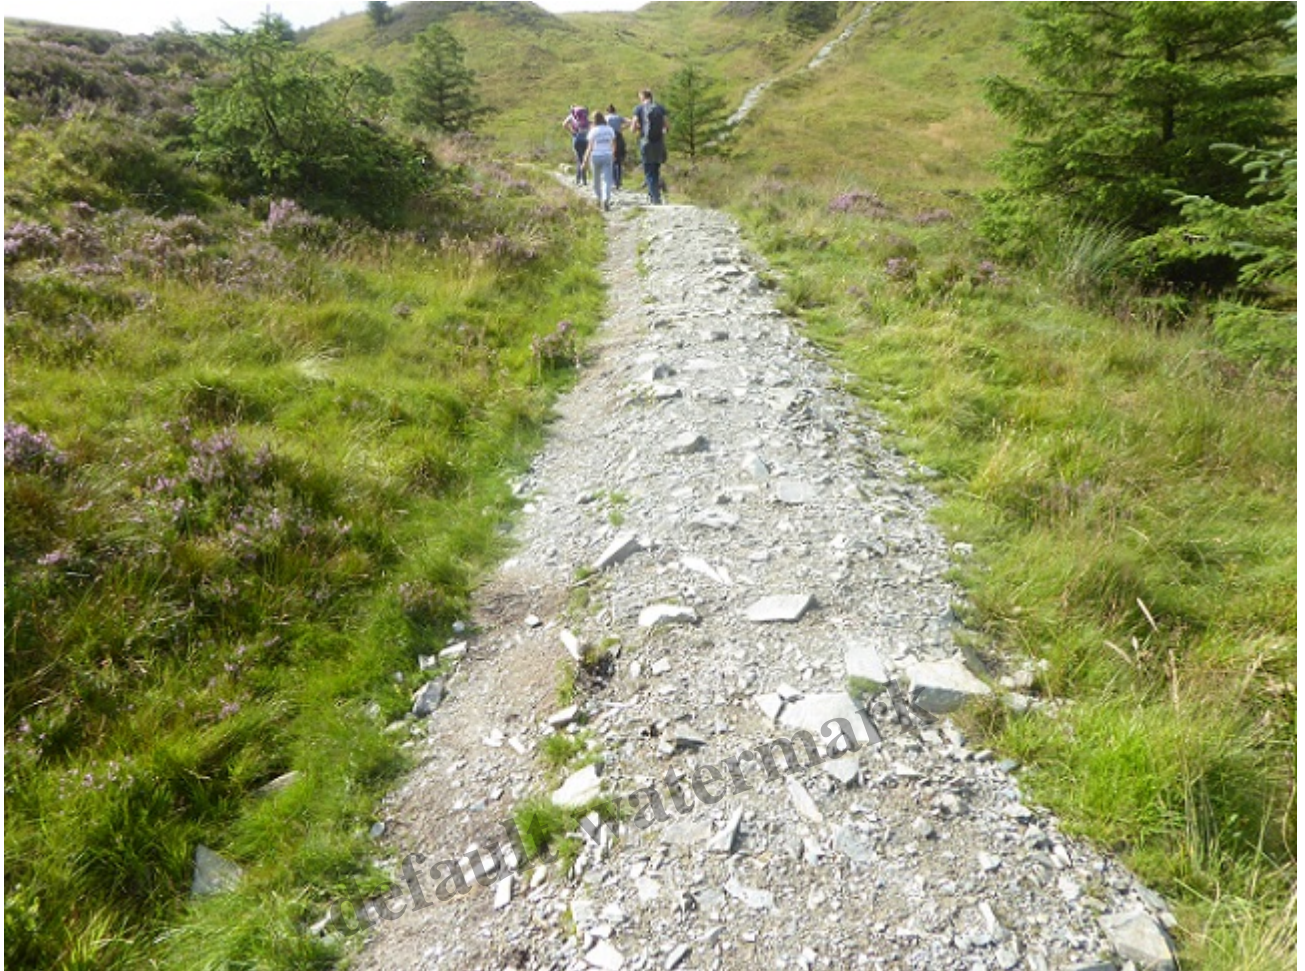
The same section of path in 2021, showing the drainage ditch on the left (already filling in with vegetation).

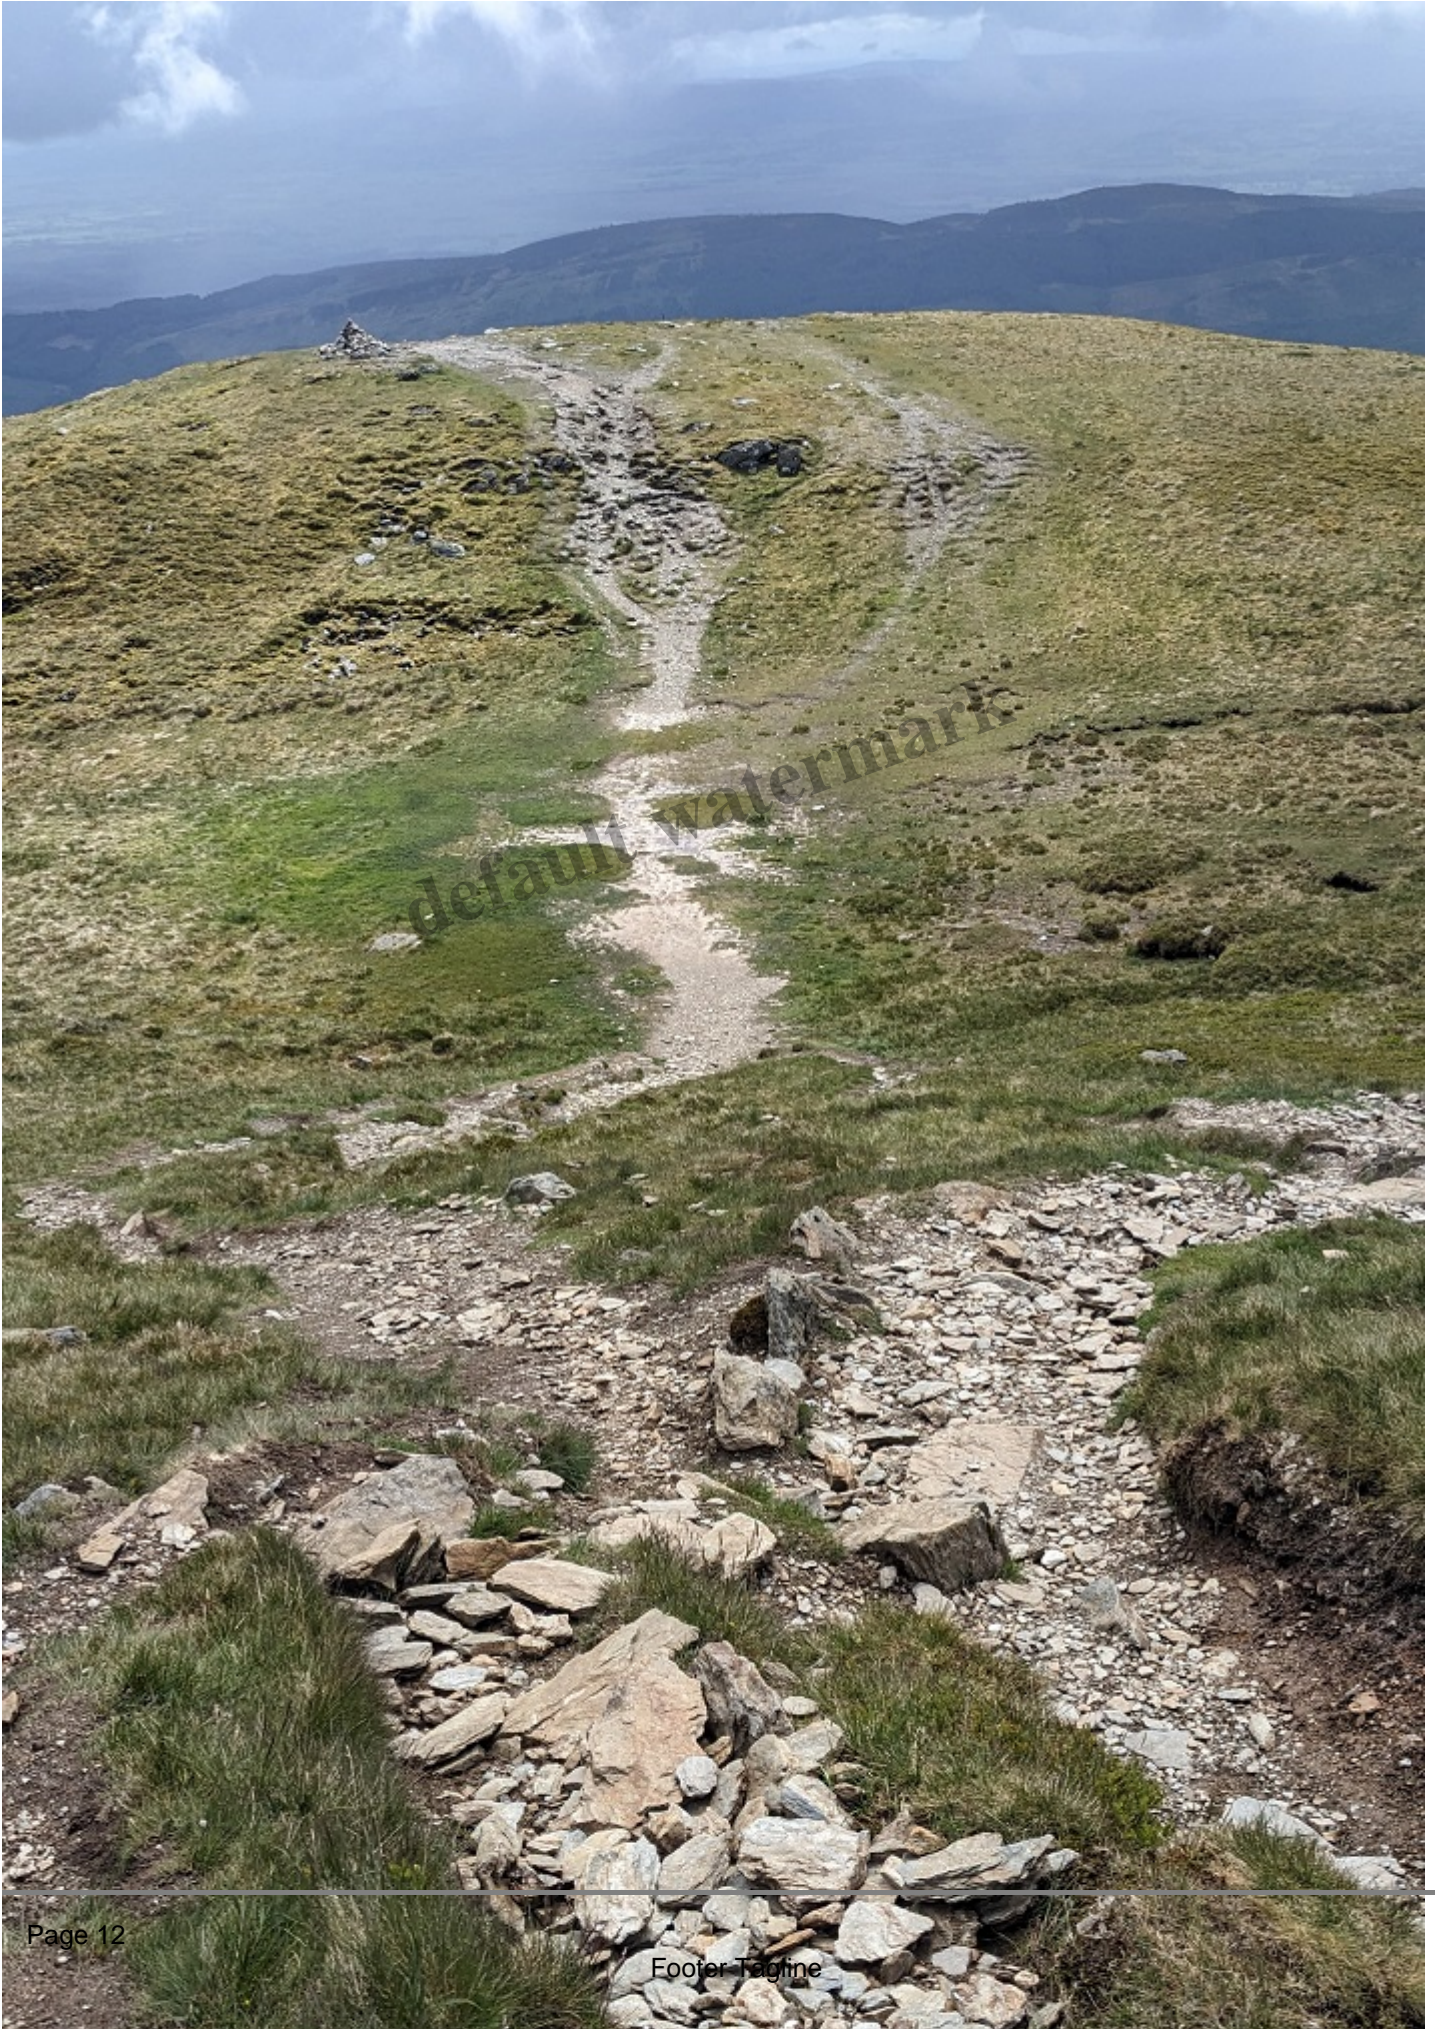
The top section of the path onto the summit of Ben Ledi, which I understand was not included in the Mountains for People Project is in an even worse state and illustrates just how little senior management at FLS, whose primary care is timber sales, care about facilitating outdoor recreation and protecting the landscape:

This upper section of the path had, like the lower section of path, been subject to repairs/construction work before the Mountains and the People Project and, in 2021, at the time of my last visit the remains of stone steps were still visible on this section. Without ongoing maintenance, much of the path work undertaken by the Mountains for People Project could end up looking like this.

While some of the erosion problems illustrated above would require the path to be redesigned, others could have been prevented or addressed if the path had been maintained properly.

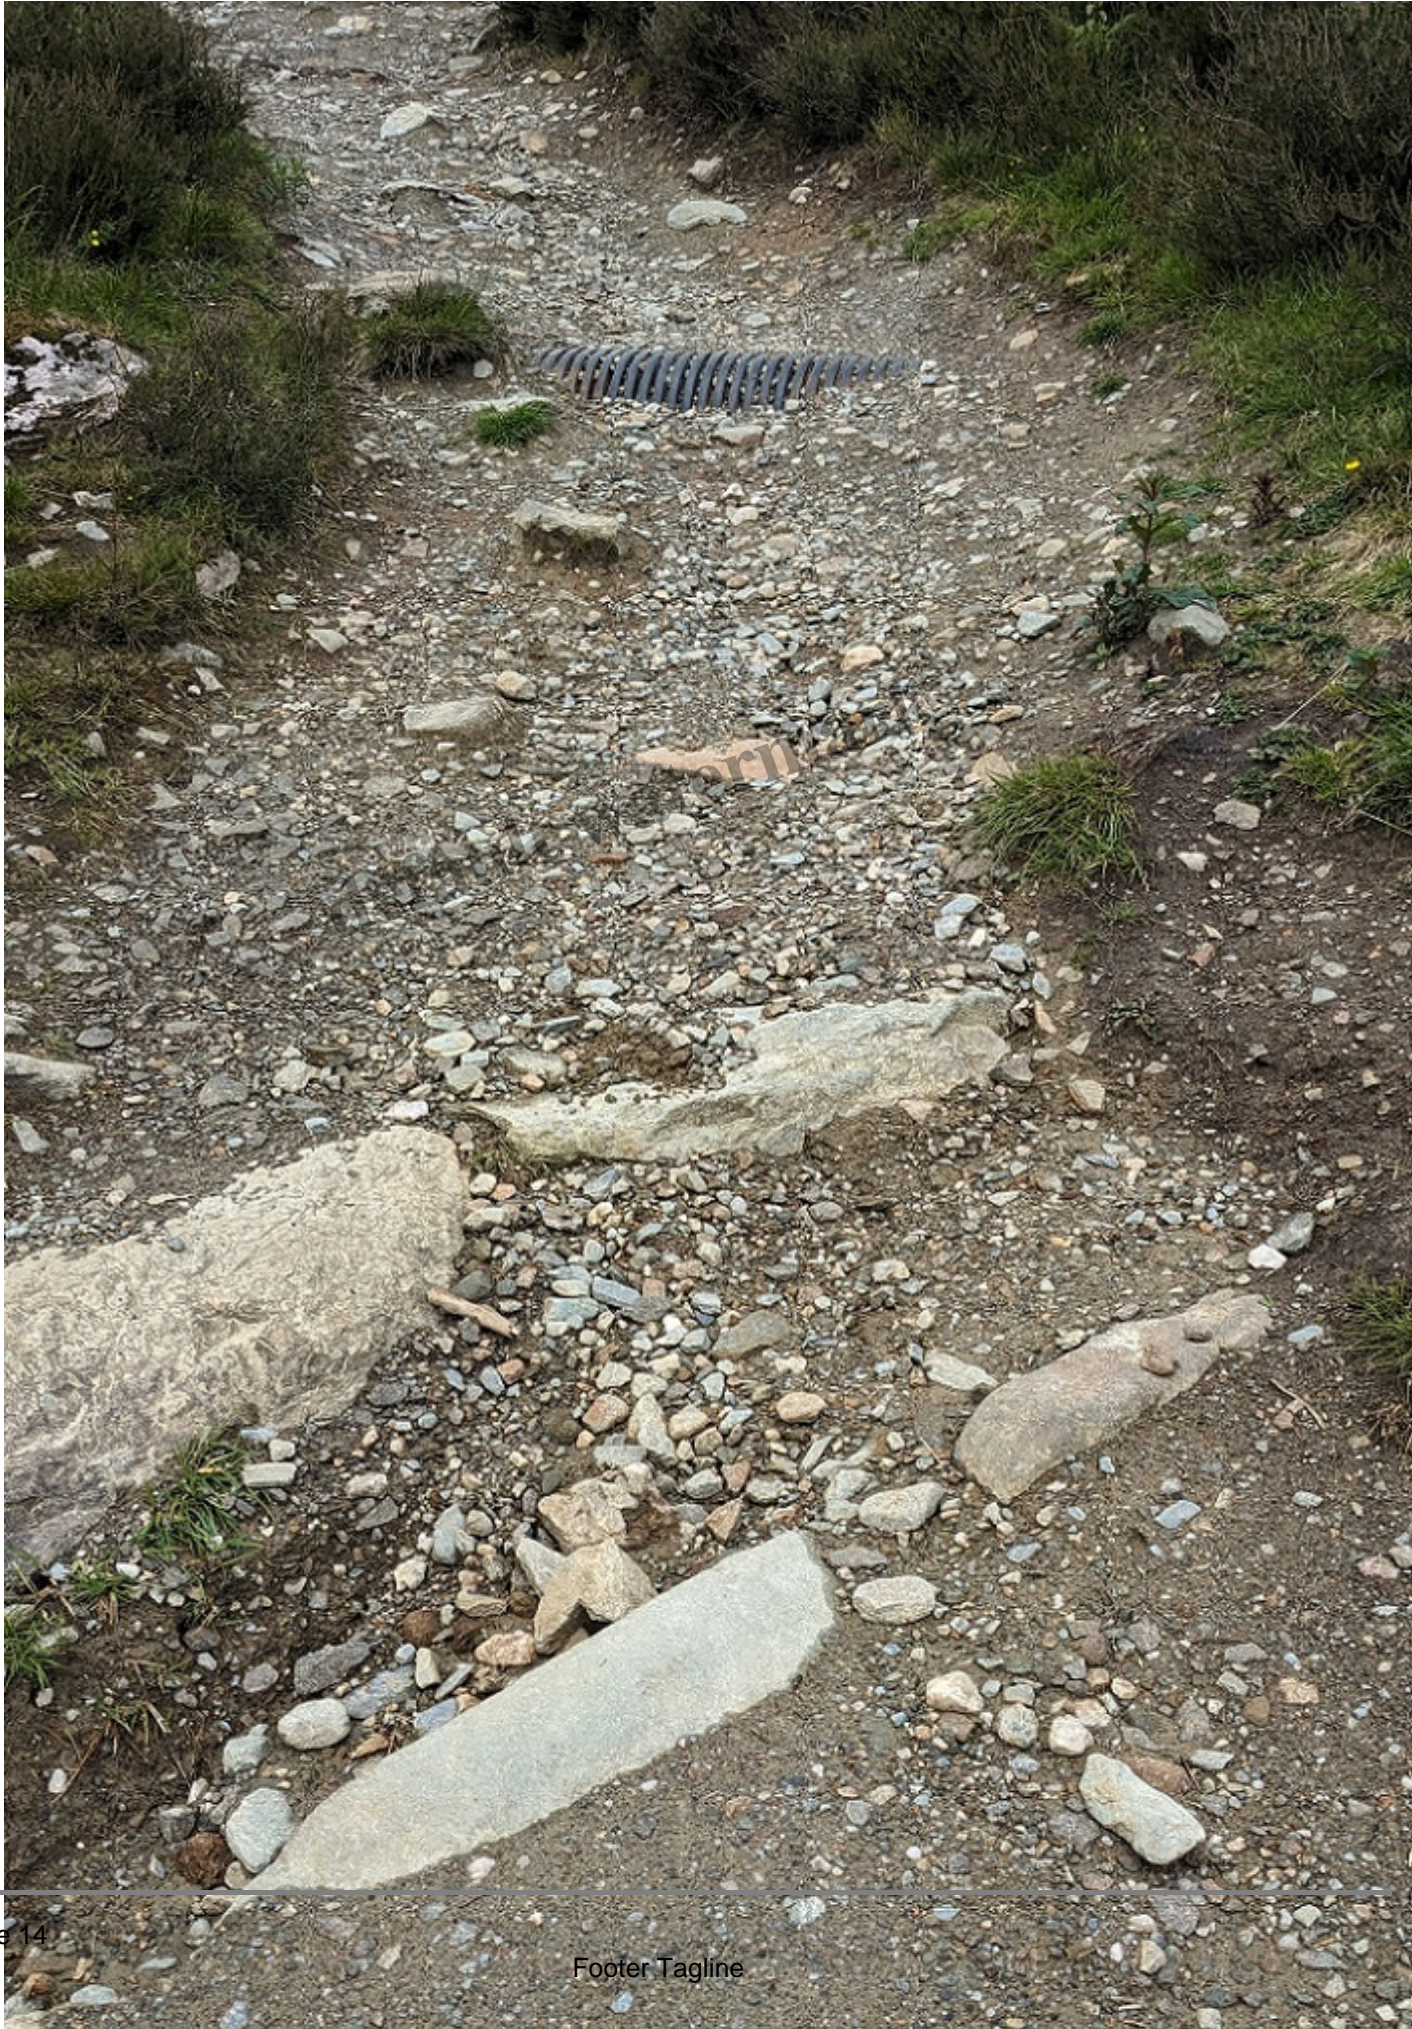
In-filled cross drain with emerging culvert behind. The material blocking the drain could be used to help cover up the plastic pipe above.

Some of these maintenance tasks are very simple. Ensuring cross drains, which are designed to drain water off the path, or side drains are kept free of material is a simple job which would enable them to continue to fulfil their intended function but FLS does not appear to have even done that.
