## HIE's planning application for a coaster mountain coaster and track erosion at Cairn Gorm

## The erosion of vehicular tracks at Cairn Gorm

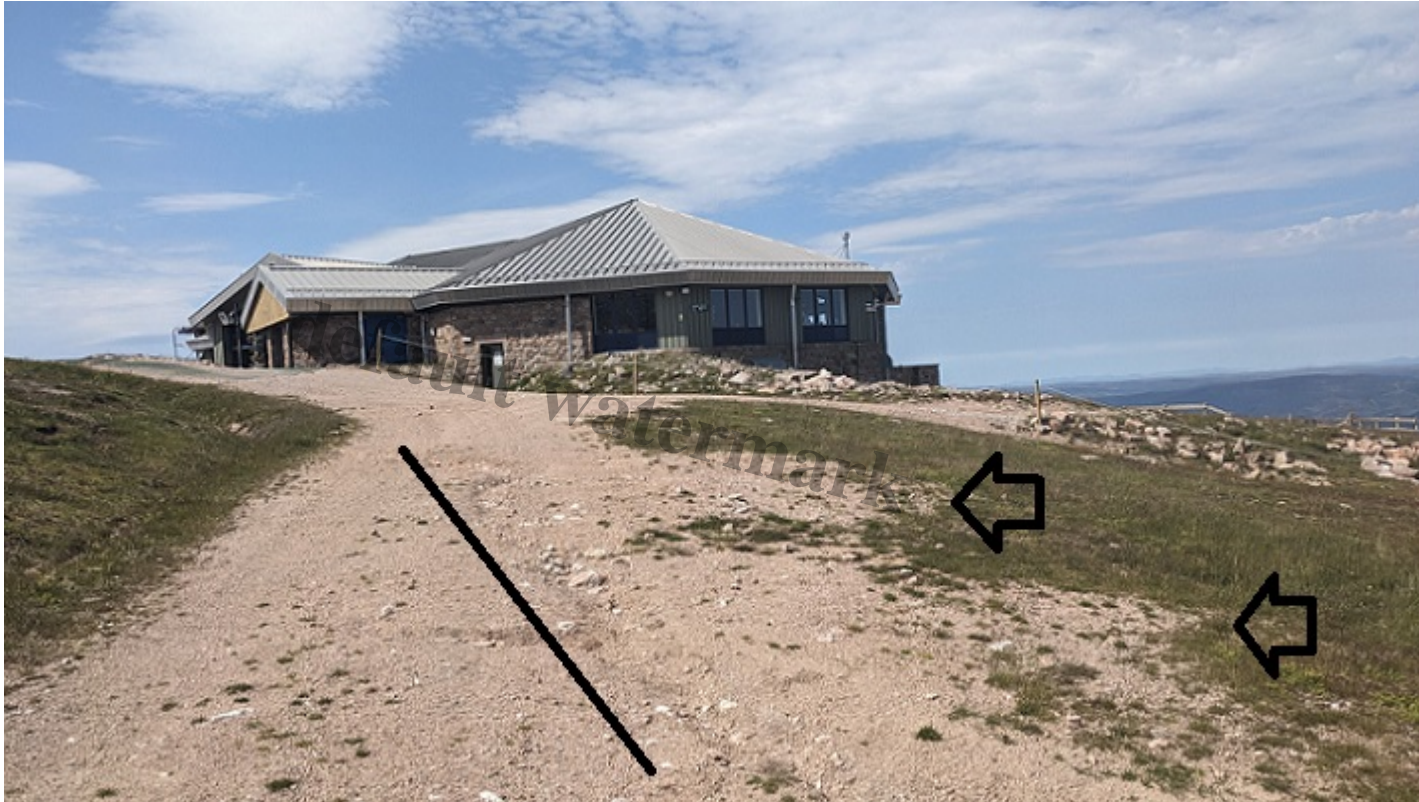
Track erosion by the Ptarmigan, with the black line indicating the current erosion channel and the black arrows areas where the track surfacing has washed out over vegetation. Photo 2025,

In theory this could make it easier for the Cairngorms National park Authority (CNPA) to approve the planning application on landscape grounds "but see below! The line, however, is far too steep for a track and is likely to erode away sooner rather than later ([see here](#)). The result will either be a bigger eyesore or the gravel surface of the track will need to be continually replaced.

It has taken me a long time to reach this conclusion but I now believe inclined gravel tracks are completely inappropriate for Cairn Gorm, whether for vehicles or for recreational purposes. The erosion of such tracks is both damaging to the environment and unsustainable. If a gravel track needs resurfacing a dozen times in a 50 year period it clearly either shouldn't be there or a different type of track is needed.

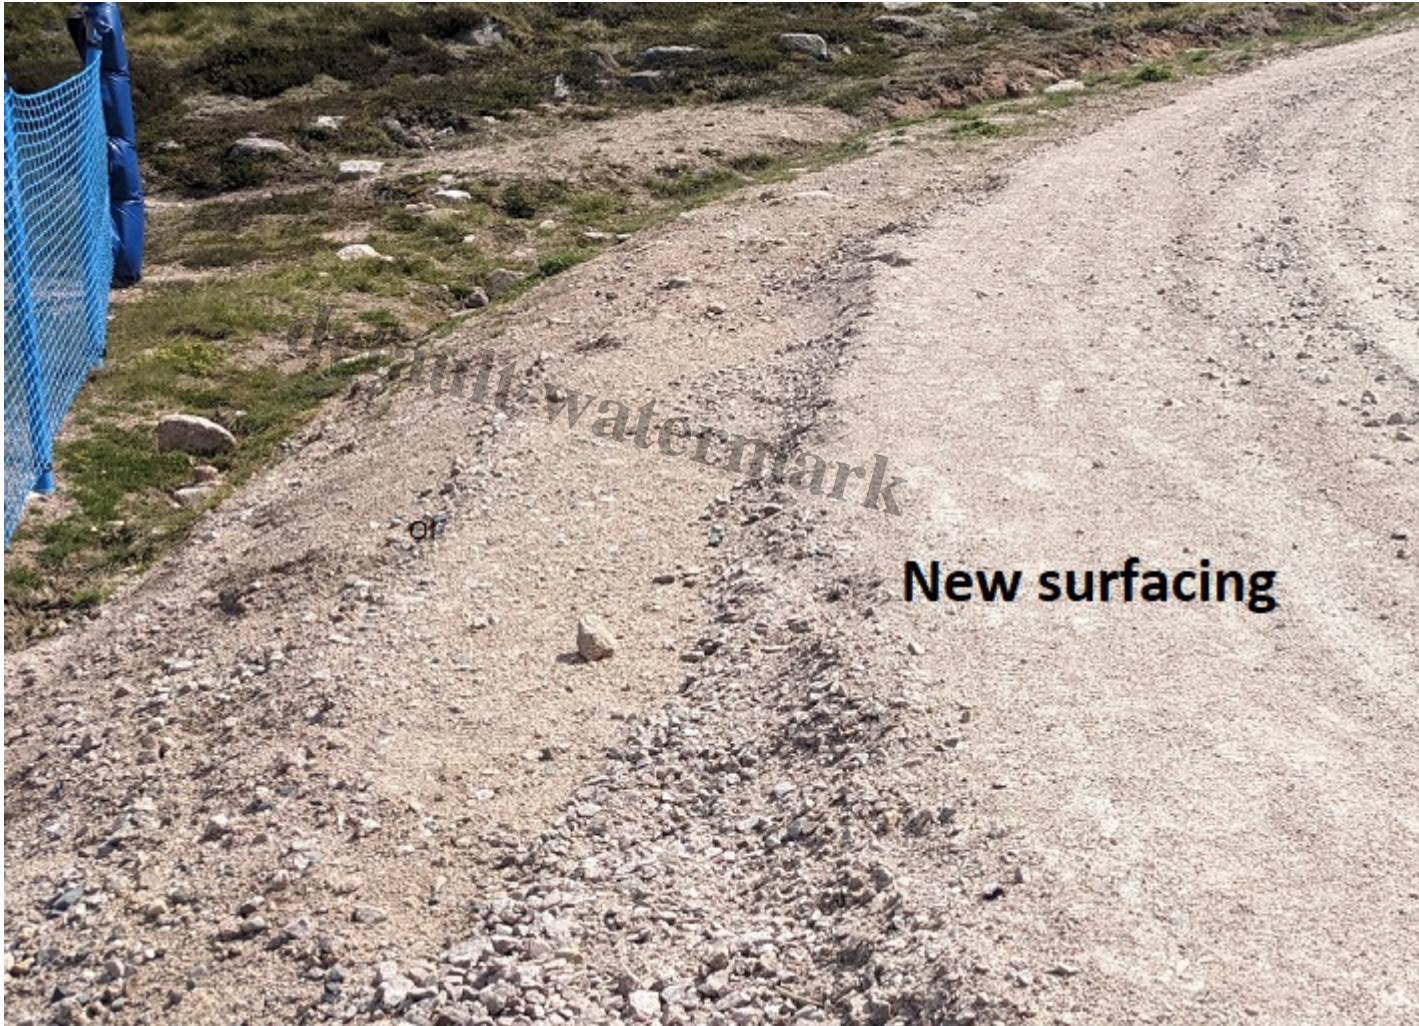
Ptarmigan access track July 2025. New granite aggregate had been spread on top of the previous eroded surface (left) to smooth it for karting but this too was eroding on the left hand side

Track erosion has been a longstanding problem at Cairn Gorm that was first documented by Adam Watson over 45 years ago. As a result of climatic factors (such as freeze thaw, precipitation, and wind), along with poor design, the materials employed and human use, the surfaces of tracks at Cairn Gorm rarely last for long as I witnessed when descending from the Ptarmigan last year.

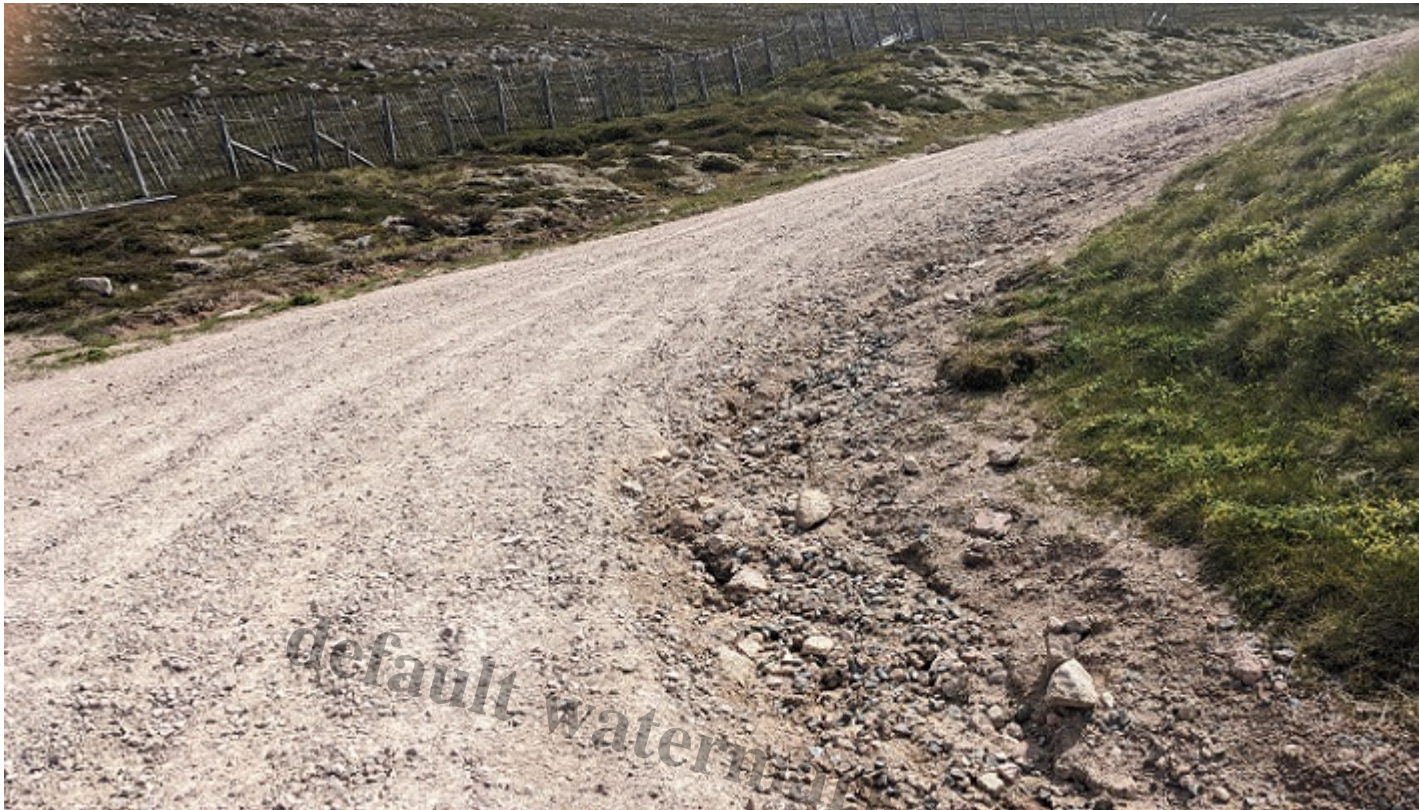
and the right. Erosion gully on opposite side of track to photo above

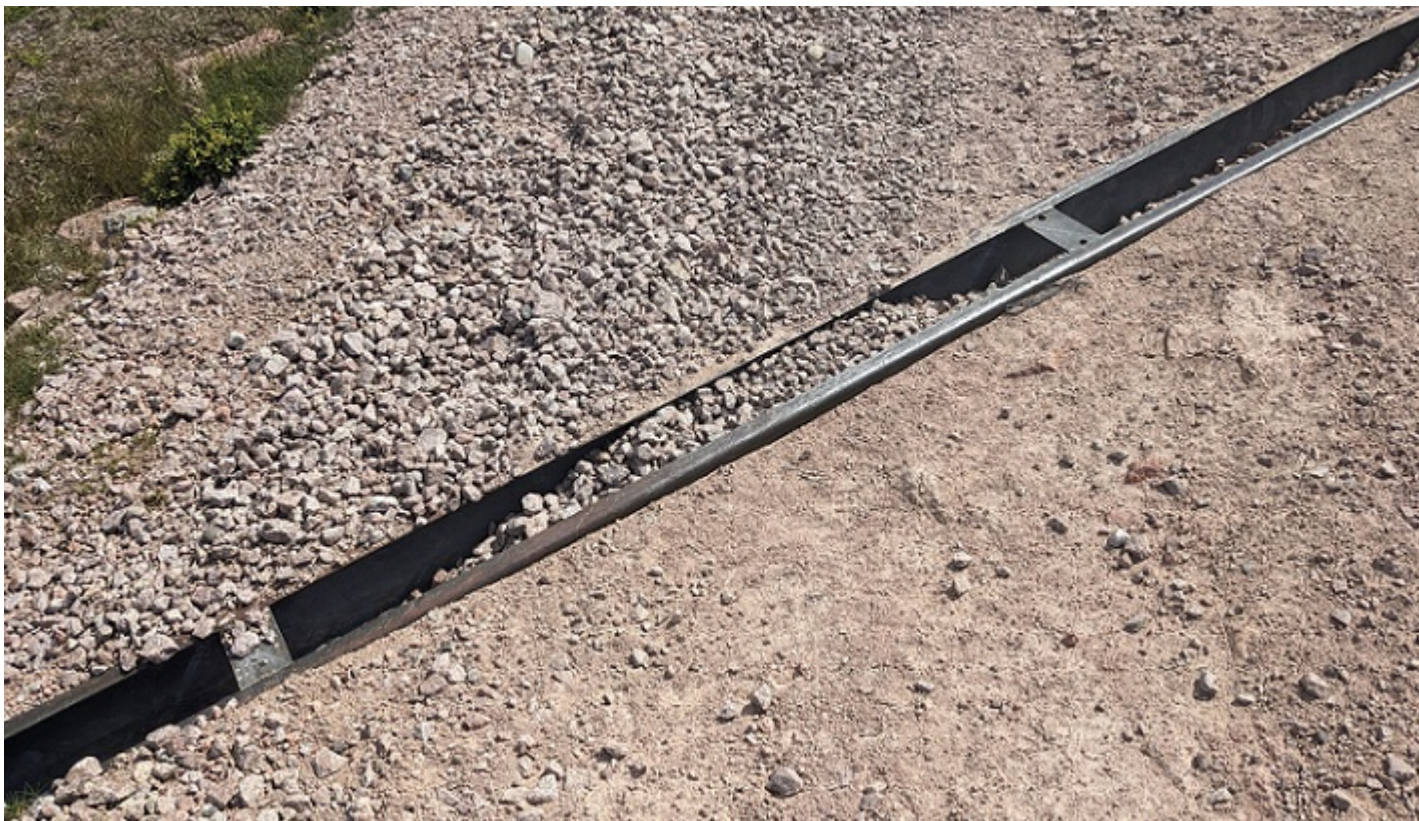
The finer materials in the granite aggregate are the first to be washed out:

Partially blocked culvert. Note how the finer materials have been washed out of track above but the culvert has reduced the amount of water flowing down the track immediately below protecting the ne surface there for a little longer.

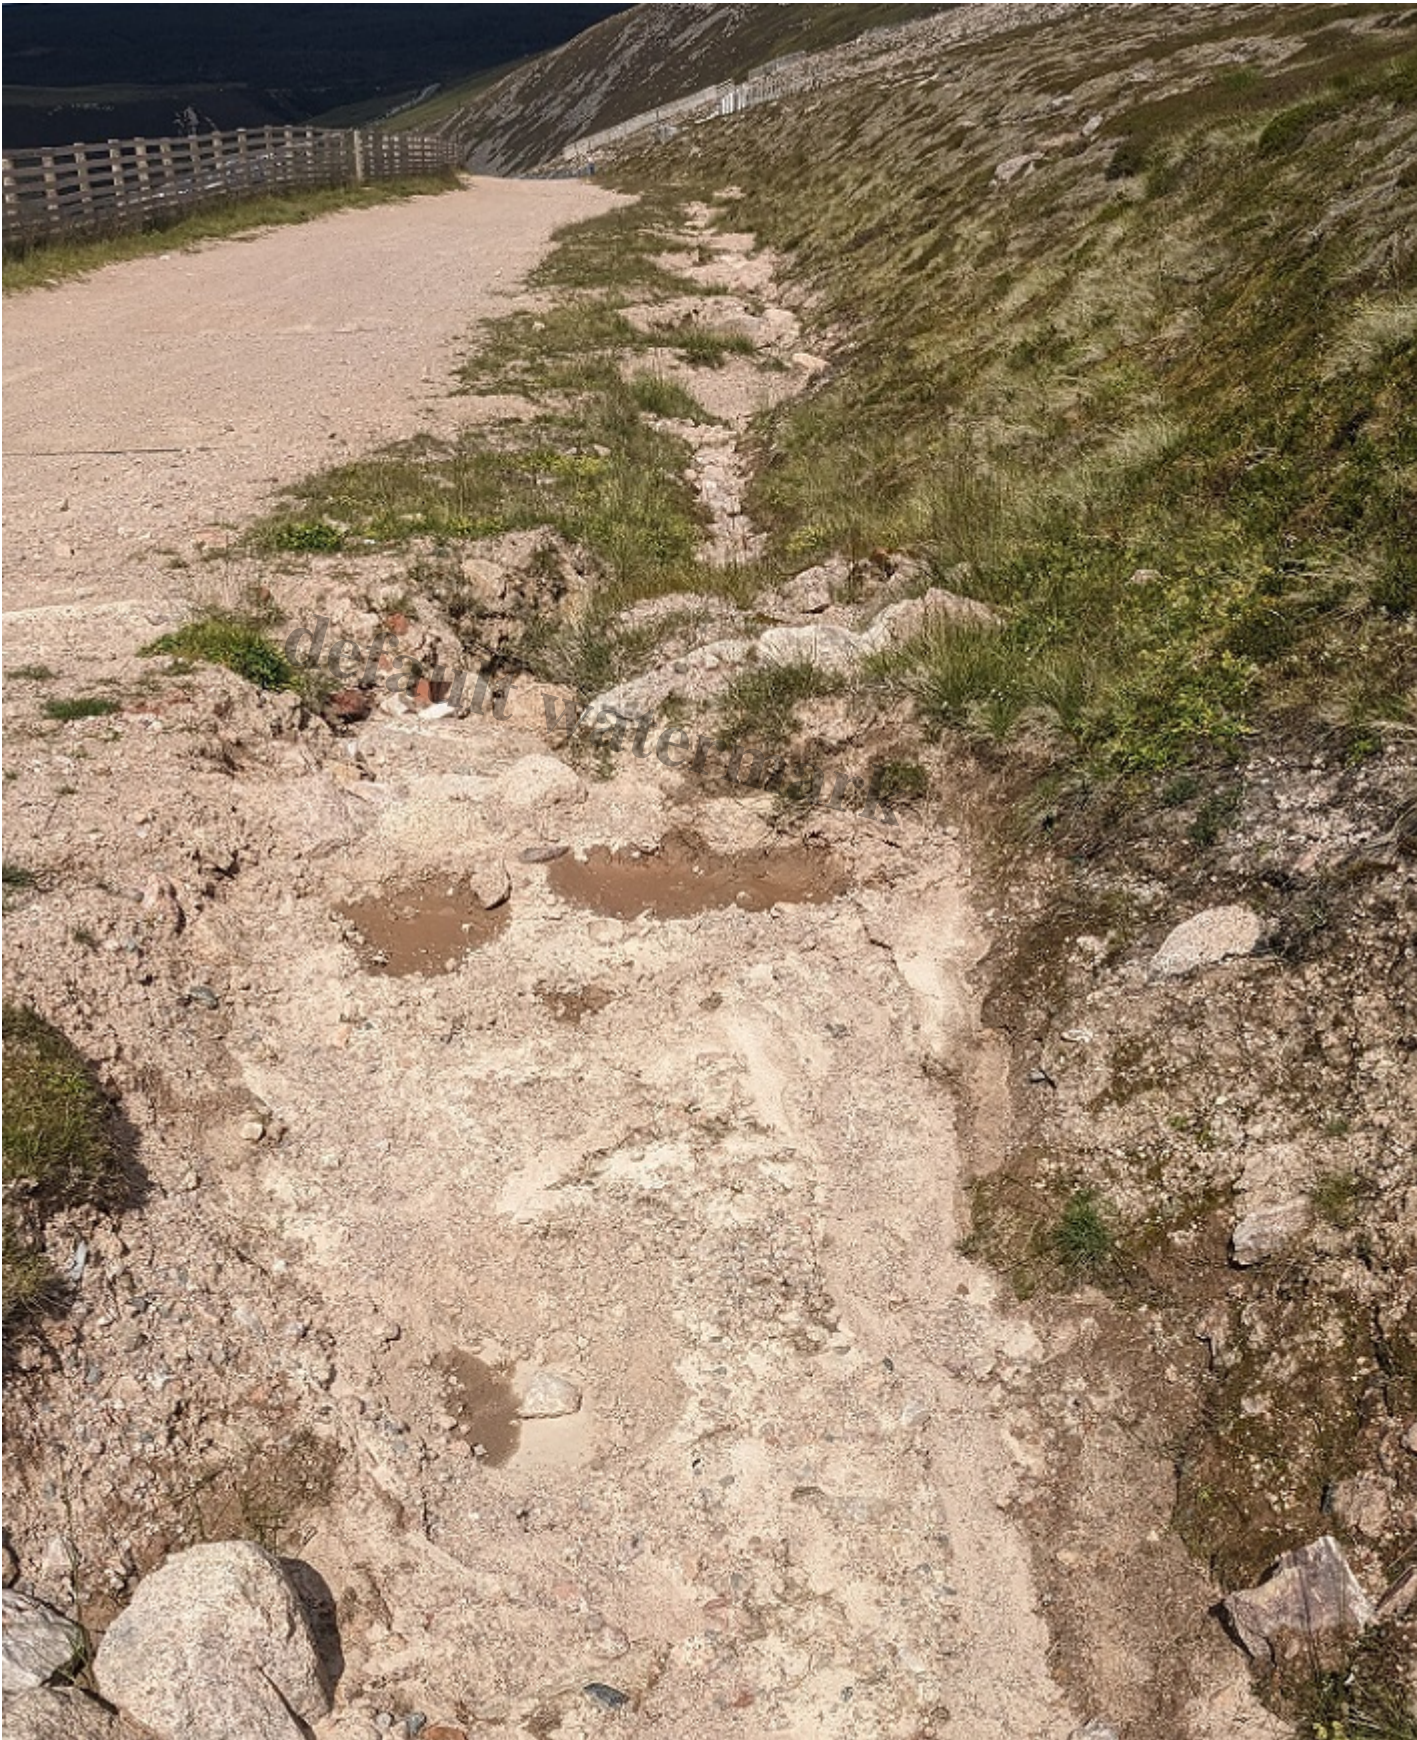
Some of these washed out materials had accumulated in the drainage ditches on the uphill side of the Ptarmigan vehicular access track:

Note the different grades of material with the finest holding in the water and showing as damp patches. Photo July 2025.

My understanding from our meeting with CMSL is that their staff clear the wash out from the drainage ditches and put it back on the tracks. This recycles part of the aggregate that has been eroded away but does not replace that washed over more open ground. As a consequence fresh aggregate, as shown in the two photos above, still requires to be imported from elsewhere. The environmental and financial costs must be significant.

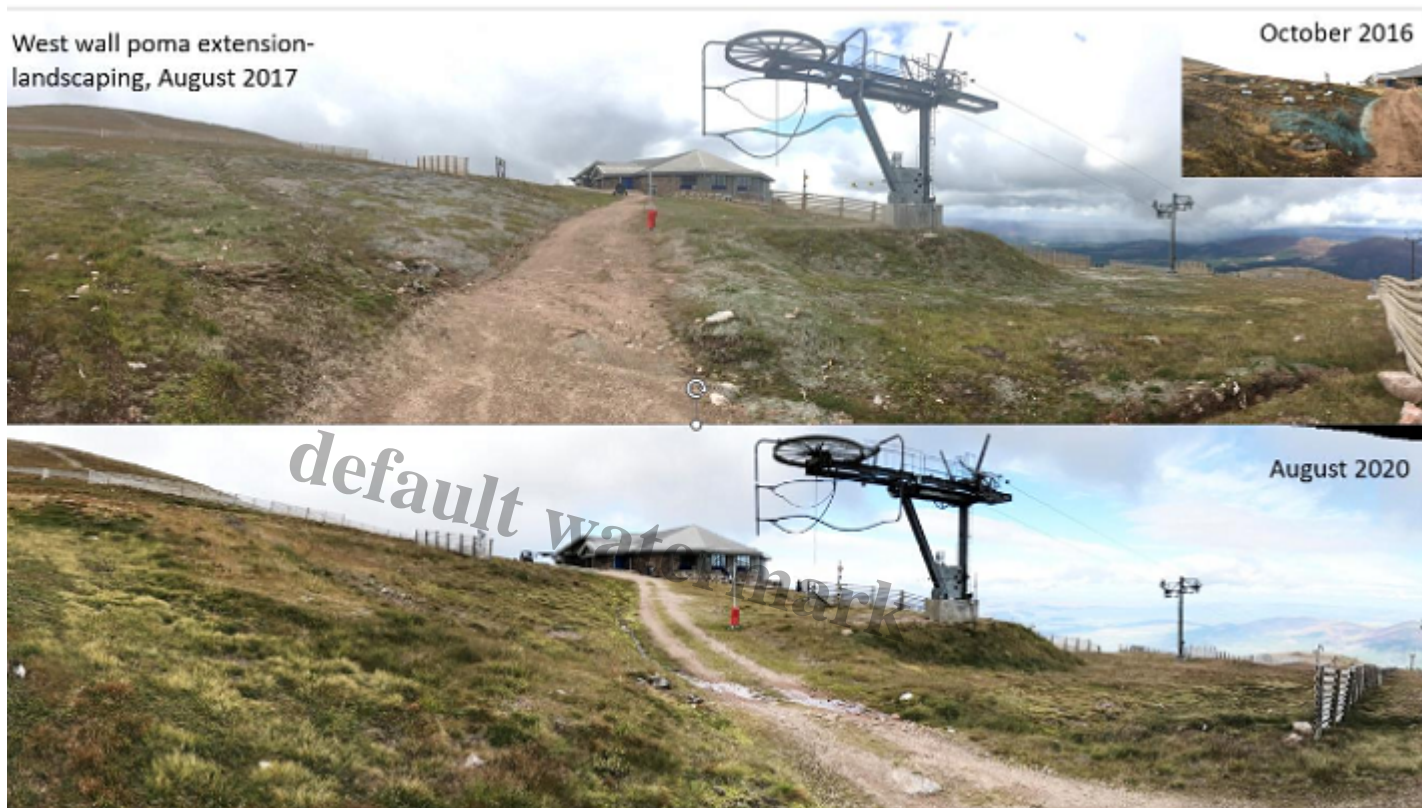
Image credit CMSL Construction Environmental Management Plan 2022

On the downhill side of tracks, washout spreads material across the hillside covering vegetation. As an example of the short time this process takes, compare the washout in the top photo of this post with these from the 2022 planning application to ‘improve’ the area around the Ptarmigan ([see here](#)):

The 2016 photos shows a bare track with re-seeding of bare areas of ground on either side (the bluish areas); the 2020 photo shows vegetation recovery including a grassy strip down the middle of the track; my photo shows how in 2025 nothing remained of the grassy strip at the top of the track and how material had spread over vegetation on the downhill side.

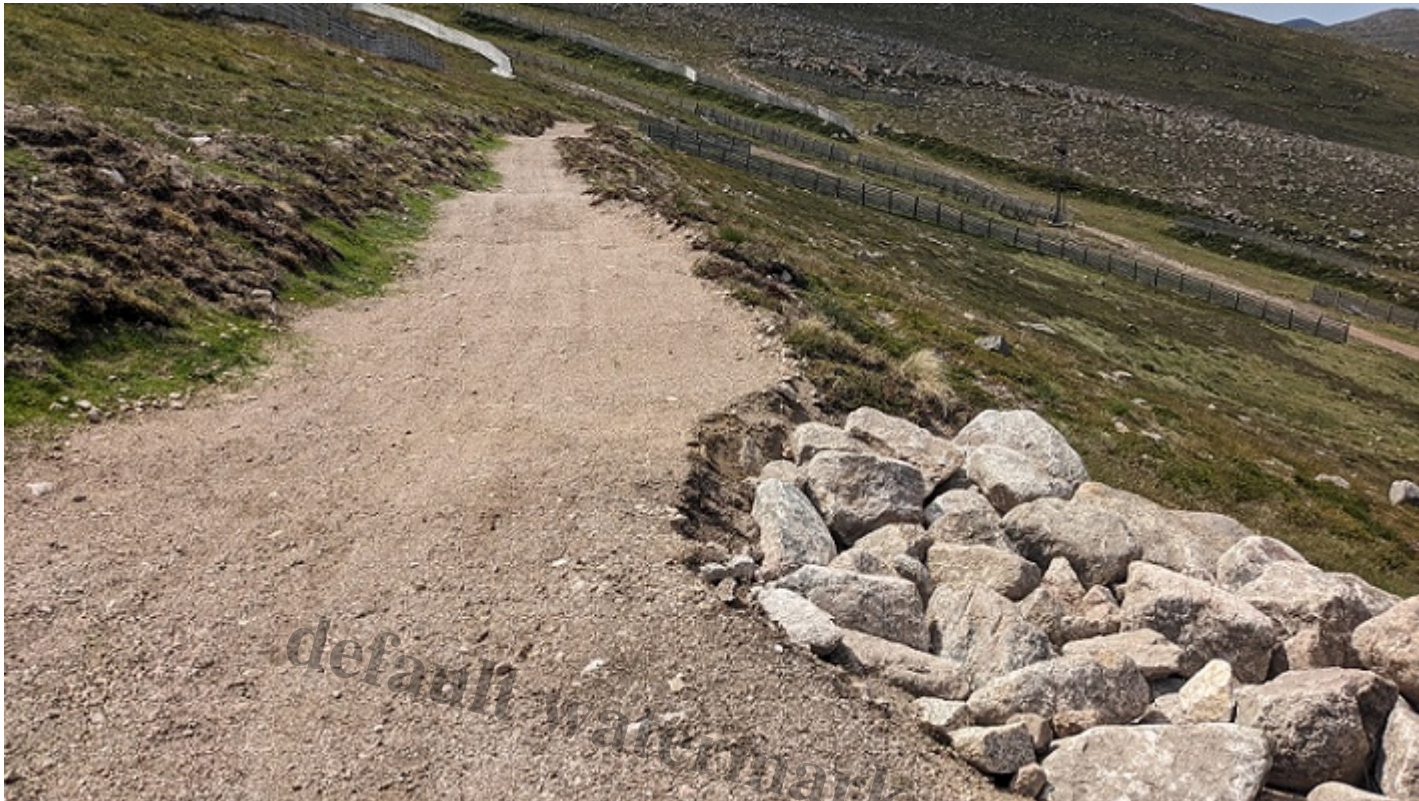
Collapse of new section of kart track (which incidentally never appears to have had planning permission) July 2025 illustrating how erosive forces punish poor design

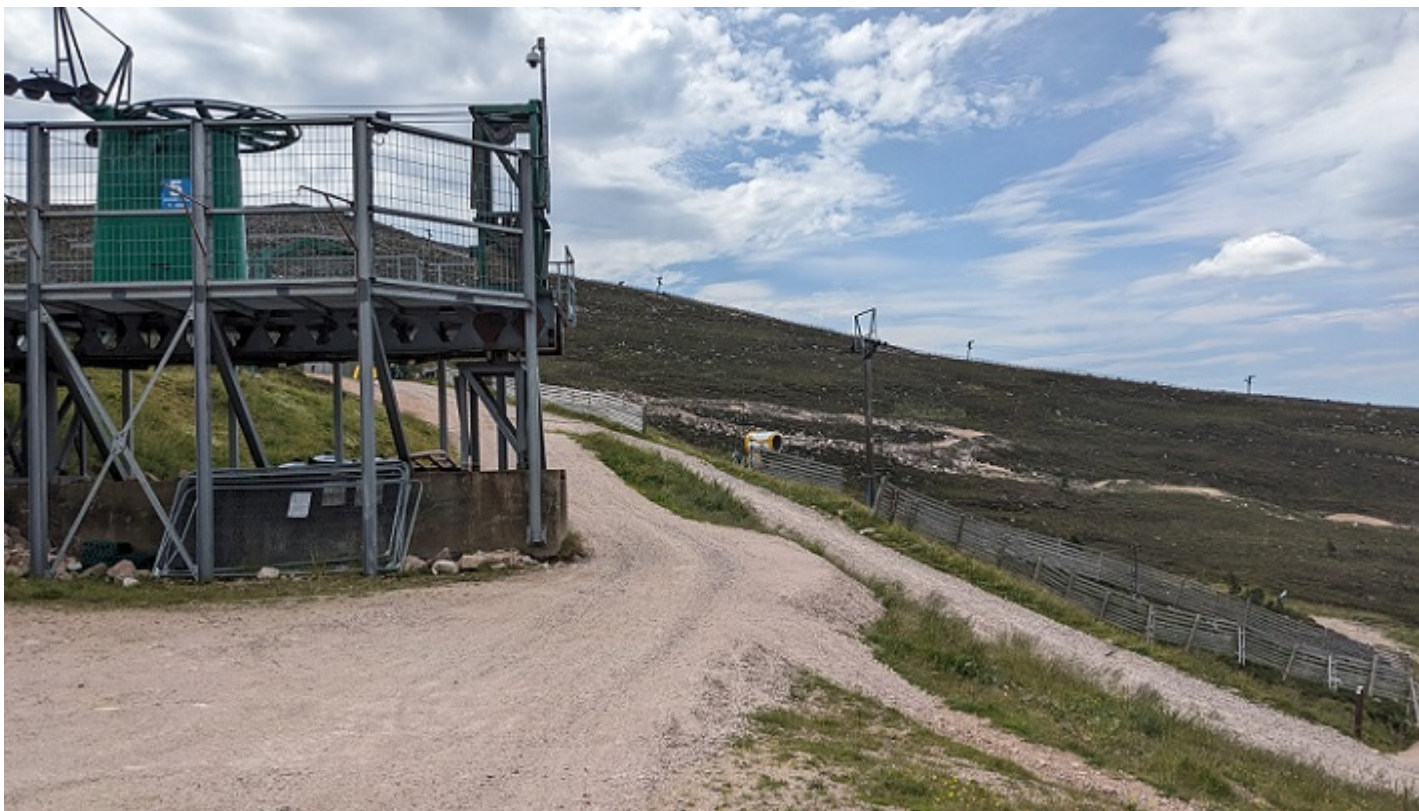
New surfacing of track at the Shieling poised to wash downhill July 2025

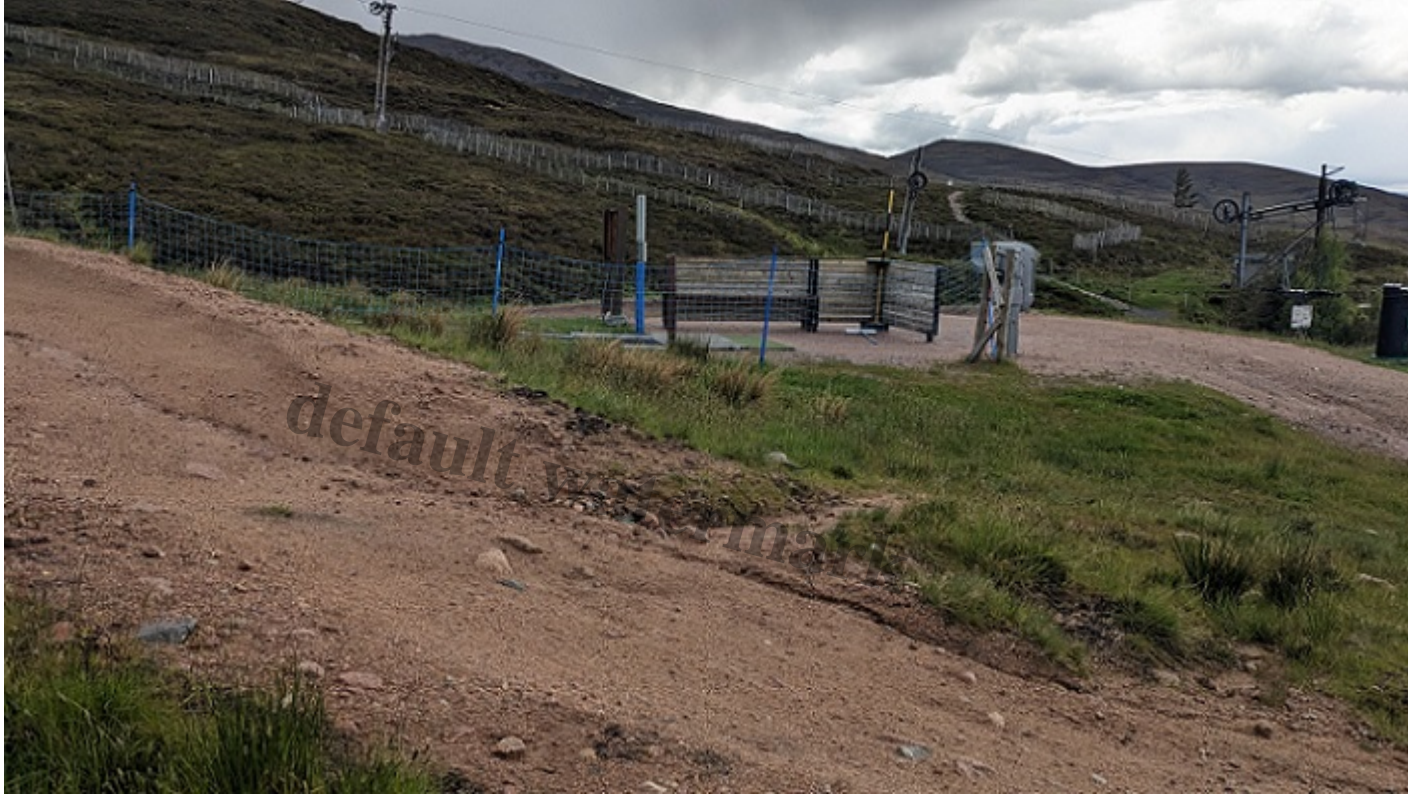
Among the signs of erosion at the bottom of the mountain bike tracks was an incipient water channel running down the far side

After our meeting with CMSL we took a walk around the area by the Day Lodge where we took a look at the bottom of the mountain bike tracks. They, like the vehicular and the karting tracks, show clear signs of erosion.
