Planning Application to retain the Access track at the Shielling tow and regraded embankment along the lower loop path.

The Retrospective planning application as required by the planners is to retain the track and document the regraded bank profiles as a starting point for future reference.

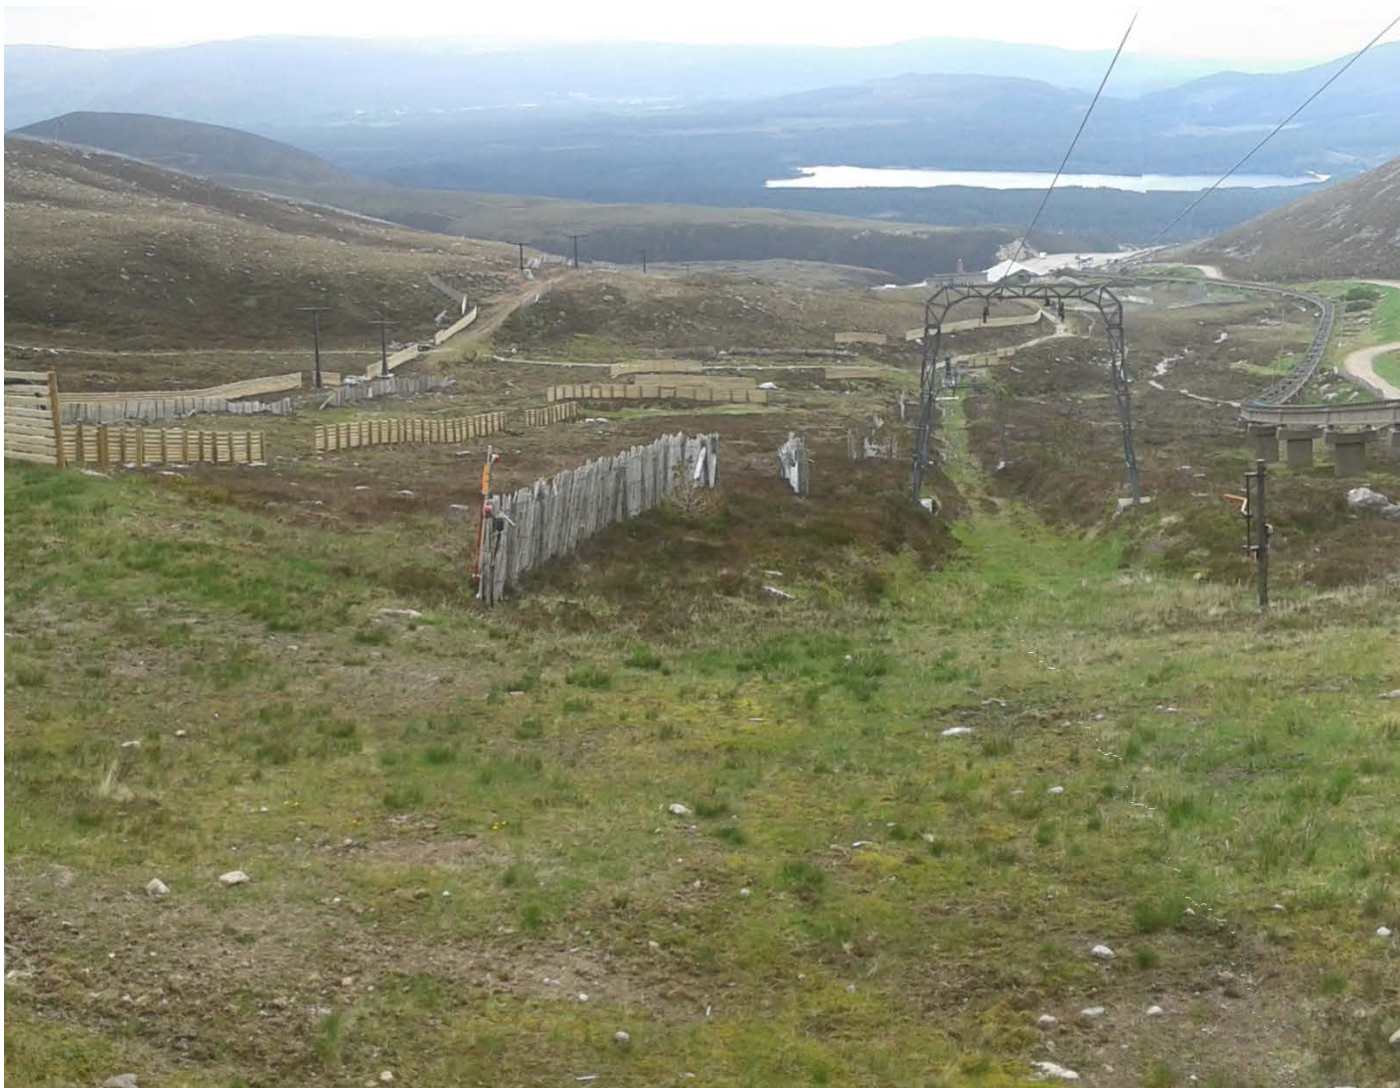
Image looking down bull dozed shieling track prior to new ski lift installation

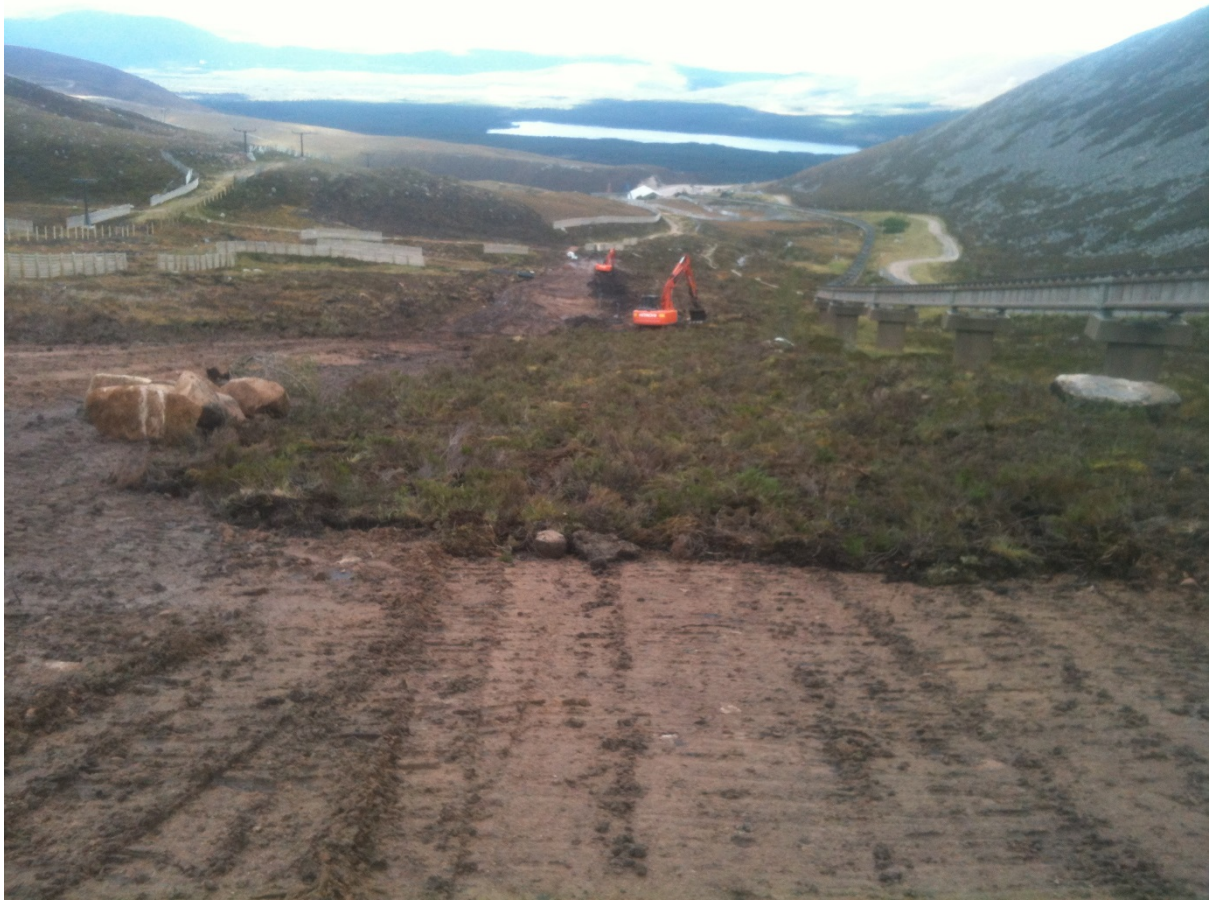
Image showing reinstatement of turf on new ground contours prior to lift installation Oct 2015. Track on left of work site retained to move materials and ski lift components avoiding tracking on reinstated vegetation.

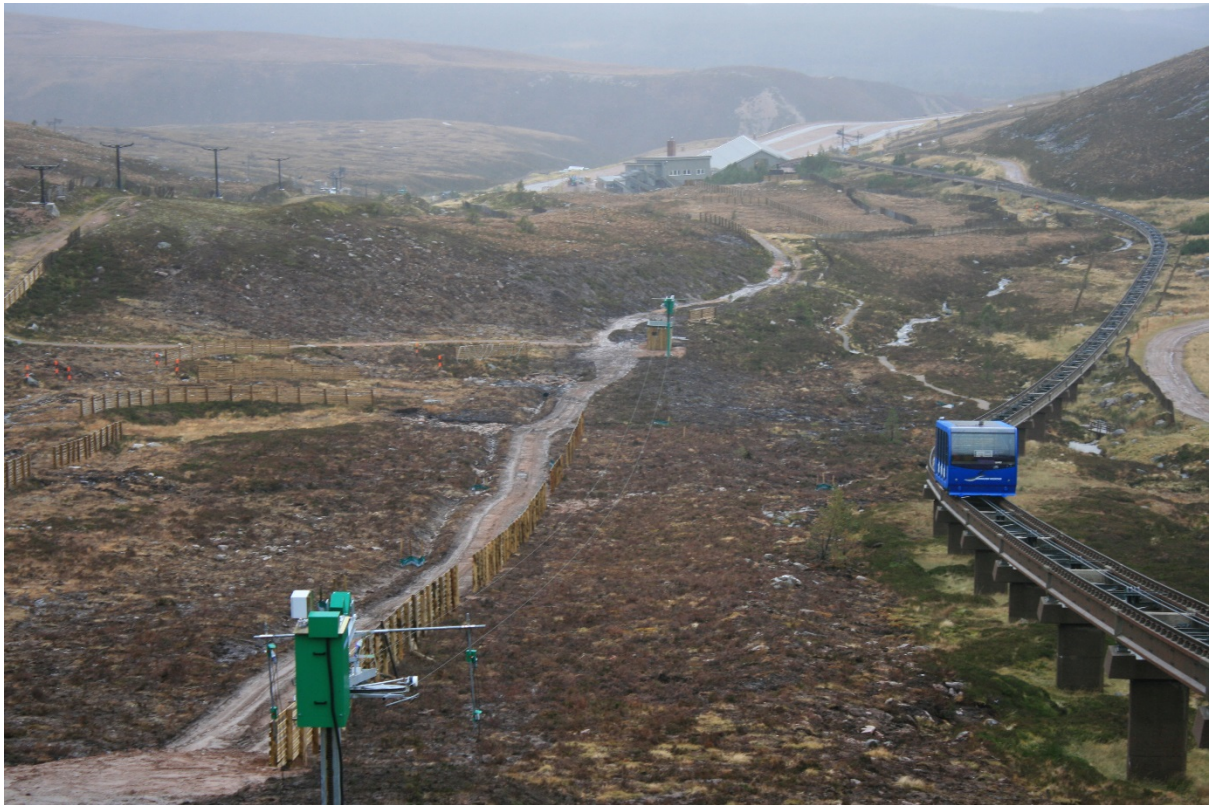
Images showing groundworks after completed ski lift installation, ground levels and reinstatement of turf.

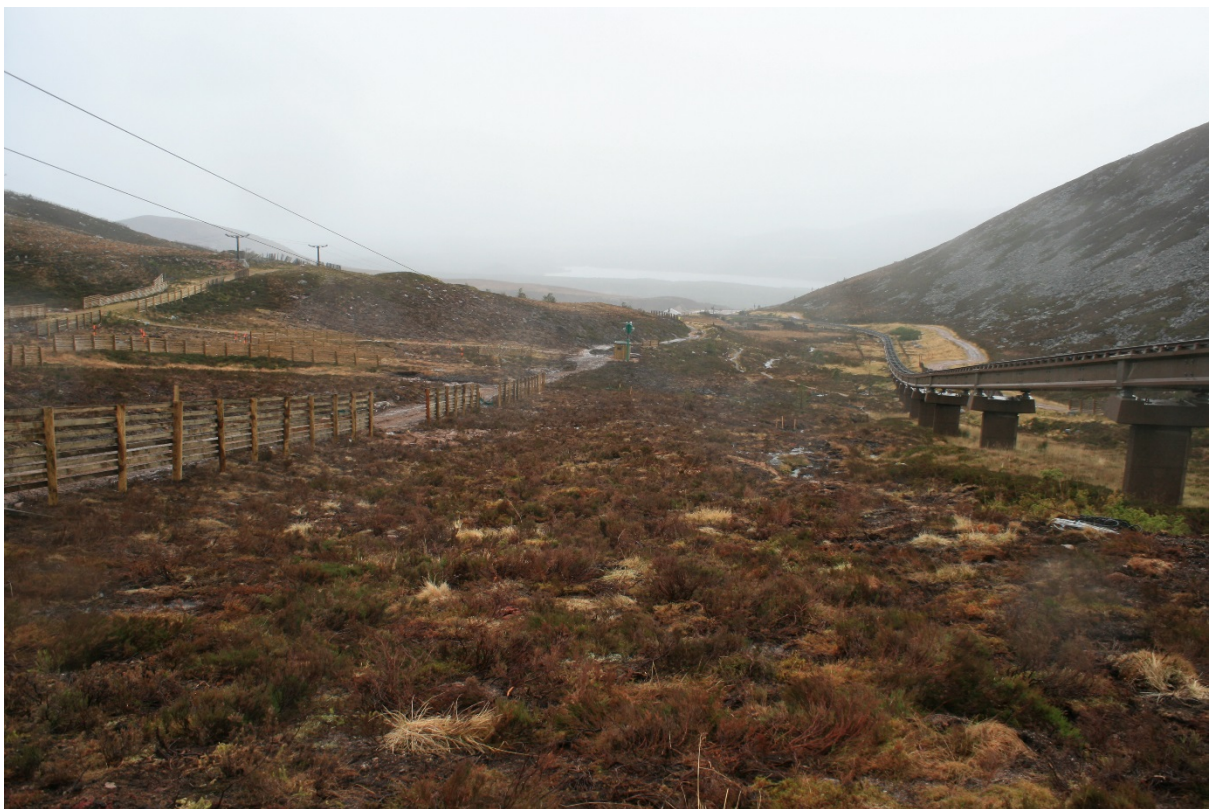
Image looking down work site in November 2015

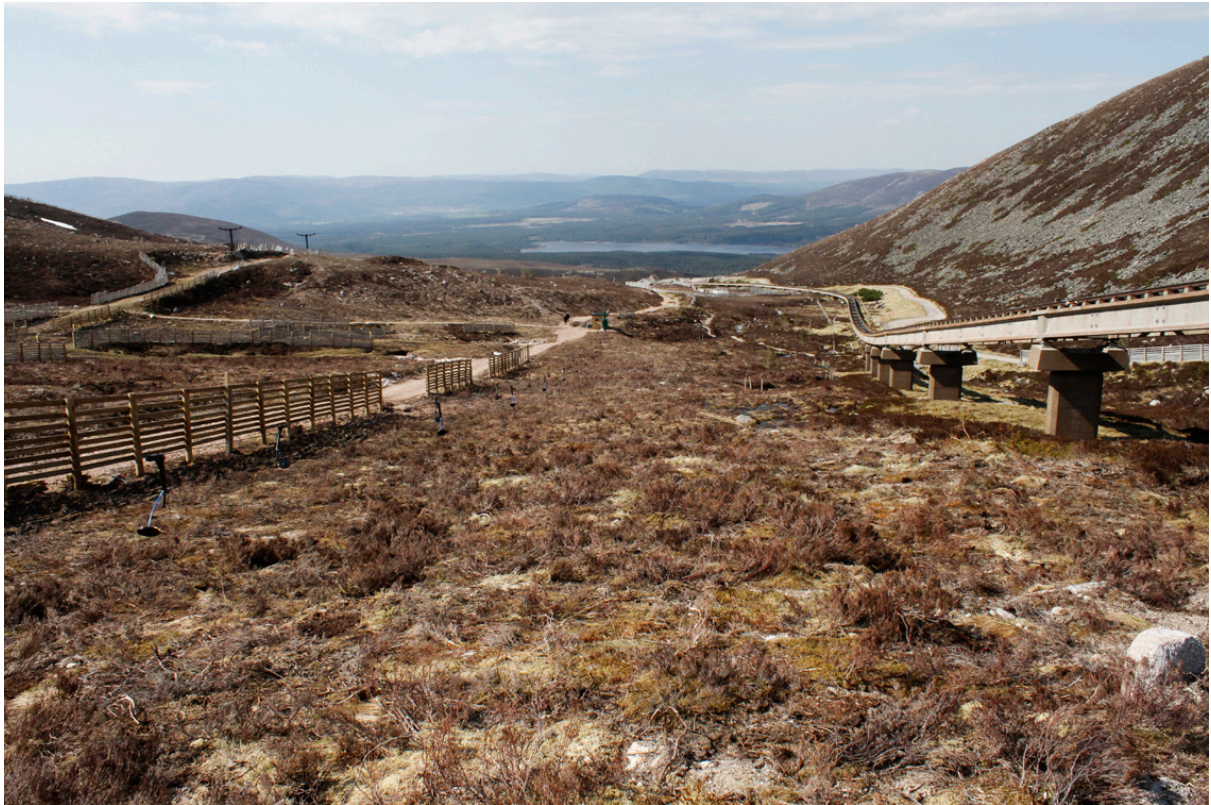
Turf restoration on new ground levels at ski lift line. November 2015.
