The Glen Falloch hydro schemes (5) is the end product good enough for a National Park?

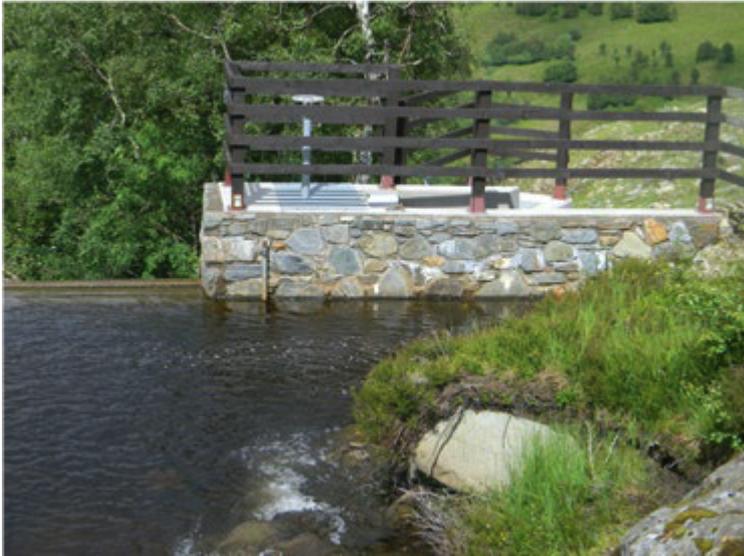
Good Practice Photo from LLTNPA Supplementary Guidance on Renewables

• If wing walls are required and concrete is to be used, choose a subdued colour which blends with the adjacent surroundings. A local source of boulders should be used to help screen the concrete structure. Be aware that concrete will stain on contact with water and that at periods of low water linear striping can be an issue. Use stone cladding on exposed faces of the concrete to assist it to blend with its surroundings. •

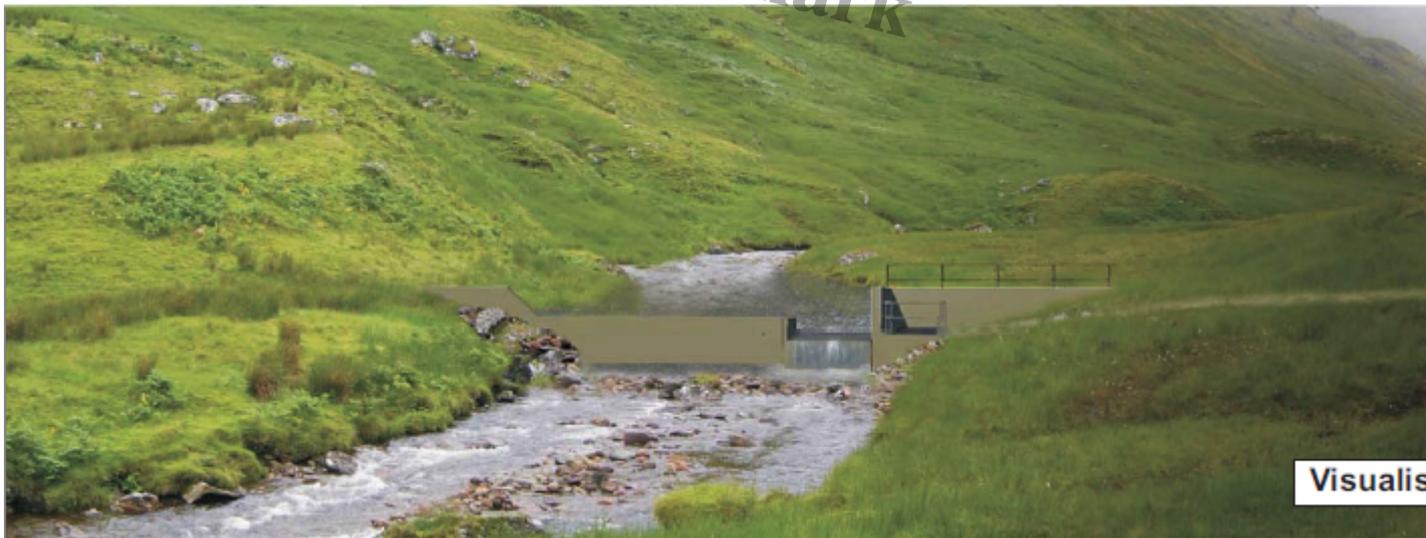
Visualisation of how the Upper Falloch intake dam would look like in 2009

The current visual impact of the Upper Falloch must be at least six times the size as in the original landscape assessment and the main reason for this is the use of boulders in screening the dam and in rip-rap retention along the banks of the intake pool but also the river below. Now its possible restoration work is not complete and some of the boulders may be covered in vegetation although its not clear where this might come from as none has been stored locally. In my view the left side wall of the dam would have looked better without the boulders. Its difficult to see anything growing on them for decades and they are likely to continue to look like a pile of boulders dumped by a digger. Its hard to see how anyone could claim this is effective restoration of the landscape. However, it appears to result from the LLTNPA Guidance:
