The Glen Falloch hydro schemes (5) – is the end product good enough for a National Park?

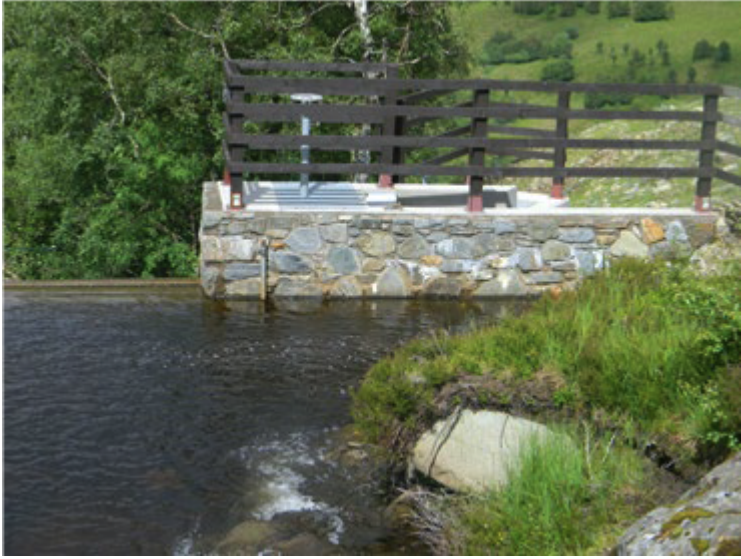
Good Practice Photo from LLTNPA Supplementary Guidance on Renewables

“If wing walls are required and concrete is to be used, choose a subdued colour which blends with the adjacent surroundings. A local source of boulders should be used to help screen the concrete structure. Be aware that concrete will stain on contact with water and that at periods of low water linear striping can be an issue. Use stone cladding on exposed faces of the concrete to assist it to blend with its surroundings.”

In fact not a single one of the Glen Falloch dams meets the Park’s current best practice guidance – all are concrete without any stone cladding though in some cases boulders have been piled against the wing walls to help screen them.

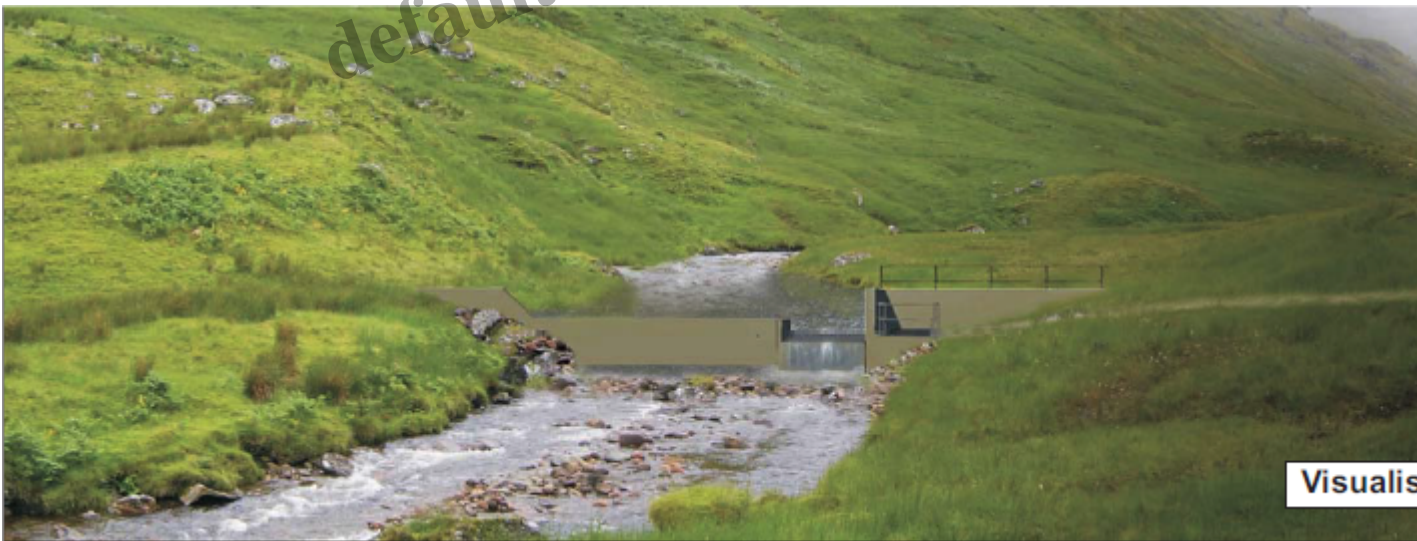
Visualisation of how the Upper Falloch intake dam would look like in 2009

The current visual impact of the Upper Falloch must be at least six times the size as in the original landscape assessment and the main reason for this is the use of boulders in screening the dam and in “rip-rap retention” along the banks of the intake pool but also the river below. Now its possible “restoration” work is not complete and some of the boulders may be covered in vegetation although its not clear where this might come from as none has been stored locally. In my view the left side wall of the dam would have looked better without the boulders. Its difficult to see anything growing on them for decades and they are likely to continue to look like a pile of boulders dumped by a digger. Its hard to see how anyone could claim this is effective restoration of the landscape. However, it appears to result from the LLTNPA Guidance:
