The Glen Falloch hydro schemes (5) – is the end product good enough for a National Park?

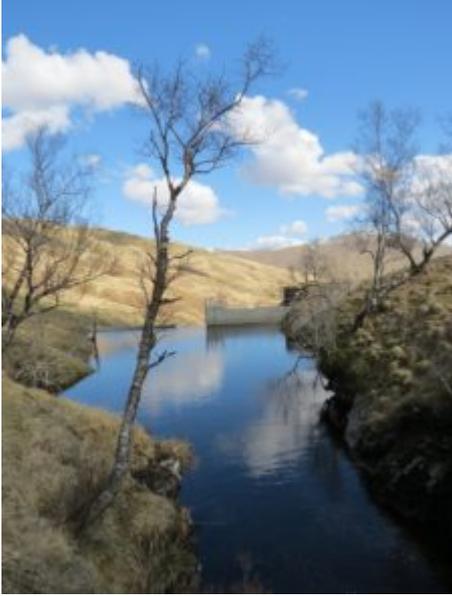
My first view of any of the dams was from above. I had come down the

Allt Fionn, after a run over Ben Oss and Beinn Dubhcaraig, and after a beautiful gorge came across the scene on the left. Hardly less beautiful and it probably coloured my initial response to the downhill side of the dam which I thought had a negligible impact on the landscape. Re-looking at the photos now I would not go that far, but I still think the Allt Fionn is the best of the Glen Falloch Hydro schemes (and the LLTNPA won an award for it).

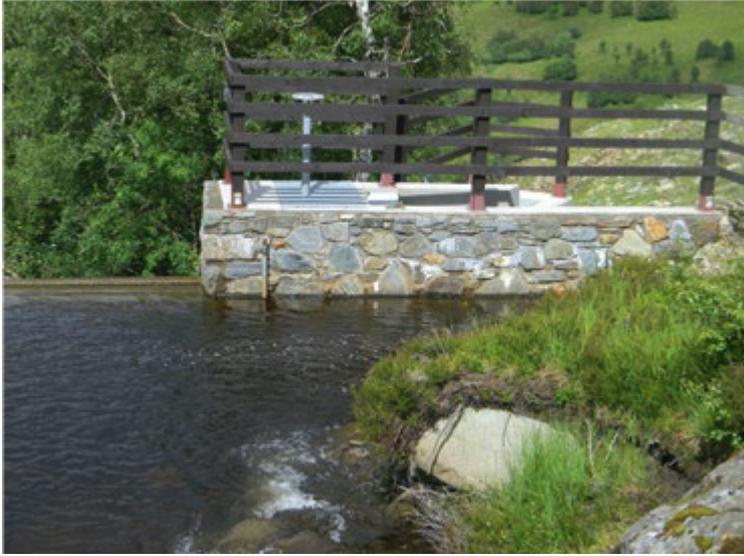
Good Practice Photo from LLTNPA Supplementary Guidance on Renewables

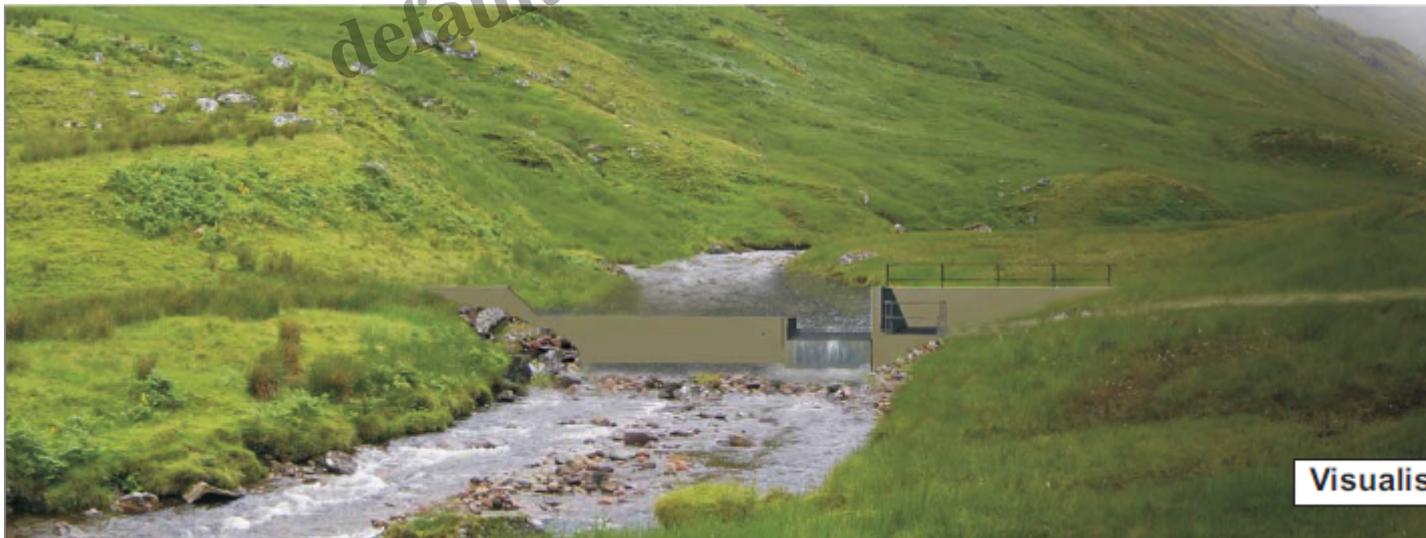
Visualisation of how the Upper Falloch intake dam would look like in 2009

The current visual impact of the Upper Falloch must be at least six times the size as in the original landscape assessment and the main reason for this is the use of boulders in screening the dam and in “rip-rap retention” along the banks of the intake pool but also the river below. Now its possible “restoration” work is not complete and some of the boulders may be covered in vegetation although its not clear where this might come from as none has been stored locally. In my view the left side wall of the dam would have looked better without the boulders. Its difficult to see anything growing on them for decades and they are likely to continue to look like a pile of boulders dumped by a digger. Its hard to see how anyone could claim this is effective restoration of the landscape. However, it appears to result from the LLTNPA Guidance:
