## Another National Park planning failure – the hydro destruction in Glen Bruar

Bruar hydro scheme in construction May 2014

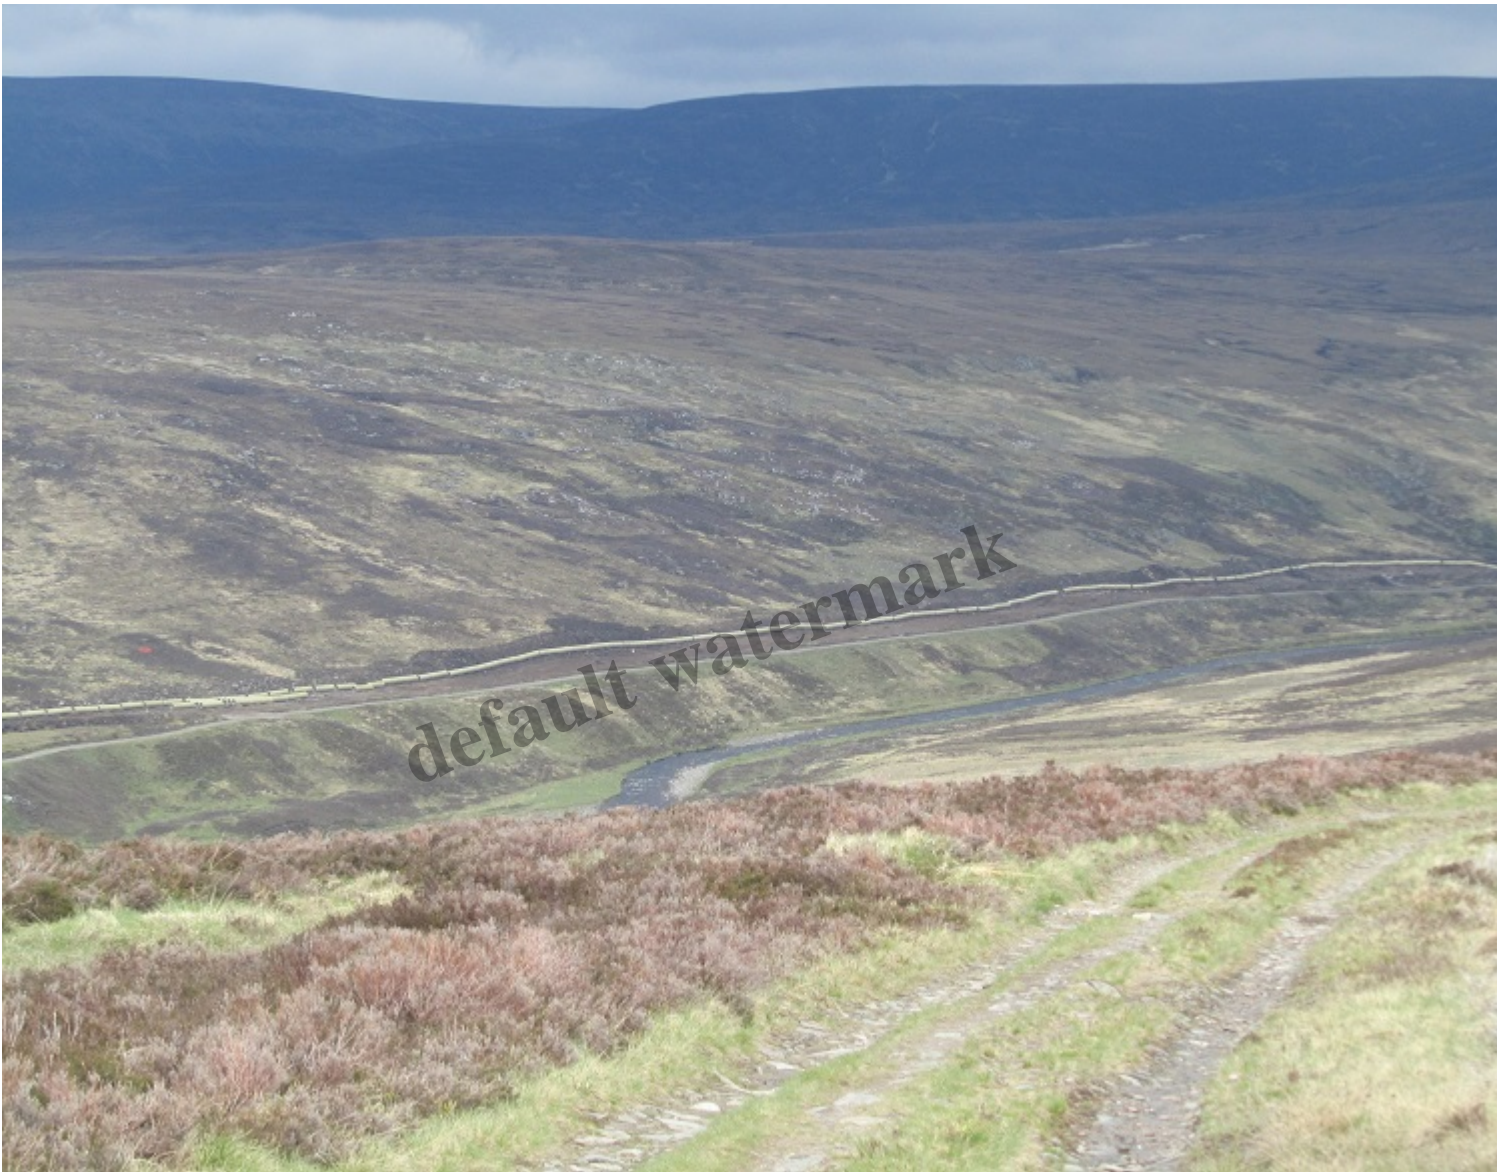
I first became aware of the Bruar Hydro Scheme in May 2014 when I spotted the construction works from afar when out for a run over Beinn Dearg and surrounding hills. I did not think twice of it then, like most of the population I assumed hydro was “a good thing”. Having become aware of the hydro planning disaster in Glen Falloch ([see here for example](#)) I went to have a closer look at Glen Bruar on 27th August 2016 (and I give the date because it is just possible some effective restoration work has taken place since then).
