The Glen Bruar hydro track

This is my second post on the Bruar Hydro Scheme ([see here](#)) which I visited at the end of August. I am fairly confident that few of the issues identified in this post will have been remedied since my visit but would welcome more up to date photos from anyone who is in the area.

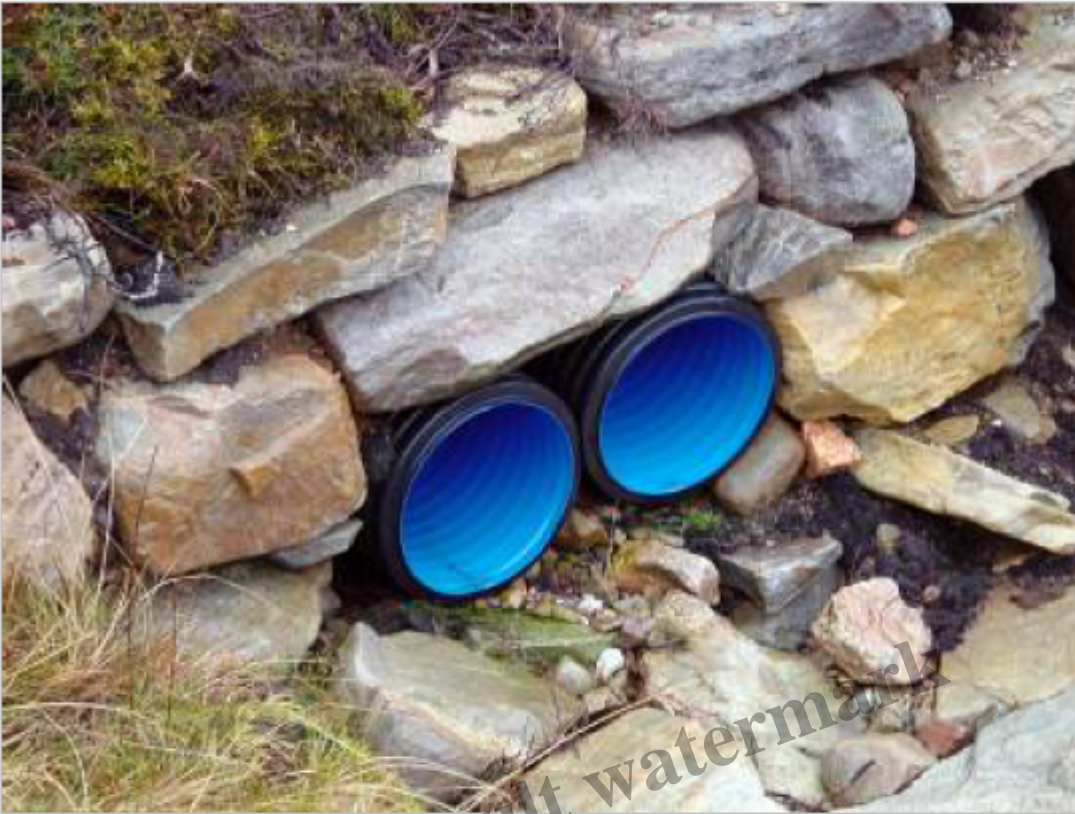
Contrast the way this culvert has been constructed – which is typical of the culverts along the new sections of track – with what the SNH Guidance says on how it should be done:

Stone facing can help culverts blend into the surrounding landscape. Culvert pipes should, however be set back into the stonework to minimise their visual prominence. Culverts should be sunk into the bed of the channel to allow access by fish and other species, and not left 'perched' as in this example. It is preferable to use a single larger pipe since this will carry more water and will be less prone to blockage.
