## The Glen Bruar hydro track

### Description

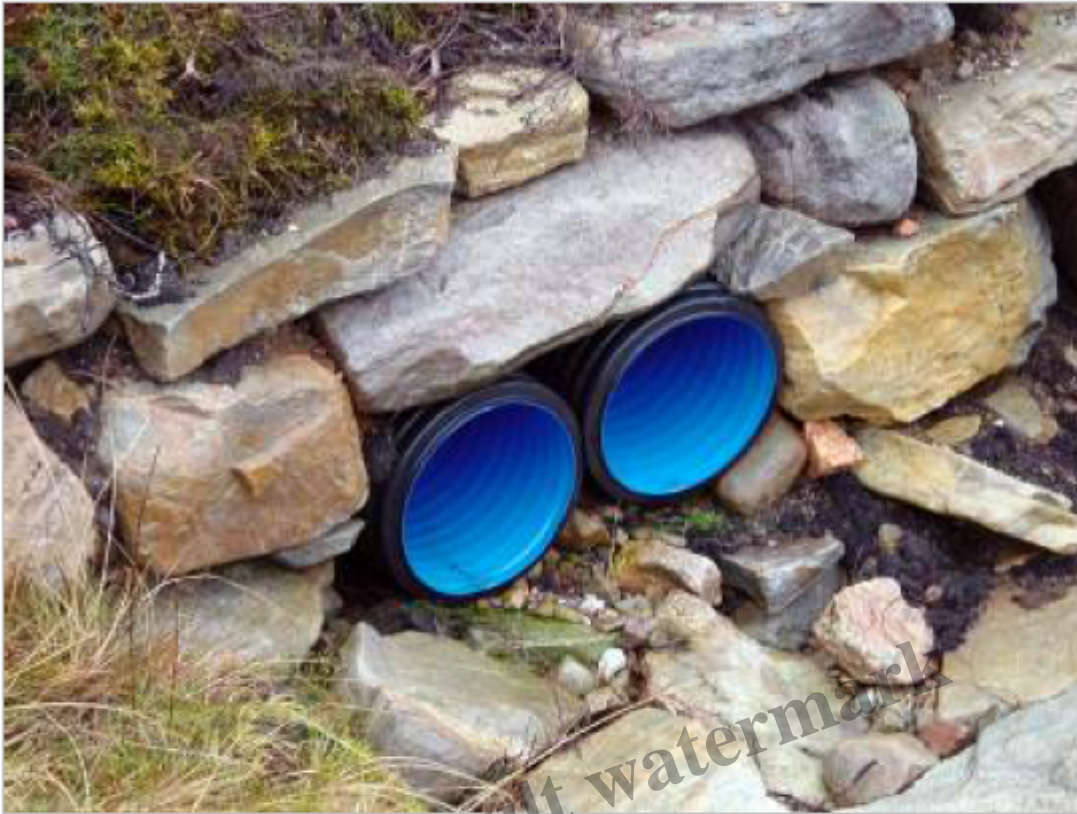
Stone facing can help culverts blend into the surrounding landscape. Culvert pipes should, however, be set back into the stonework to minimise their visual prominence. Culverts should be sunk into the bed of the channel to allow access by fish and other species, and not left 'perched' as in this example. It is preferable to use a single larger pipe since this will carry more water and will be less prone to blockage.

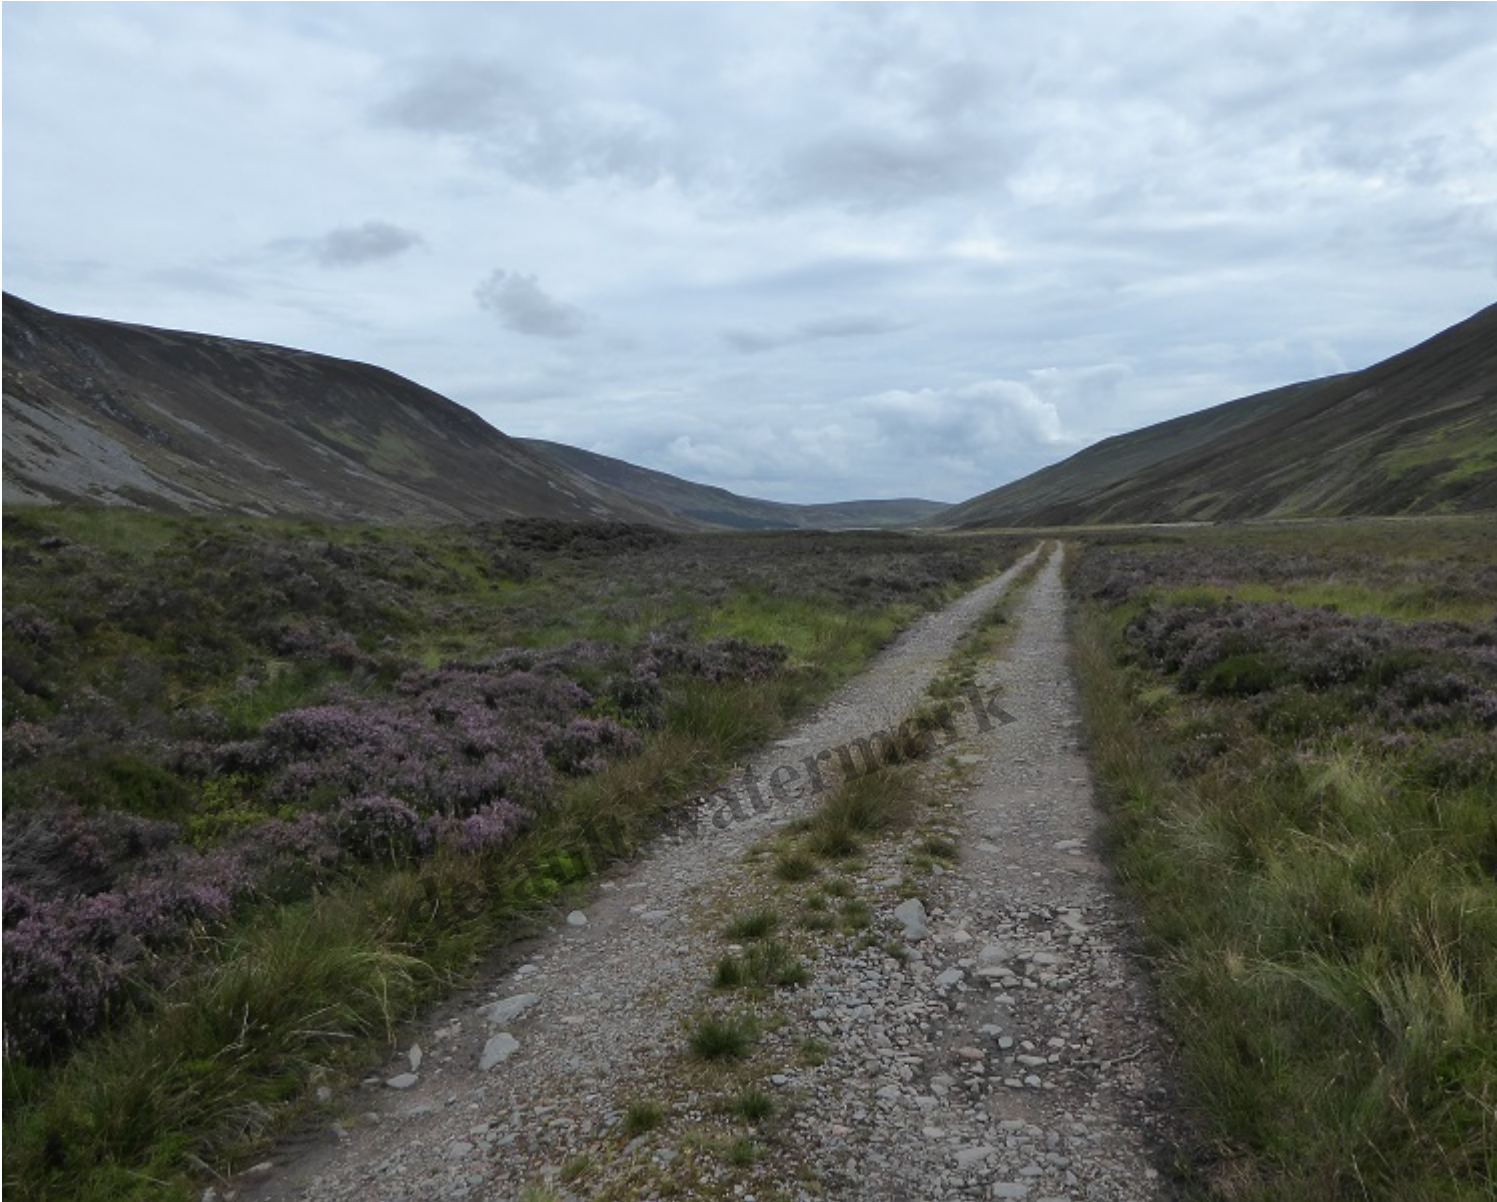
This is the section of the old track north of the dam, ie beyond the hydro scheme. It illustrates a number of features that the CNPA should ensure are applied to the 12k of track to the dam, namely its narrow, the sides are vegetated and a narrow vegetated strip runs down the centre of the track (as recommended in guidance by the Lomond and Trossachs National Park Authority on hydro tracks). While this track penetrates a prime area of wild land, in design terms it illustrates the standards our National Park should be aspiring too where tracks are agreed.
