Large scale environmental dereliction in the National Park

**By Nick Halls**

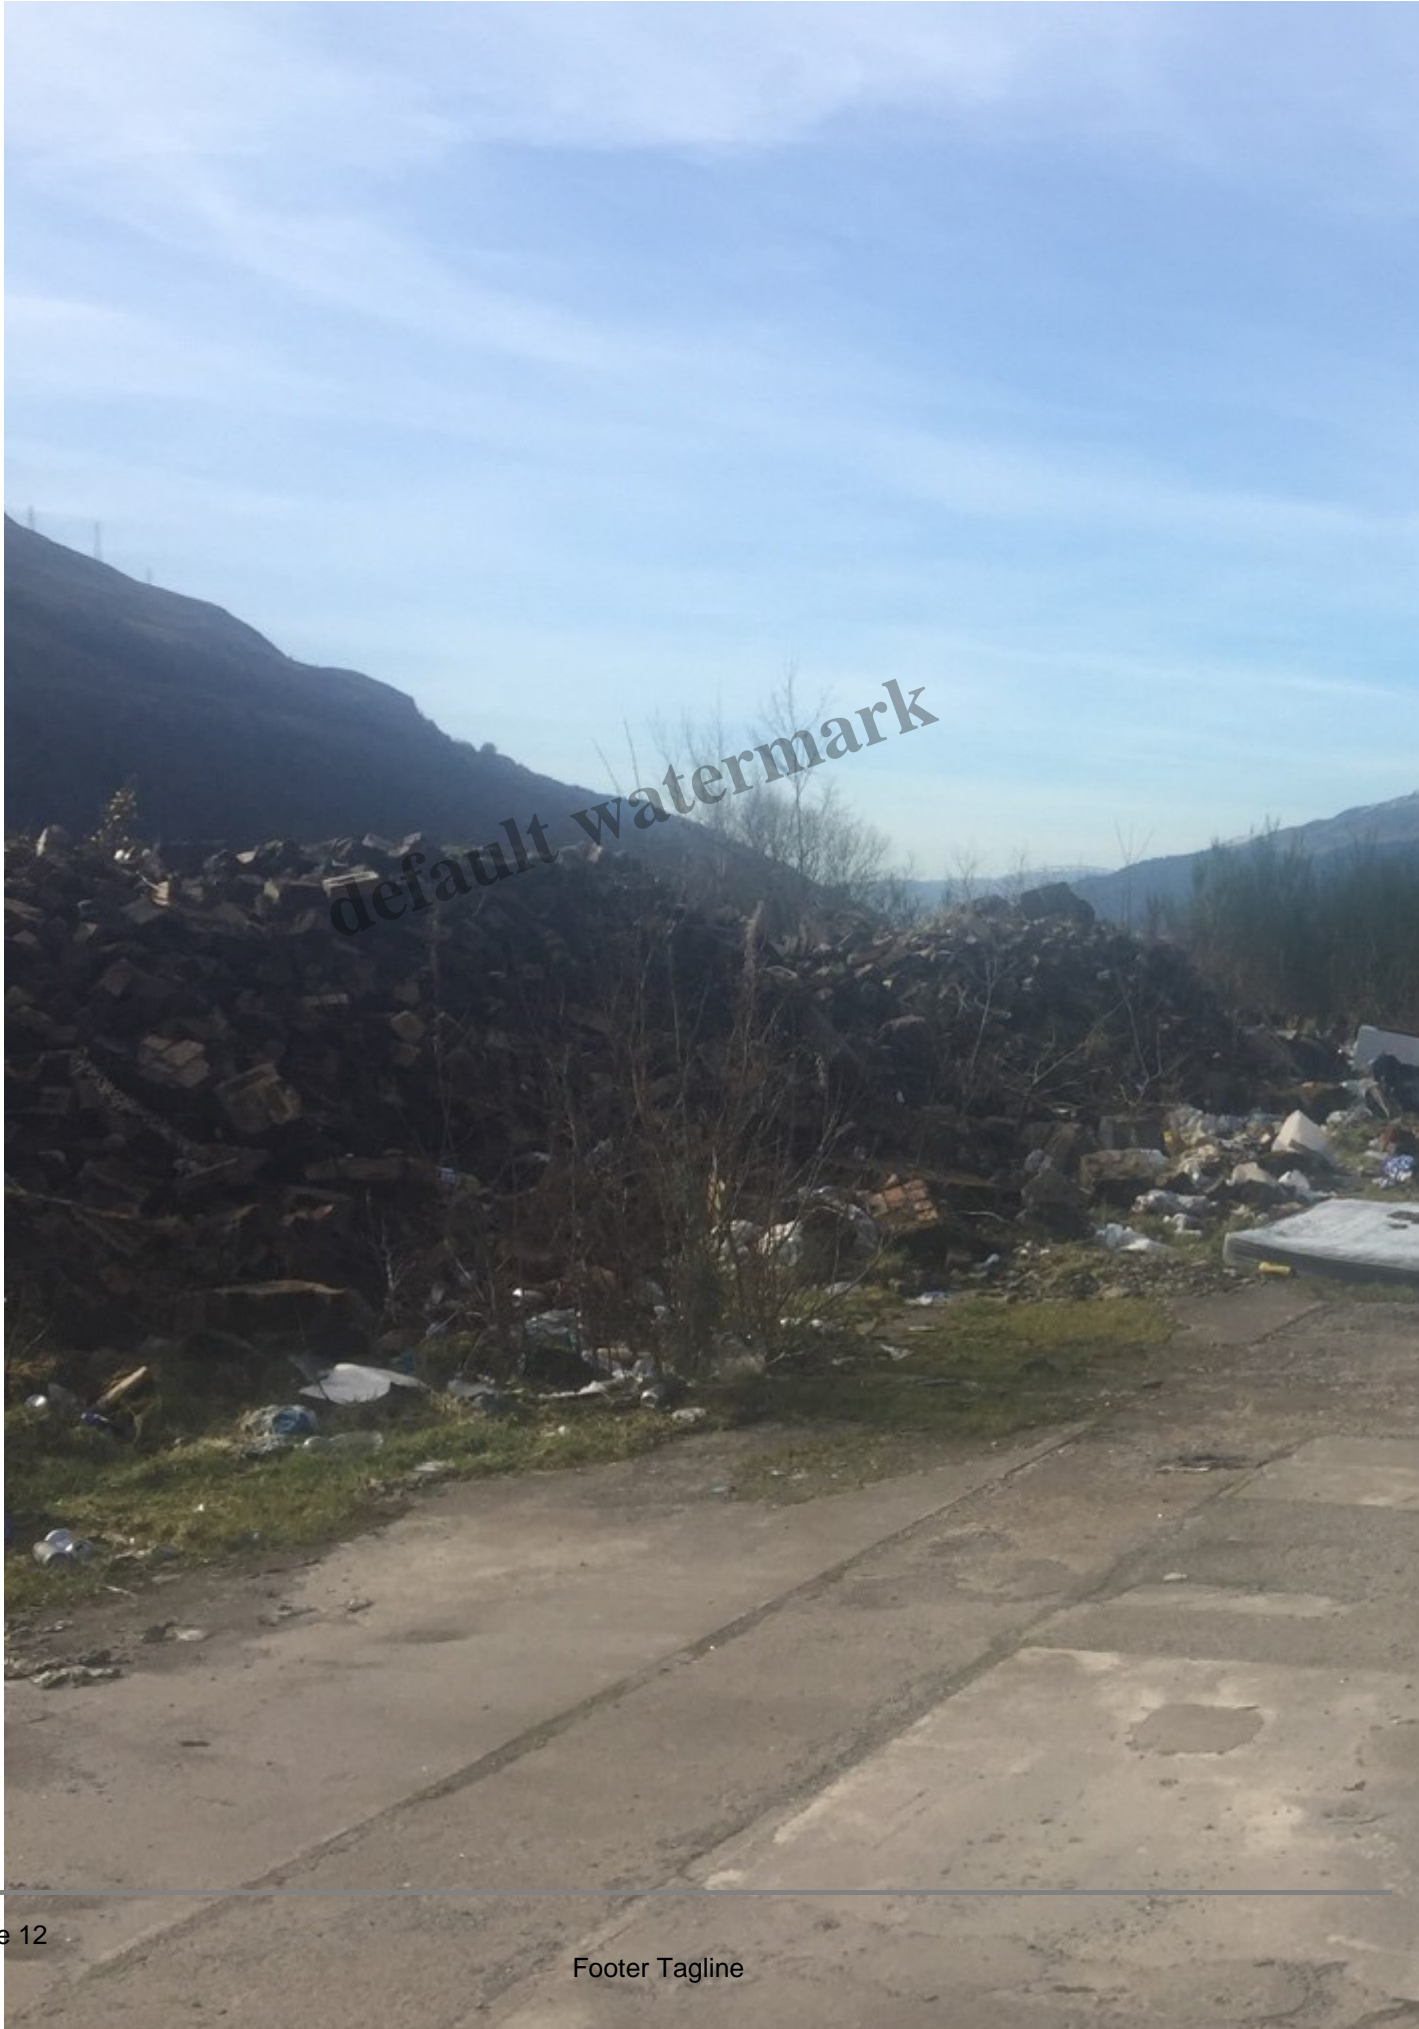
View south

The next photos are of tipping and garbage disposal within the gated area, on the area that was the former torpedo factory, on a road that leads from the old main road into the decayed industrial ruins.

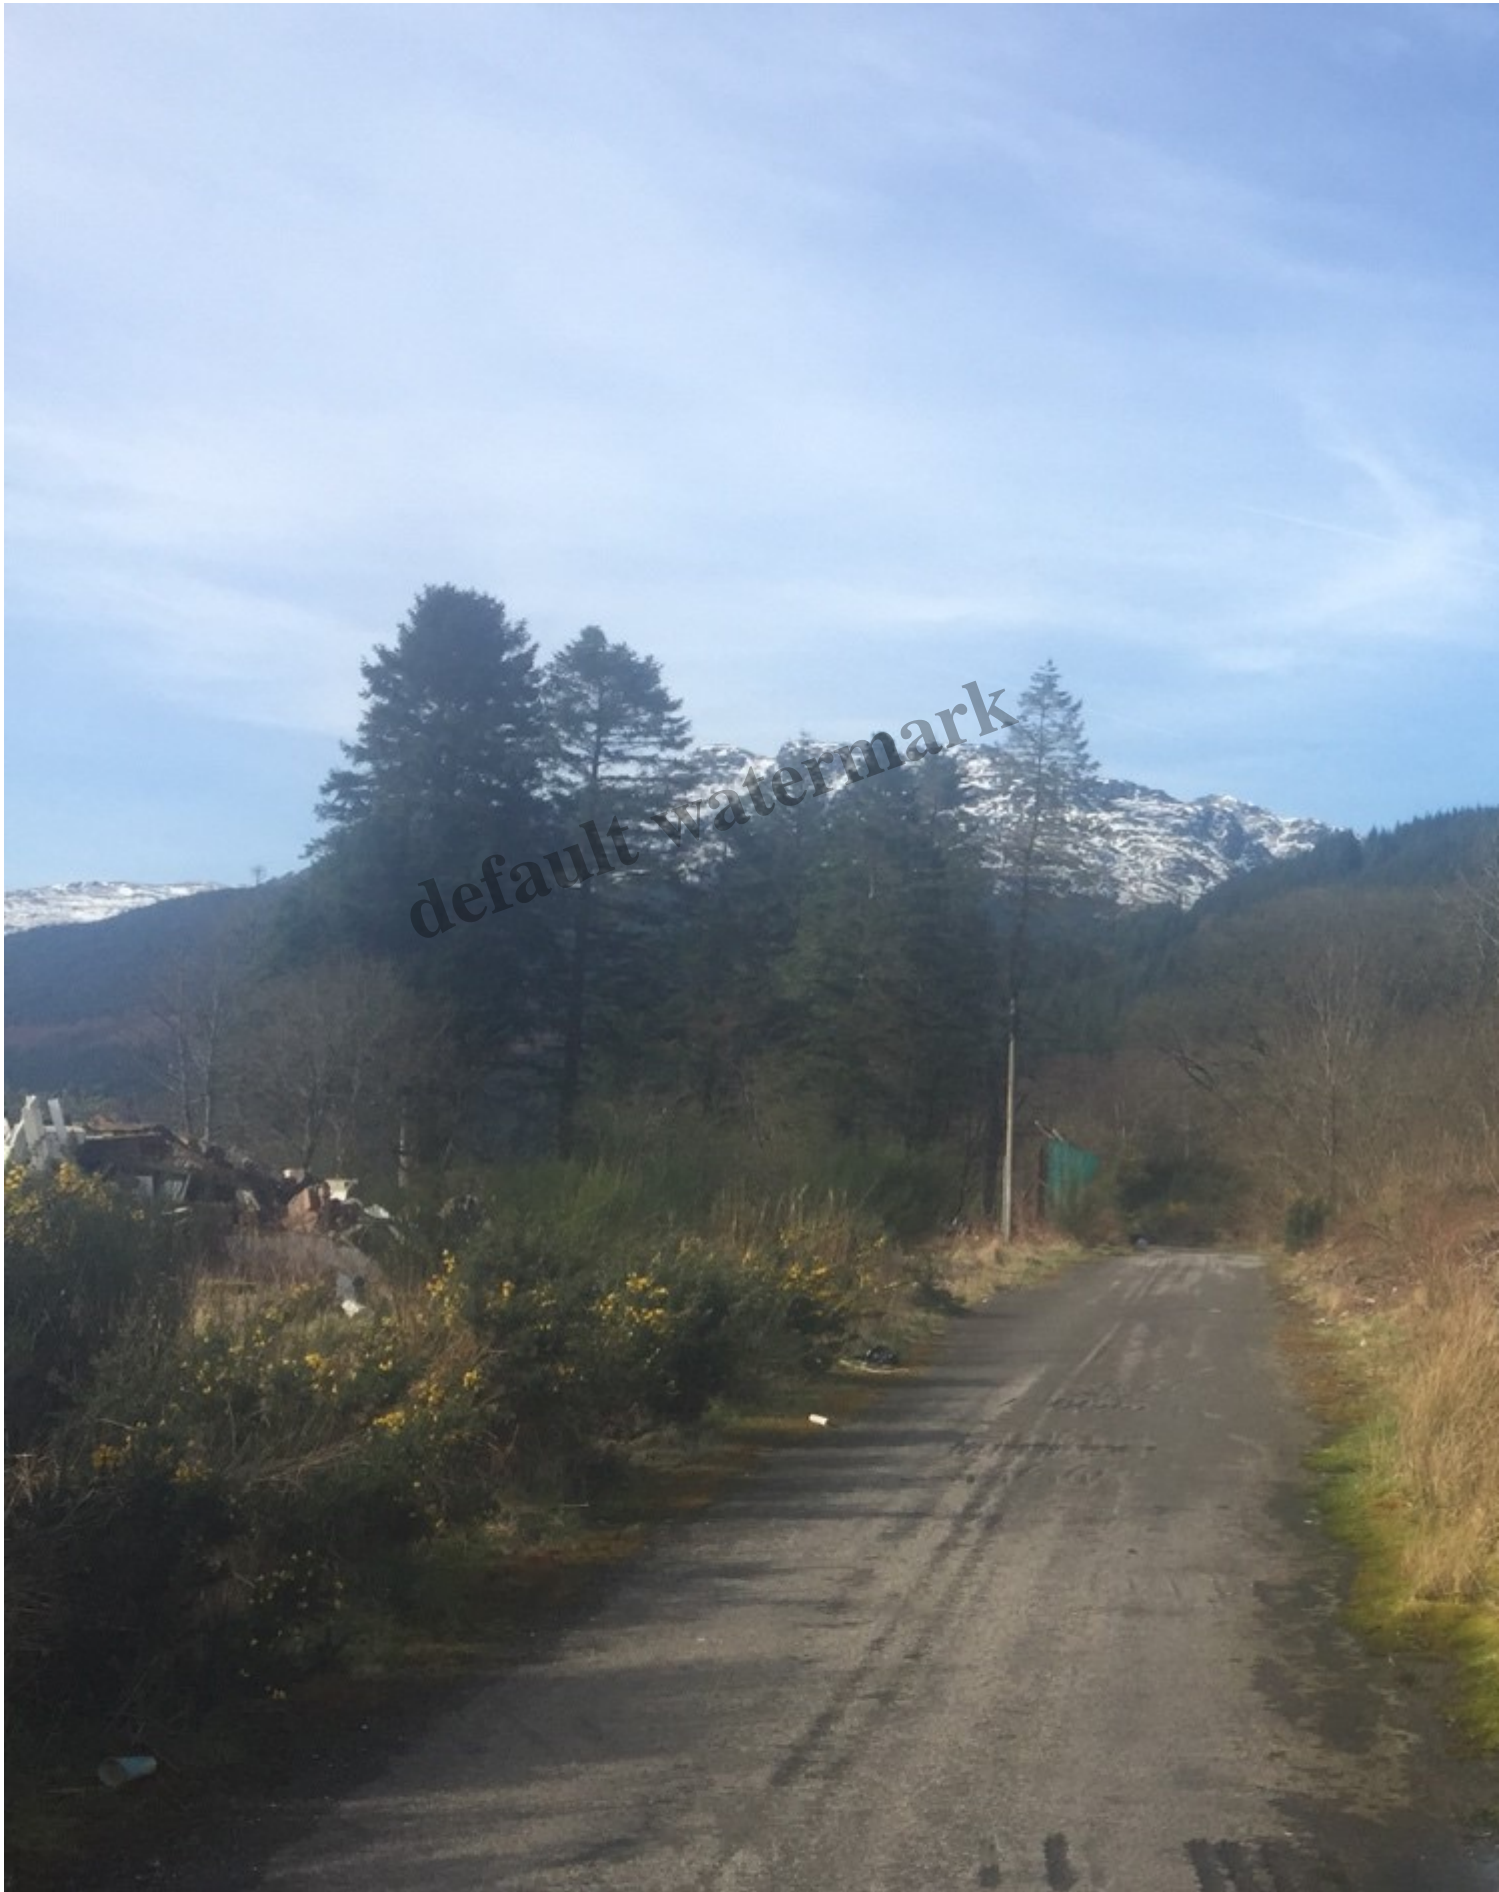
Most of the unsightly material seems to be the remains of demolished buildings, which have not previously given rise to concerns, whether on health and safety or amenity grounds, and have been in this state for decades. The blight at the former torpedo testing site is far greater than the flytipping and while the LLTNPA needs to address the flytipping, a much bigger challenge is to clear the site up and make it fit for public enjoyment again. Its a prime site in the heart of our National Park, a disgrace, a challenge and an opportunity.
