The Loch Earn hydro schemes – and surprise general elections!

Ardvorlich estate hydro scheme

Tarken Glen hydro scheme

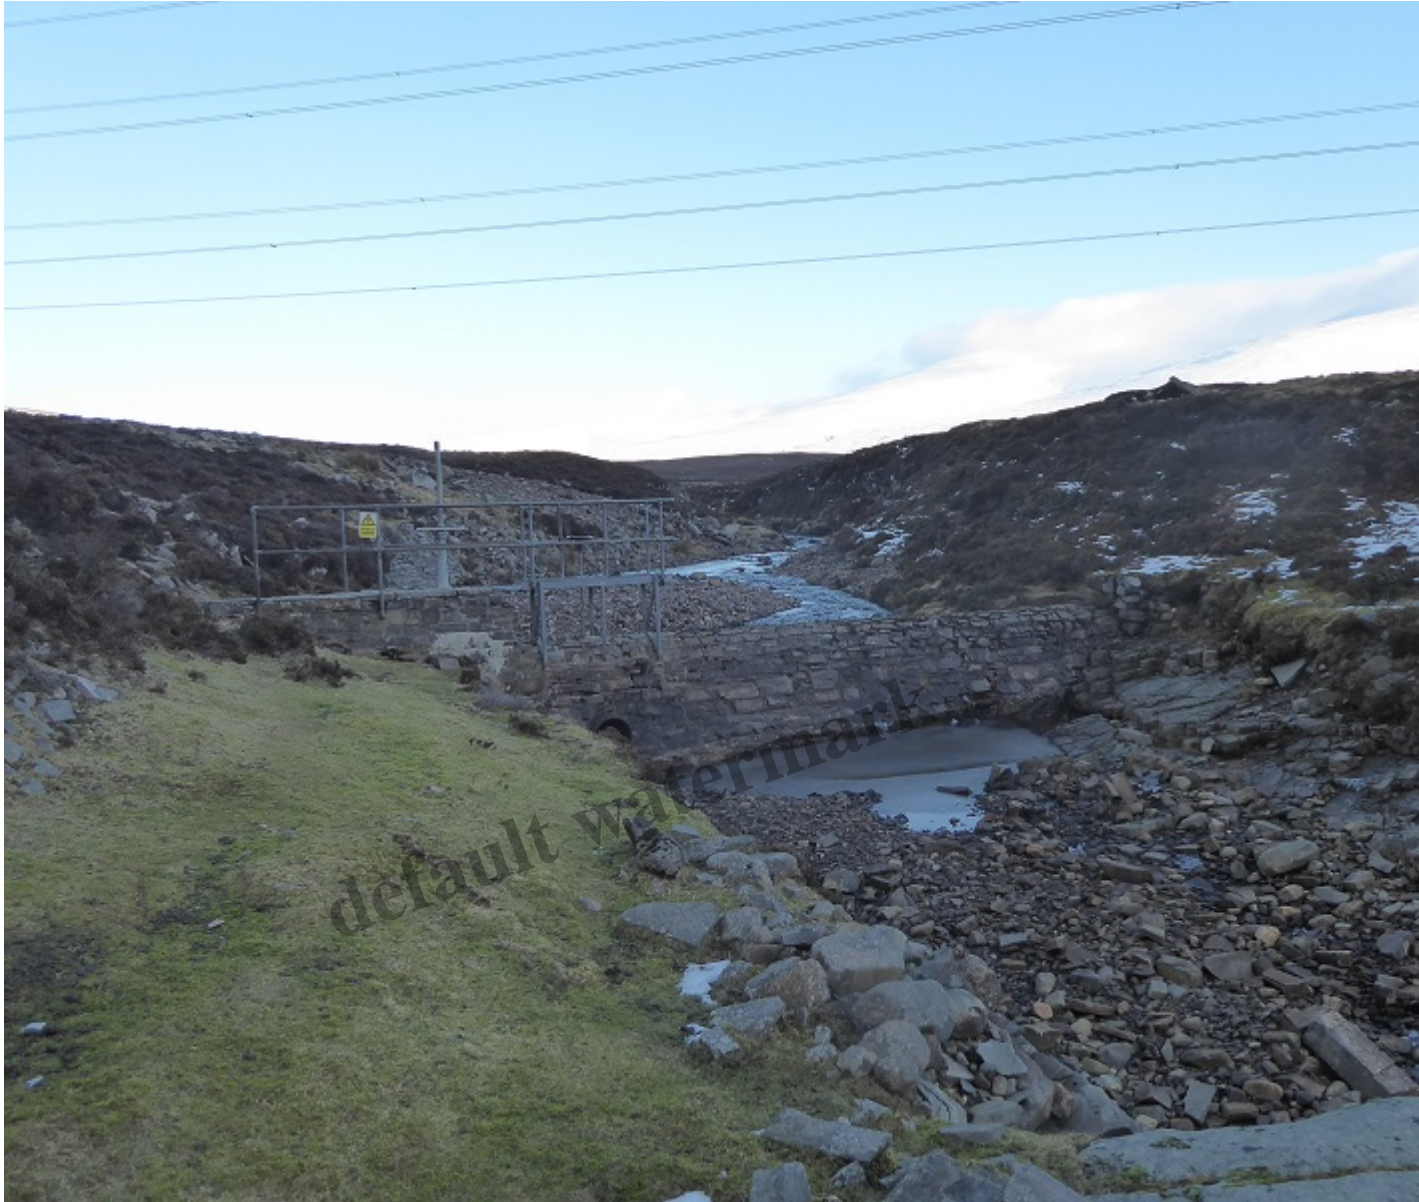
Stone faced intake, Cuaich hydro scheme, beneath Beaully Denny powerline, Drumochter.
