The Loch Earn hydro schemes – and surprise general elections!

Ardvorlich estate hydro scheme

Tarken Glen hydro scheme

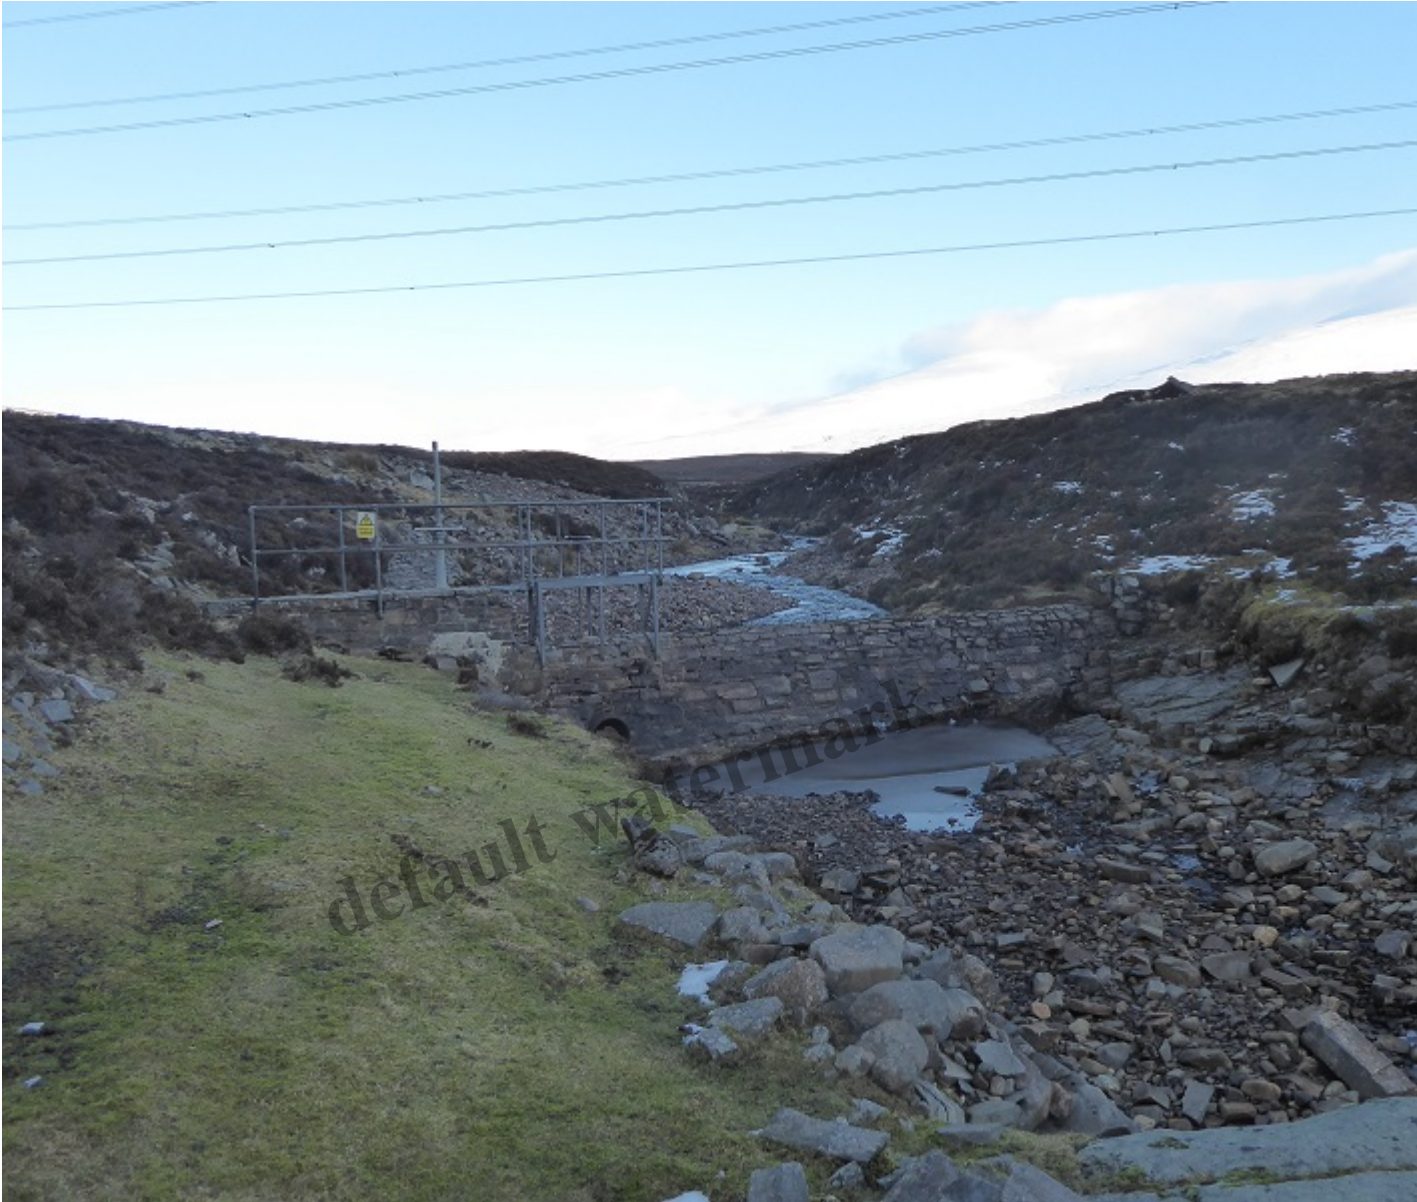
Stone faced intake, Cuaich hydro scheme, beneath Beaully Denny powerline, Drumochter.

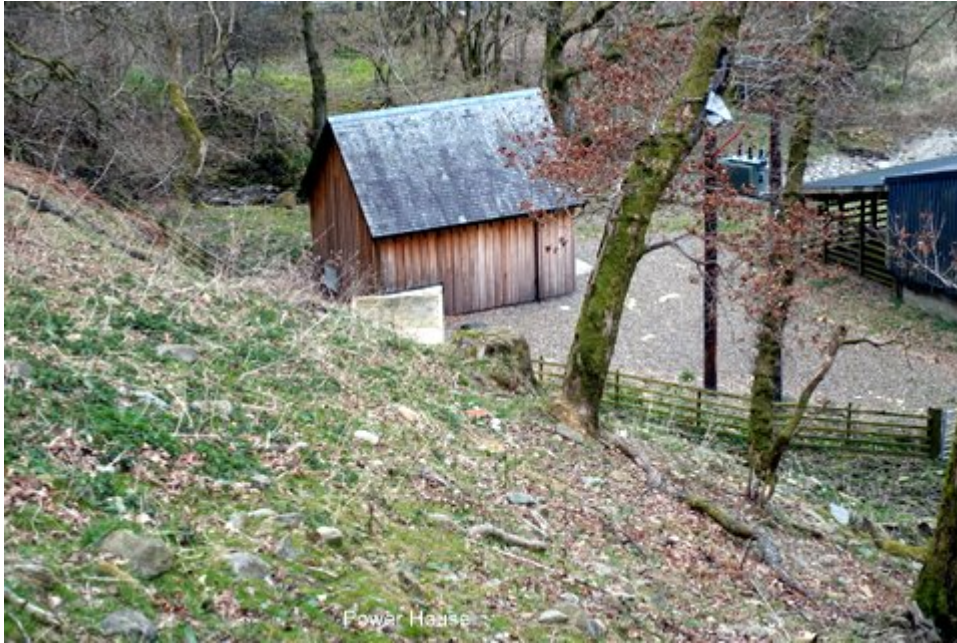
Within the National Park there is a small section of new track to the powerhouse, the powerhouse itself and a very short area of open pipeline behind the powerhouse. This is well concealed and not possible to see from Jim's photos.

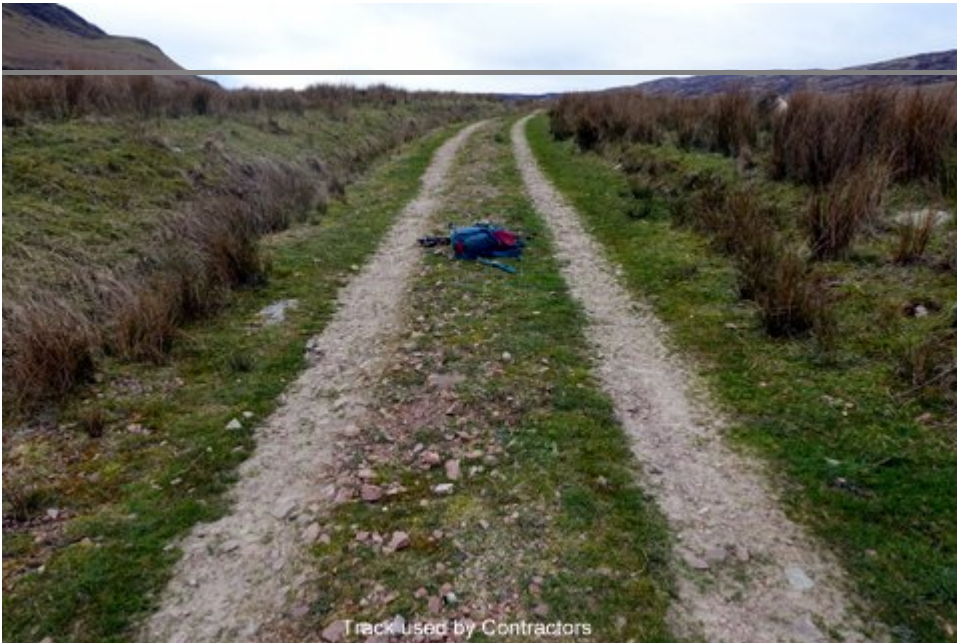
The track demonstrates what a

track looks like from close up where there is a central vegetated strip – as advocated in the LLTNPA's Best Practice Guidance.

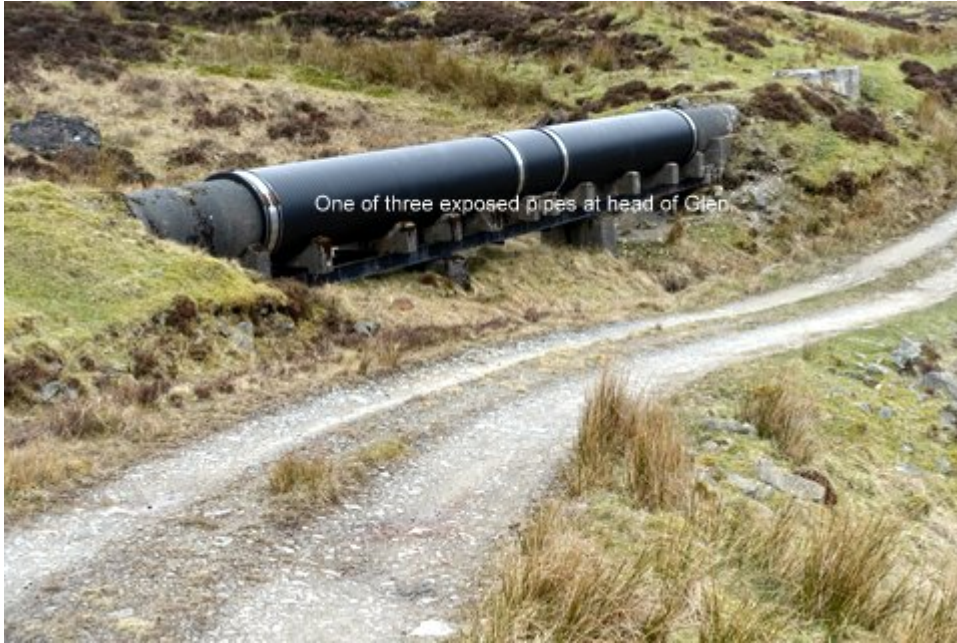
One of three exposed pipes at head of Glen
