The Loch Earn hydro schemes â?? and surprise general elections!

Ardvorlich estate hydro scheme

Tarken Glen hydro scheme

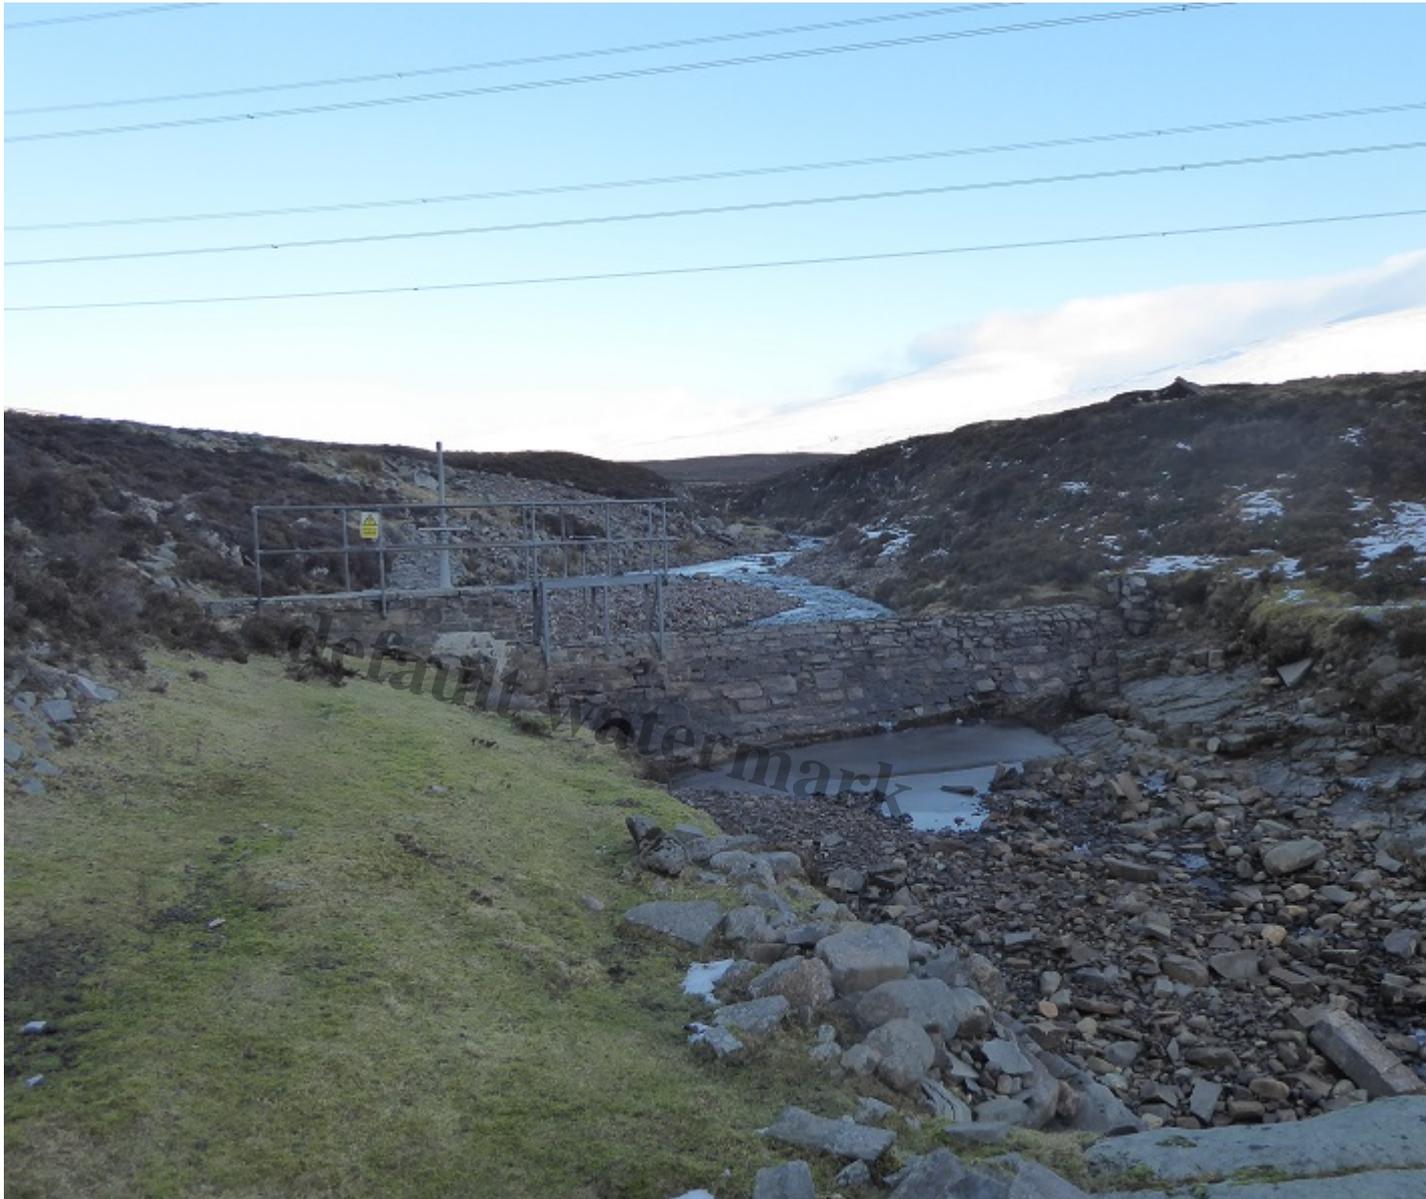
Stone faced intake, Cuaich hydro scheme, beneath Beaully Denny powerline, Drumochter.

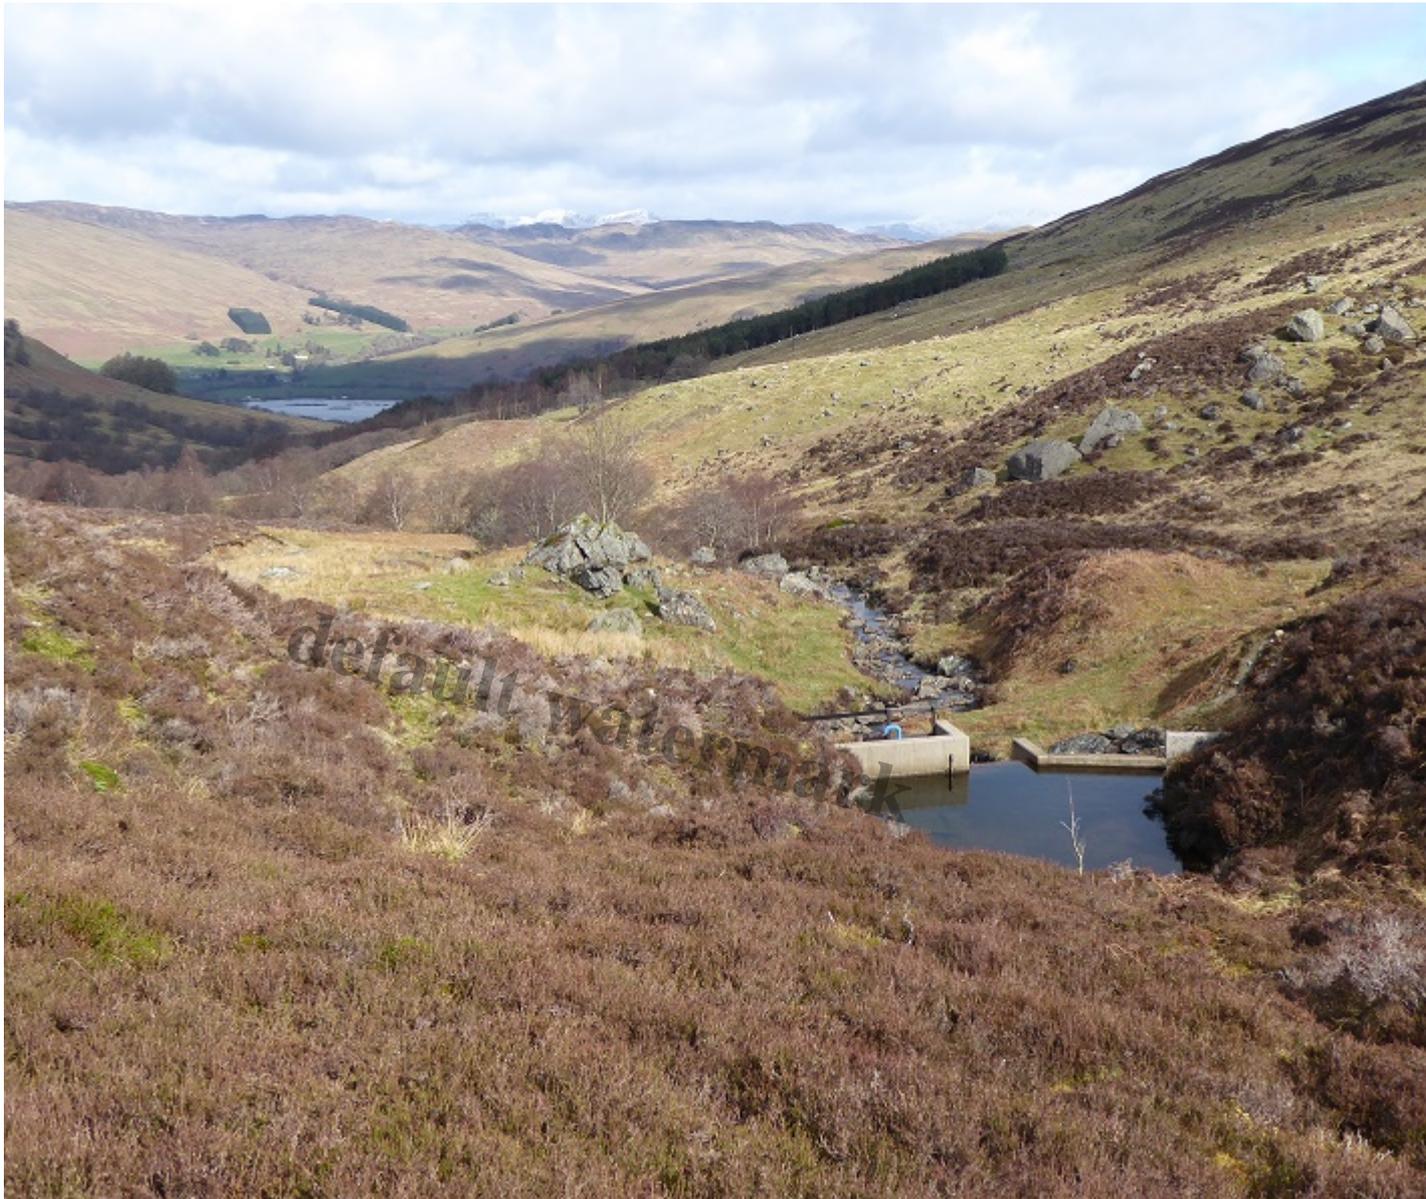
eastern intake

The second intake is closer to the track than the first and more intrusive. While the lower concrete has stained there is a much greater expanse of light grey concrete retaining wall, which is made even more obvious by the Lomond blue piping. Added to this there rip-rap boulder embankment on the far side of the burn and the excavation of the banks on either side of the burn where vegetation has not recovered (its too steep, just like the bank of the track below the bridge). The design of this intake could, in my view, have been considerable improved and the impact on the landscape reduced.

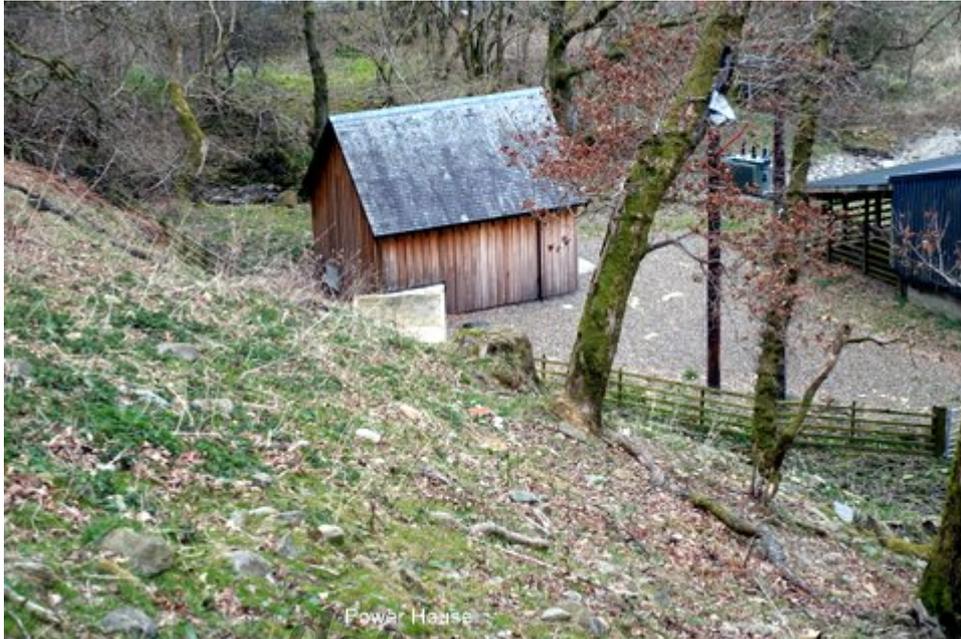
Within the National Park there is a small section of new track to the powerhouse, the powerhouse itself and a very short area of open pipeline behind the powerhouse. This is well concealed and not possible to see from Jim's photos.

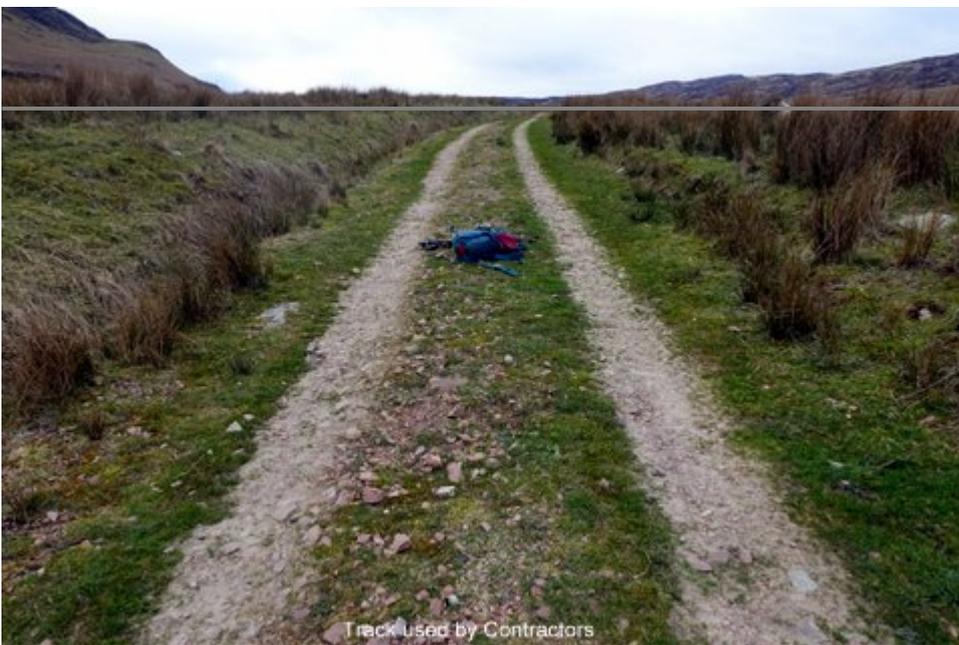
The track demonstrates what a

track looks like from close up where there is a central vegetated strip as advocated in the LLTNPA's Best Practice Guidance.

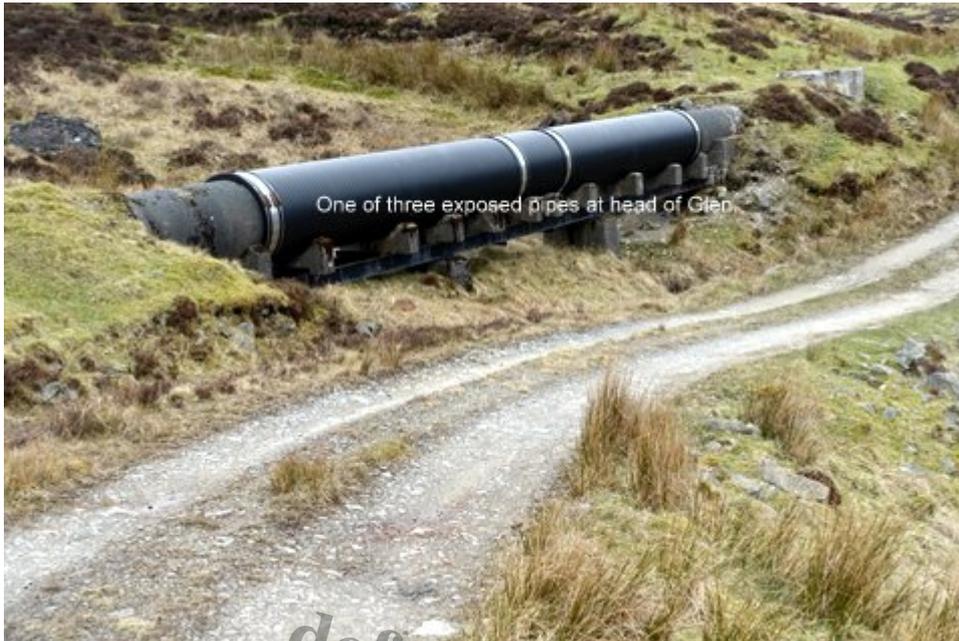
There is a much older hydro scheme at the head of Glen Tarken â?? part of the extensive Breadalbane hydro scheme â?? which demonstrates that at least in respect of pipelines, some progress has been made.

Jimâ??s photo though raises questions about how much progress has been made in reducing the impact of dams and hydro intakes. In this case, the intake diverts all the normal flow of the burn, which will only flow in spate conditions, whereas intakes are always designed nowadays, due to greater awareness of hydrology and the framework of water catchment plans, to maintain some flow. Are the concrete embankments of the existing hydro intake though any worse than the rip rap tendering shown in Jimâ??s second photo of the new scheme?
