## The Glen Falloch hydro schemes (8) – their impact on the landscape and what needs to be done

Mid Glen Falloch, viewed from shoulder of An Caisteal. The area It is now a mass of tracks, leading dams. Foreground Allt Andoran, far right Eas Eonan and left background start of track up Allt a Chur hydro powerhouse is centre background, Derrydarroch to the right.

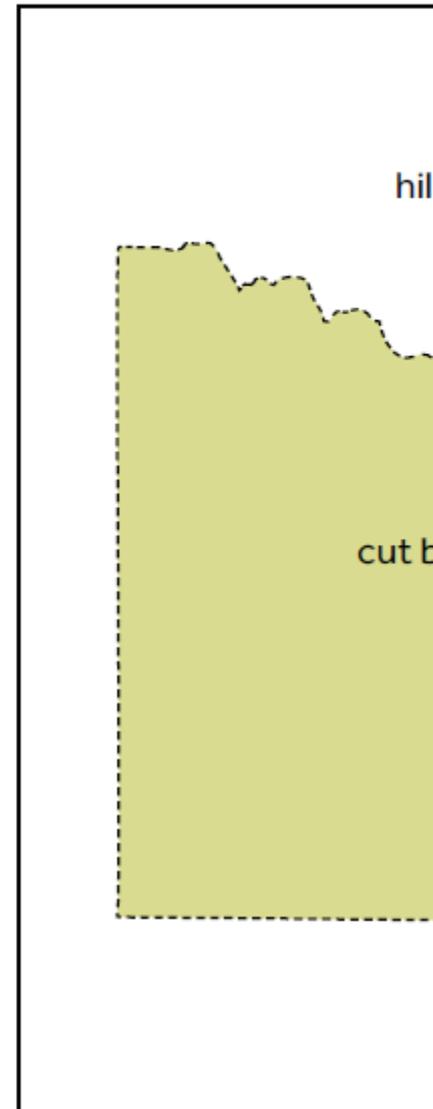
Batters are the constructed earth slopes that connect the track or road surface to the contour of the surrounding land (see figure 5). A track running across a slope will often have a cut batter on the upslope and a fill batter on the down slope. Once the track is constructed the batters are bare earth surfaces that can scar the landscape, so in order to reduce their visual impact batters must be graded in order that re-vegetation can occur. Developers should follow best practice techniques:

- Minimise the length of the batter slope by avoiding steep hillsides.
- Ensure that the slope of the batter is shallow enough for vegetation to grow.
- Complete batters at the time of road construction, not retrospectively.
- Preferably cut and put aside turves during construction of track batters; or leave a prepared (cultivated) batter surface to assist re-vegetation.
- Assist re-vegetation using appropriate techniques (for example grass seed).
- Protect the batter from water erosion.

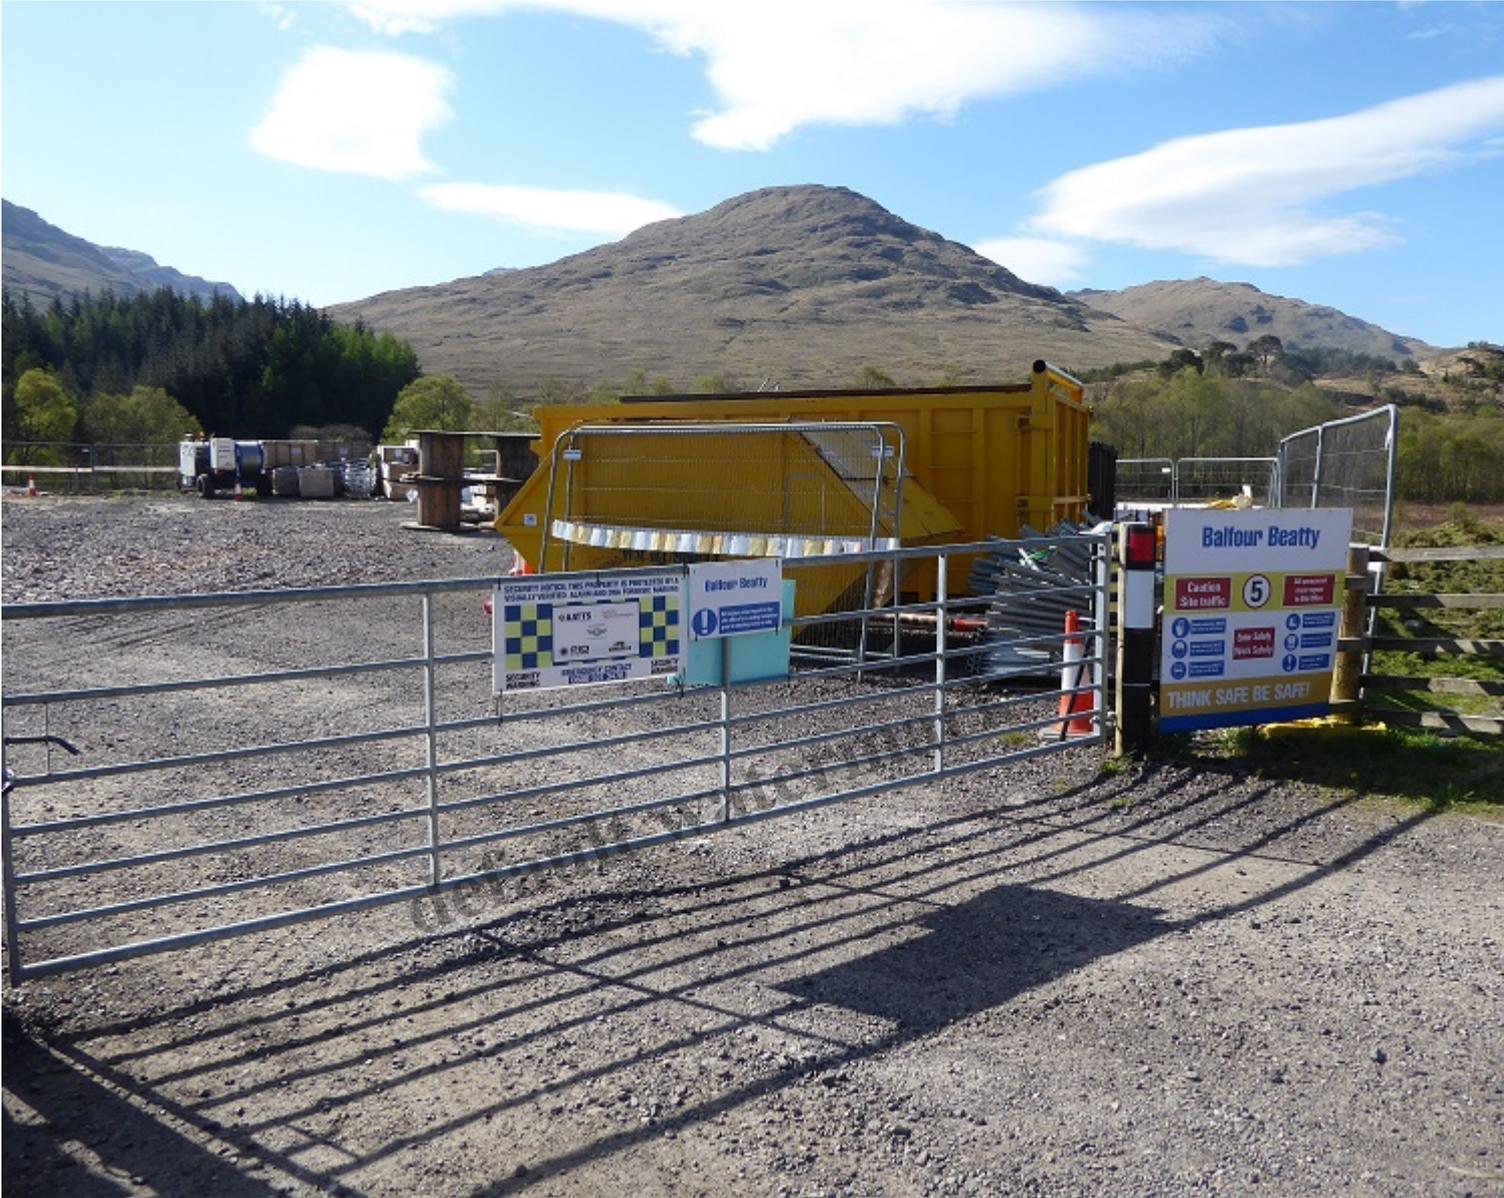
Readers who have driven up the Glen Falloch or walked there will know that the construction compound is still in place and, during my walk, there was some evidence that some further work had been undertaken to restore the destruction caused by the hydro scheme.
