The Glen Falloch hydro schemes (8) – their impact on the landscape and what needs to be done

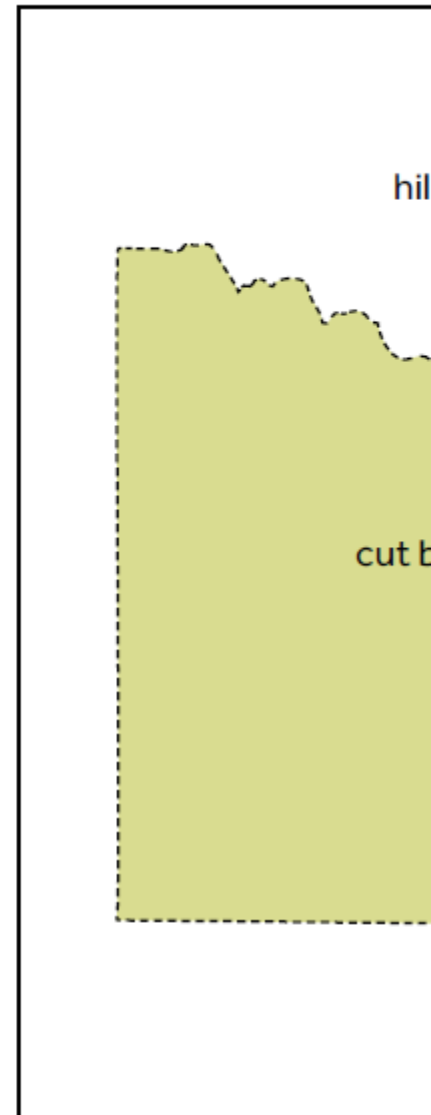
Batters are the constructed earth slopes that connect the track or road surface to the contour of the surrounding land (see figure 5). A track running across a slope will often have a cut batter on the upslope and a fill batter on the down slope. Once the track is constructed the batters are bare earth surfaces that can scar the landscape, so in order to reduce their visual impact batters must be graded in order that re-vegetation can occur. Developers should follow best practice techniques:

- Minimise the length of the batter slope by avoiding steep hillsides.
- Ensure that the slope of the batter is shallow enough for vegetation to grow.
- Complete batters at the time of road construction, not retrospectively.
- Preferably cut and put aside turves during construction of track batters; or leave a prepared (cultivated) batter surface to assist re-vegetation.
- Assist re-vegetation using appropriate techniques (for example grass seed).
- Protect the batter from water erosion.

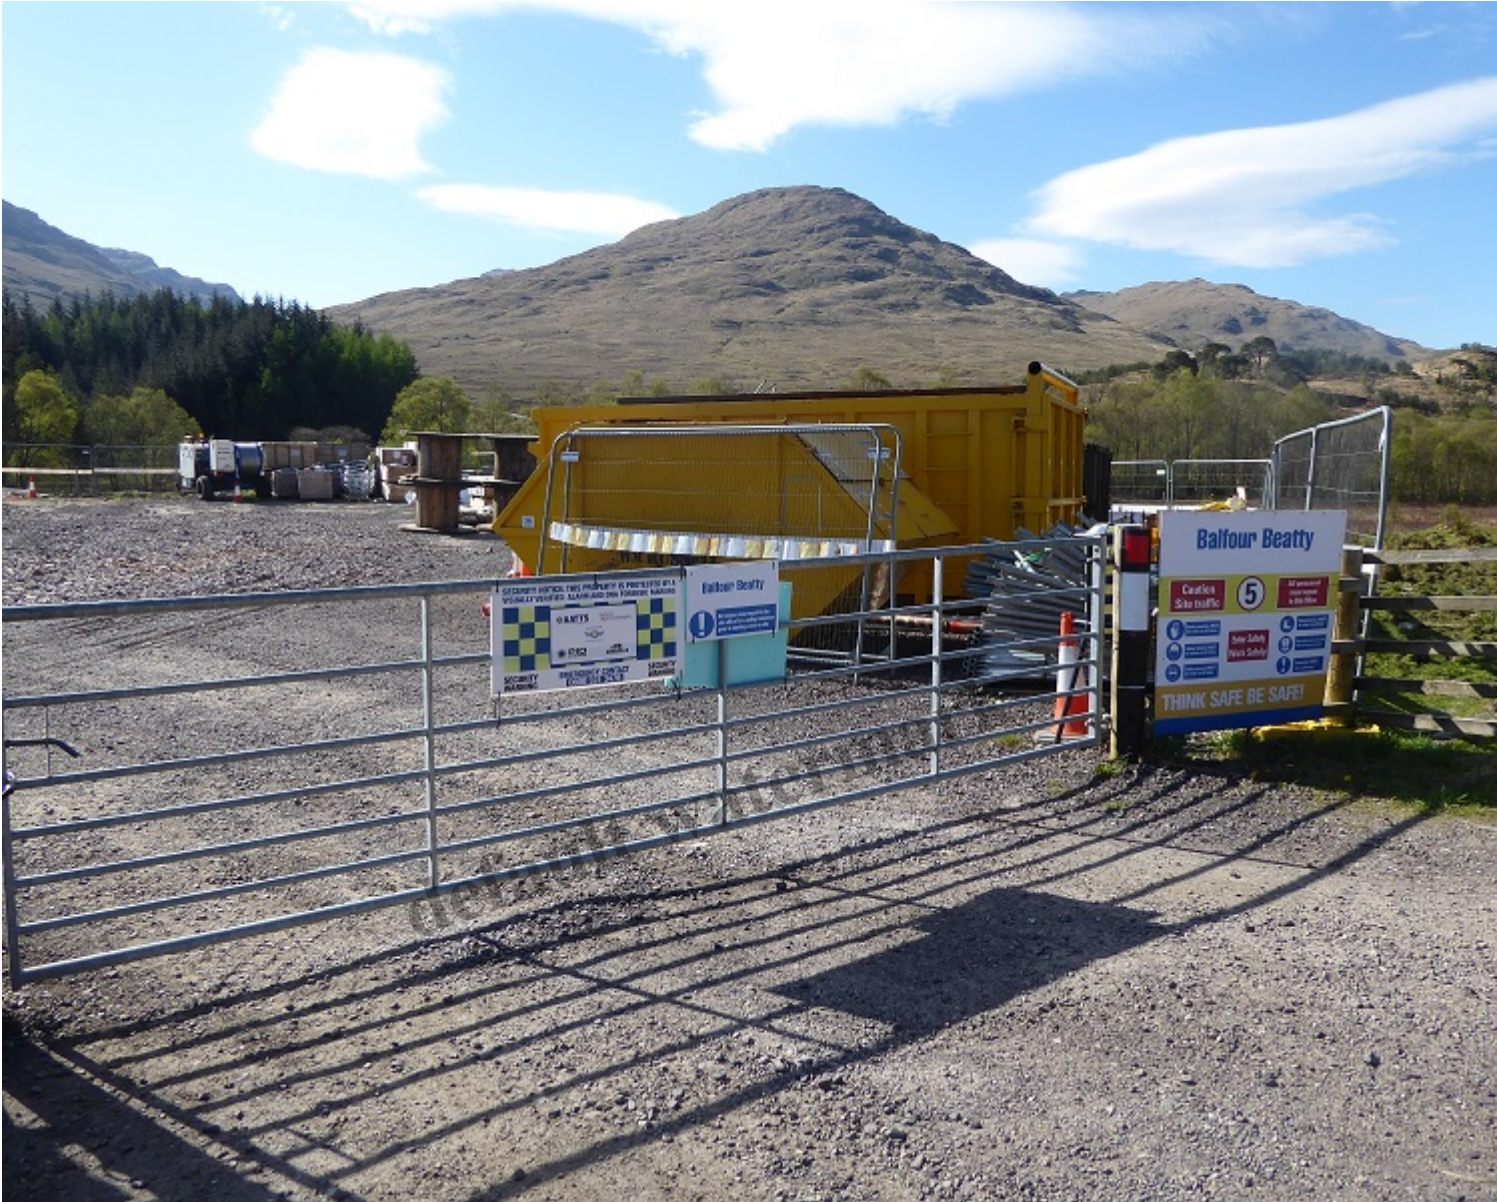
Readers who have driven up the Glen Falloch or walked there will know that the construction compound is still in place and, during my walk, there was some evidence that some further work had been undertaken to restore the destruction caused by the hydro scheme.
