Ledcharrie Hydro – another plook in the Park

June 11, 2017

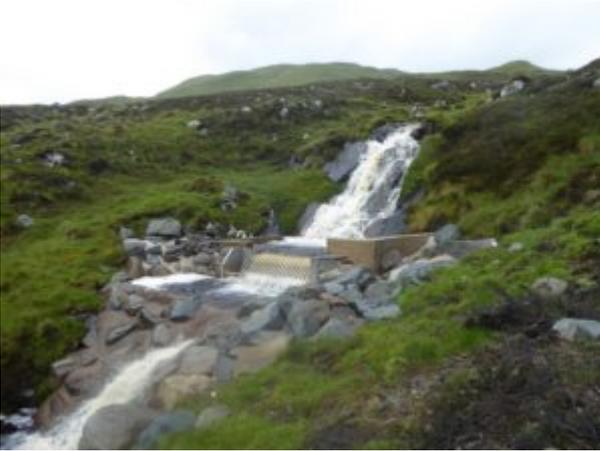
We then walked down the track a bit before heading up to the second intake which I had only realised was there because of the disturbed ground above the pipe. You could not see it from below and some of those present had doubts about whether there was a second intake â?? a really good sign! Again the visual impact of the intake itself was not significant in landscape terms, although the concrete walls could have been faced with stone.
