Ledcharrie Hydro – another plook in the Park

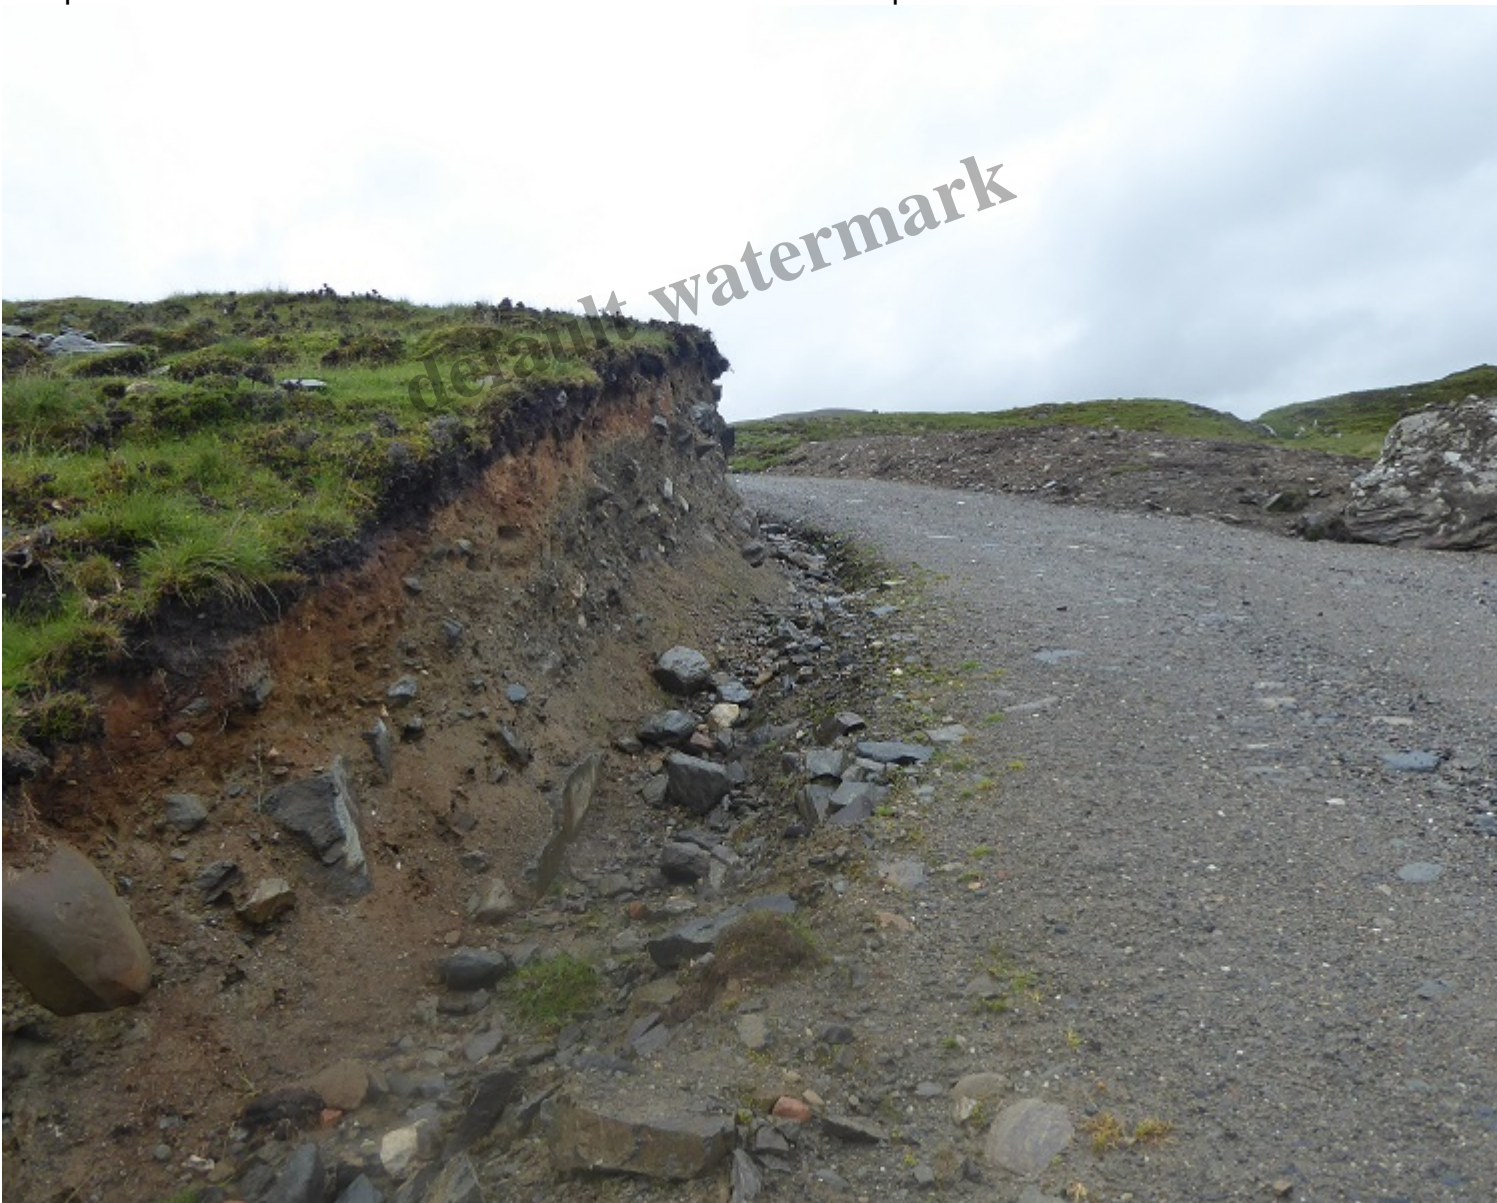
The width of the new track is in places extraordinarily wide, as the double gates illustrate. Double gates have also been left in place at the Glen Falloch Hydro Scheme. One way the LLTNPA could help ensure tracks are narrower is by requiring all double gates to be replaced by single gates after construction has finished.

The LLTNPA's Chief Executive subsequently clarified in a letter to Mountaineering Scotland that this should mean tracks are no more than 2m wide, which would allow for a vegetated central strip, except on uphill sections and bends where he has stated 2.5m is acceptable.
