Well designed hydro schemes (1) â?? Gynack

Gynack Scheme 1 â?? Kingussie Community Development Company

Gynack Scheme 2

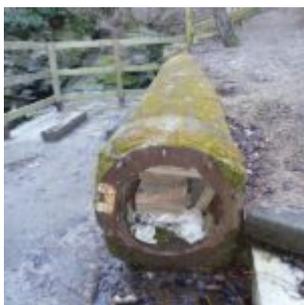
The section of former pipe

The power house has been constructed just 4m below the intake on a beautiful section of river by the former powerhouse (a remnant of the old pipe can be seen between the tree and powerhouse and there was a concrete base here previously). It is however tucked away and hard to see from above and the finishing, apart from the brick is good. The line of the pipe to the powerhouse is marked by the

boulders on the bank on the left. In summer, when the trees are in full leaf, it would be even easier to miss.

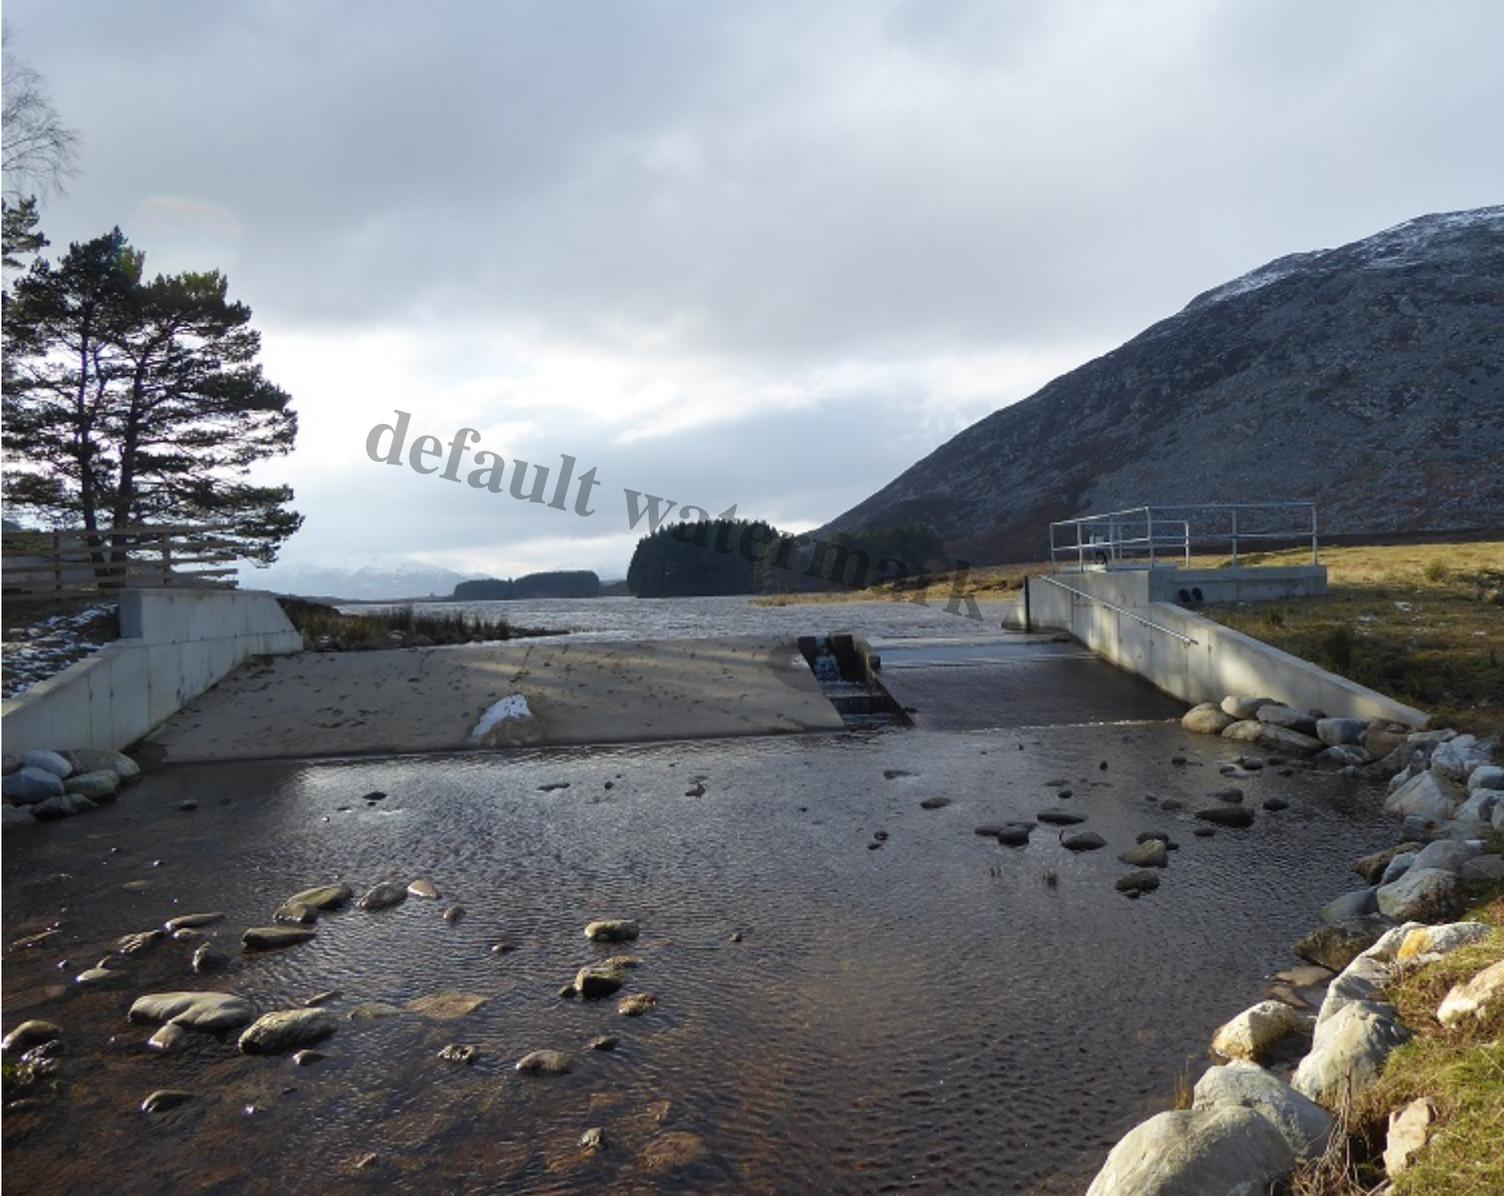
The mid-Gynack scheme has been constructed by the Pitmain Estate and runs from Loch Gynack to near the top of the golf course. Again its atypical because there was a scheme here constructed in the 1920s to provide electricity to the estate. Loch Gynack was dammed at that time and the old dam had fallen into disrepair and was leaking. The new dam has not raised water levels.

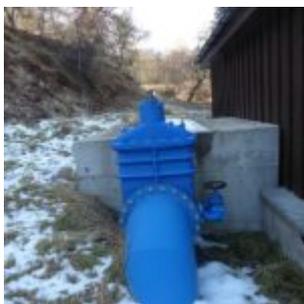
Close up of penstock

Another photo demonstrating how good the restoration of vegetation has been. The line of the buried pipe that leaves the powerhouse can be seen, mainly due to the lack of rushes, but there is no bare

ground at all. The contractor must have saved all the turf removed to bury the pipe and has then replaced it. This is something very rarely seen in hydro developments where failure to store and re-use turves is usually all too evident. The whole is only marred by the blue penstock.
