## Well designed hydro schemes (1) – Gynack

### Gynack Scheme 1 – Kingussie Community Development Company

## Gynack Scheme 2

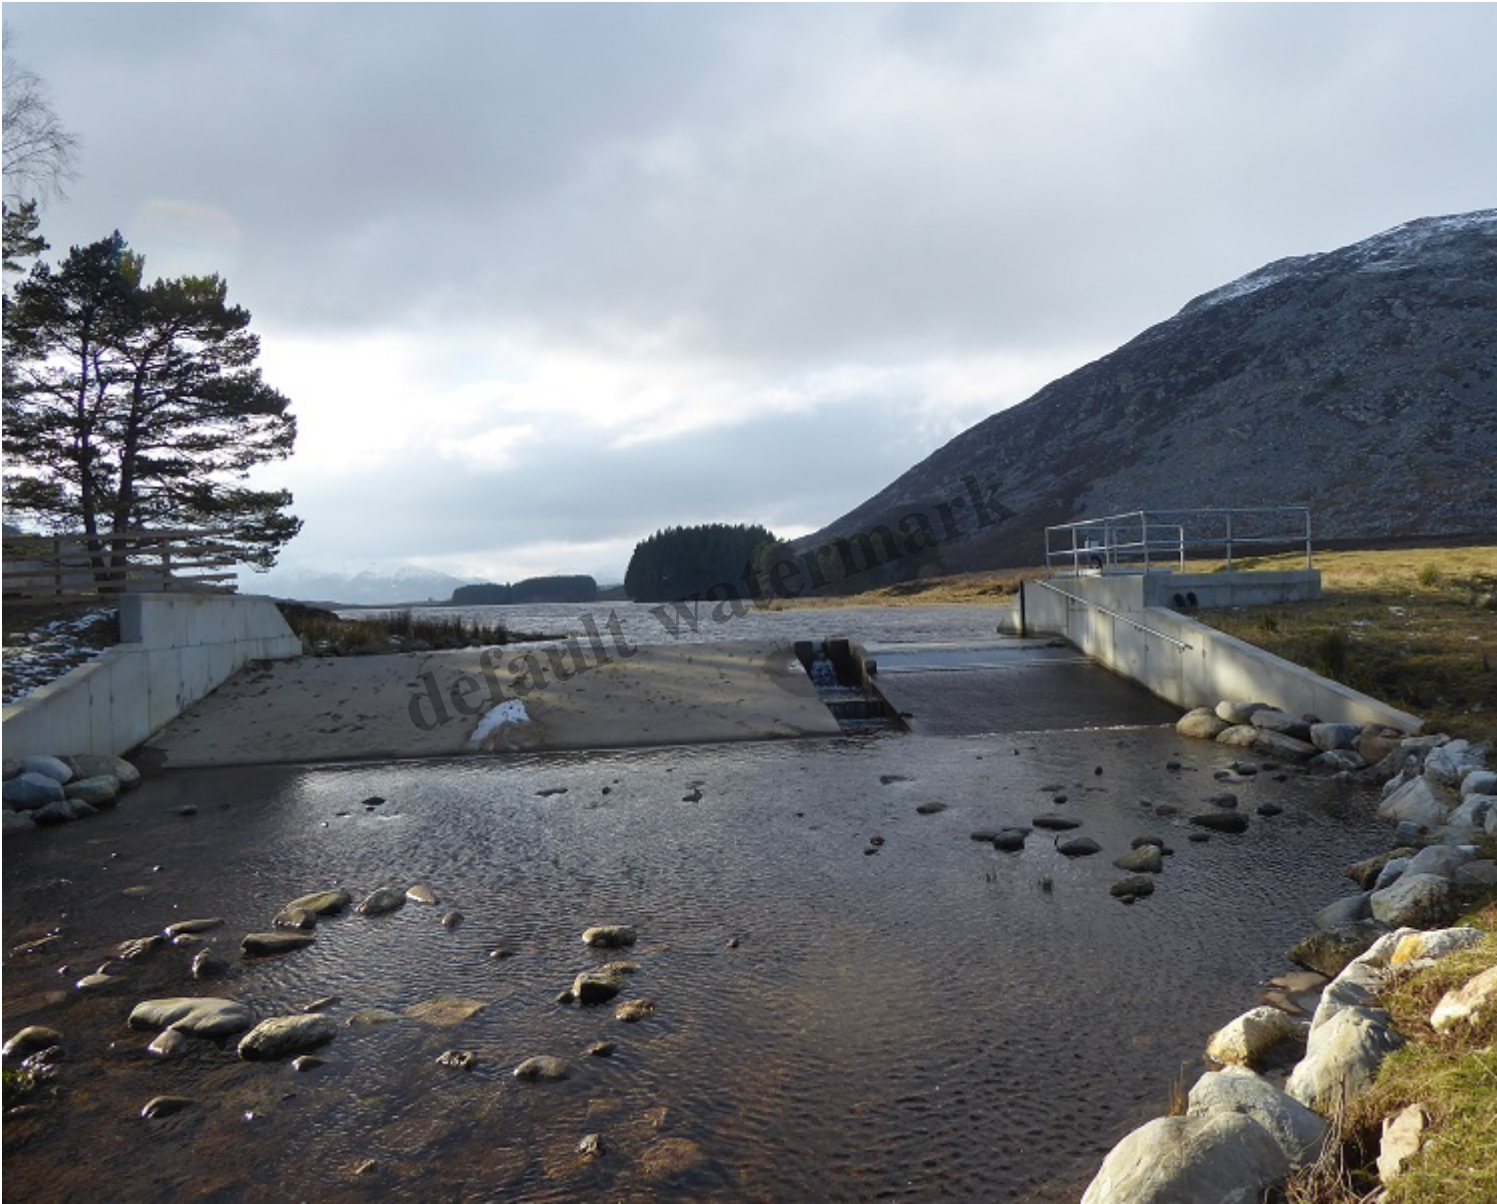
The mid-Gynack scheme has been constructed by the Pitmain Estate and runs from Loch Gynack to near the top of the golf course. Again its atypical because there was a scheme here constructed in the 1920s to provide electricity to the estate. Loch Gynack was dammed at that time and the old dam had fallen into disrepair and was leaking. The new dam has not raised water levels.

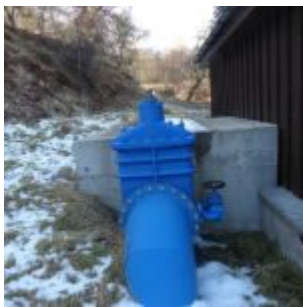
Close up of penstock

Another photo demonstrating how good the restoration of vegetation has been. The line of the buried

pipe that leaves the powerhouse can be seen, mainly due to the lack of rushes, but there is no bare ground at all. The contractor must have saved all the turf removed to bury the pipe and has then replaced it. This is something very rarely seen in hydro developments where failure to store and re-use turves is usually all too evident. The whole is only marred by the blue penstock.
