Well designed hydro schemes (1) – Gynack

Gynack Scheme 1 – Kingussie Community Development Company

Gynack Scheme 2

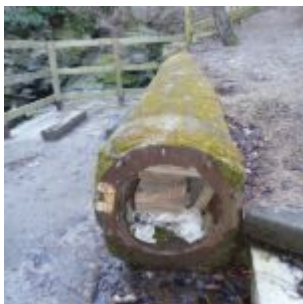
The section of
former pipe

The power house has been constructed just 4m below the intake on a beautiful section of river by the former powerhouse (a remnant of the old pipe can be seen between the tree and powerhouse and there was a concrete base here previously). It is however tucked away and hard to see from above

and the finishing, apart from the brick is good. The line of the pipe to the powerhouse is marked by the boulders on the bank on the left. In summer, when the trees are in full leaf, it would be even easier to miss.
