Coilessan hill track “upgrade”

June 18, 2017

nickkempe

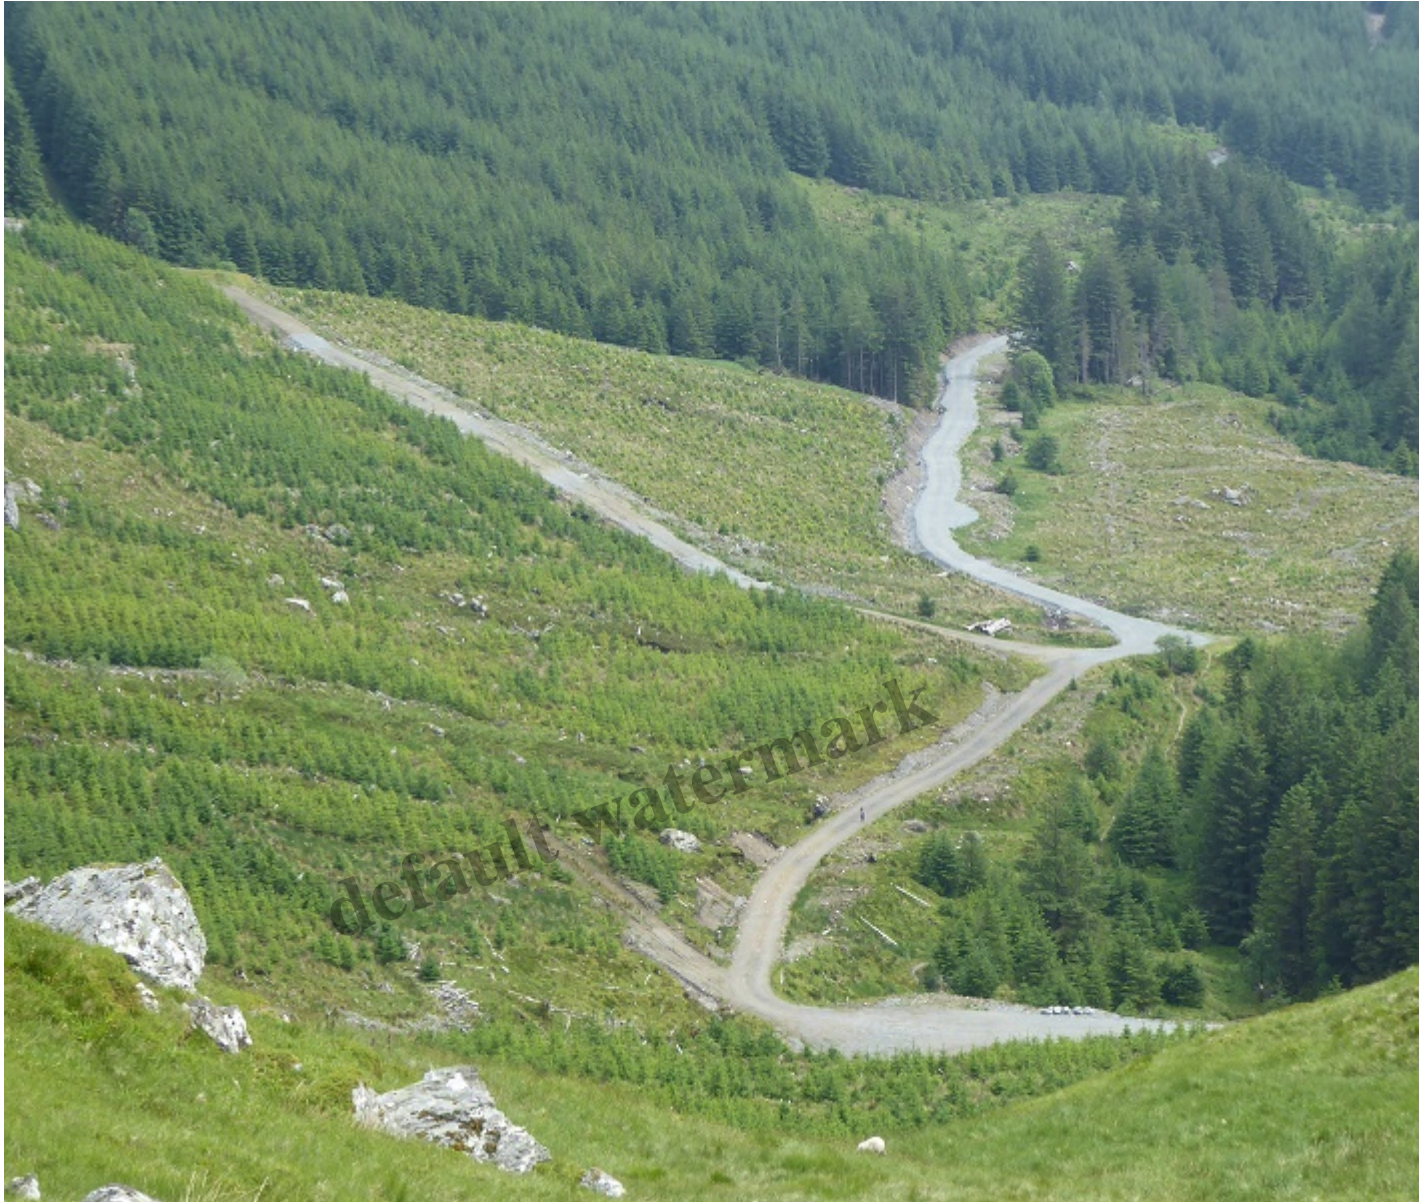
The felling and replanting in background (slopes of Brack) all took place without this track “upgrade” demonstrating that there was no need for works of anything like the extent of those that have been undertaken.

Looking down Coileasan Glen – footpath in trees on right
