The Corriemulzie community hydro scheme

The Corriemulzie community hydro scheme <http://braemarhydro.org.uk/scheme/>, just west of Braemar on the road to Linn of Dee, provides an interesting case of how developments can go badly wrong despite the best intentions of the main players. I first visited this scheme, which became operational last summer, in September 2016 and was horrified by what I saw. Subsequent research and correspondence with the Cairngorms National Park Authority established the situation was a little more

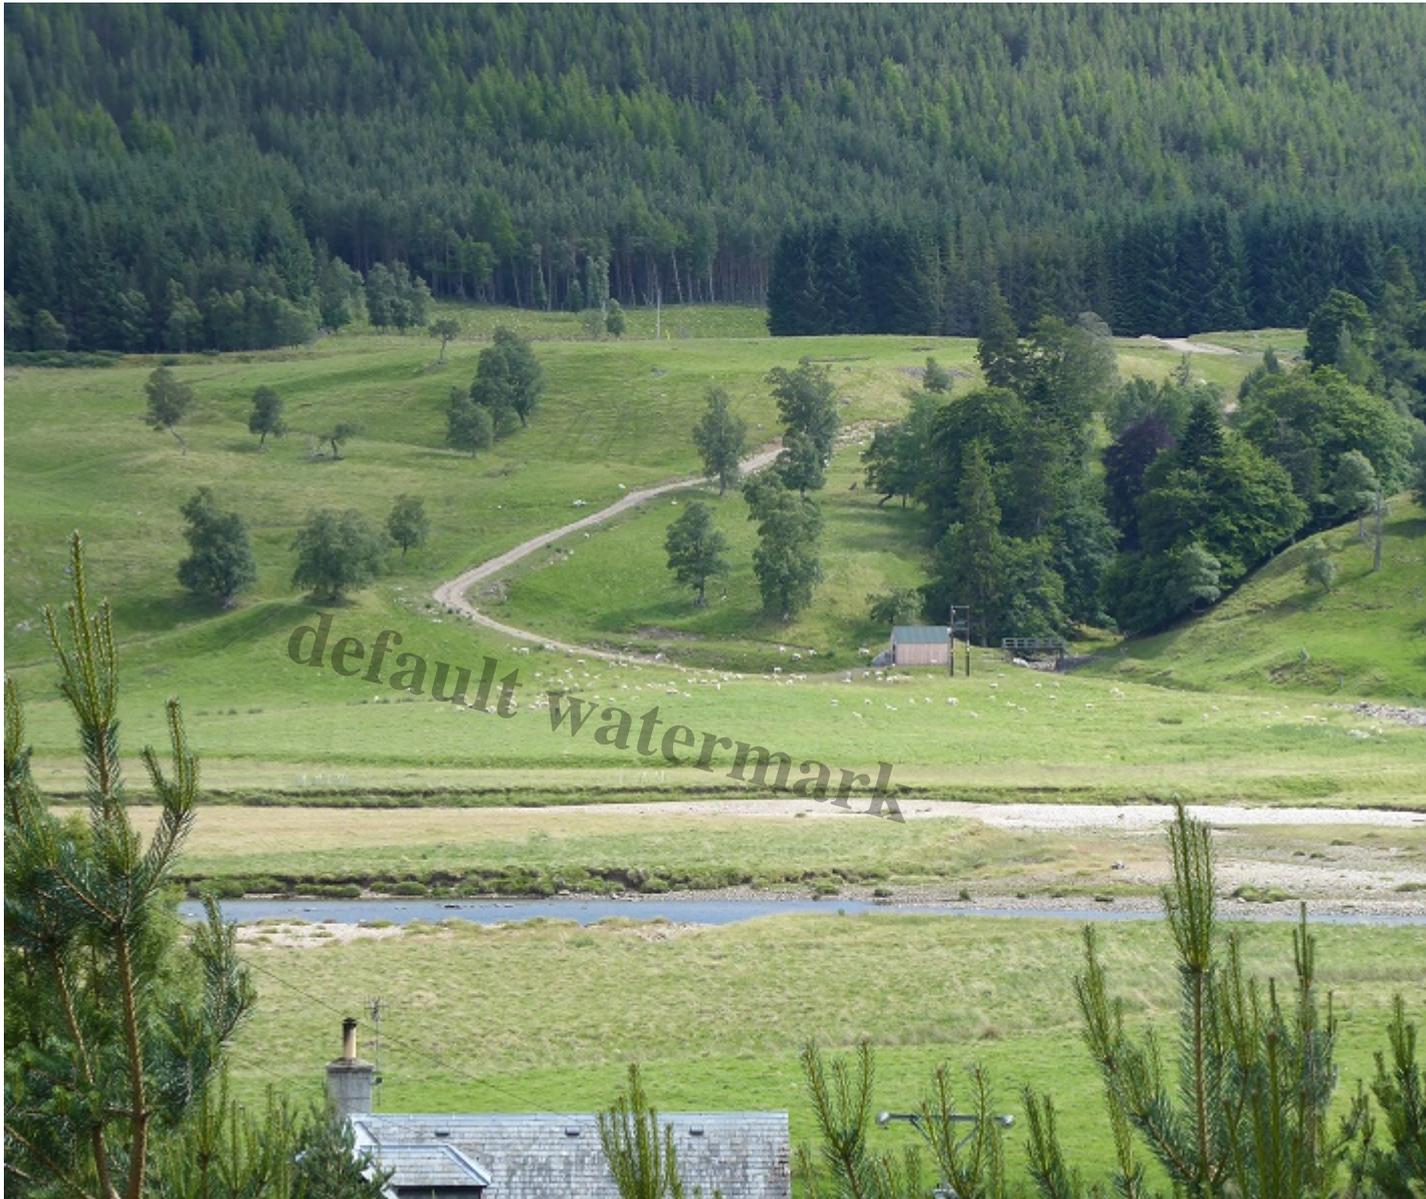
View of powerhouse from Linn of Quoich July 2017

The new powerhouse sits by site of former powerhouse although the track to it, down from the Braemar to Linn of Dee Road, is new. In my view $\hat{??}$ and I realise this is just a matter of opinion $\hat{??}$ the wider landscape impact of the track is not a major issue. I did not revisit the track though last September there were both good things and bad about how the land around it had been restored.

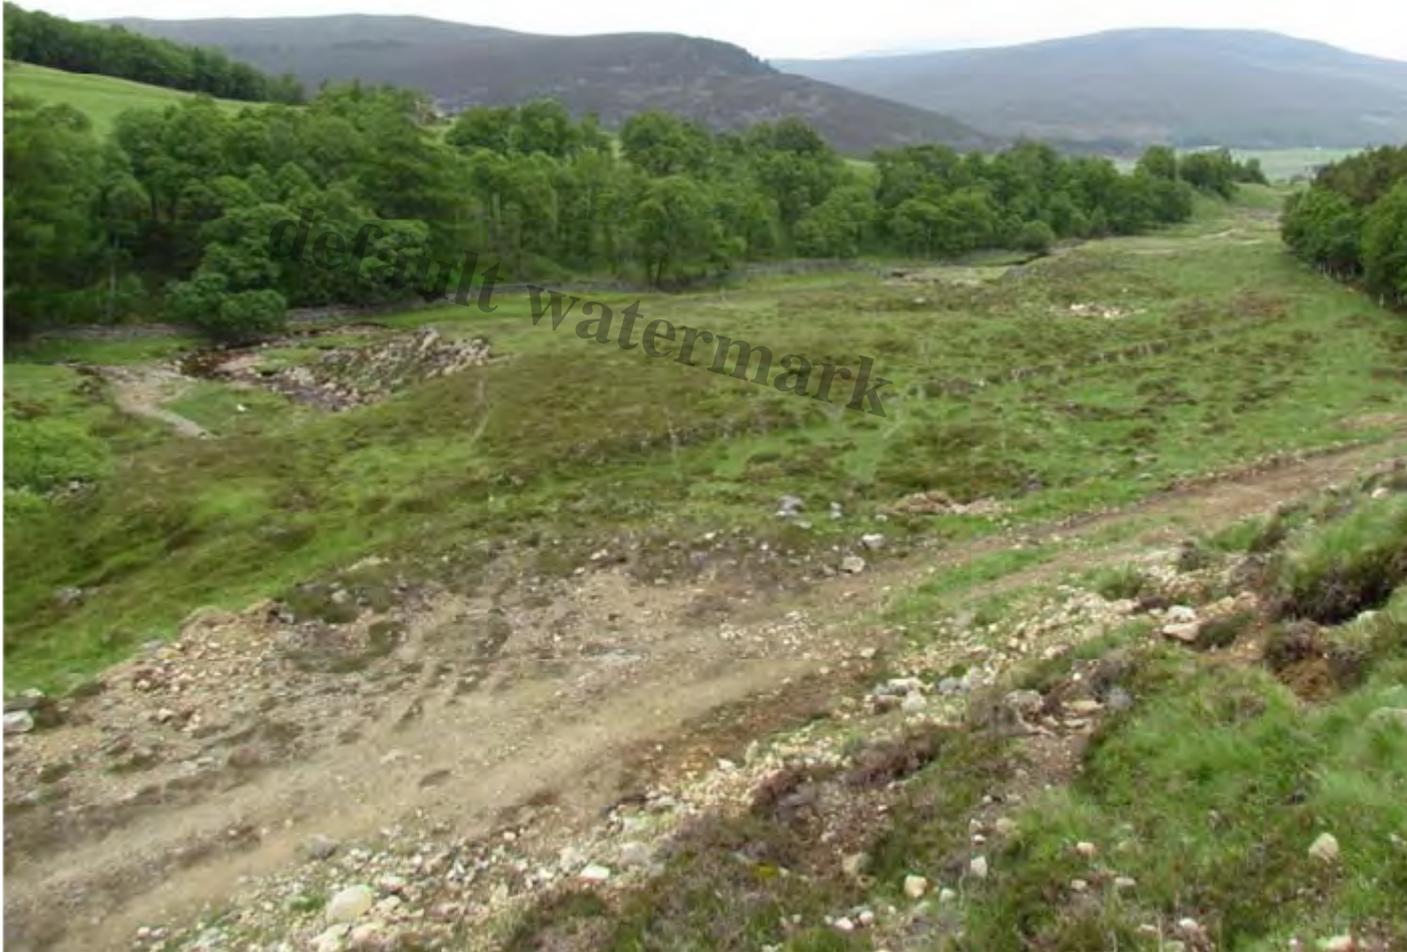
Plate 7.8: View towards Braegarie (behind trees centre-left) from mound above primary intake

The hydro scheme and burn is just to the left. Note the steep bank down to the track.

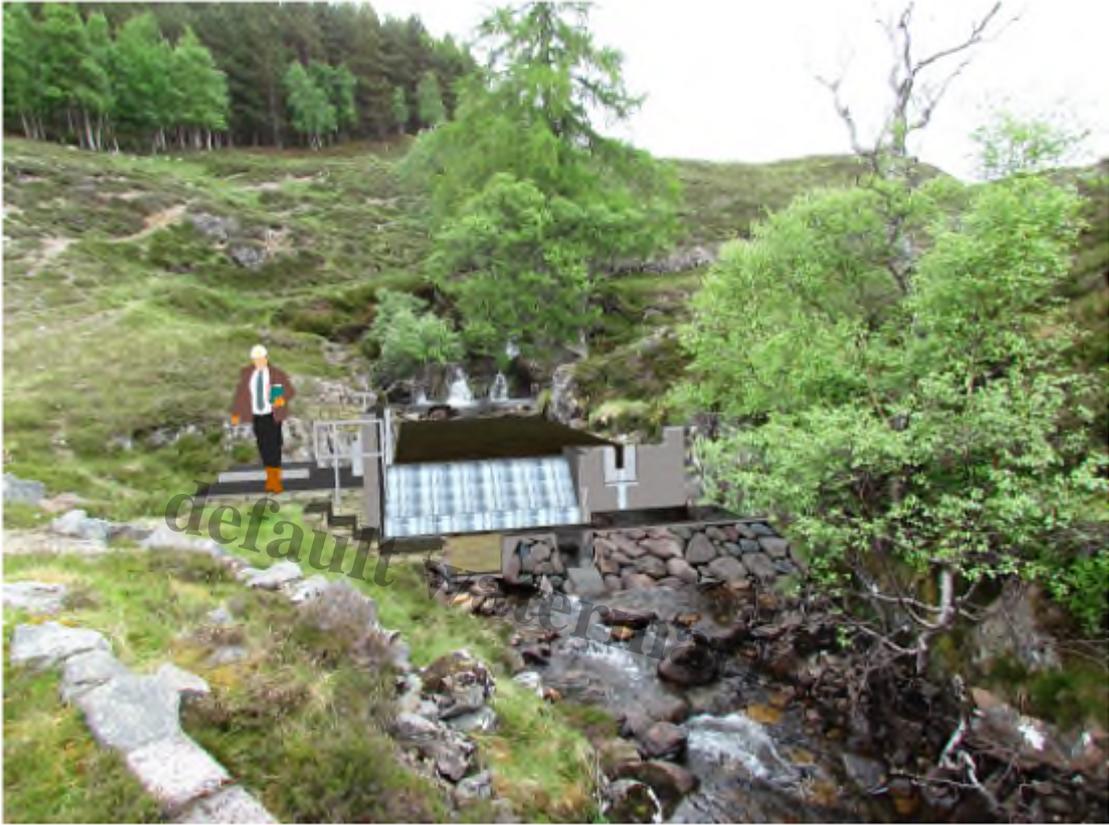
Figure 3 (a) Primary Intake

Photomontage from CNPA Planning Committee report which approved the scheme in December 2013

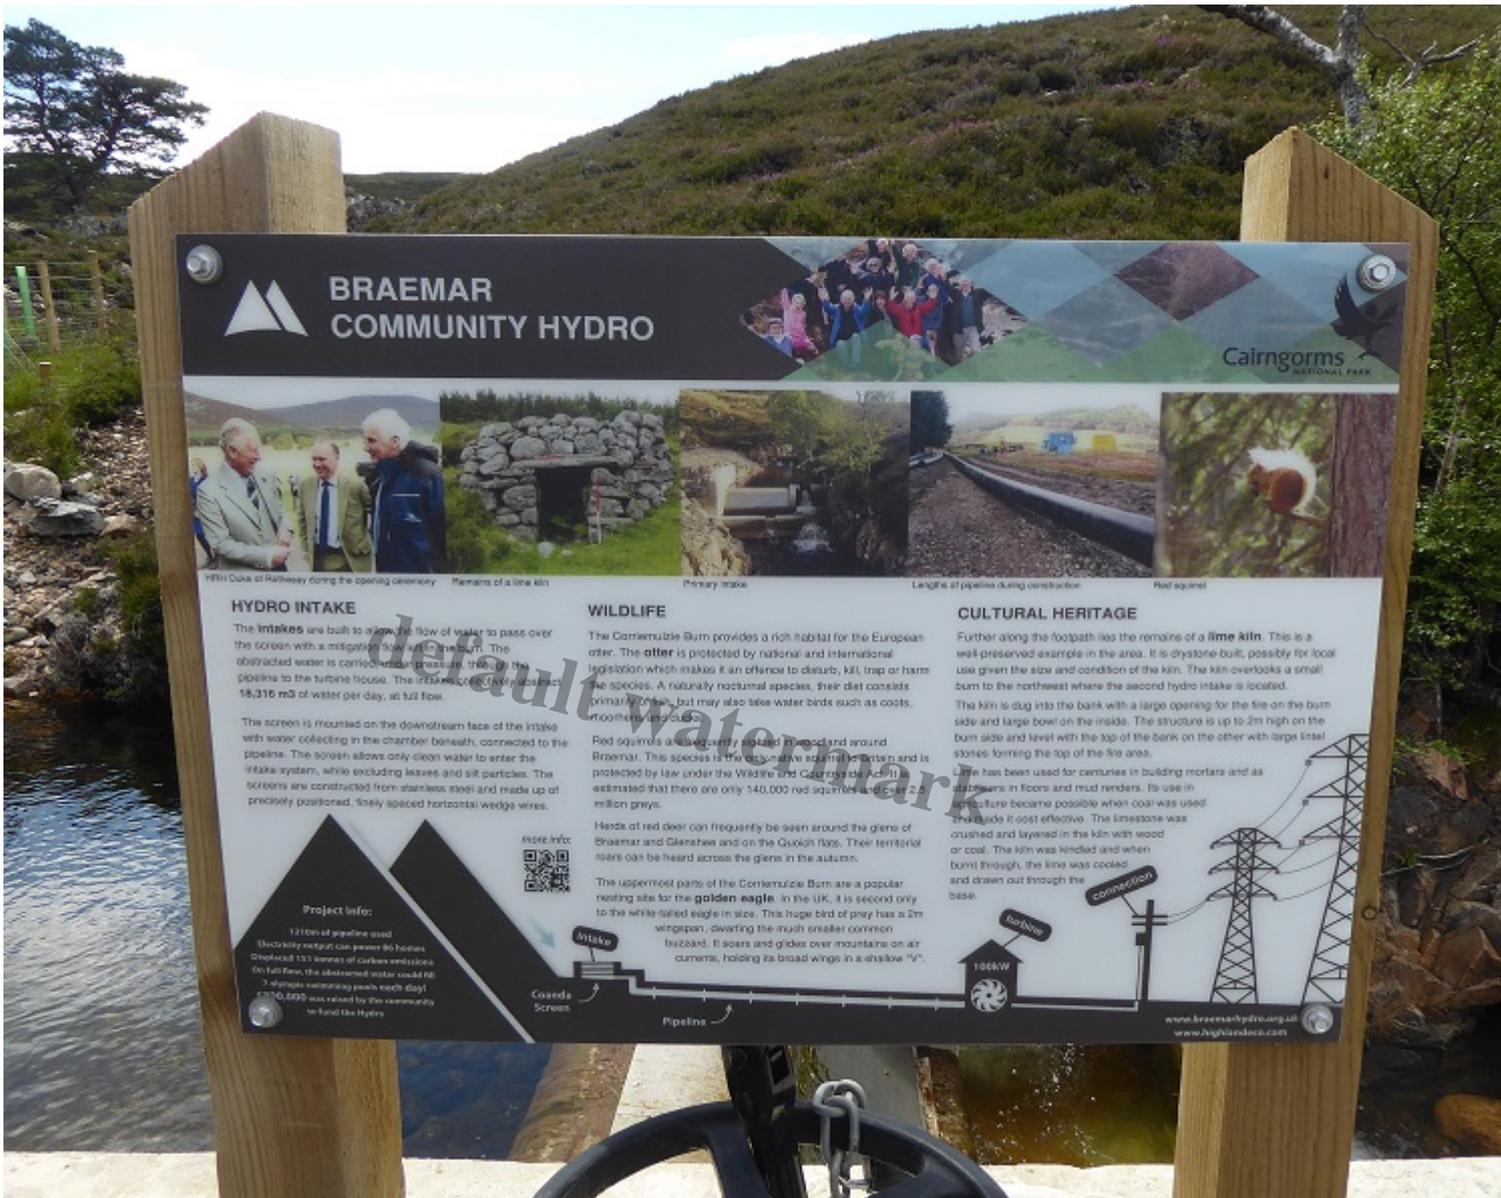
A new signboard has been erected by the intake. The line of pylons is rather ironic given CNPA's opposition to the Beaully Denny and I wonder what Prince Charles, who opened the scheme, and talks so much about architectural standards and traditional landscapes thought about the destruction. Its as if, though, everyone at the official opening had their eyes shut.
