## The Corriemulzie community hydro scheme

The Corriemulzie community hydro scheme <http://braemarhydro.org.uk/scheme/>, just west of Braemar on the road to Linn of Dee, provides an interesting case of how developments can go badly wrong despite the best intentions of the main players. I first visited this scheme, which became operational last summer, in September 2016 and was horrified by what I saw. Subsequent research and correspondence with the Cairngorms National Park Authority established the situation was a little more

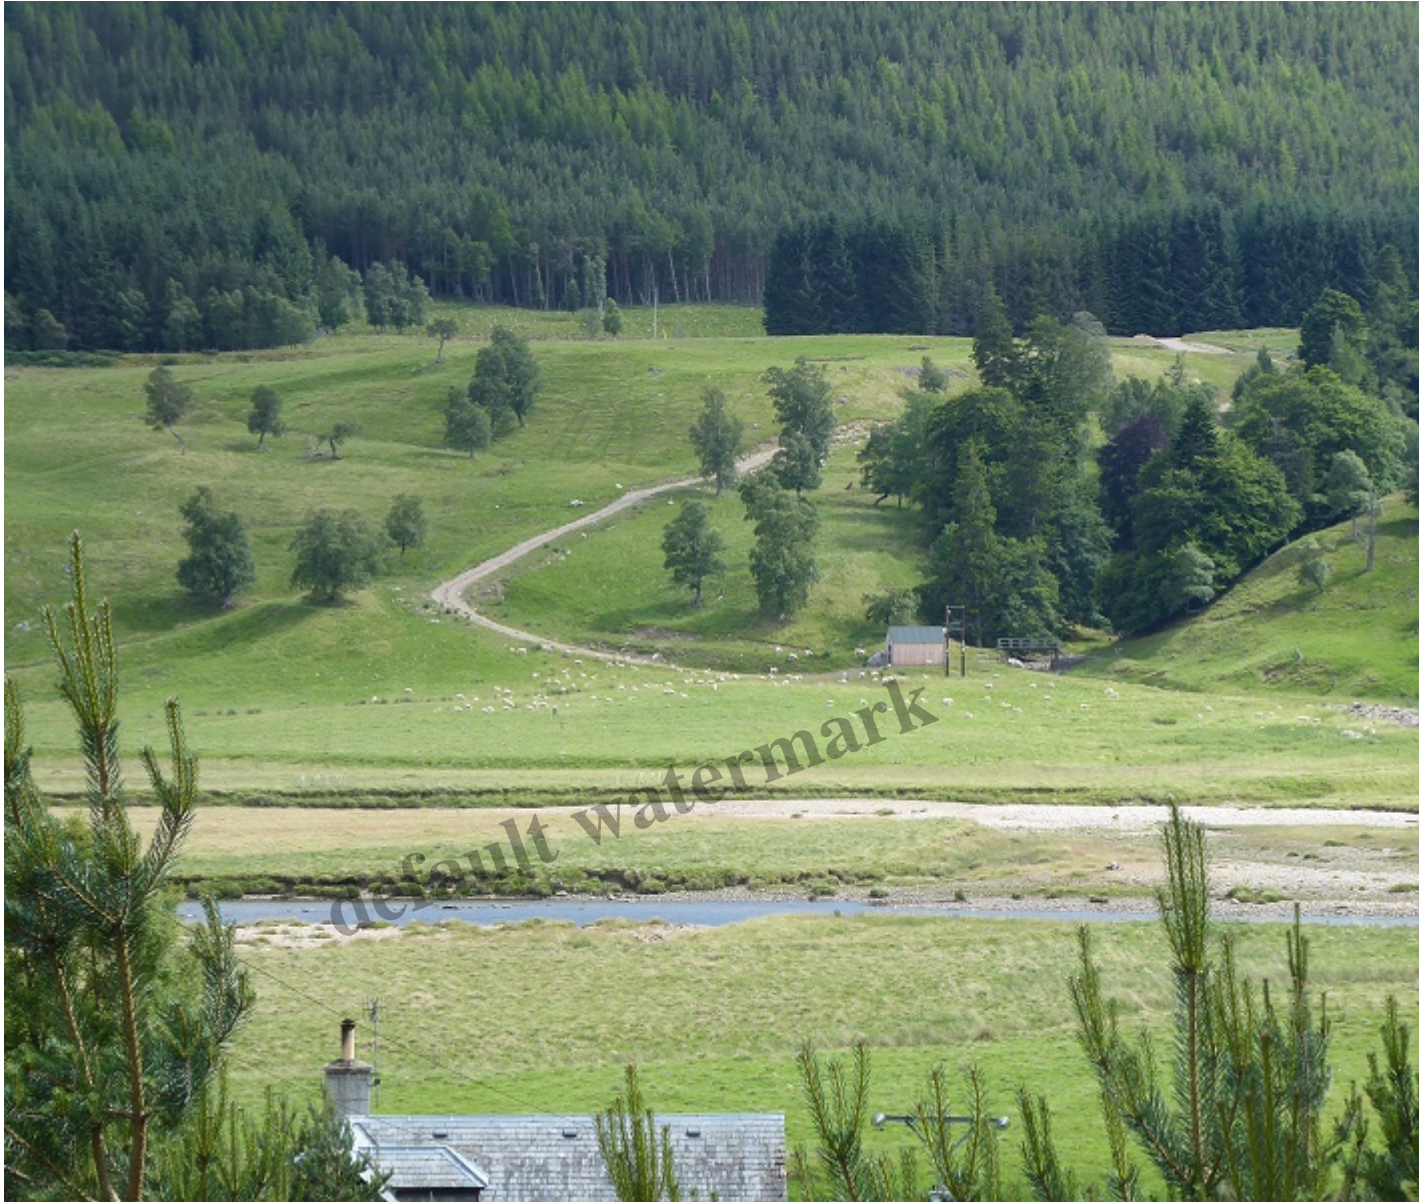
View of powerhouse from Linn of Quoich July 2017

The new powerhouse sits by site of former powerhouse although the track to it, down from the Braemar to Linn of Dee Road, is new. In my view – and I realise this is just a matter of opinion – the wider landscape impact of the track is not a major issue. I did not revisit the track though last September there were both good things and bad about how the land around it had been restored.

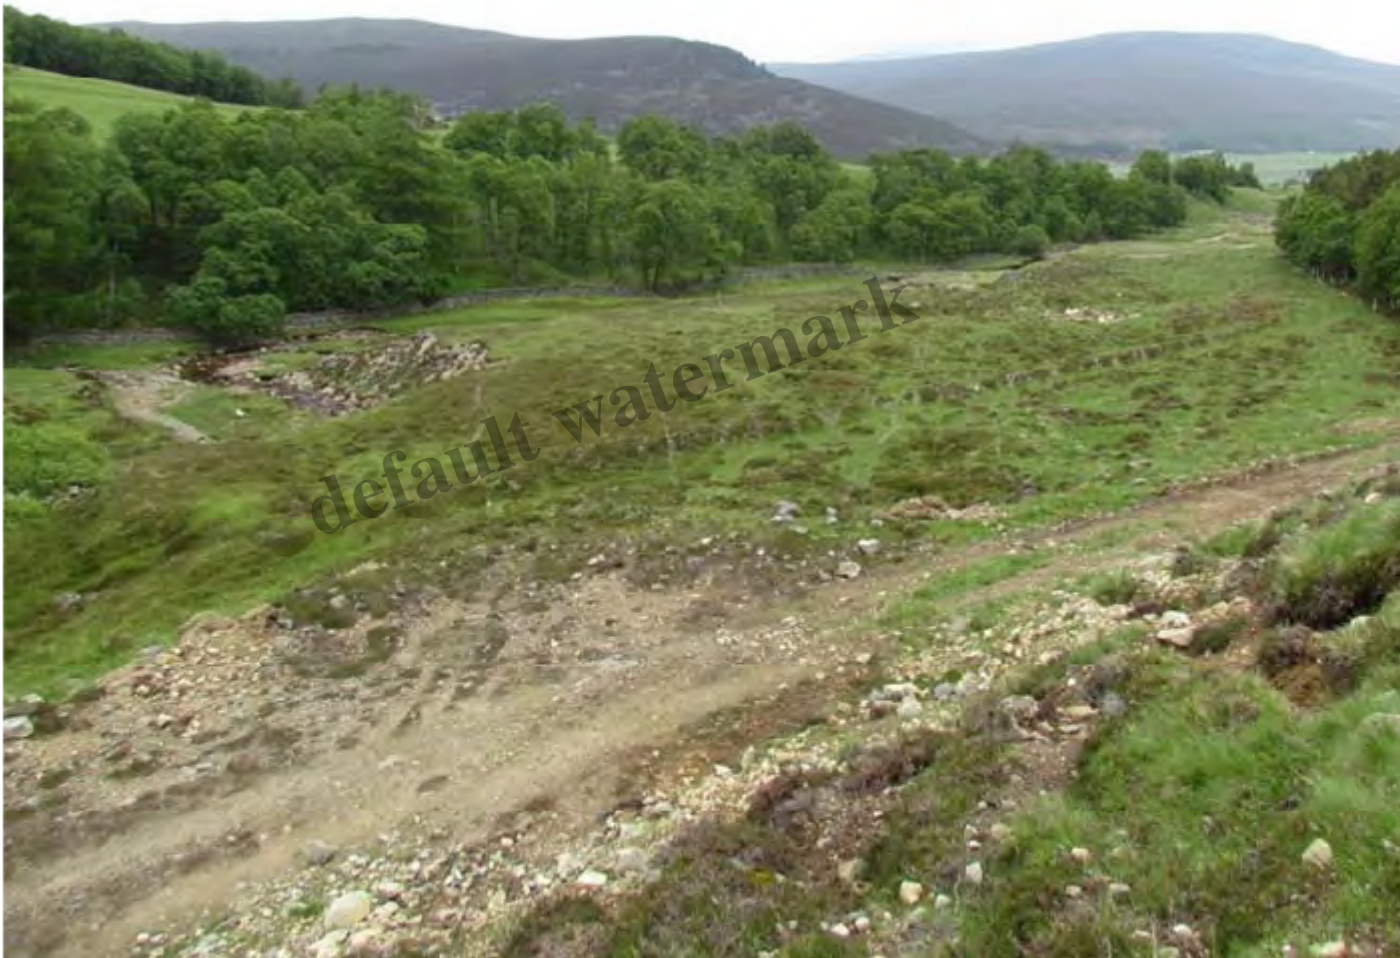
**Plate 7.8: View towards Braegarie (behind trees centre-left) from mound above primary intake**

The hydro scheme and burn is just to the left. Note the steep bank down to the track.

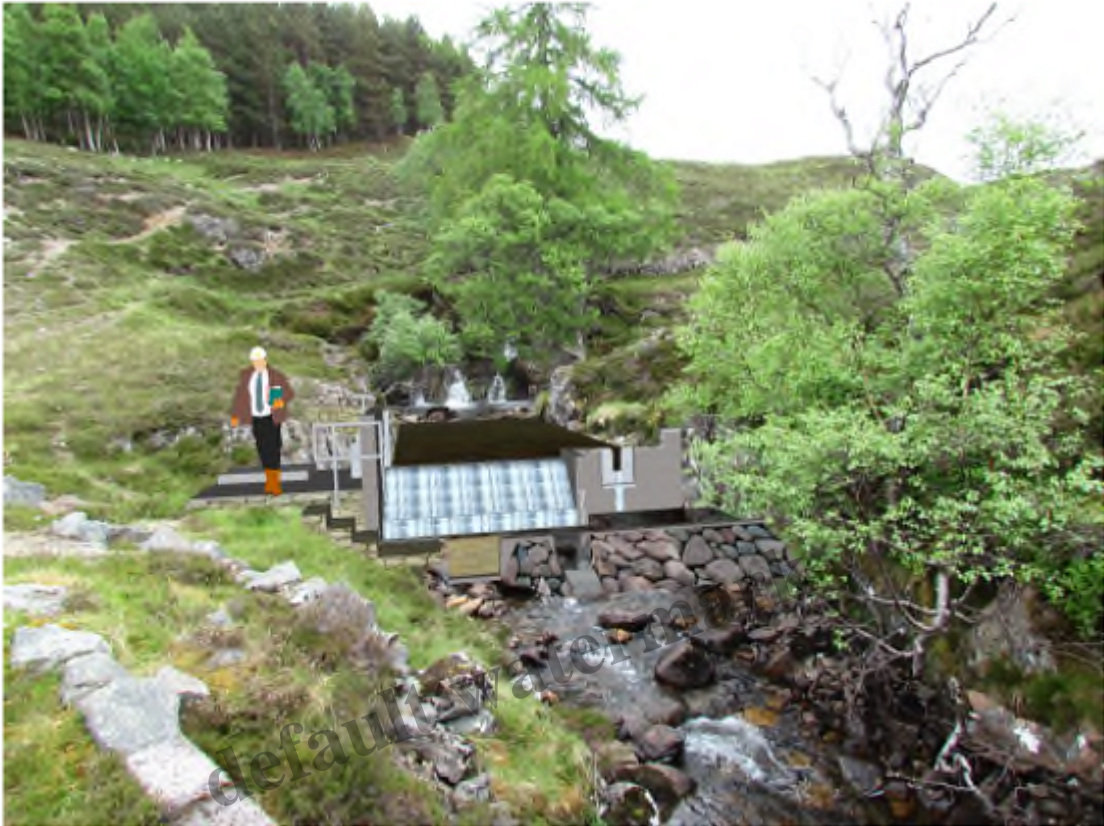
**Figure 3 (a) Primary Intake**

Photomontage from CNPA Planning Committee report which approved the scheme in December 2013

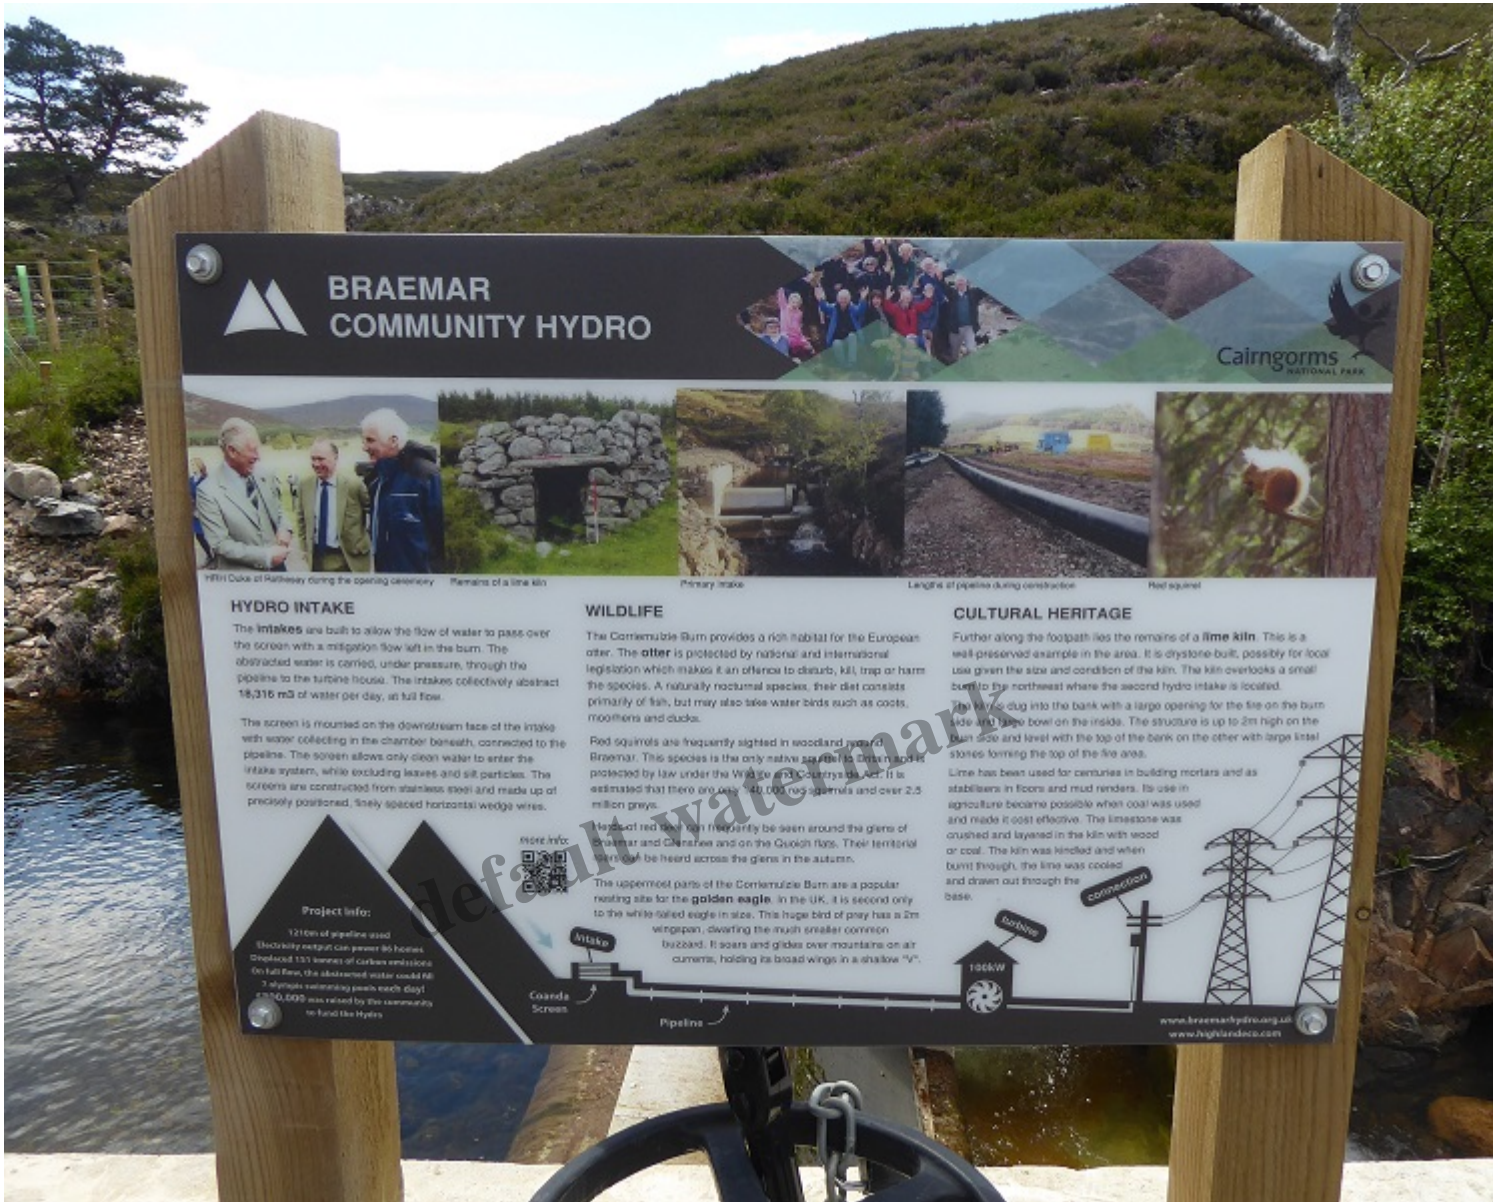
A new signboard has been erected by the intake. The line of pylons is rather ironic given CNPA's opposition to the Beaulieu Denny and I wonder what Prince Charles, who opened the scheme, and talks so much about architectural standards and traditional landscapes thought about the destruction. Its as if, though, everyone at the official opening had their eyes shut.
