The Corriemulzie community hydro scheme

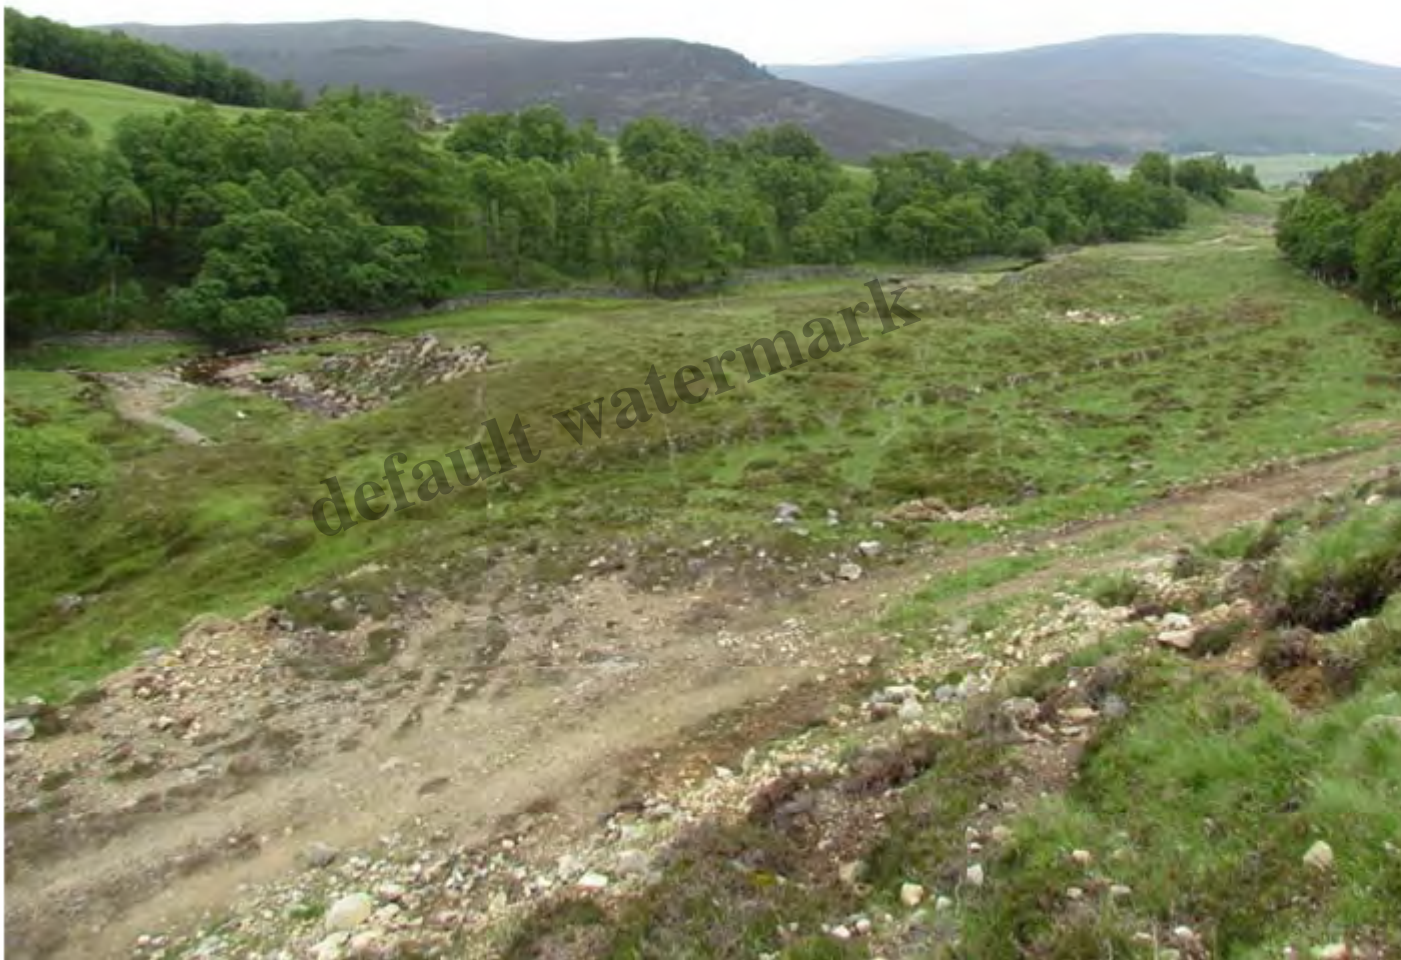
Plate 7.8: View towards Braegarie (behind trees centre-left) from mound above primary intake

The hydro scheme and burn is just to the left. Note the steep bank down to the track.

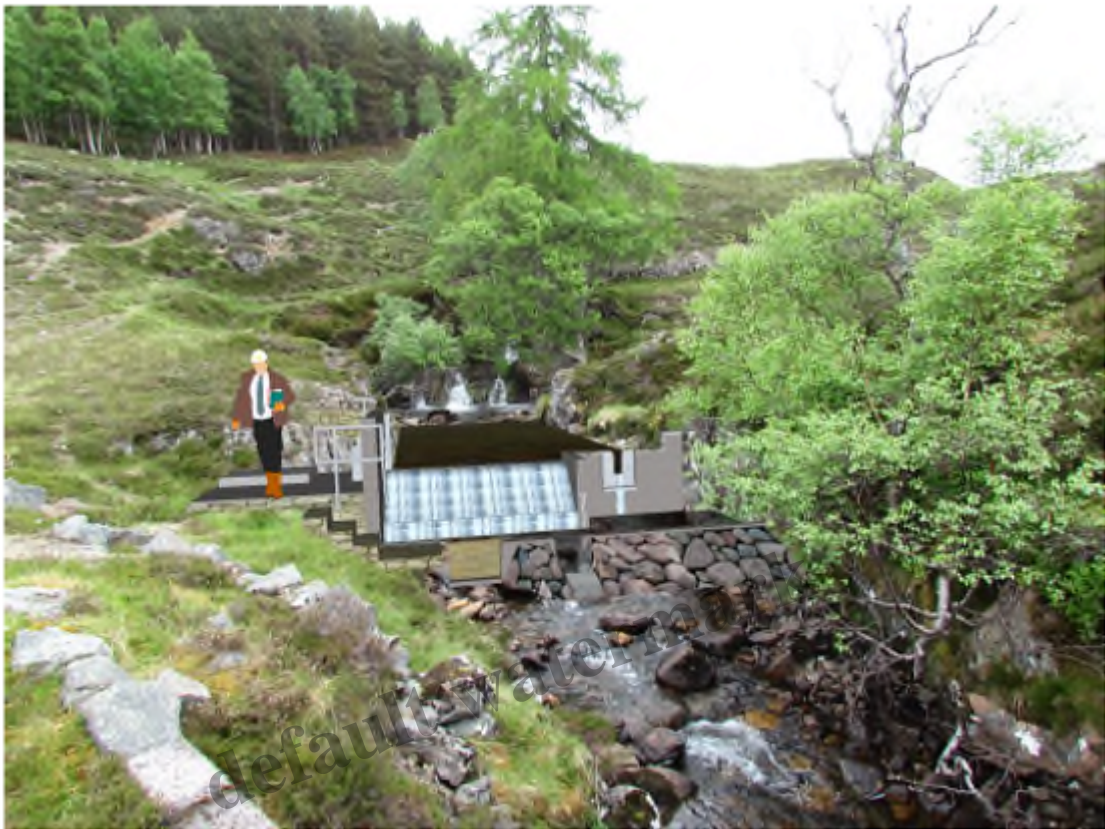
Figure 3 (a) Primary Intake

Photomontage from CNPA Planning Committee report which approved the scheme in December 2013

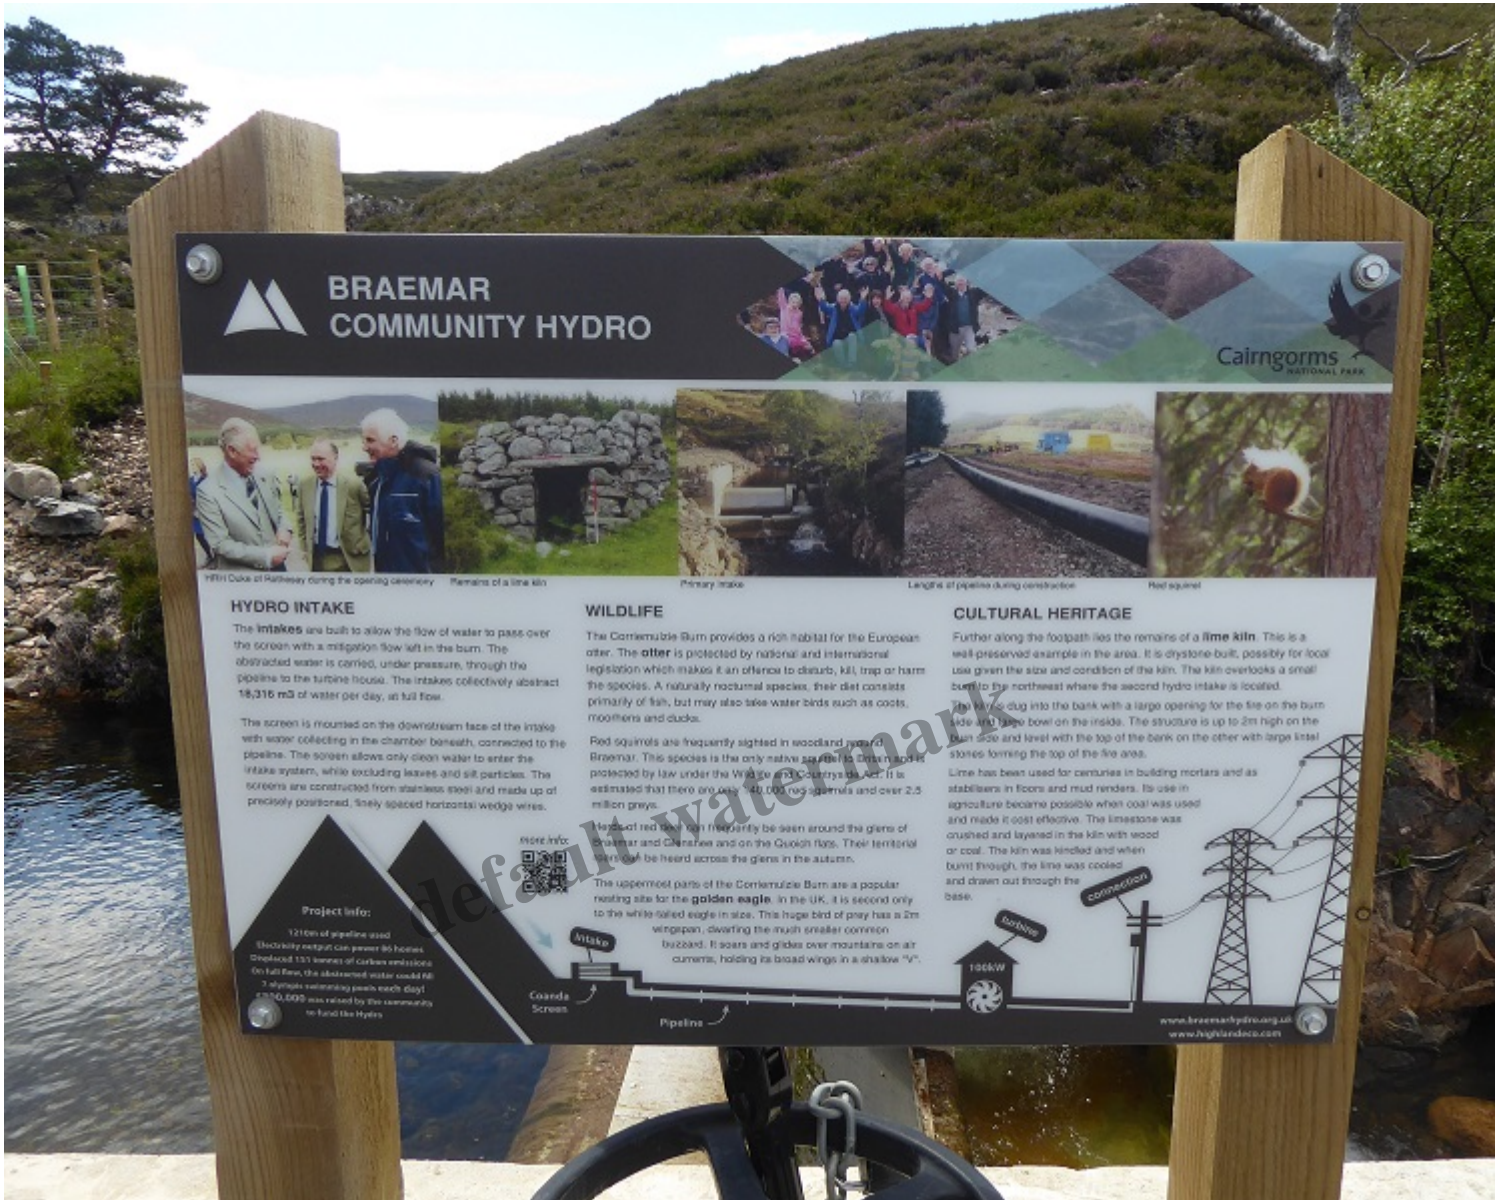
A new signboard has been erected by the intake. The line of pylons is rather ironic given CNPA's opposition to the Beaulieu Denny and I wonder what Prince Charles, who opened the scheme, and talks so much about architectural standards and traditional landscapes thought about the destruction. Its as if, though, everyone at the official opening had their eyes shut.
