The Allt Essan and Auchessan Hydro schemes in Glen Dochart

March 26, 2018

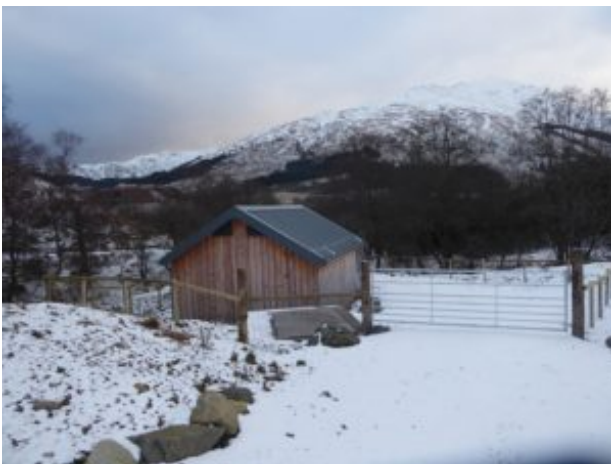
The much smaller Auchessan powerhouse

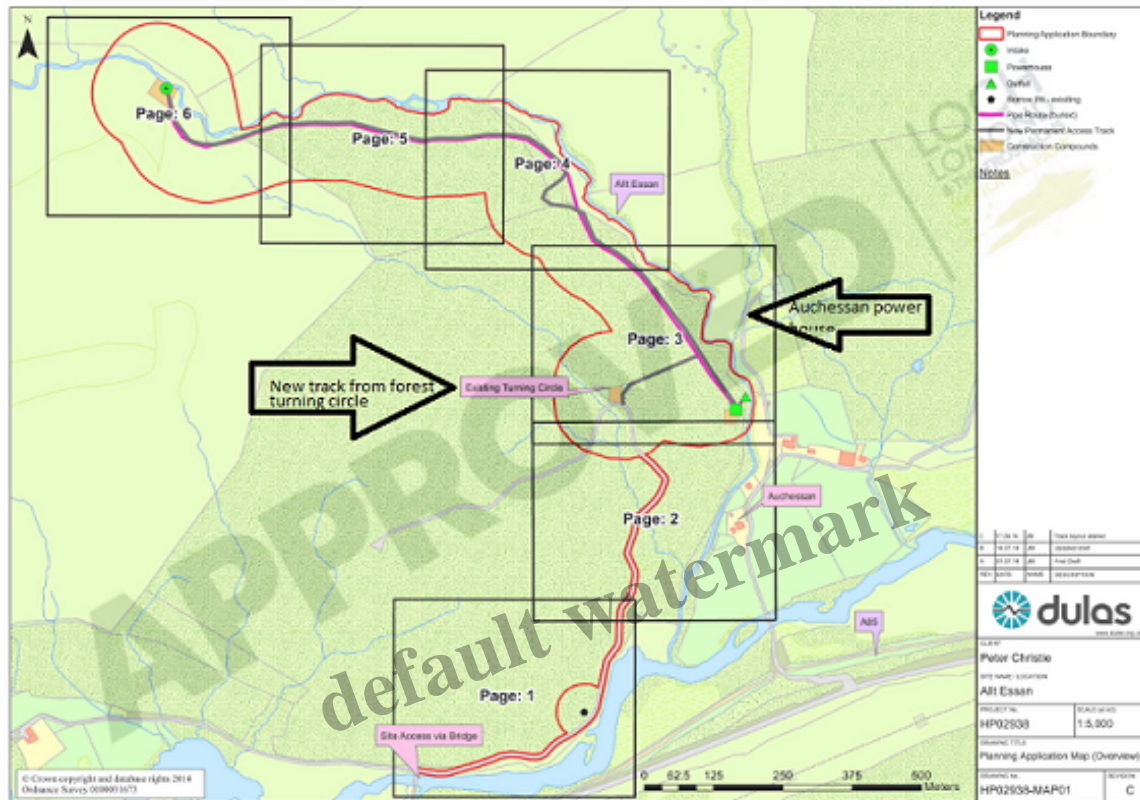
The Allt Essan hydro scheme with the Loch Dochart Estate boundary following the upper red line. The Auchessan scheme runs is on the burn above the righthand arrow (Allt Essan planning papers LLTNPA Ref 2014/0261 DET).

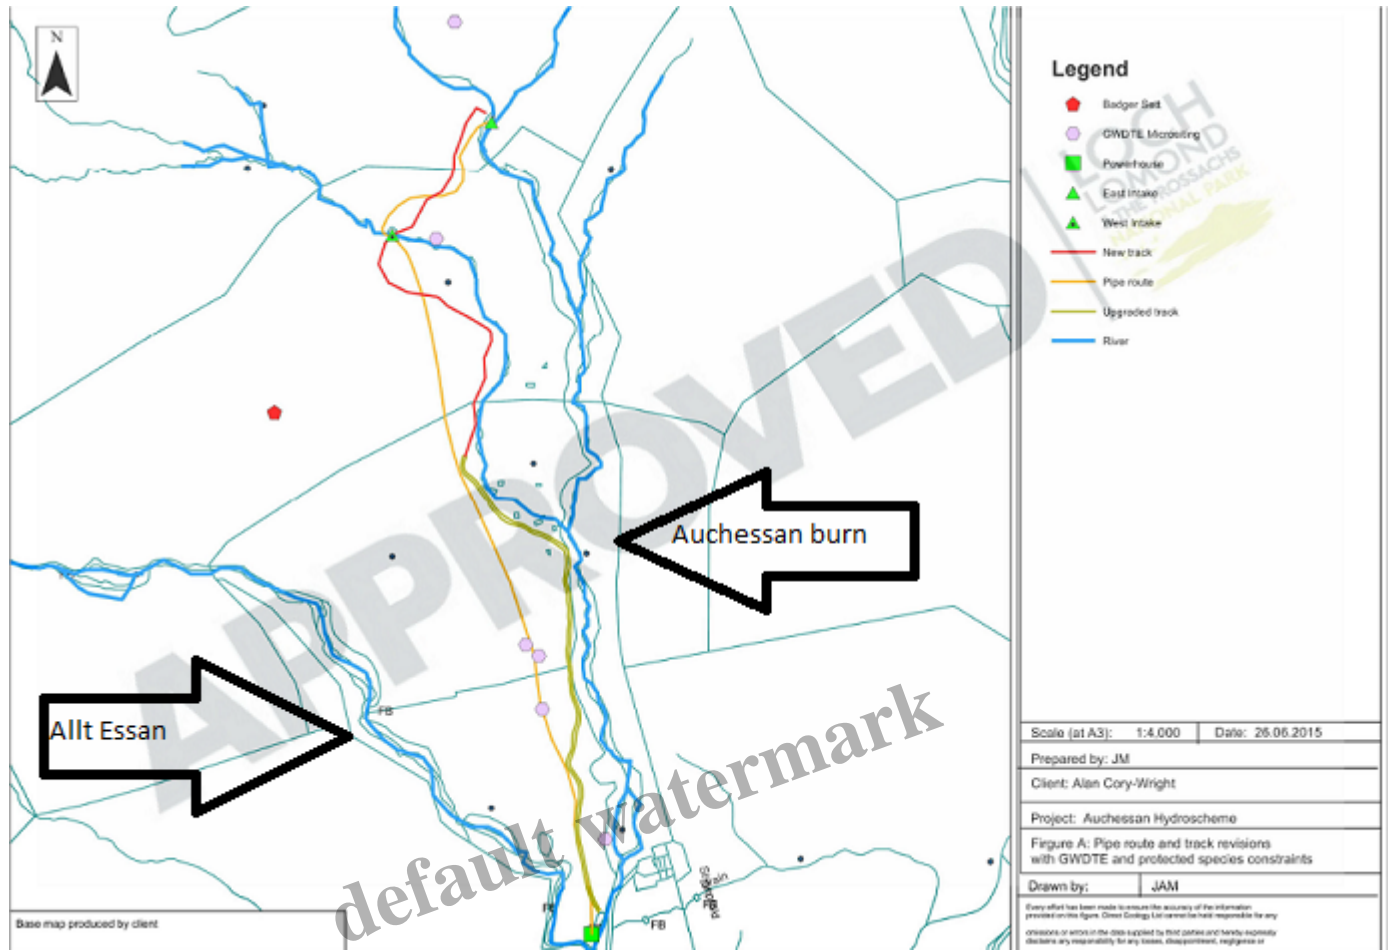
The Auchessan burn hydro scheme and tracks, with track extension in red

What struck me immediately running up the track, the first section of which had preceded the hydro but has been “upgraded”, by being widened and having new aggregate dumped on the surface, is that it is far too steep:
