## The Allt Essan and Auchessan Hydro schemes in Glen Dochart

Looking down onto the Allt Essan (power house centre photo and tracks through forestry) and Auchessan (power house above and left of Allt Essan power house leading to top left corner of photo) hydro schemes from Ben Alder. Photo taken in 2017.

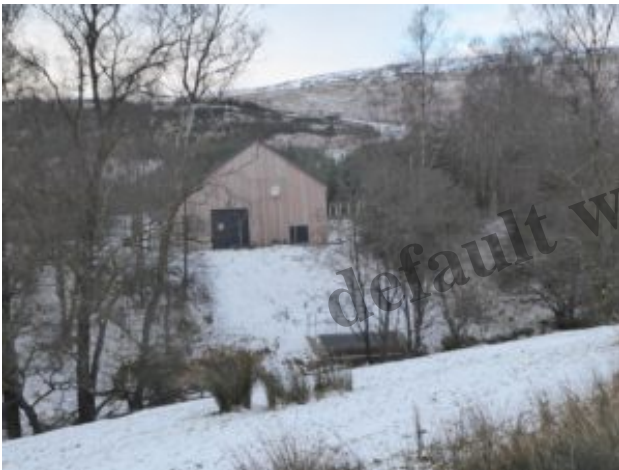
The Allt Essan powerhouse with the new intake track visible on hillside behind

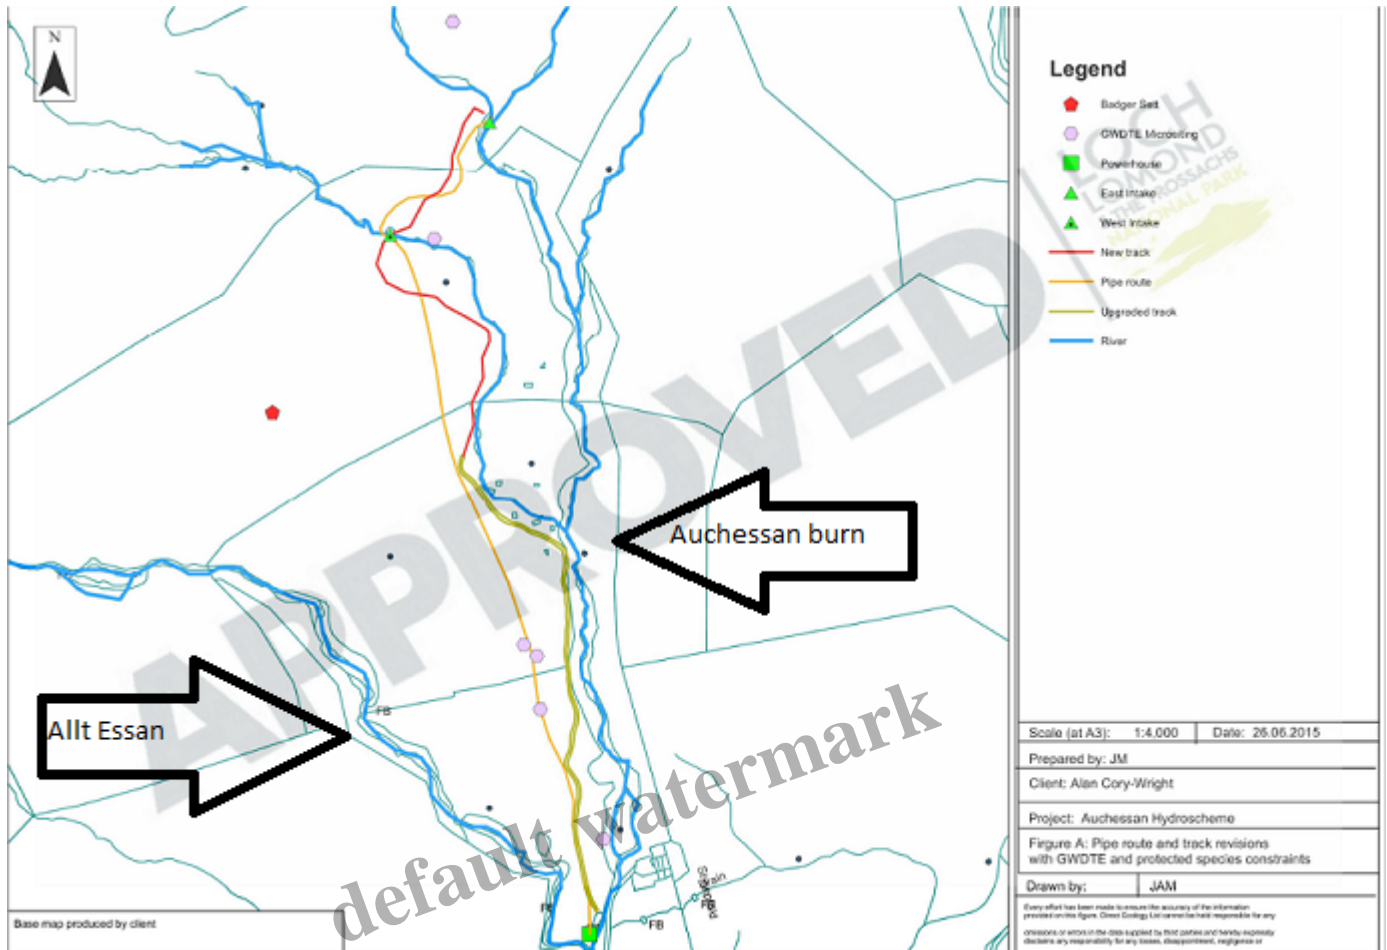
I started up the track to the Auchessan intakes. The track and location of the intakes was altered from the original planning application and the track takes a direct line up the hill:

The Auchessan burn hydro scheme and tracks, with track extension in red

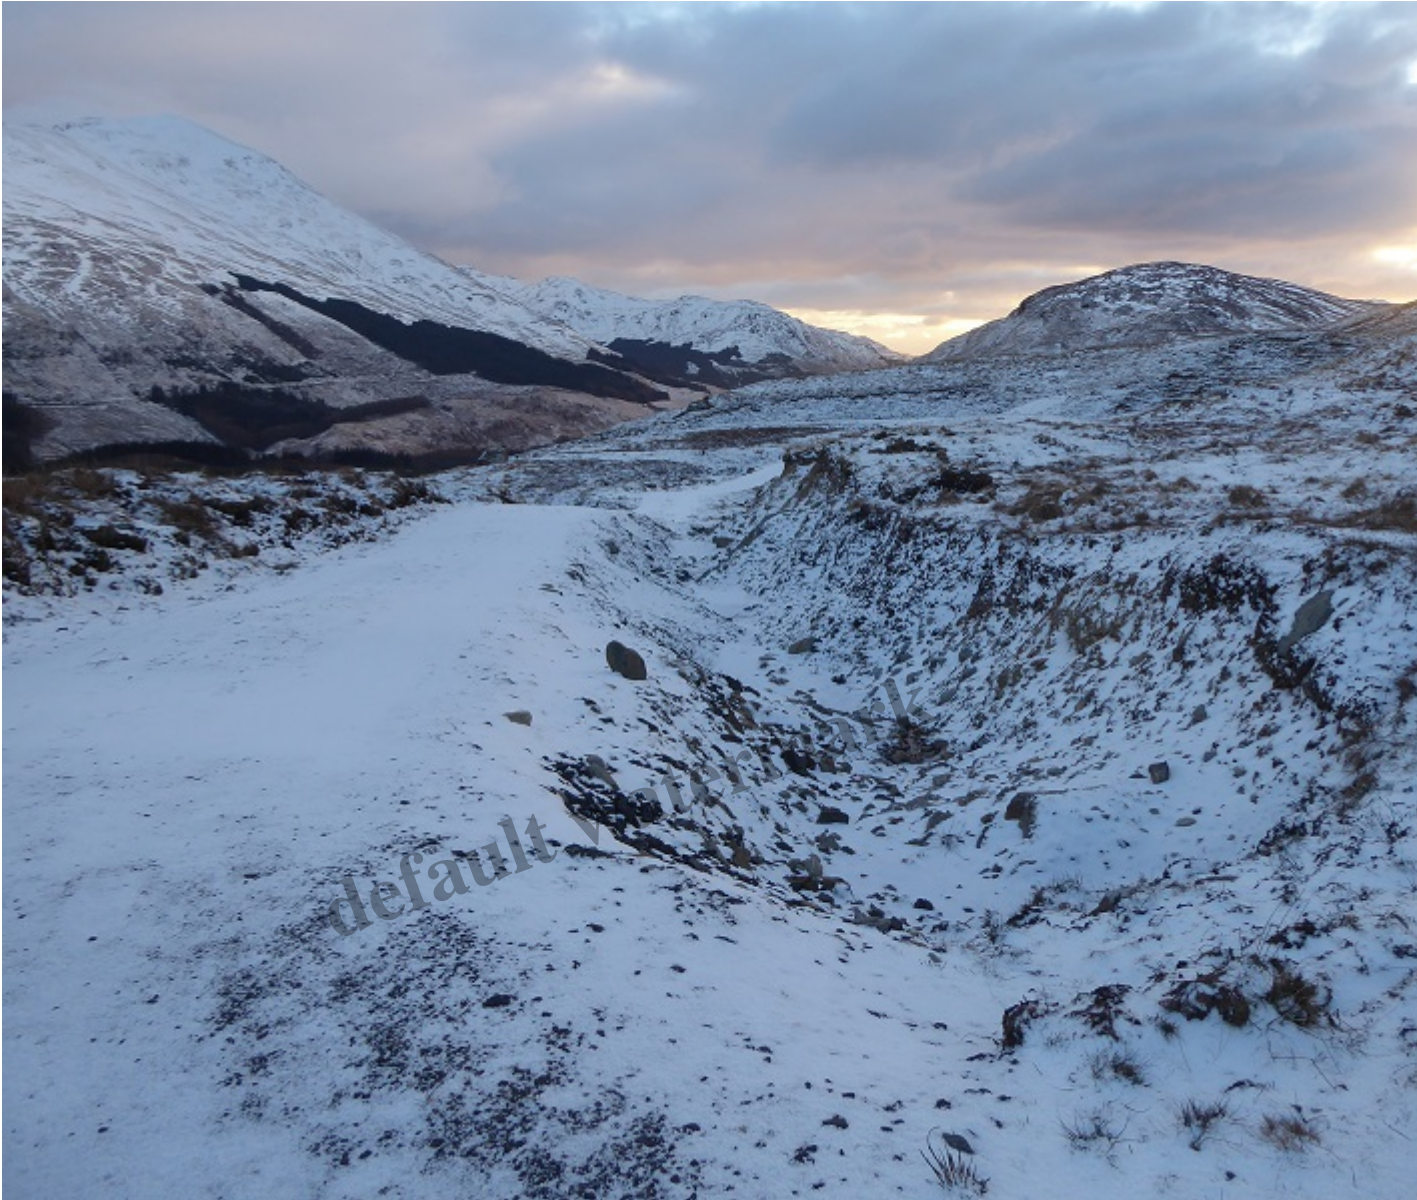
Higher up there was less evidence of any attempt to restore the track properly in contravention of LL guidance which states “*complete batters at time of road construction*”.

Looking west along the upper section of the Auchessan track, Ben More left

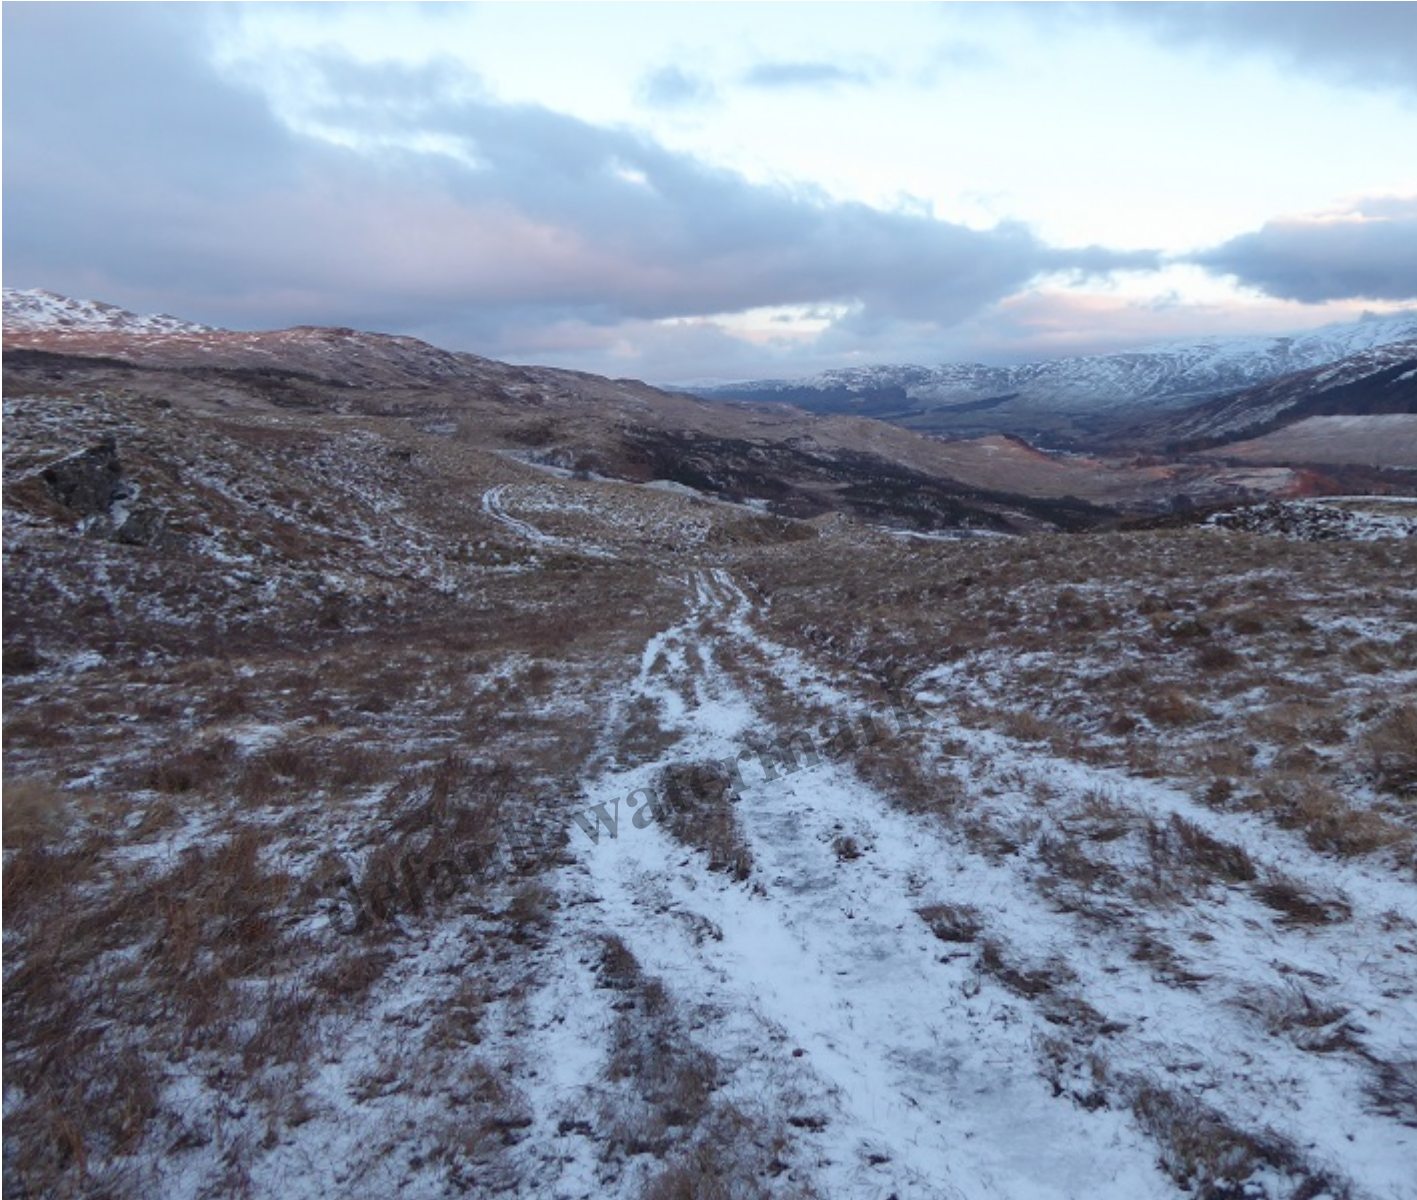
Looking east along north slopes Glen Dochart from close to Allt Essan intake – Auchessan hydro track diagonally up slope beyond
