The Allt Essan and Auchessan Hydro schemes in Glen Dochart

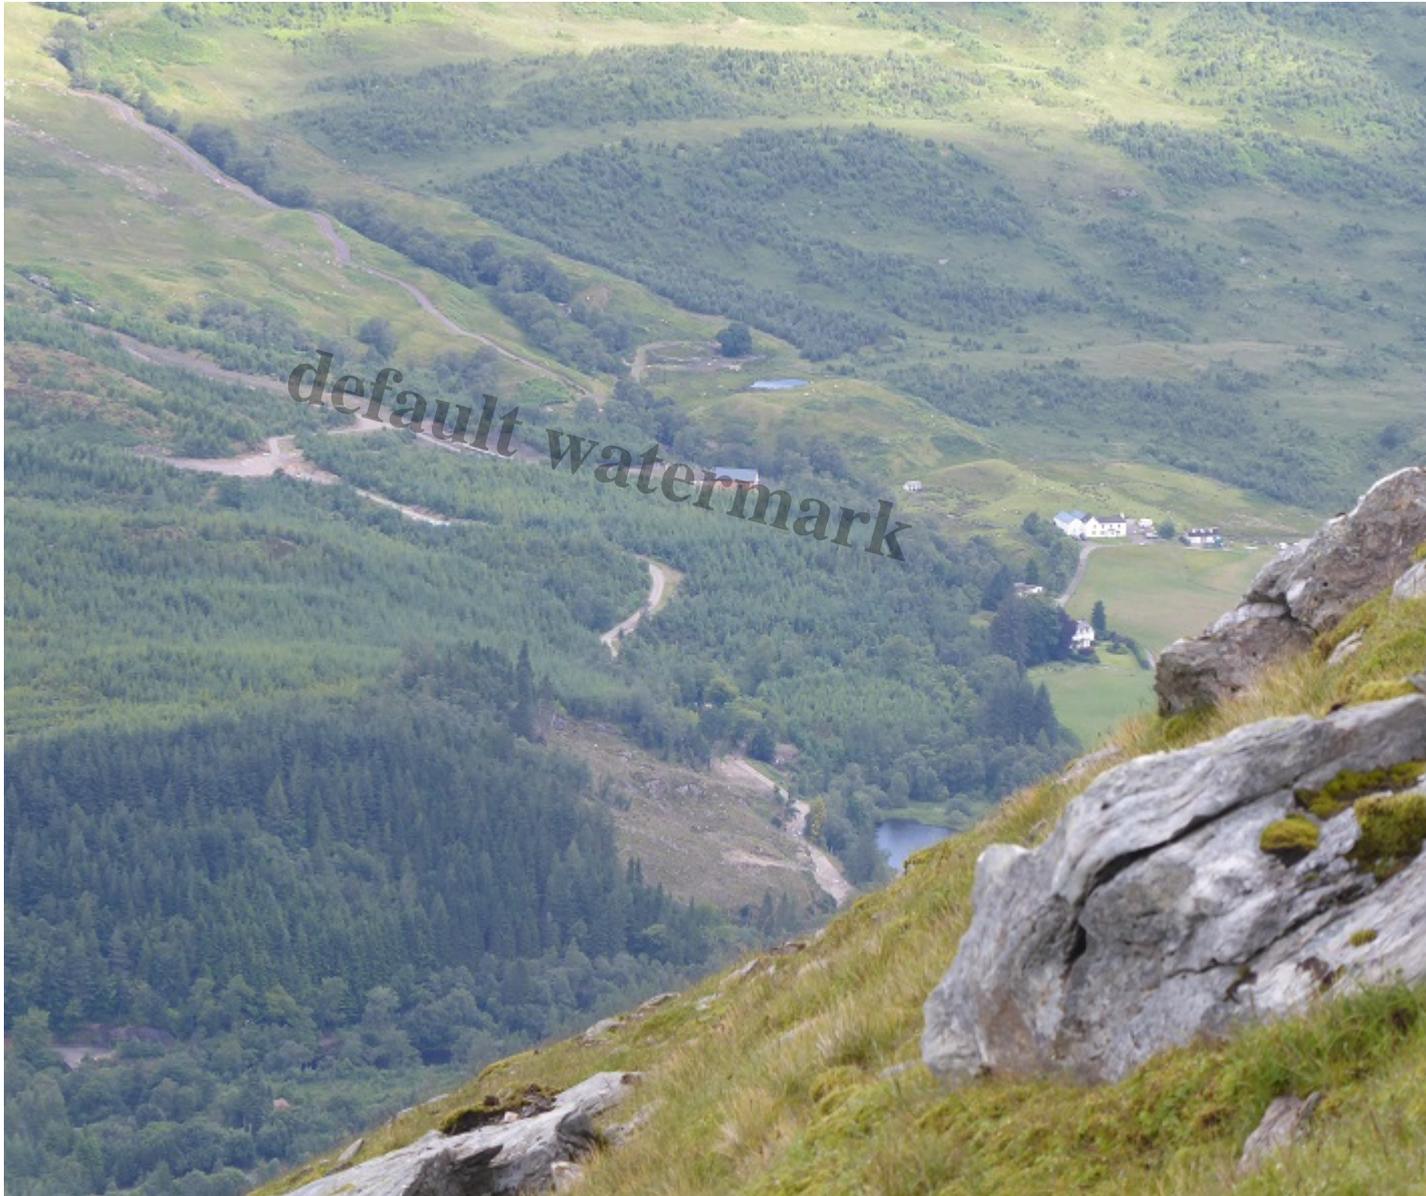
Looking down onto the Allt Essan (power house centre photo and tracks through forestry) and Auchessan (power house above and left of Allt Essan power house leading to top left corner of photo) hydro schemes from Ben Alder in 2017.

I had been meaning to visit these schemes since becoming aware of the destruction caused to the landscape by the new access tracks (photo above) while taking a look at the site of the new proposed Ben More hydro scheme ([see here](#)). I did so after attending the Board Meeting which gave the go ahead for the Cononish gold mine and just before the beast from the east arrived. While the light covering of snow and fading light did limit what could be seen, enough was visible to show up the claims the Head of Planning, Stuart Mearns, had made earlier that day: he had claimed that LLTNPA staff had learned sufficient about restoration of hydro schemes for the Board to be confident that they could successfully create a vast artificial moraine field out of the Cononish tailings in an area of wild land.

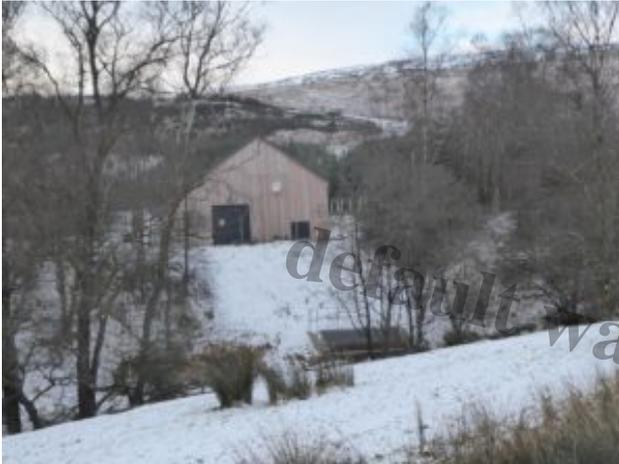
The Allt Essan powerhouse with the new intake track visible on hillside behind

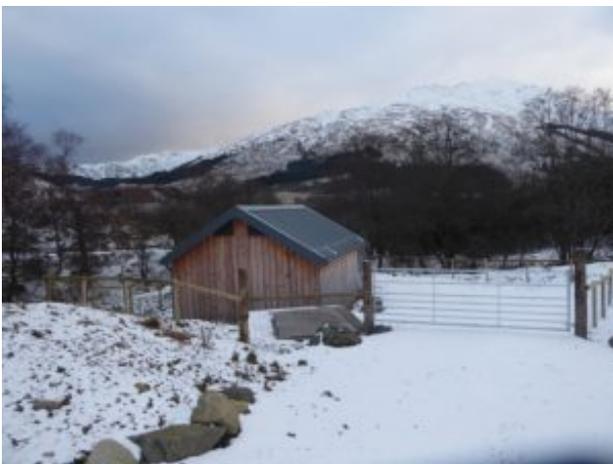
The much smaller Auchessan powerhouse

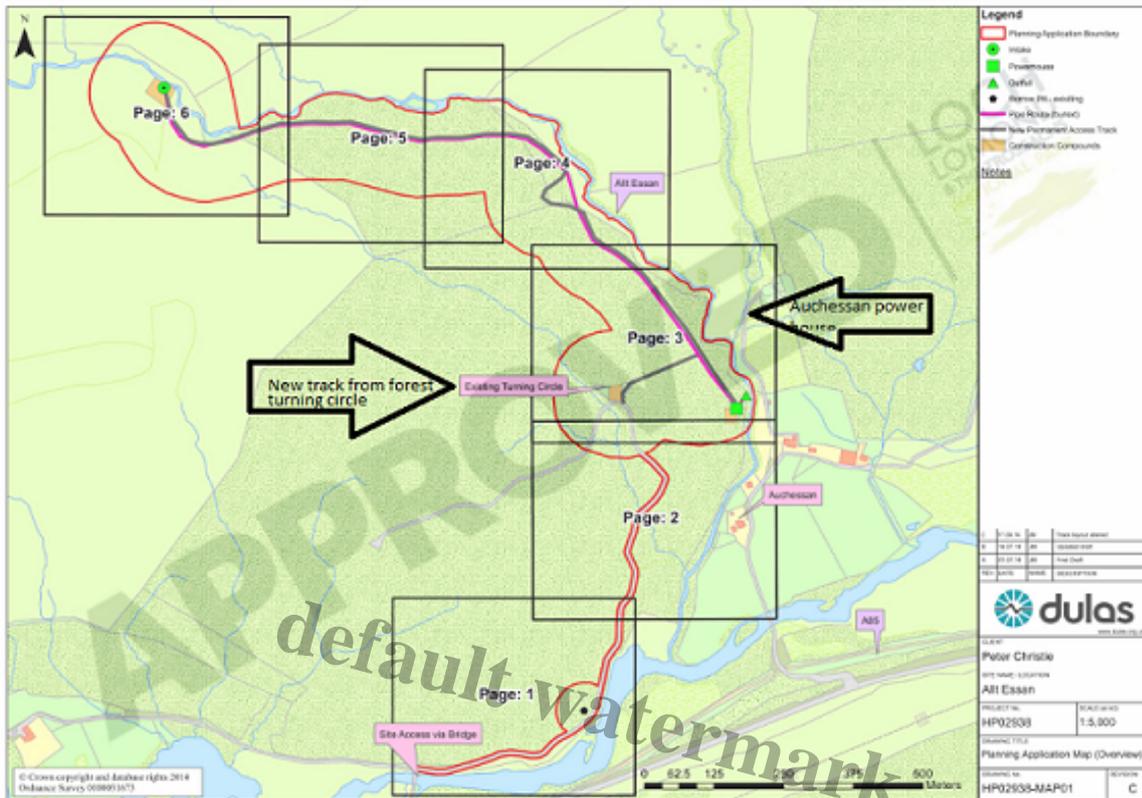
The Allt Essan hydro scheme with the Loch Dochart Estate boundary following the upper red line. The Auchessan scheme runs is on the burn above the righthand arrow (Allt Essan planning papers LLTNPA Ref 2014/0261 DET).

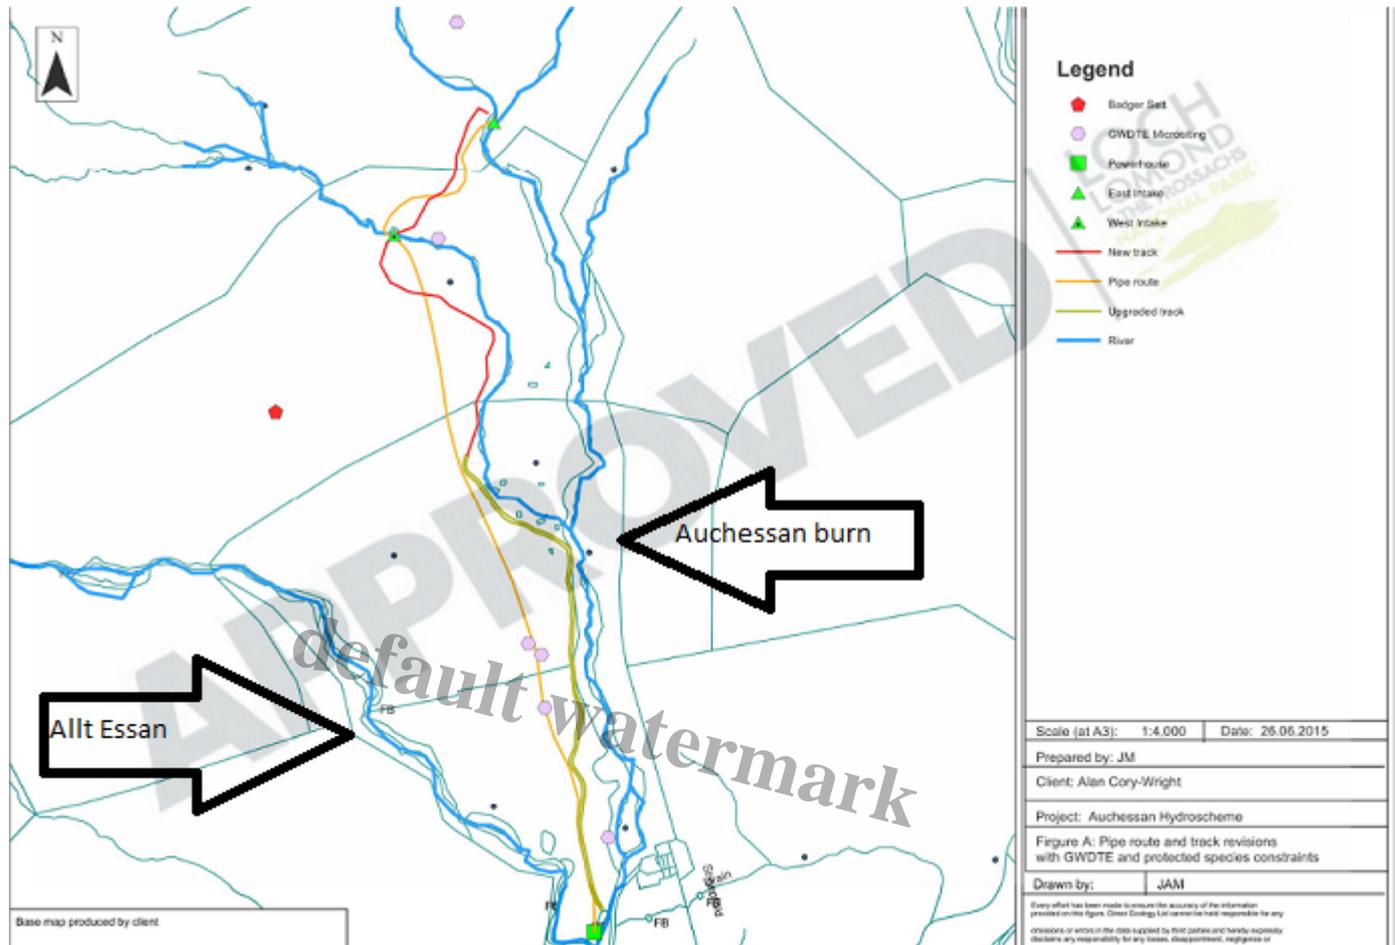
I started up the track to the Auchessan intakes. The track and location of the intakes was altered from the original planning application and the track takes a direct line up the hill:

The Auchessan burn hydro scheme and tracks, with track extension in red

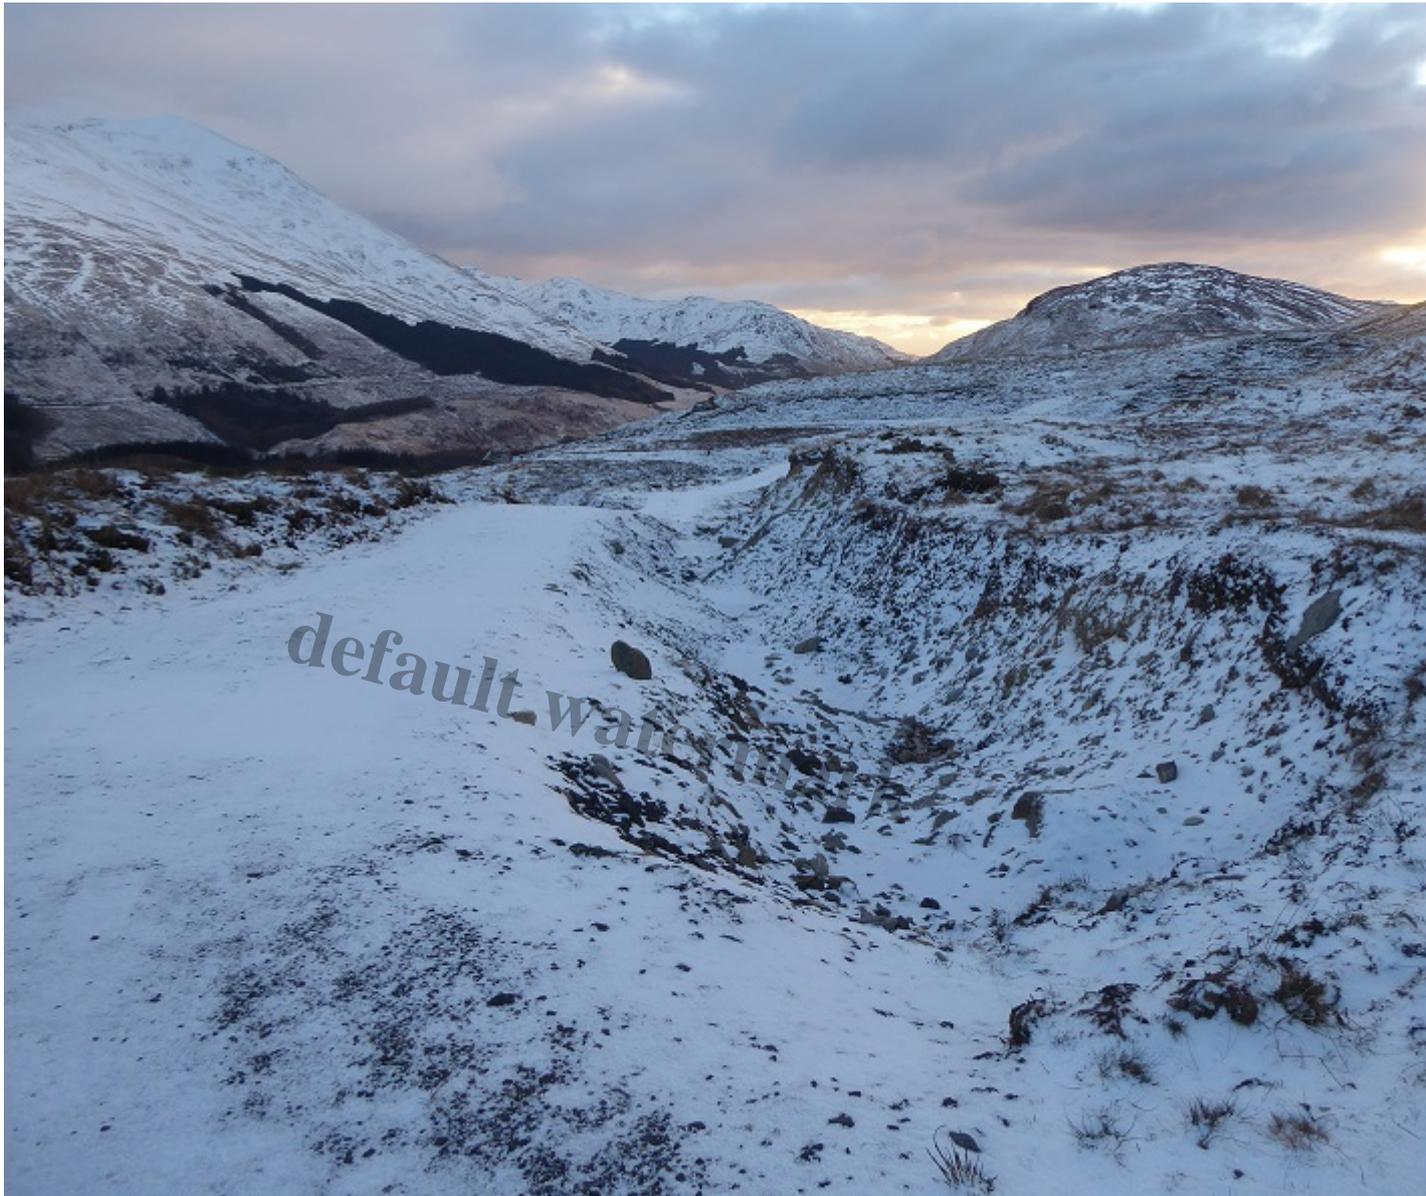
Higher up there was less evidence of any attempt to restore the track properly in contravention of LL guidance which states *“complete batters at time of road construction”*.

Looking west along the upper section of the Auchessan track, Ben More left

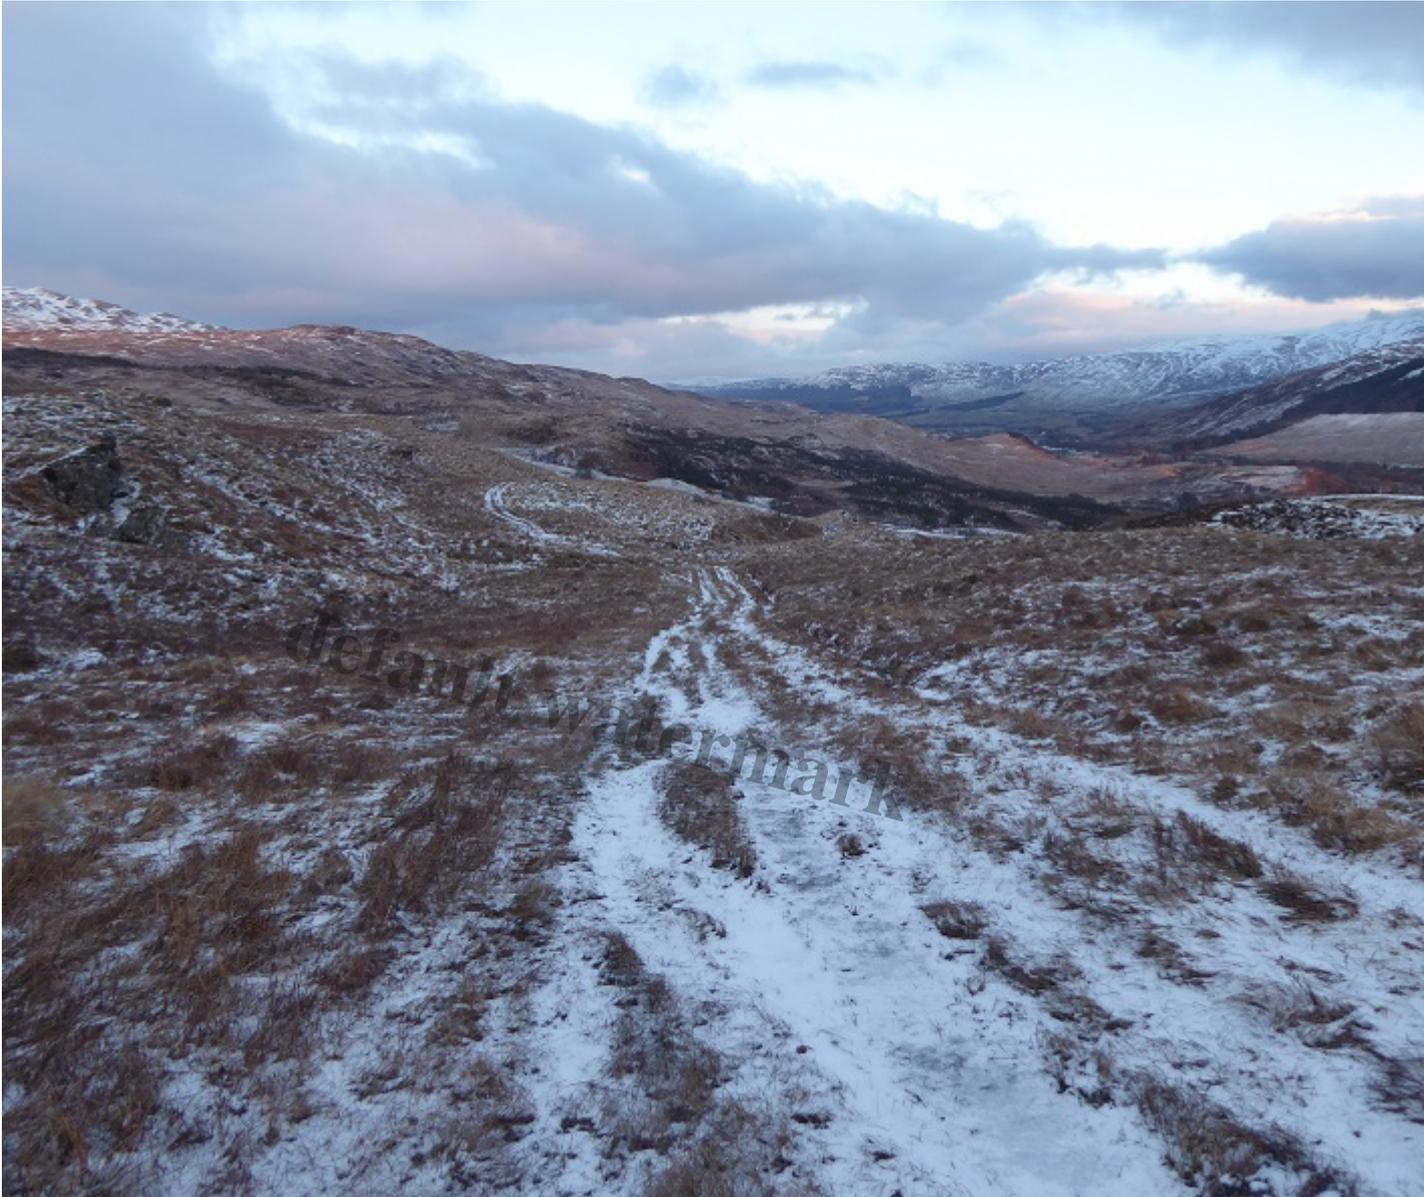
Looking east along north slopes Glen Dochart from close to Allt Essan intake â?? Auchessan hydro diagonally up slope beyond
