## The impact of hydro tracks on the landscape – the Allt a Chuillinn scheme in Glen Falloch

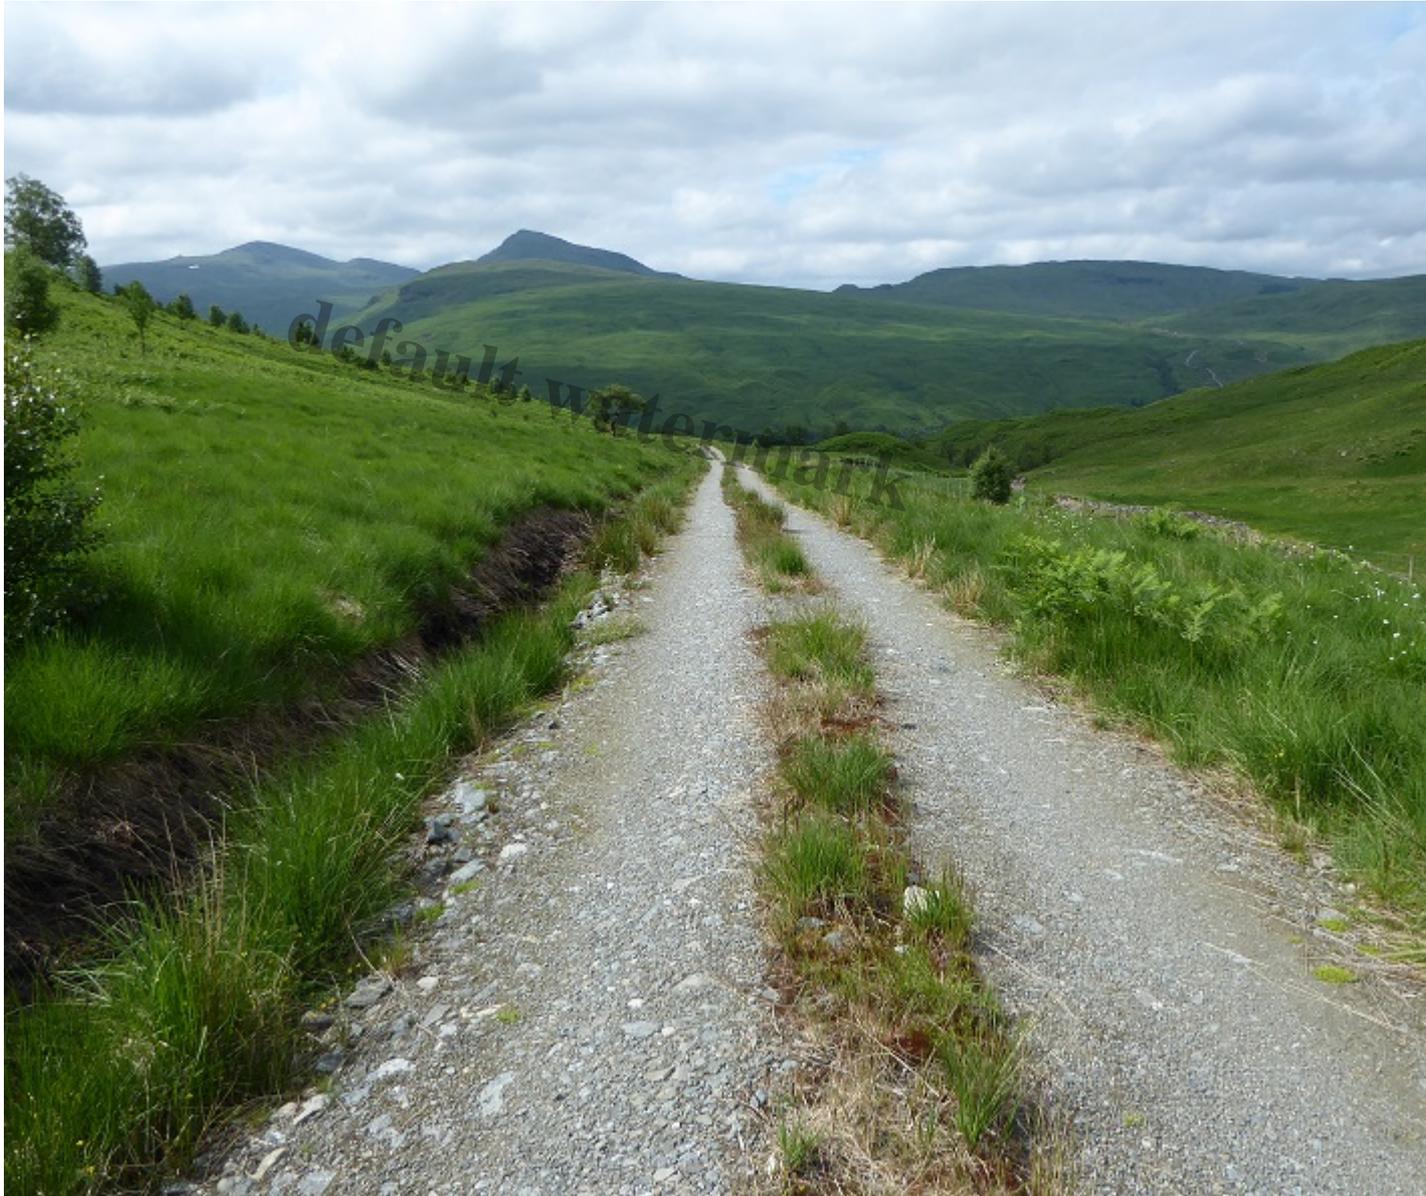
Beinn Dubhcraig and Beinn Oss, far left, from the Allt a Chuillinn hydro track

Close up, the track to the three Allt a Chuillinn hydro intakes, which form part of the Derrydarroch hydro scheme in Glen Falloch, does not look too bad. It's been significantly narrowed since construction, the sides covered with vegetation and a central strip of vegetation placed down the middle. It's quite a pleasant walking experience which is why I believe the Loch Lomond and Trossachs National Park Authority brought the Mountaineering Council and Ramblers Scotland here last year to demonstrate what the work they were doing to restore the land after the construction of hydro schemes.

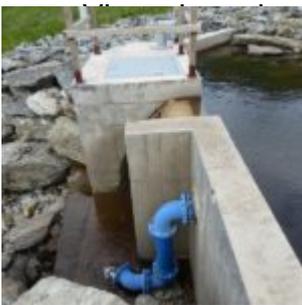
pipe which leads down from the second intake

While there is no track up the second intake and the ground above the pipe is

recovering quite well, its location is all too evident from the spill of boulders which contrasts with the surrounding grassland. Why wooden restraining rails were used here and not at the main intake, as per the LLTNPA own good practice guidance, is unclear and the penstock has been left bright blue. The equally bright yellow danger signs warn people of the danger of pools, health and safety gone mad, when most of the side burns and the Allt aâ??Chuillin itself contain similar pools.

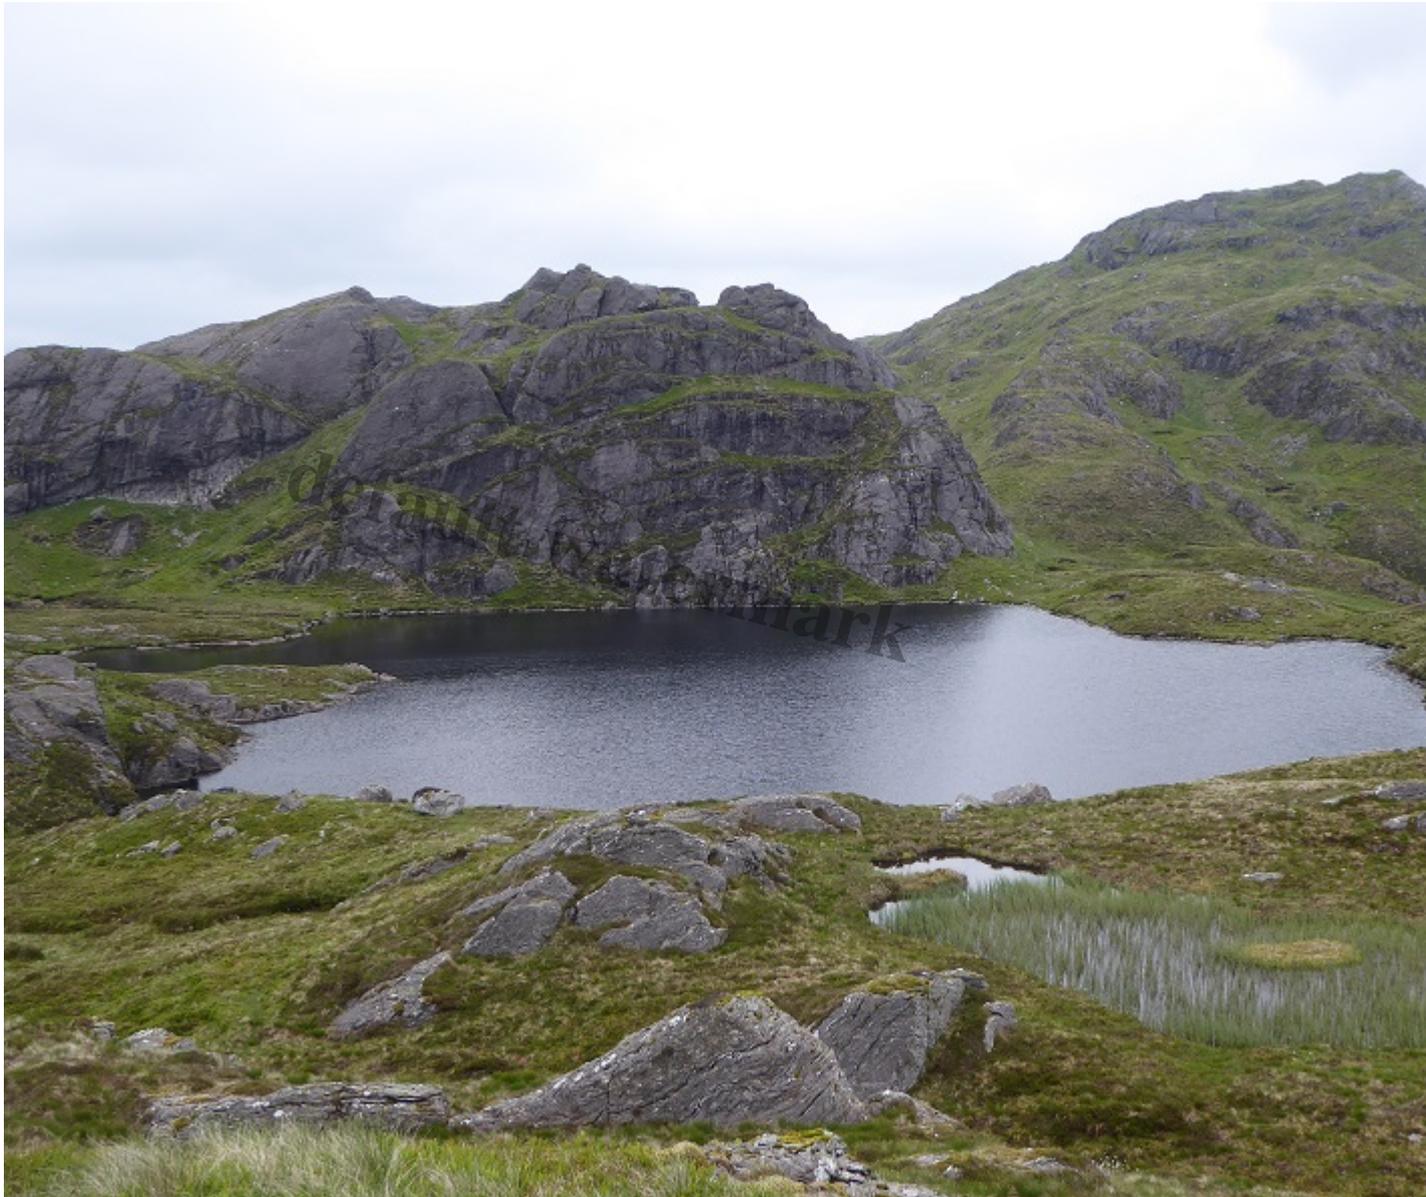
The well named Lochan a Chaisteal â?? lochan of the castle â?? nestled under Ben Glas, Stob Creag and Ben Fhithich behind.

Last Autumn I blogged on the impact of the Glen Falloch hydro schemes on wild land ([see here](#)) and featured a fine photo from Tom Prentice of the Allt a' Chuillinn hydro track from the head of the glen. If you walk along the wonderful ridge from Ben Glas, above the Ben Glas campsite and Eagle Falls, to Beinn Chabhair and then down Coire a' Chuillinn the destructive impact of this scheme, both on the landscape and wild land experience is only too evident.

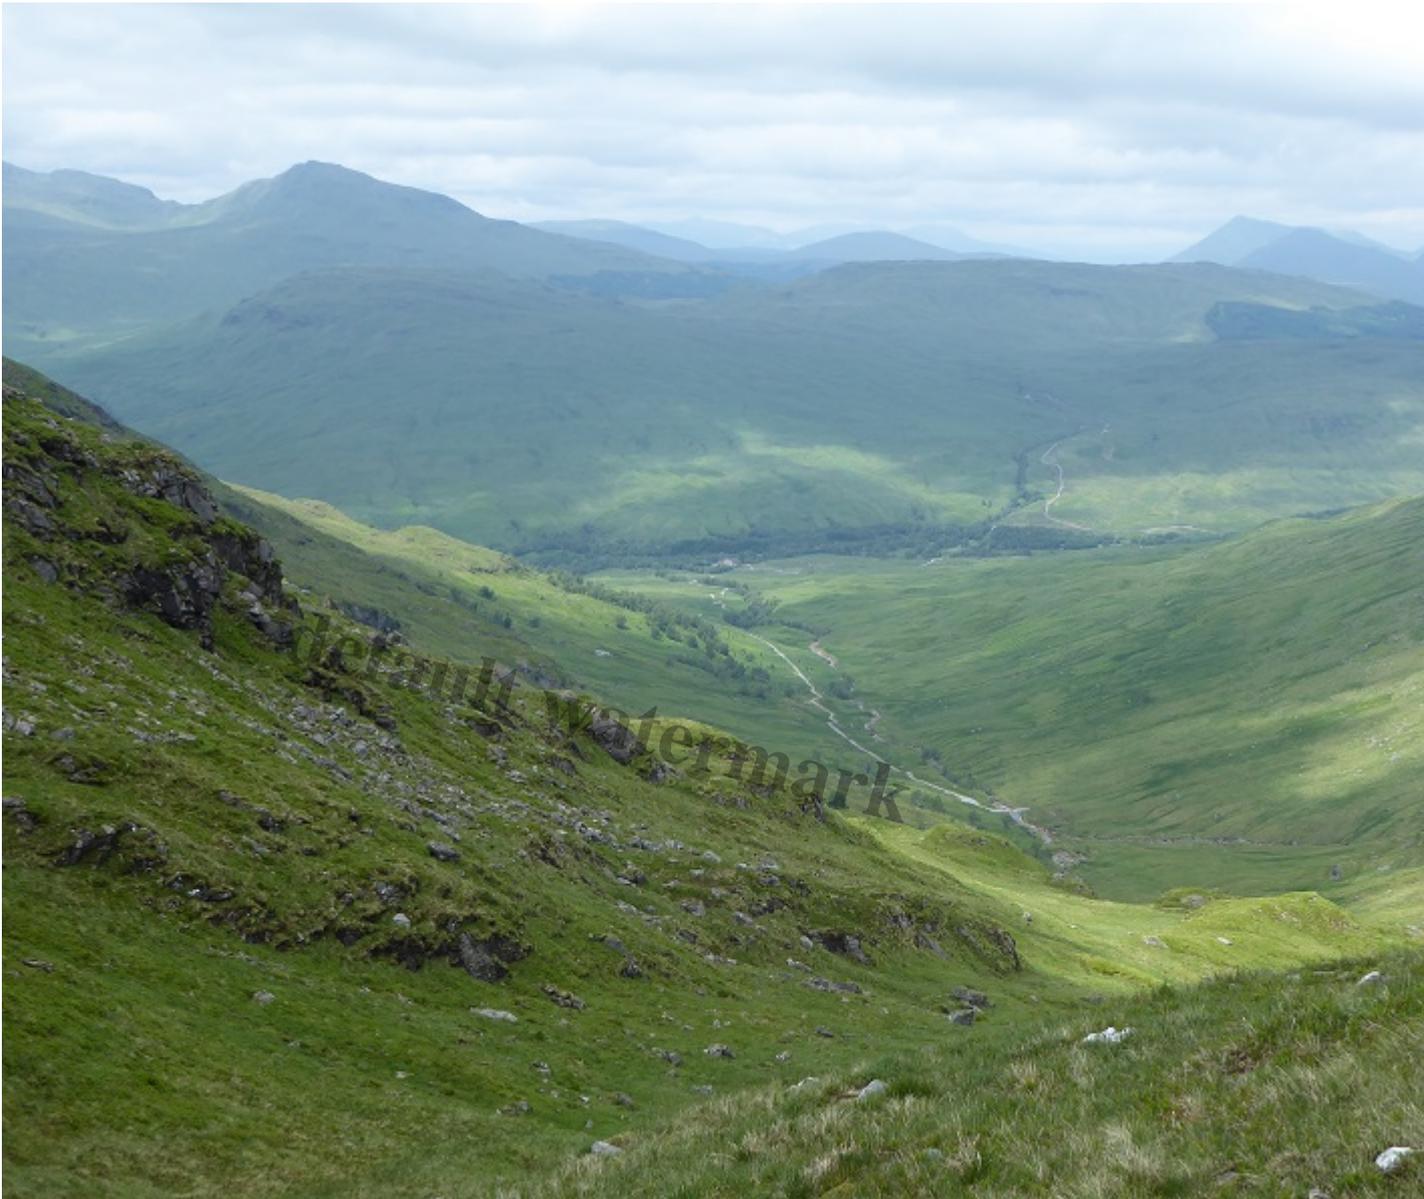
The Allt a Chuillinn track from col Meall nan Tarmachan and Beinn Chabhair with Eas Eonan track of Glen Falloch, Bridge of Orchy hill behind right and Beinn Dubhcraig left

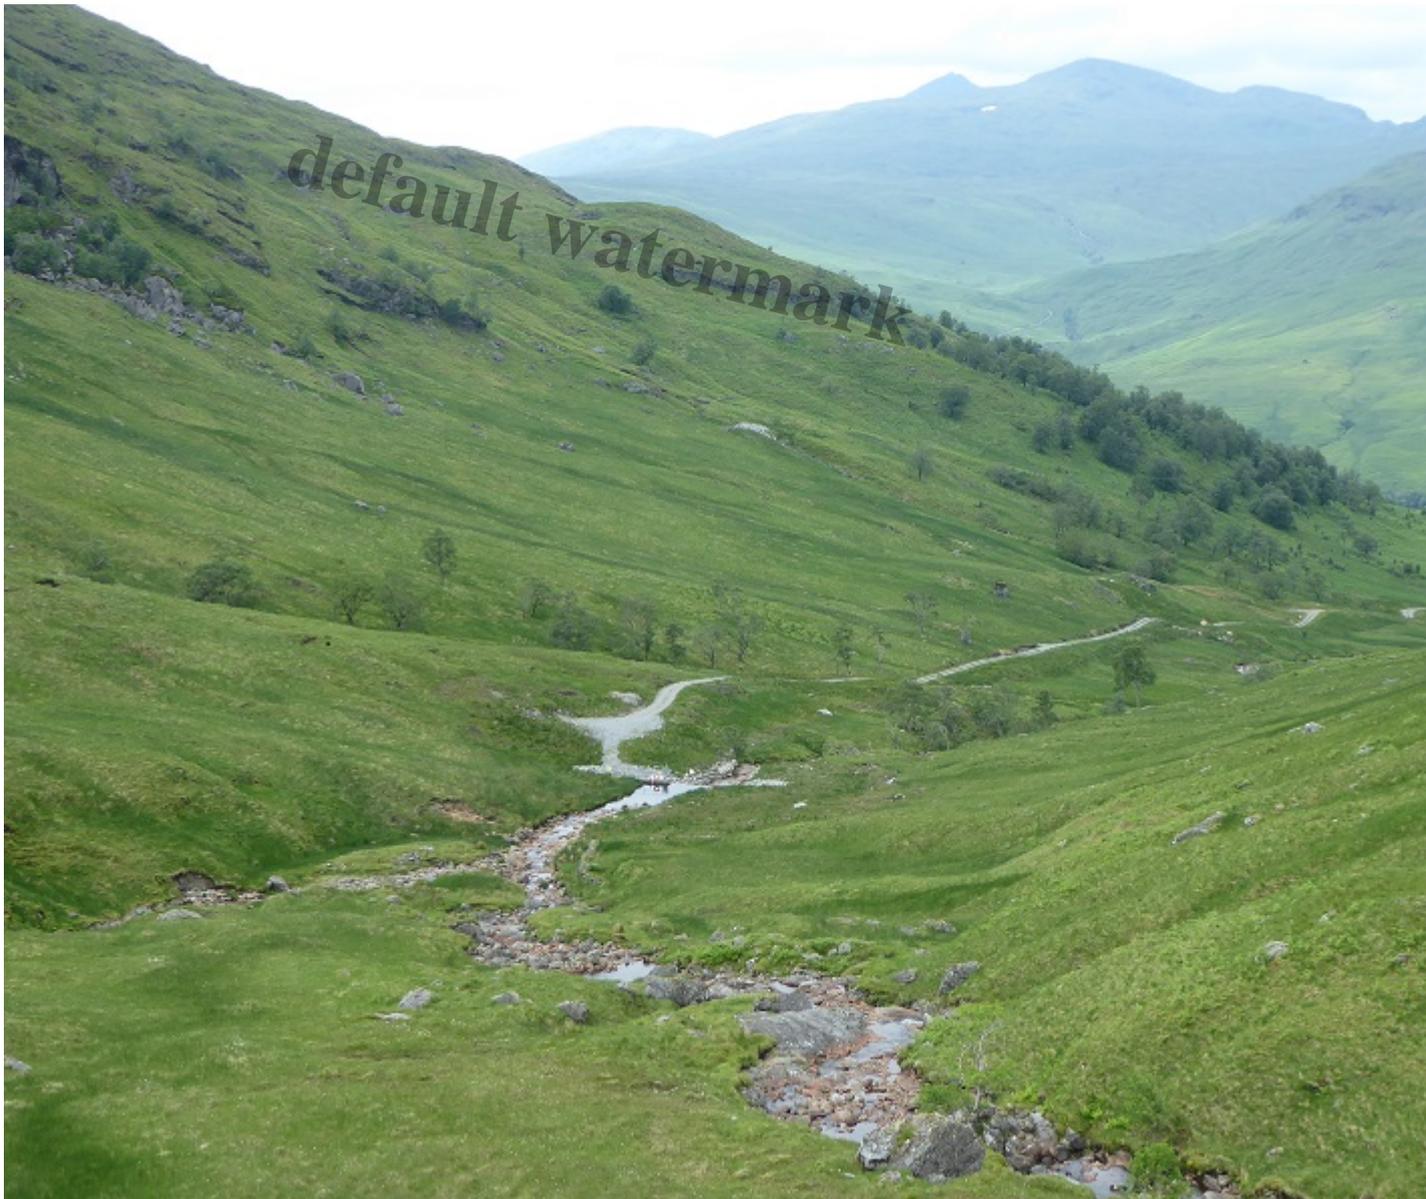
Same view closer up

Unfortunately, the tracks have NOT been restored as originally intended and the Wild Land Area has been permanently damaged. What has SNH said about this? Unfortunately, they defer to the National Park Authorities within our two National Parks that has been a disaster in the Loch Lomond and Trossachs National Park.

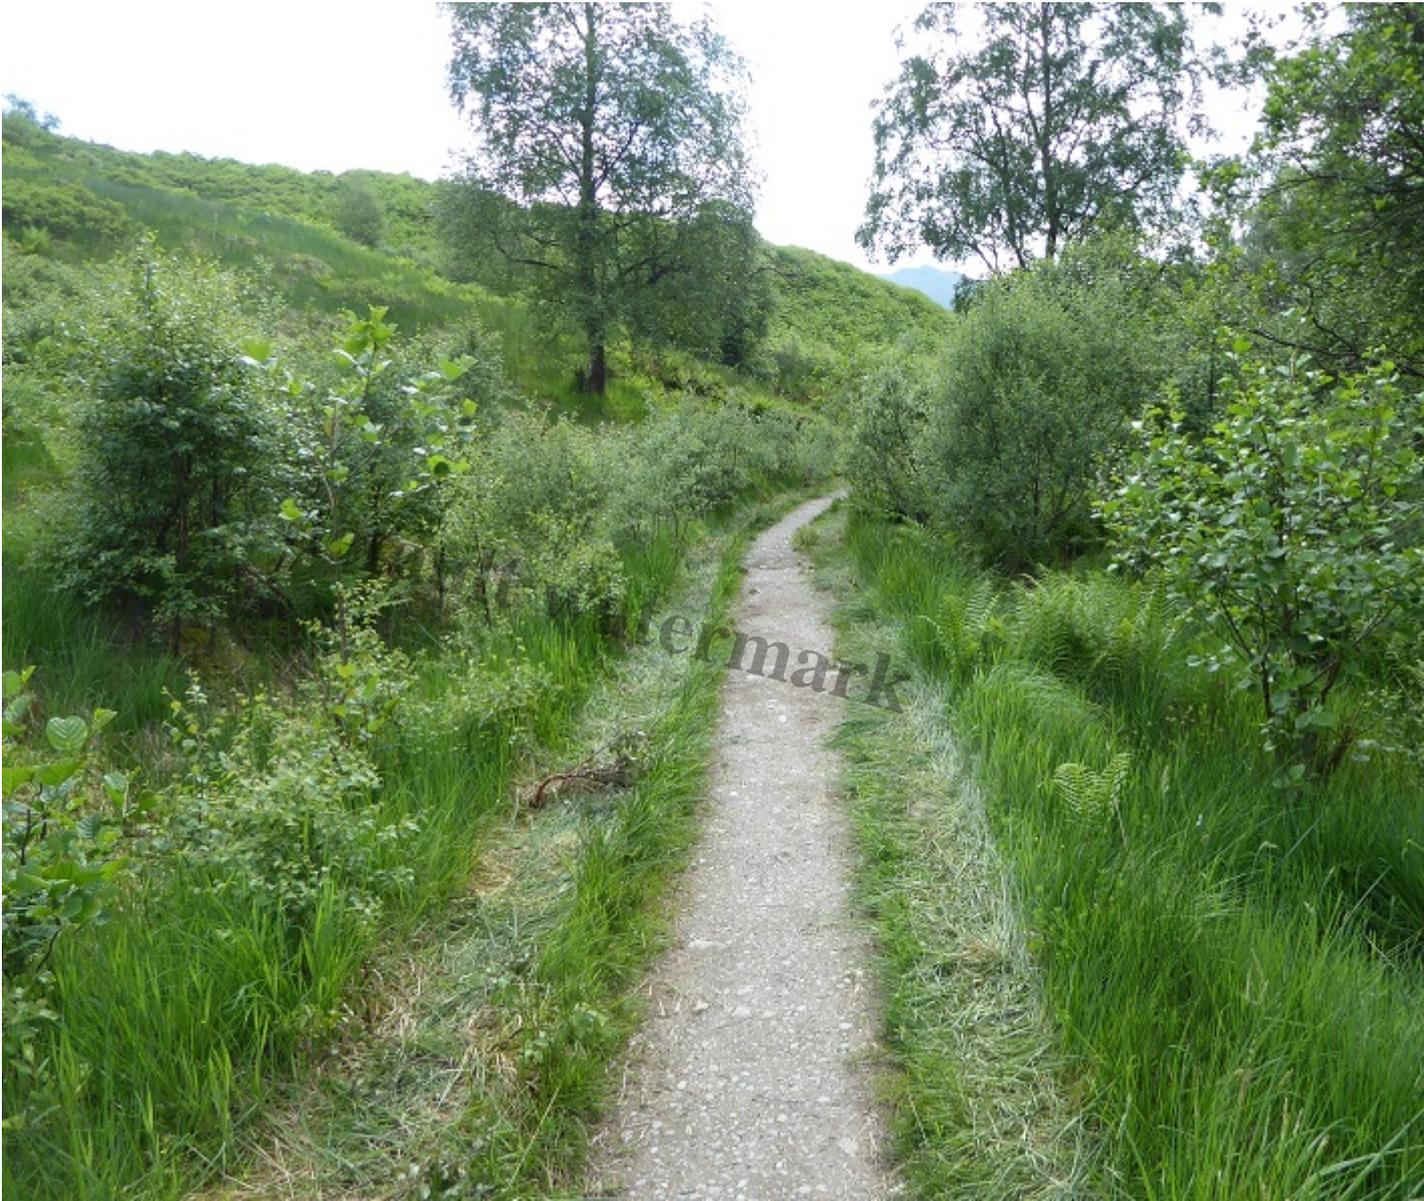
ATV tracks along the West Highland Way – this level of use is not necessarily bad, the vehicle use mows the vegetation on either side of the track keeping it clear for walkers

If the estate can get vehicles along this narrow track what justification is there for the LLTNPA, even on its own logic, approving retention of hydro tracks that are 2.5 to 3m wide in previously unspoilt glens such as along the Allt à Chuillin. A 1.5m wide track would be perfectly adequate for a small ATV to service the hydro intakes and would have less landscape impact and could have been presented as an extension to the path network. This National Park however seems incapable of even imposing such standards and just lets landowners do what they want – for – estate management purposes – as the delegated planning report put it.
