The impact of hydro tracks on the landscape – the Allt a Chuillinn scheme in Glen Falloch

June 18, 2018

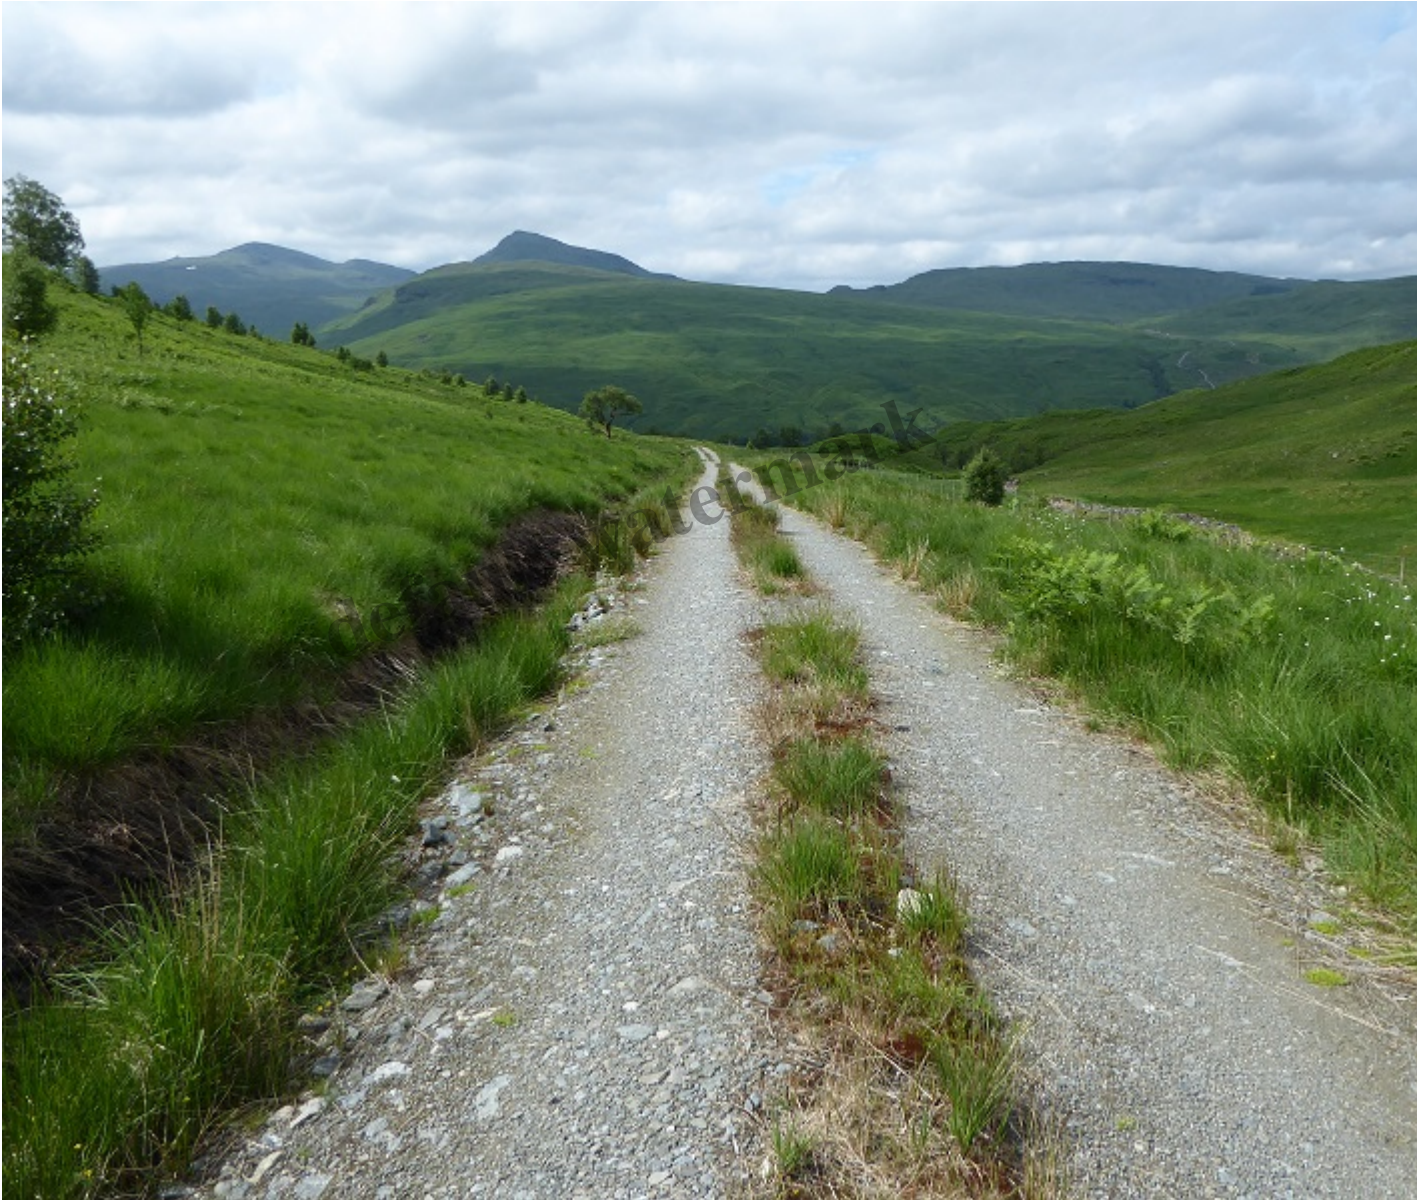
Beinn Dubhcraig and Beinn Oss, far left, from the Allt a' Chuillinn hydro track

Close up, the track to the three Allt a' Chuillinn hydro intakes, which form part of the Derrydarroch hydro scheme in Glen Falloch, does not look too bad. It's been significantly narrowed since construction, the sides covered with vegetation and a central strip of vegetation placed down the middle. It's quite a pleasant walking experience which is why I believe the Loch Lomond and Trossachs National Park Authority brought the Mountaineering Council and Ramblers Scotland here last year to demonstrate what the work they were doing to restore the land after the construction of

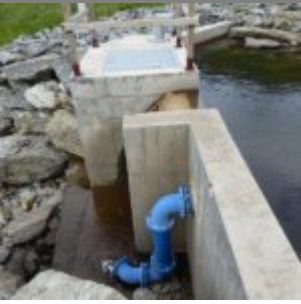
View along the pipe which leads down from the second intake

While there is no track up the second intake and the ground above the pipe is

recovering quite well, its location is all too evident from the spill of boulders which contrasts with the surrounding grassland. Why wooden restraining rails were used here and not at the main intake, as per the LLTNPA own good practice guidance, is unclear and the penstock has been left bright blue. The equally bright yellow danger signs warn people of the danger of pools, health and safety gone mad, when most of the side burns and the Allt a'Chuilin itself contain similar pools.

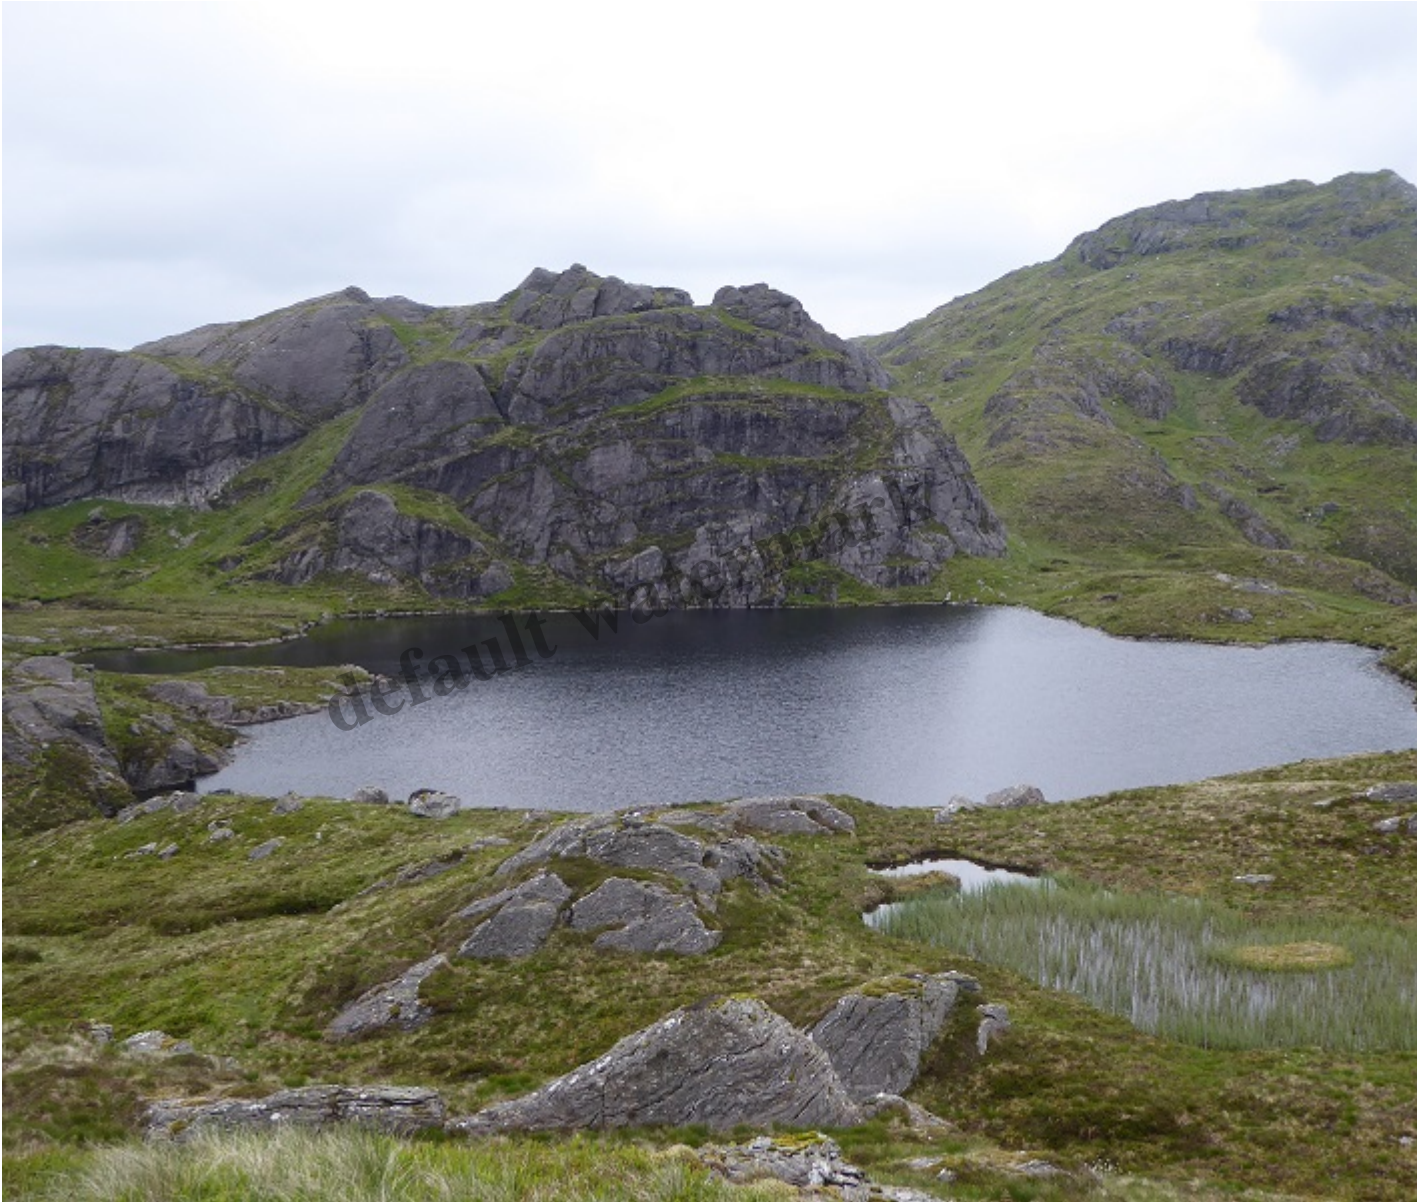
The well named Lochan a Chaisteal – lochan of the castle – nestled under Ben Glas, Stob Creag and behind.

Last Autumn I blogged on the impact of the Glen Falloch hydro schemes on wild land ([see here](#)) and featured a fine photo from Tom Prentice of the Allt a' Chuillinn hydro track from the head of the glen. If you walk along the wonderful ridge from Ben Glas, above the Ben Glas campsite and Eagle Falls, to Beinn Chabhair and then down Coire a' Chuillinn the destructive impact of this scheme, both on the landscape and wild land experience is only too evident.

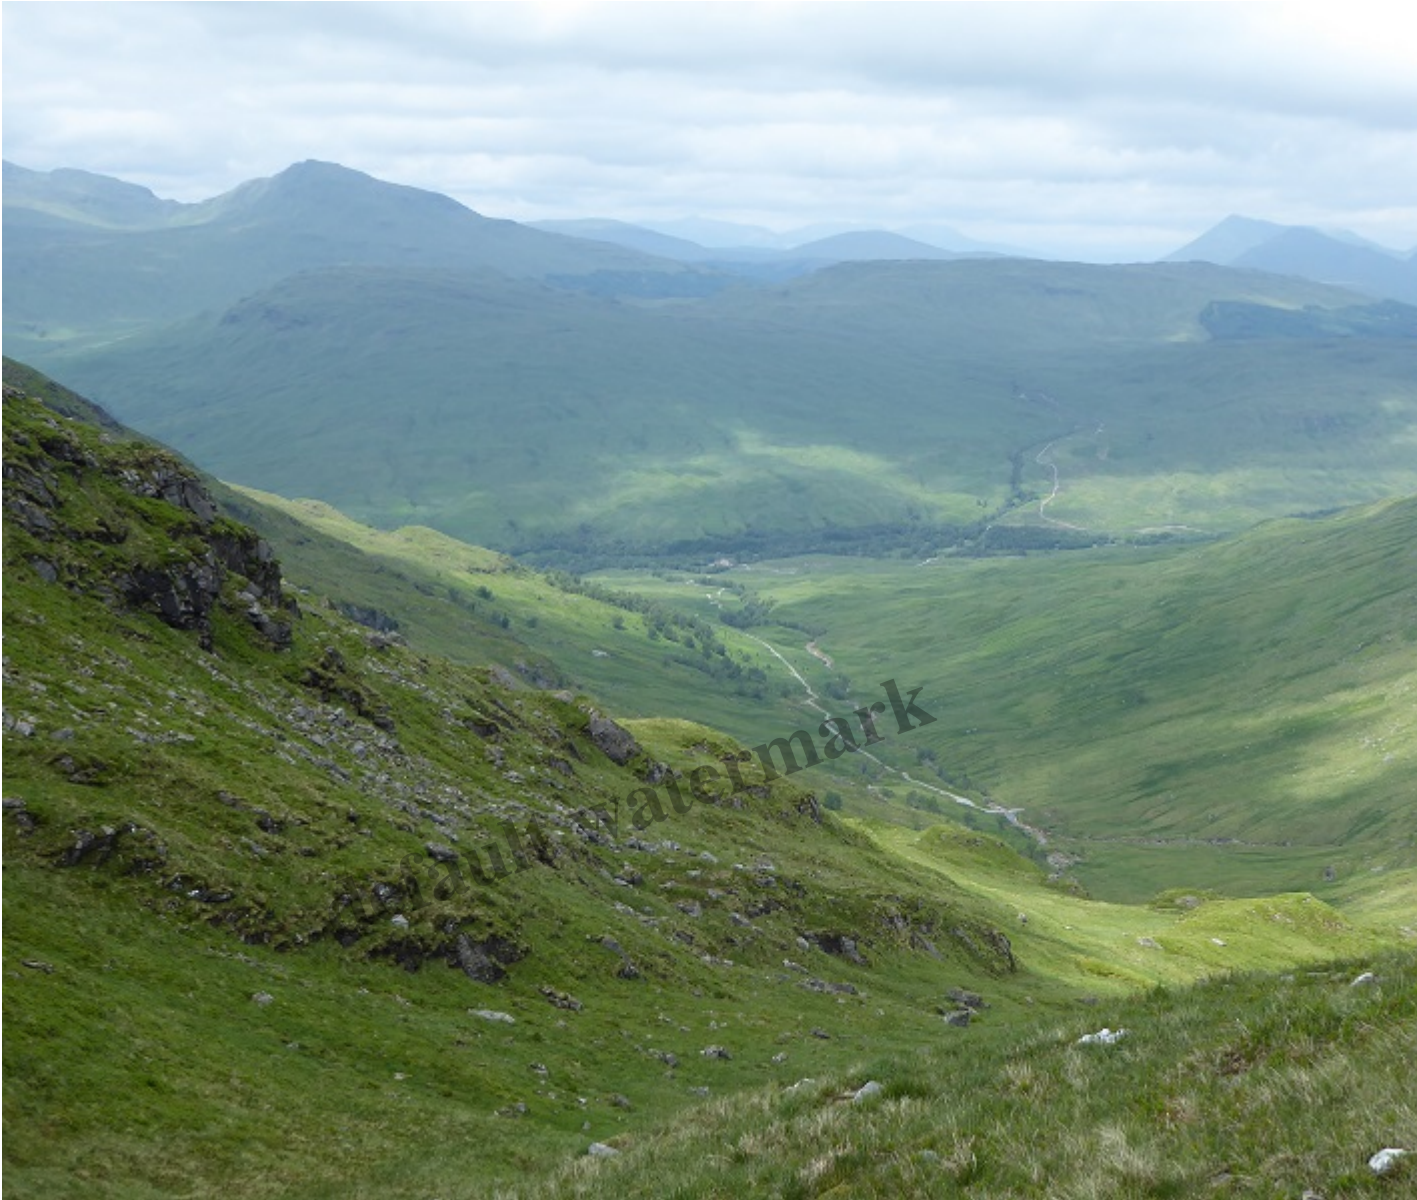
While the A82 and West Highland line are hidden in trees, the new tracks provide a stark contrast to the surrounding landscape.

The Allt a Chuillinn track from col Meall nan Tarmachan and Beinn Chabhair with Eas Eonan track of Glen Falloch, Bridge of Orchy hill behind right and Beinn Dubhcraig left

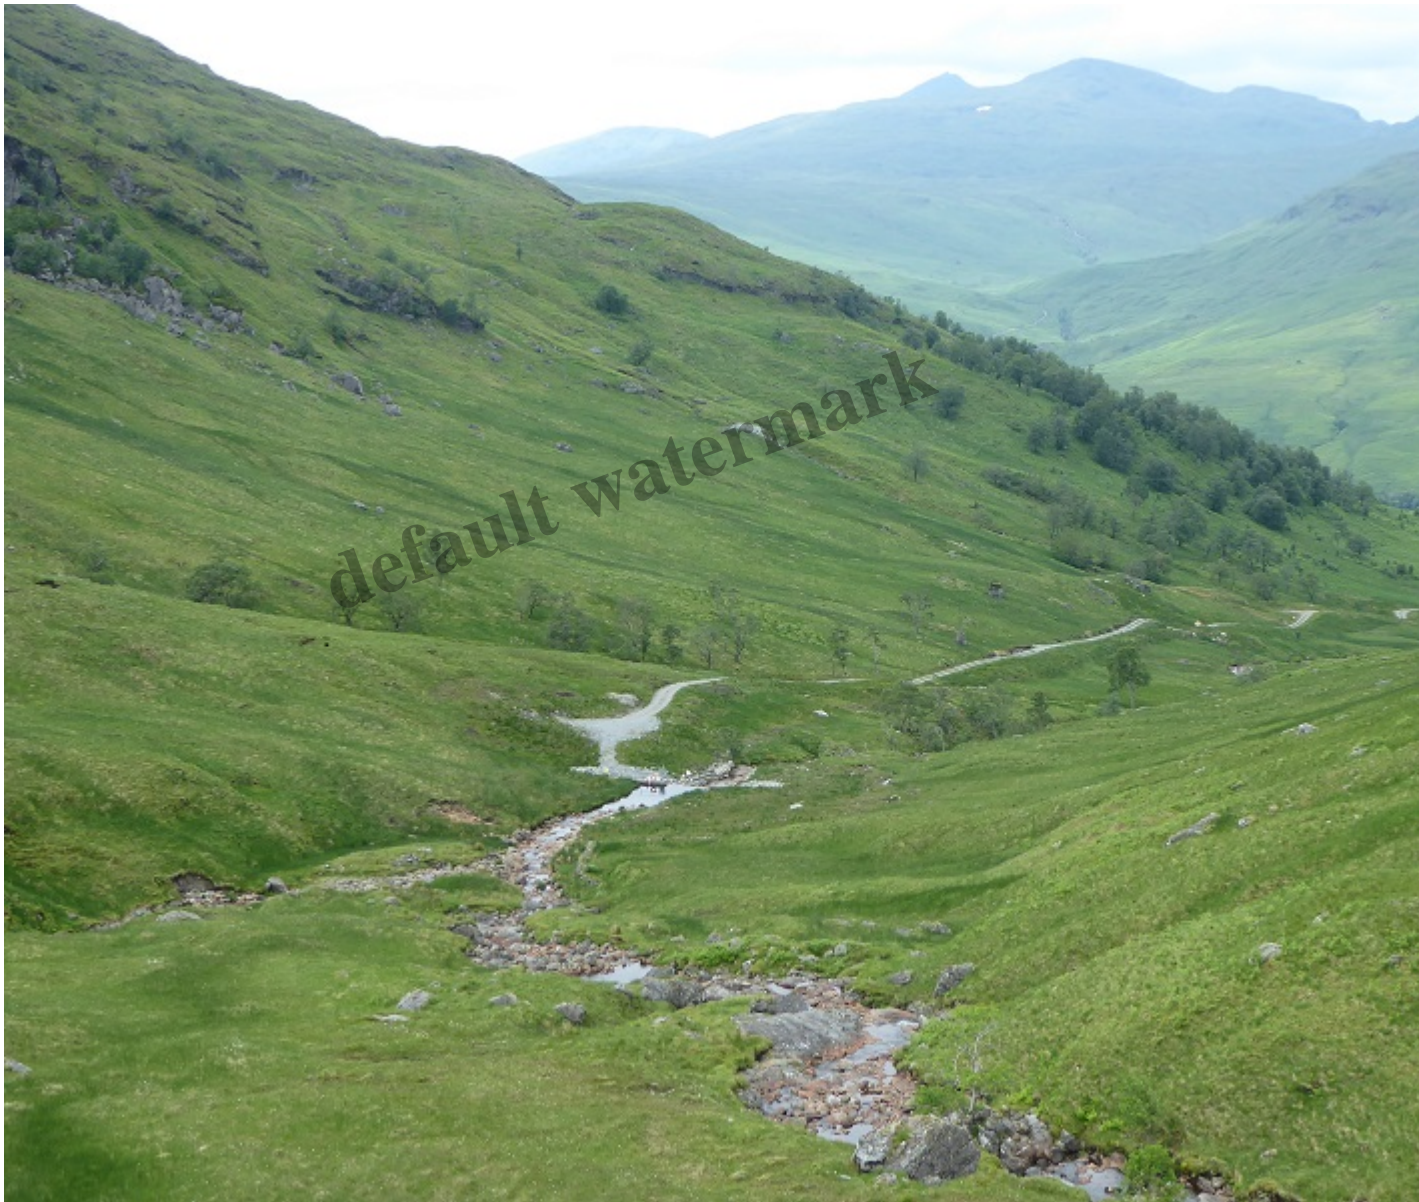
Same view closer up

“Several hydro developments on burns flowing into Glen Falloch, Glen Dochart and Glen Finglas are currently under construction. Although the schemes lie mostly outwith the WLA, they are visible from the open slopes within, affecting the sense of remoteness, sanctuary and solitude. Construction tracks are often the most obvious feature prior to restoration, due to the contrast in colour against the subdued tones of the moorland.”

Unfortunately, the tracks have NOT been restored as originally intended and the Wild Land Area has been permanently damaged. What has SNH said about this? Unfortunately, they defer to the National Park Authorities within our two National Parks – that has been a disaster in the Loch Lomond and Trossachs National Park.

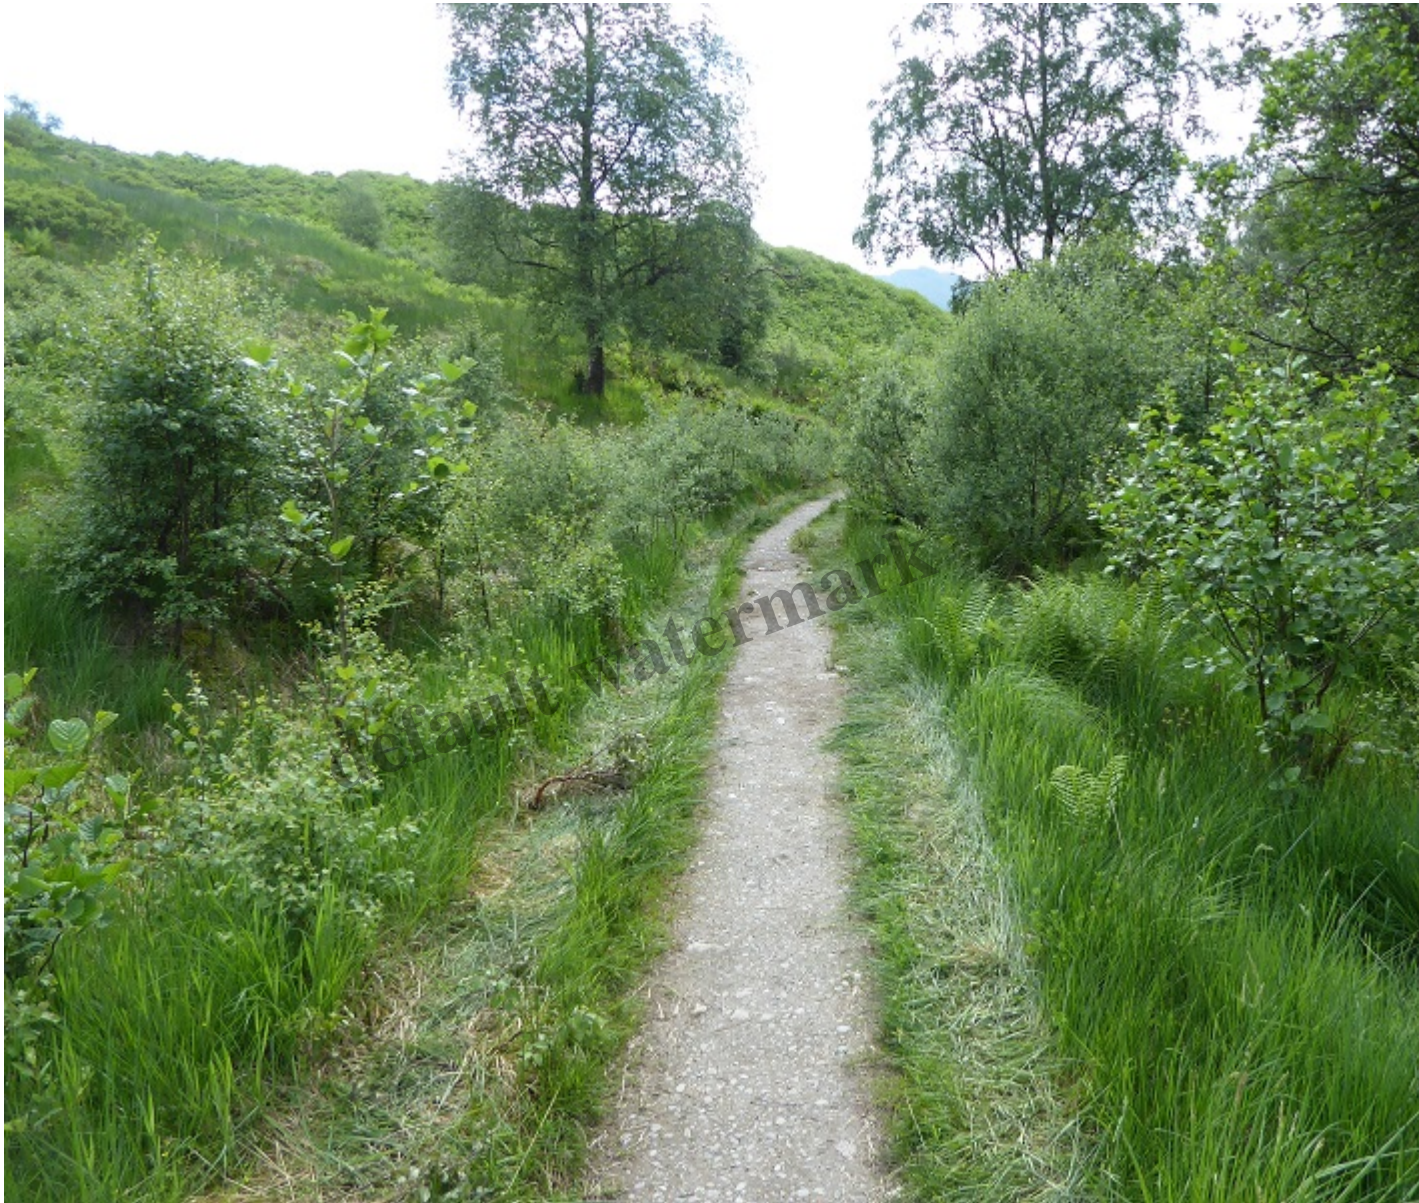
ATV tracks along the West Highland Way – this level of use is not necessarily bad, the vehicle use in fact mows the vegetation on either side of the track keeping it clear for walkers

If the estate can get vehicles along this narrow track what justification is there for the LLTNPA, even on its own logic, approving retention of hydro tracks that are 2.5 to 3m wide in previously unspoilt glens such as along the Allt a' Chuillin. A 1.5m wide track would be perfectly adequate for a small ATV to service the hydro intakes and would have less landscape impact and could have been presented as an extension to the path network. This National Park however seems incapable of even imposing such standards and just lets landowners do what they want – for “*estate management purposes*” as the delegated planning report put it.
