The impact of hydro tracks on the landscape – the Allt a Chuillinn scheme in Glen Falloch

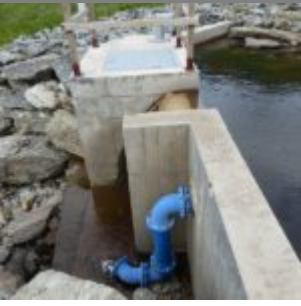
View along the pipe which leads down from the second intake

While there is no track up the second intake and the ground above the pipe is

recovering quite well, its location is all too evident from the spill of boulders which contrasts with the surrounding grassland. Why wooden restraining rails were used here and not at the main intake, as per the LLTNPA own good practice guidance, is unclear and the penstock has been left bright blue. The equally bright yellow danger signs warn people of the danger of pools, health and safety gone mad, when most of the side burns and the Allt a'Chuilin itself contain similar pools.

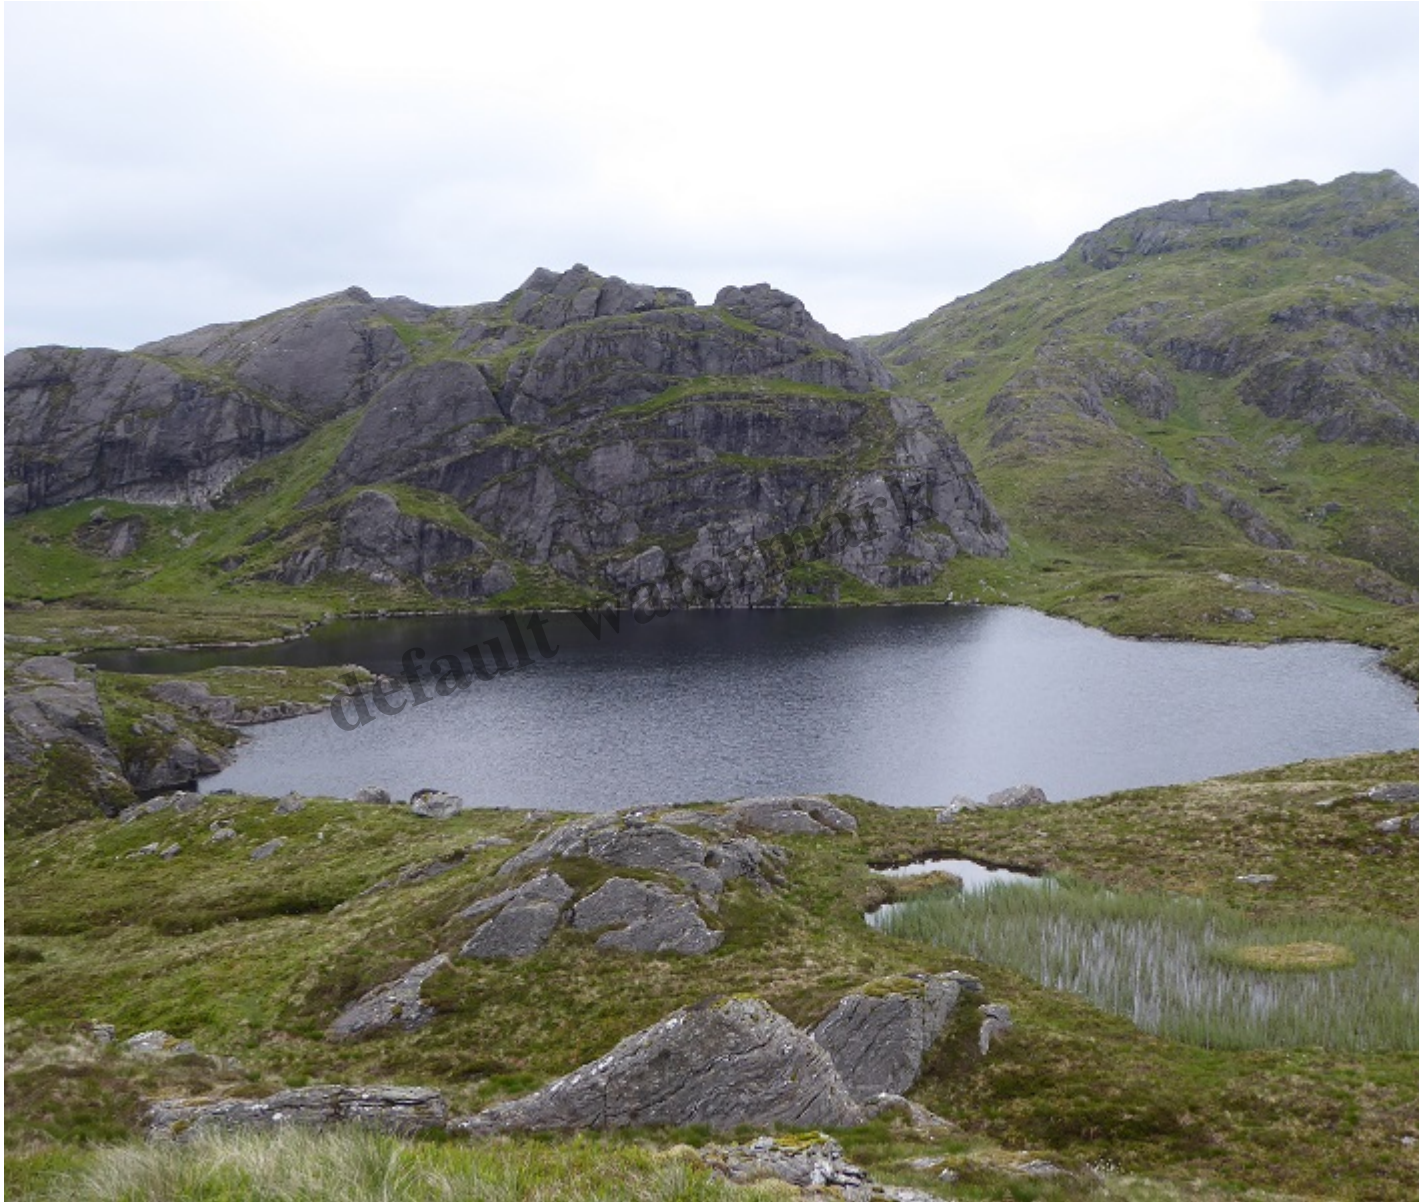
The well named Lochan a Chaisteal – lochan of the castle – nestled under Ben Glas, Stob Creag and behind.

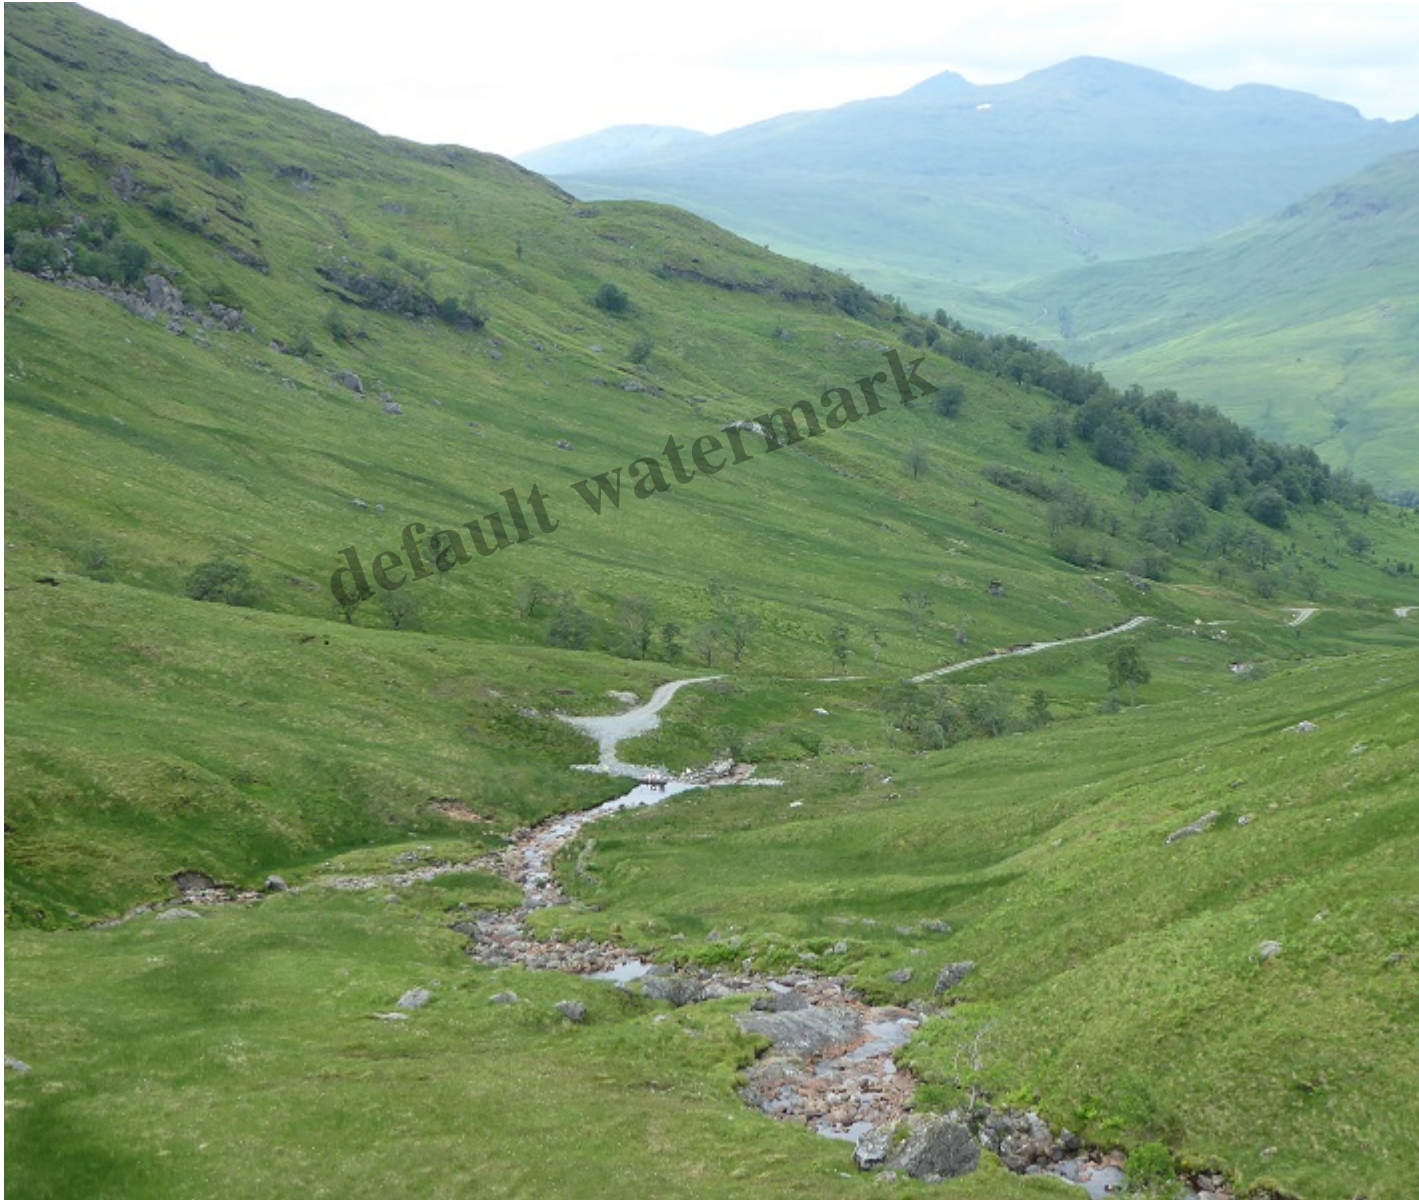
Same view closer up

“Several hydro developments on burns flowing into Glen Falloch, Glen Dochart and Glen Finglas are currently under construction. Although the schemes lie mostly outwith the WLA, they are visible from the open slopes within, affecting the sense of remoteness, sanctuary and solitude. Construction tracks are often the most obvious feature prior to restoration, due to the contrast in colour against the subdued tones of the moorland.”

Unfortunately, the tracks have NOT been restored as originally intended and the Wild Land Area has been permanently damaged. What has SNH said about this? Unfortunately, they defer to the National Park Authorities within our two National Parks – that has been a disaster in the Loch Lomond and Trossachs National Park.

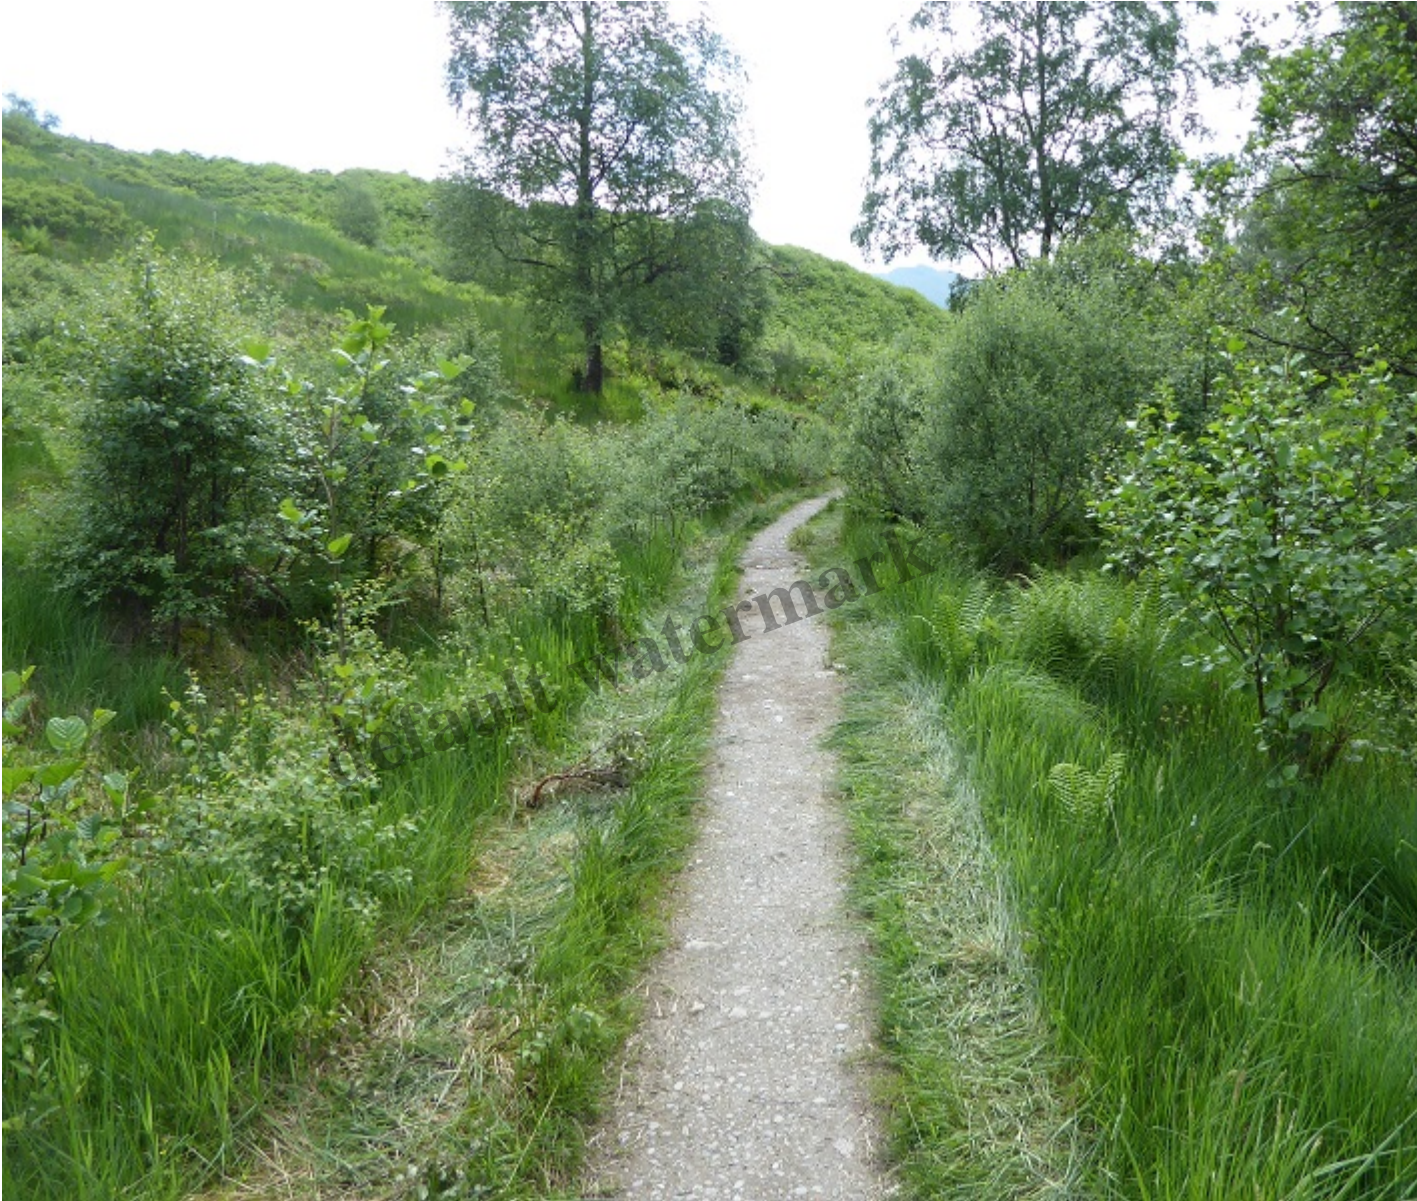
ATV tracks along the West Highland Way – this level of use is not necessarily bad, the vehicle use in fact mows the vegetation on either side of the track keeping it clear for walkers

If the estate can get vehicles along this narrow track what justification is there for the LLTNPA, even on its own logic, approving retention of hydro tracks that are 2.5 to 3m wide in previously unspoilt glens such as along the Allt a' Chuillin. A 1.5m wide track would be perfectly adequate for a small ATV to service the hydro intakes and would have less landscape impact and could have been presented as an extension to the path network. This National Park however seems incapable of even imposing such standards and just lets landowners do what they want – for “*estate management purposes*” as the delegated planning report put it.
