Glen Falloch – the destruction caused by the Eas Eonan hydro scheme

Birds eye view of central section of Eas Eonan scheme June 2018 showing the landscape impact of The line of the buried pipe has been accentuated by the dry weather.

early July. It forms part of the Derrydarroch Hydro Scheme.

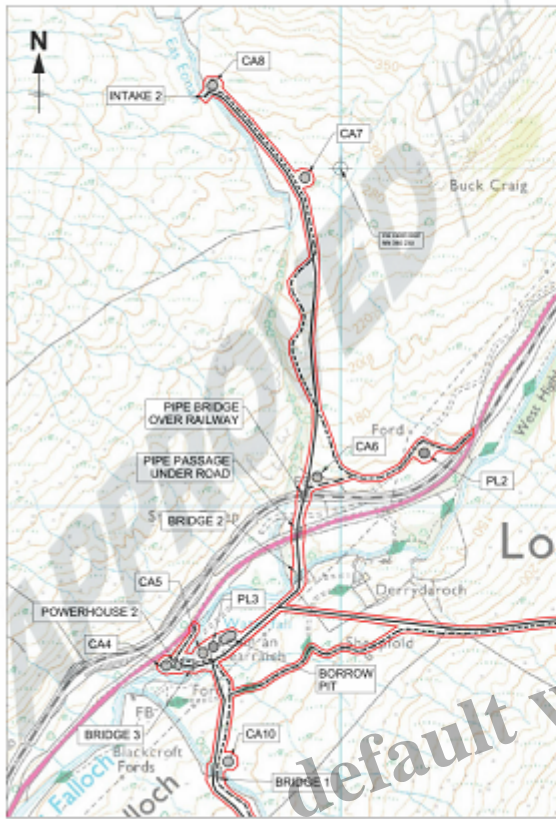
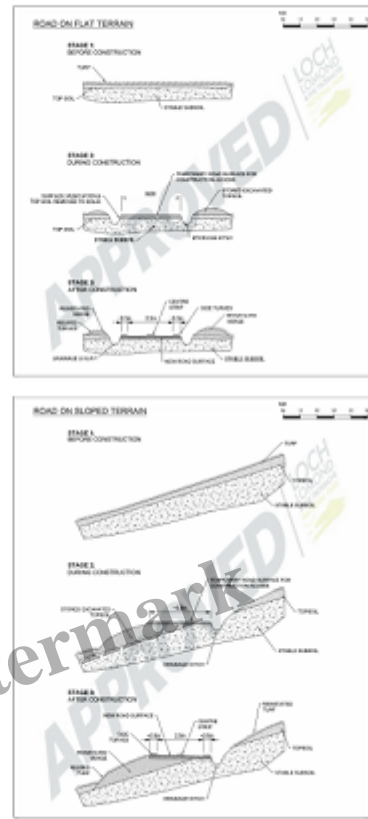
ENHANCED PLAN OF ACCESS TO INTAKE 2

Approved plan from LLTNPA planning portal for the access tracks – Eas Eonan is Intake 2 for the Derrydarroch hydro schemes, the other intakes being south of the River Falloch
