Glen Falloch – the destruction caused by the Eas Eonan hydro scheme

August 2, 2018

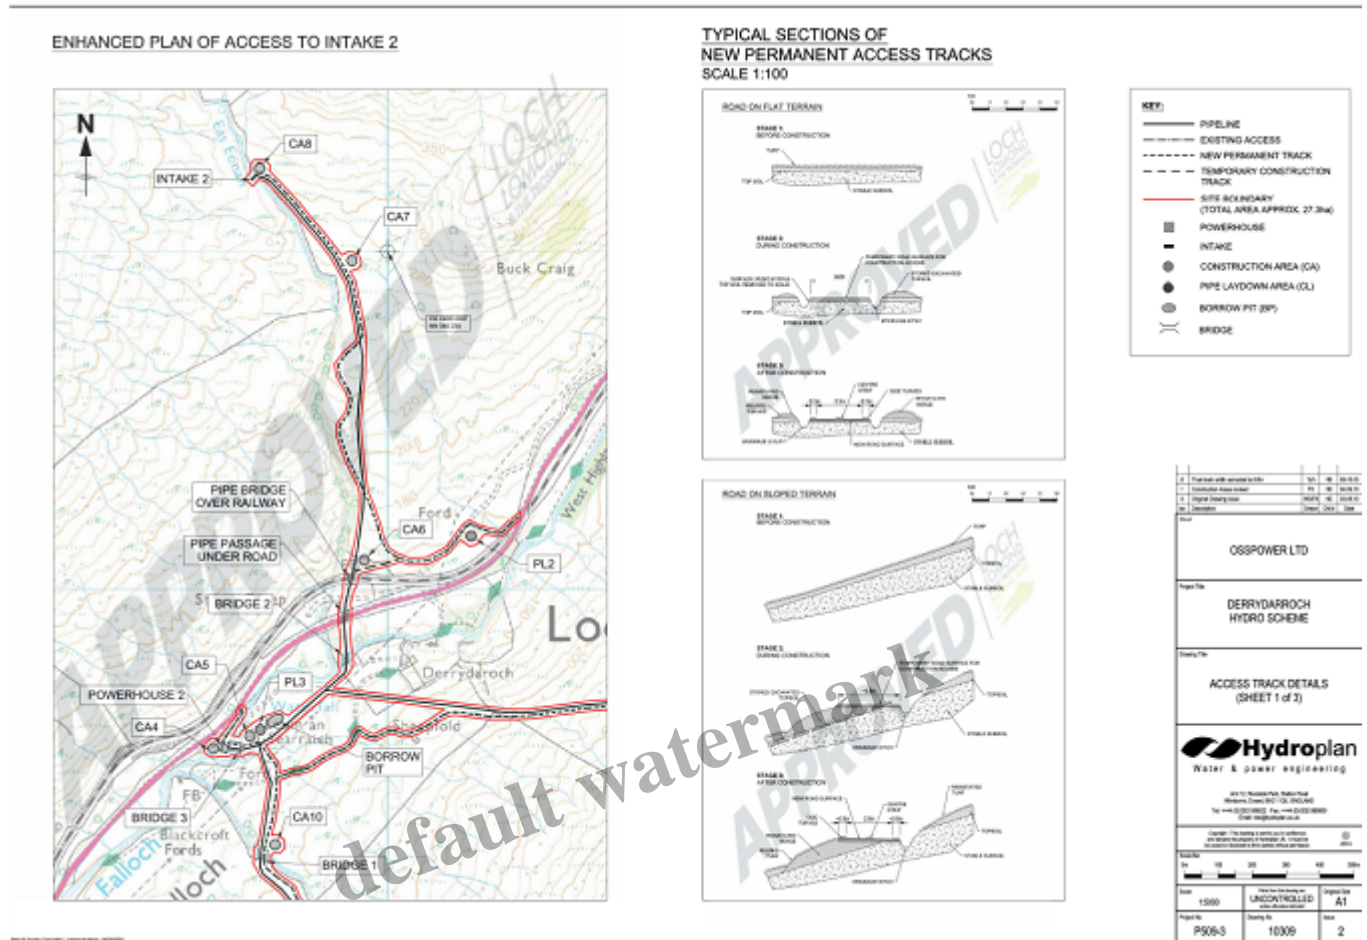
Approved plan from LLTNPA planning portal for the access tracks – Eas Eonan is Intake 2 for the Derrydarroch hydro schemes, the other intakes being south of the River Falloch
