The Keltie Water hydro scheme and Scottish quality awards for planning

Background to the Keltie Water hydro scheme

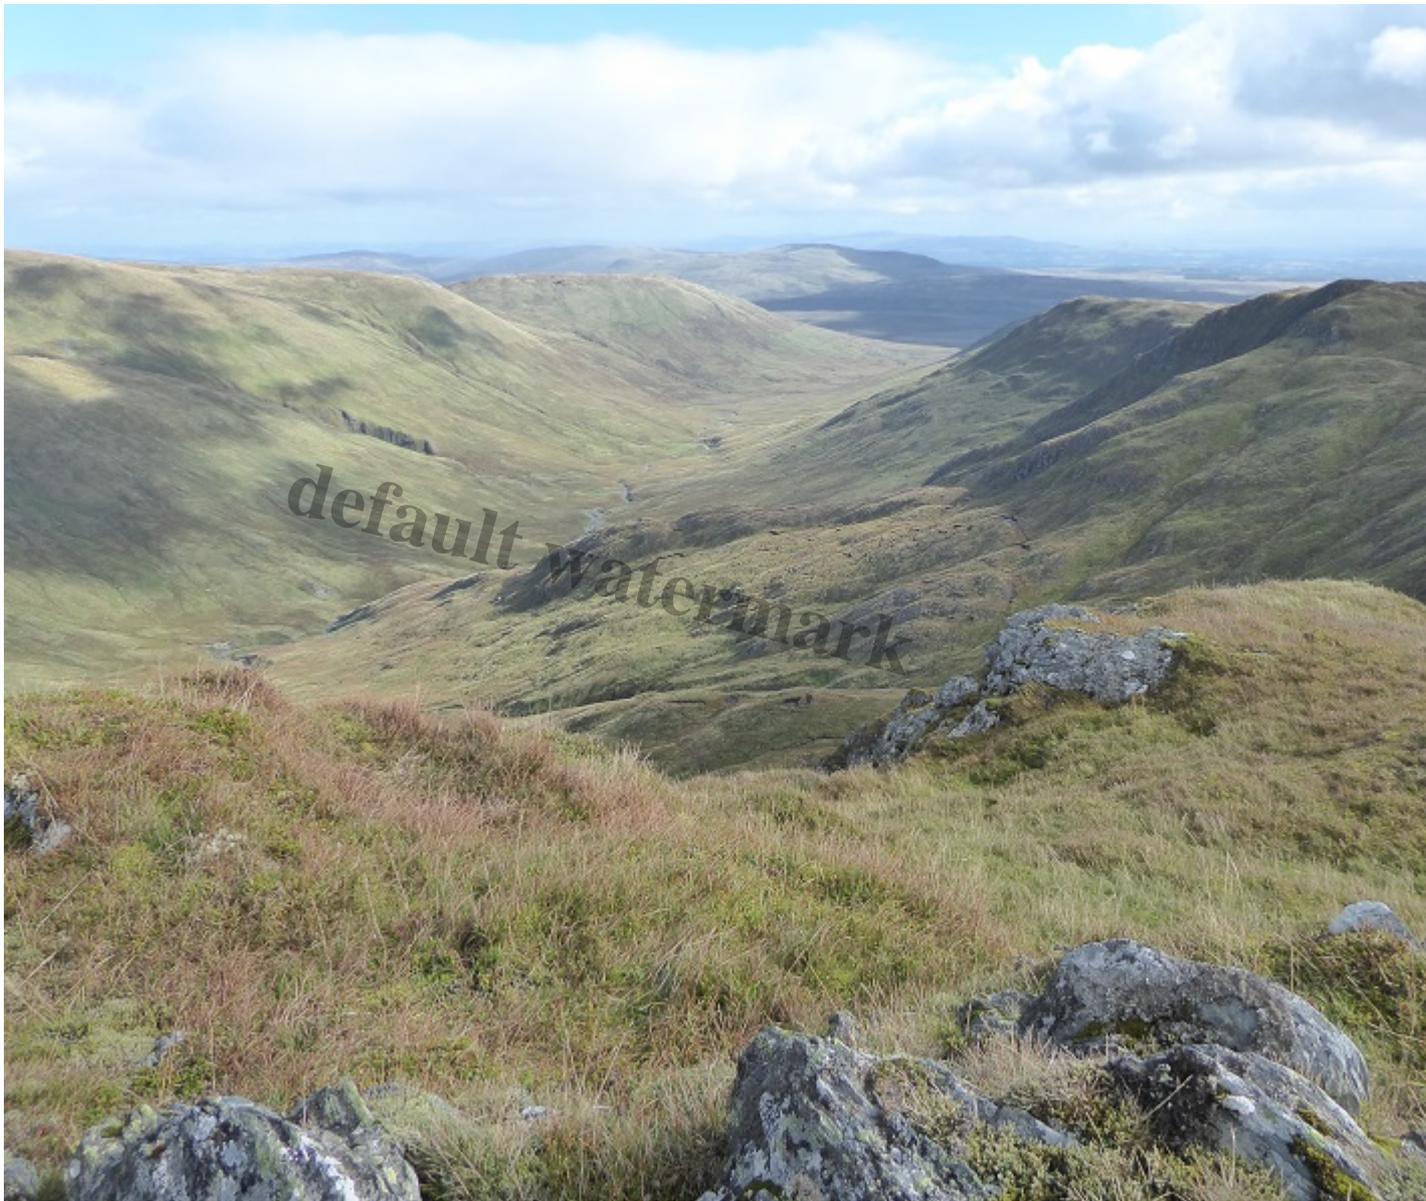
Looking down Gleann a Chroin along the upper reaches of the Keltie Water from near the summit of ...
The hydro scheme is out of sight and the glen unspoilt.

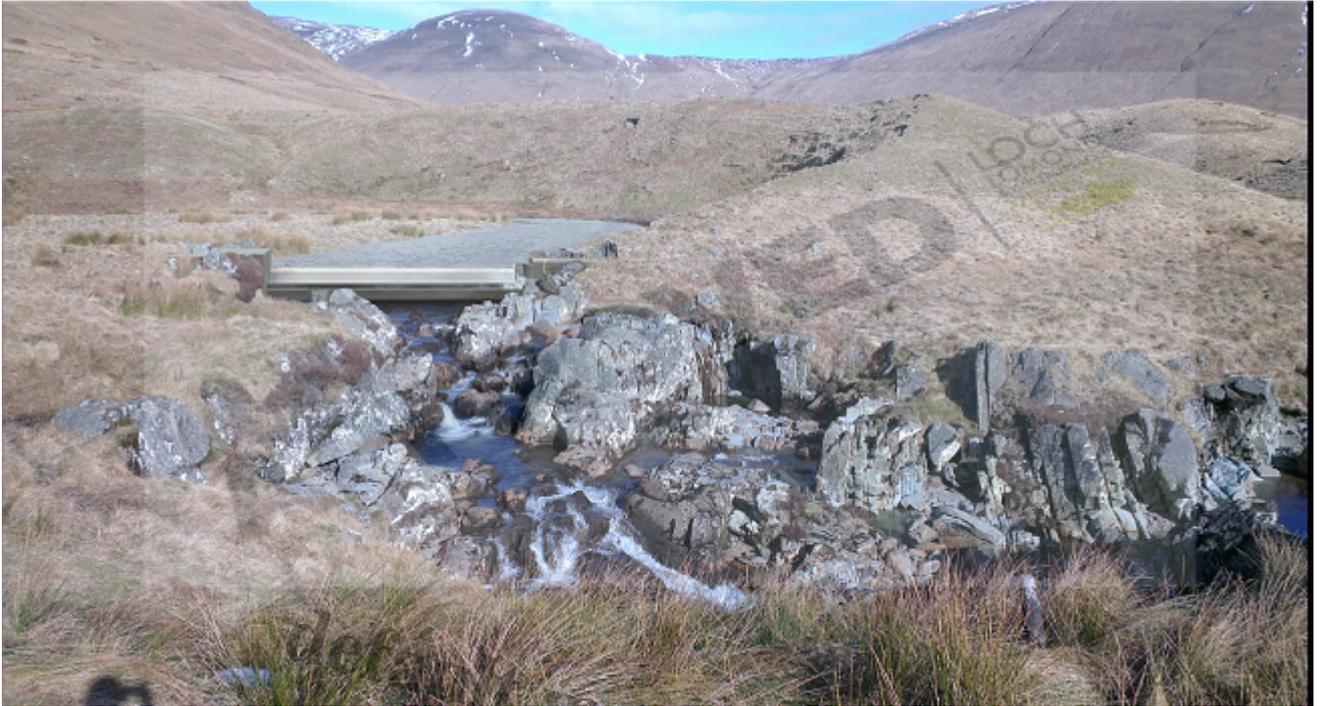
Photomontage of secondary intake from original planning application

The original photomontage failed to show either the new section of access track or the rip rap bouldering which is unlikely to revegetate

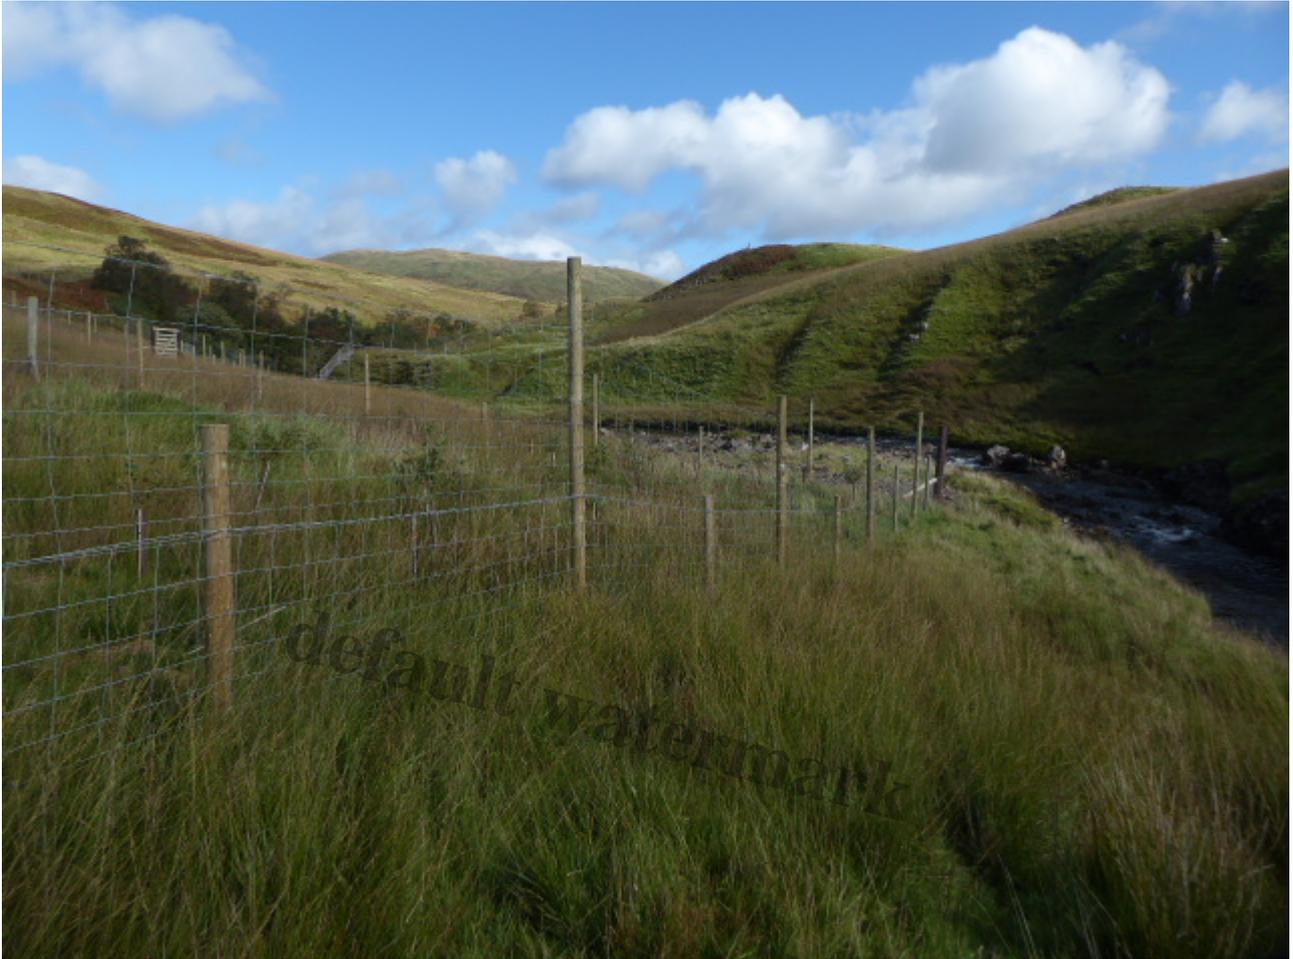
New woodland enclosure north of power house with existing native woodland beyond

As for the small fenced enclosures of new native woodland, which the LLTNPA claims as a success, well that is pretty common in hydro schemes and I think the question the LLTNPA should be asking is whether this is sufficient to justify/compensate for all the rush?
