The Keltie Water hydro scheme and Scottish quality awards for planning

Background to the Keltie Water hydro scheme

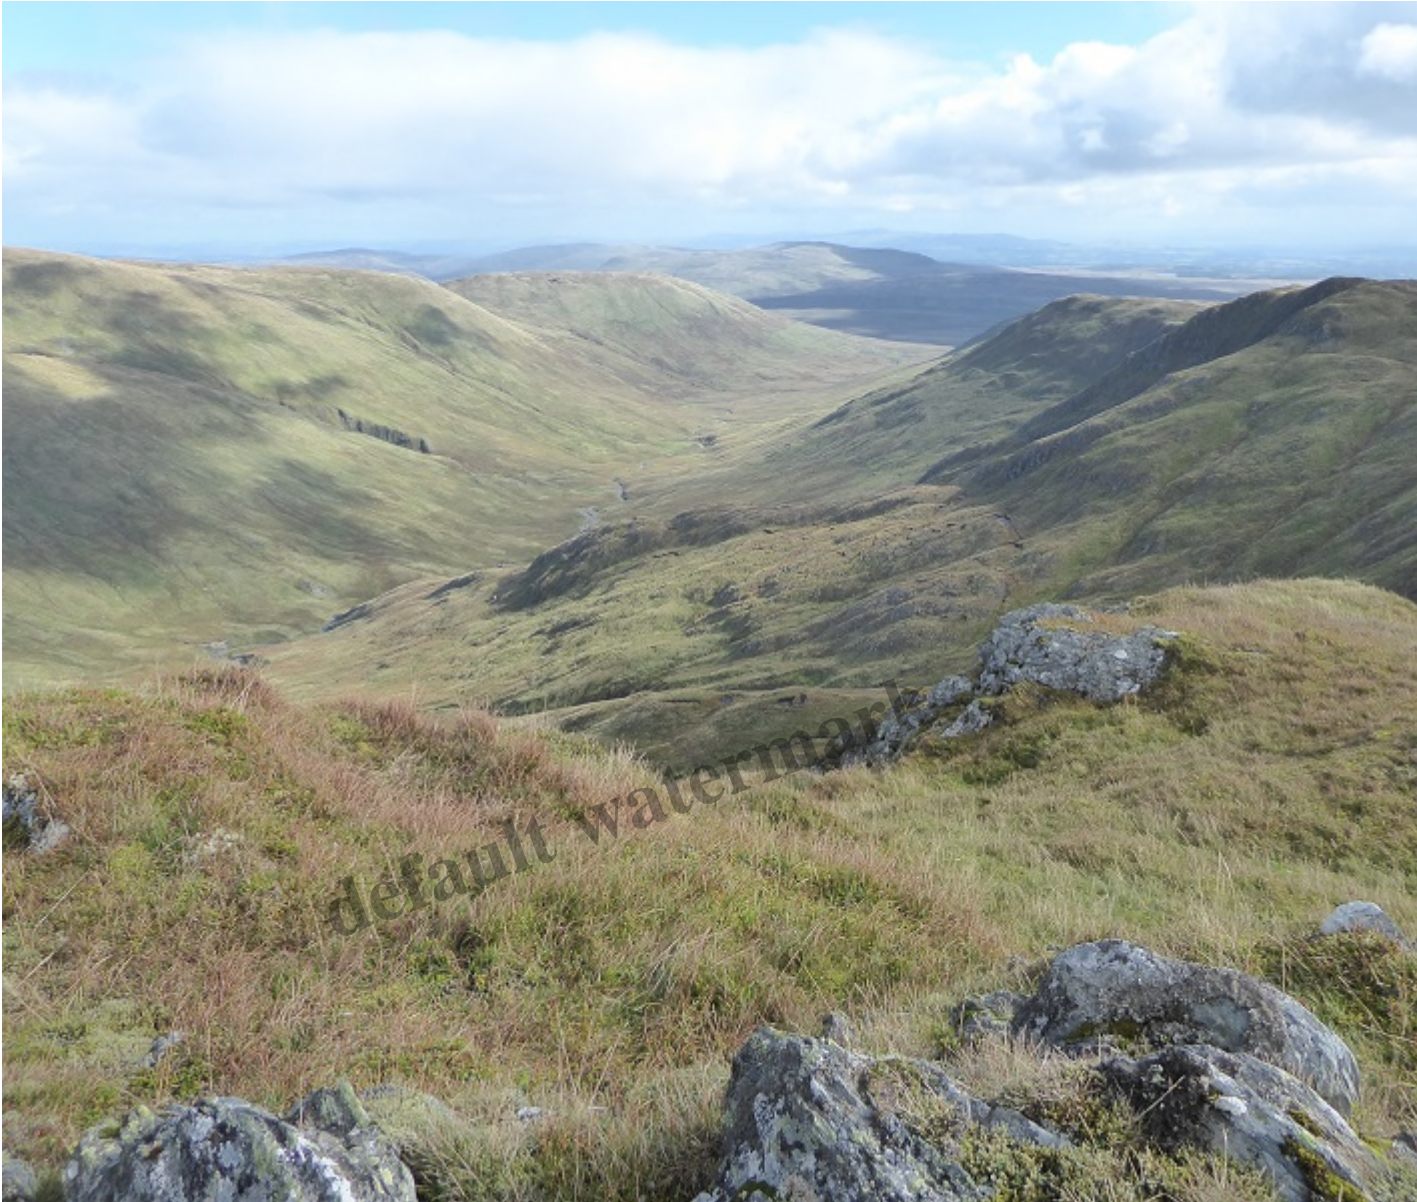
Looking down Gleann a Chroin along the upper reaches of the Keltie Water from near the summit of
The hydro scheme is out of sight and the glen unspoilt.

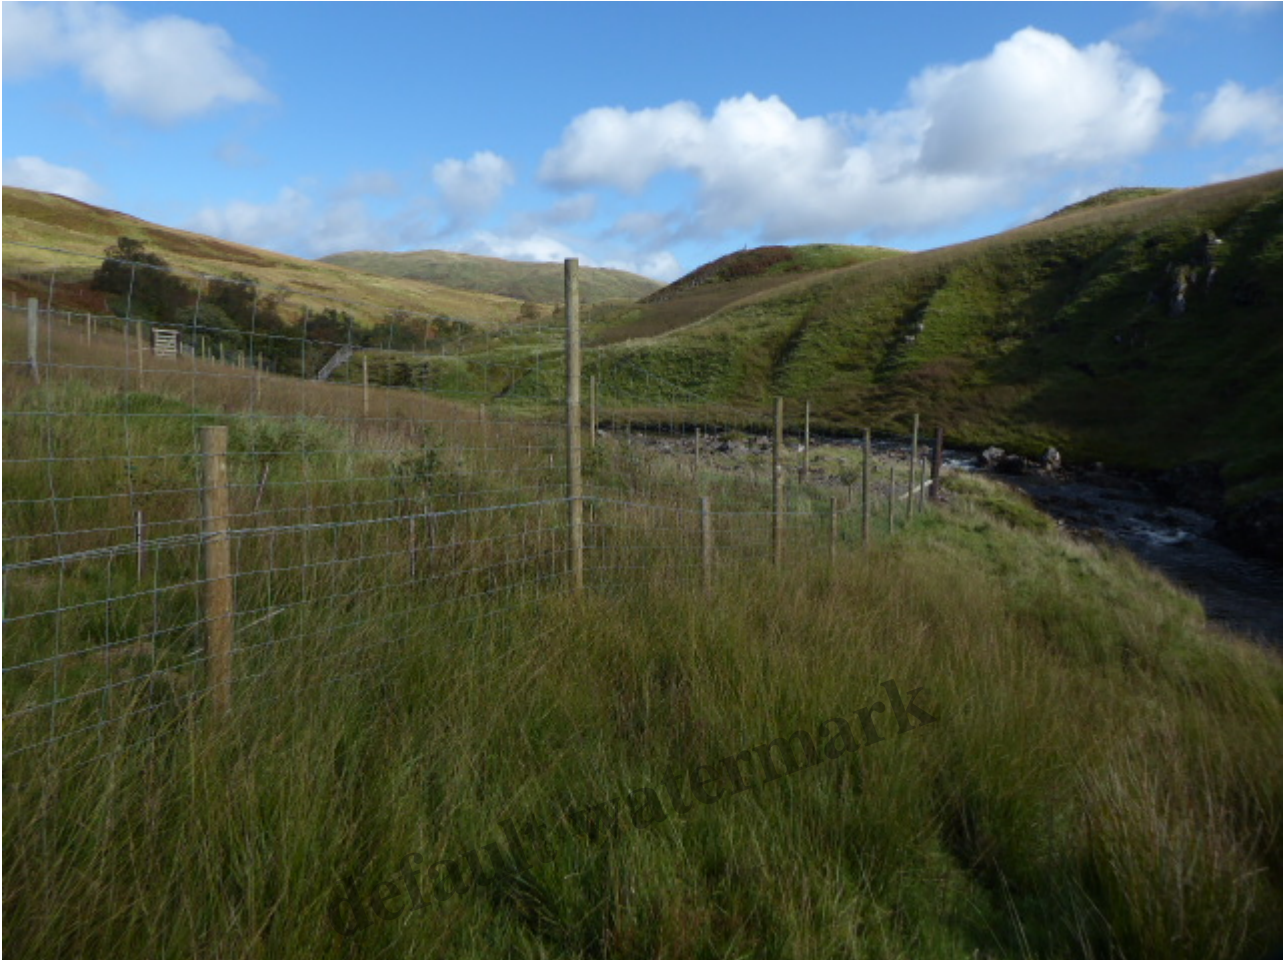
New woodland enclosure north of power house with existing native woodland beyond

As for the small fenced enclosures of new native woodland, which the LLTNPA claims as a success, well that is pretty common in hydro schemes and I think the question the LLTNPA should be asking is whether this is sufficient to justify/compensate for all the rush?
