The Keltie Water hydro scheme and Scottish quality awards for planning

Background to the Keltie Water hydro scheme

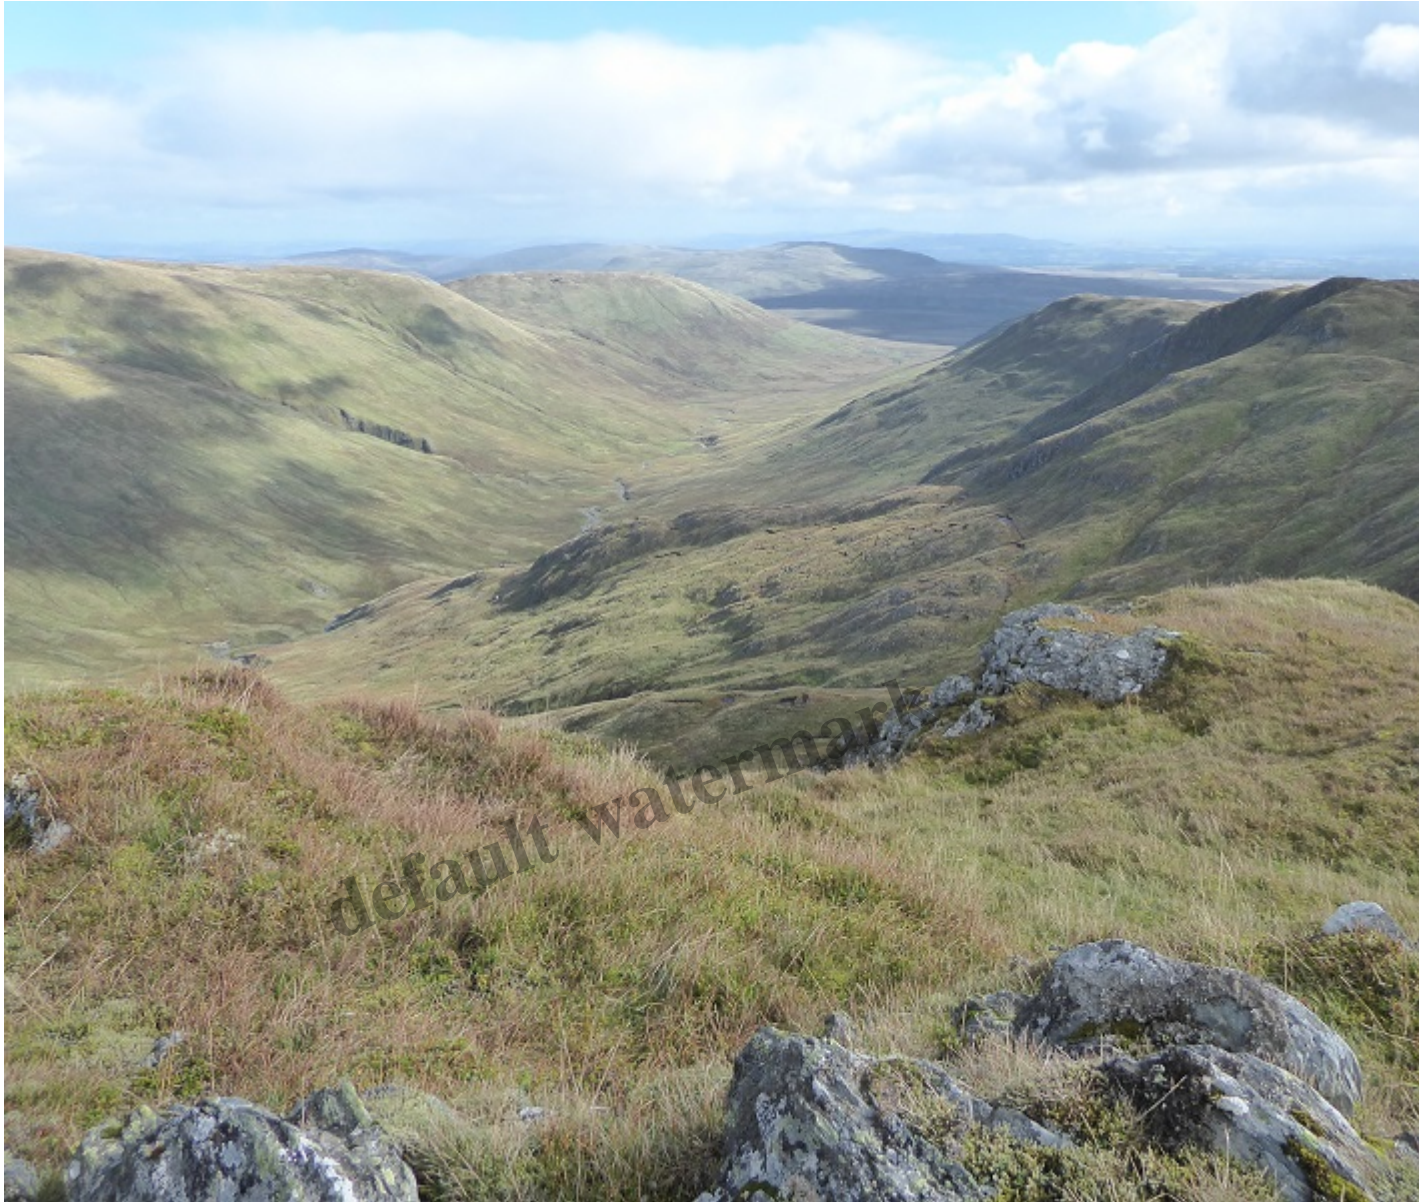
Looking down Gleann a Chroin along the upper reaches of the Keltie Water from near the summit of
The hydro scheme is out of sight and the glen unspoilt.

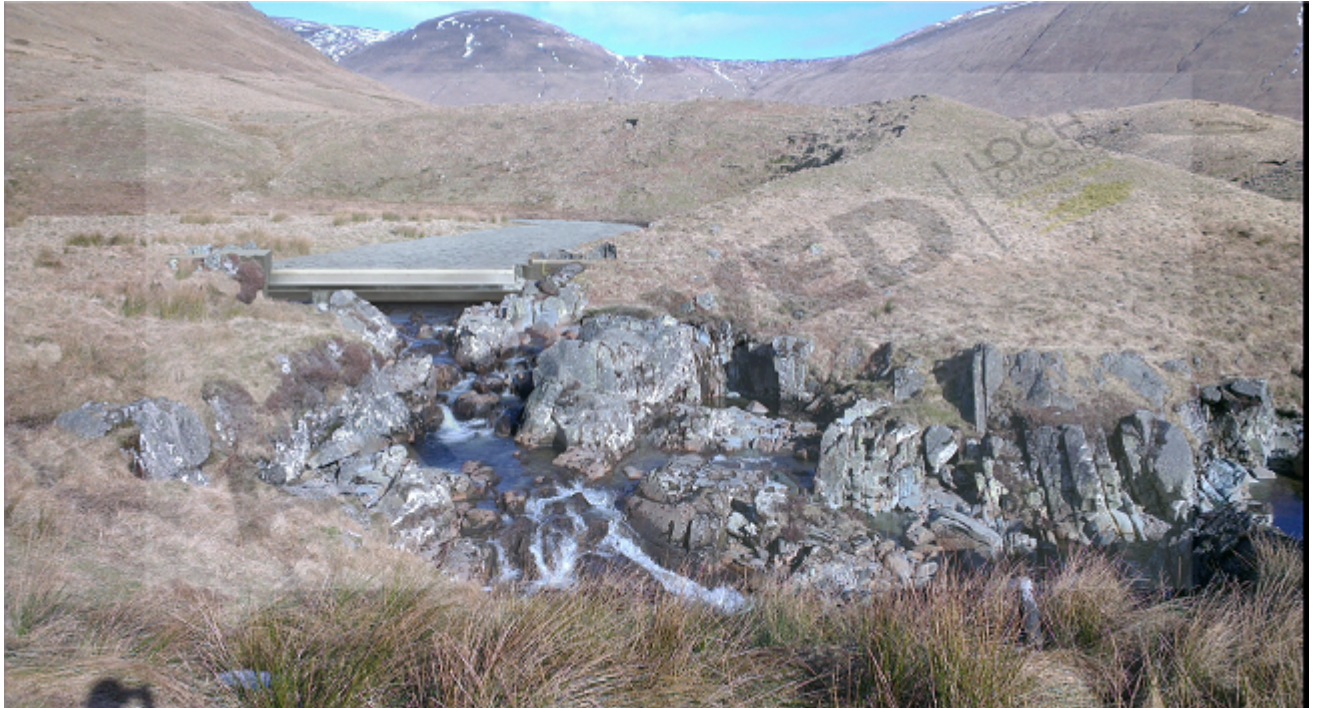
Also evident are the usual problems of poor landscaping around new intake dams. The actual landscape impact at the secondary intake is far greater than suggested in the plans:

Photomontage of secondary intake from original planning application

The original photomontage failed to show either the new section of access track or the rip rap bouldering which is unlikely to revegetate
