The hill and hydro roads disaster at the head of Glen Prosen

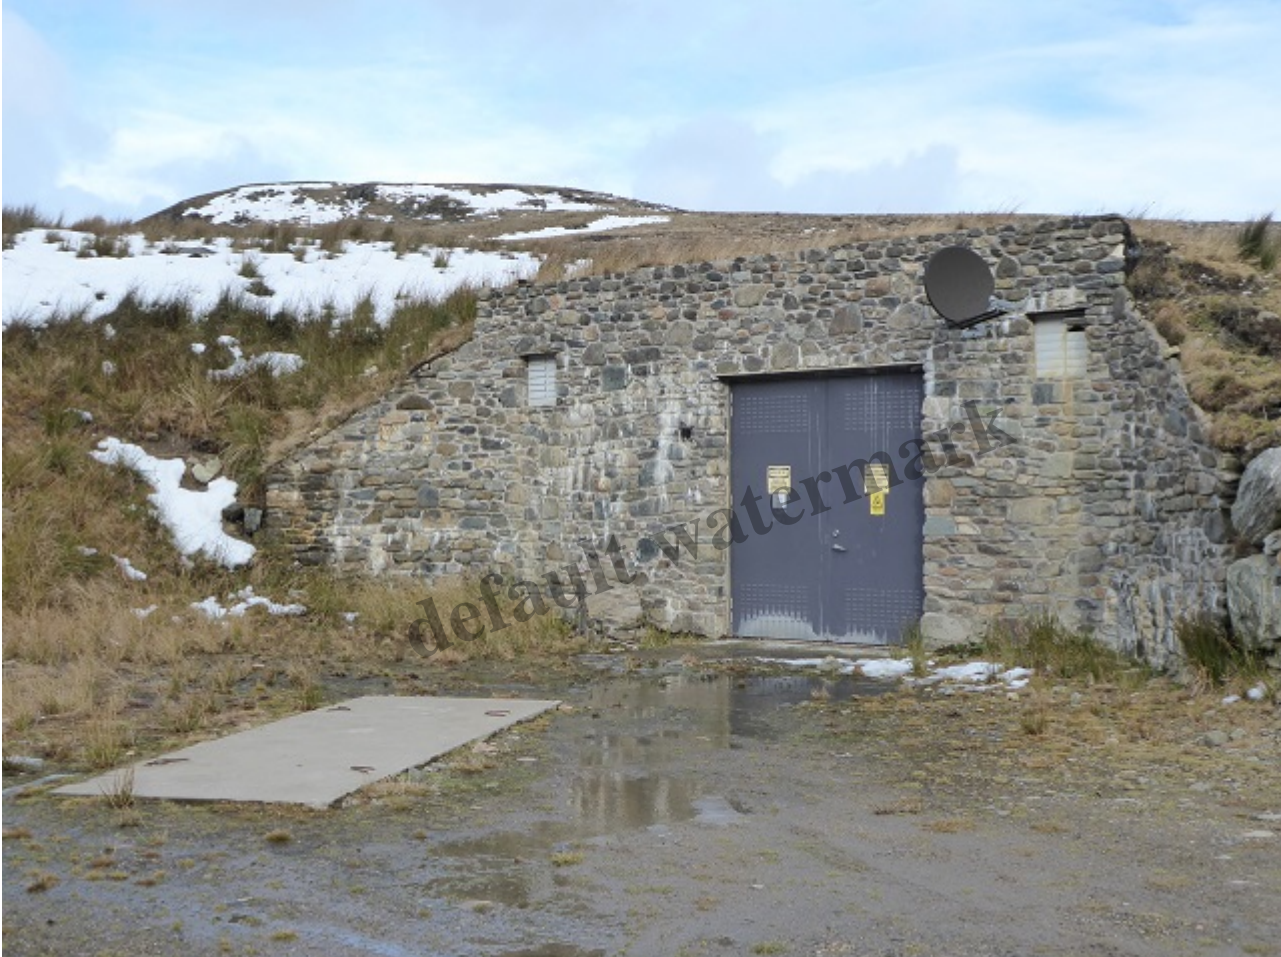
Apart from the new roads, the other elements of the Glen Prosen hydro scheme have been well done. The 3.2 km powerline from the powerhouse to Old Craig has been buried and the line of this barely discernible. The powerhouse itself has also been buried and is one of the best examples of this I have seen.
