The hill and hydro roads disaster at the head of Glen Prosen

The landscape impact of the two new hydro roads

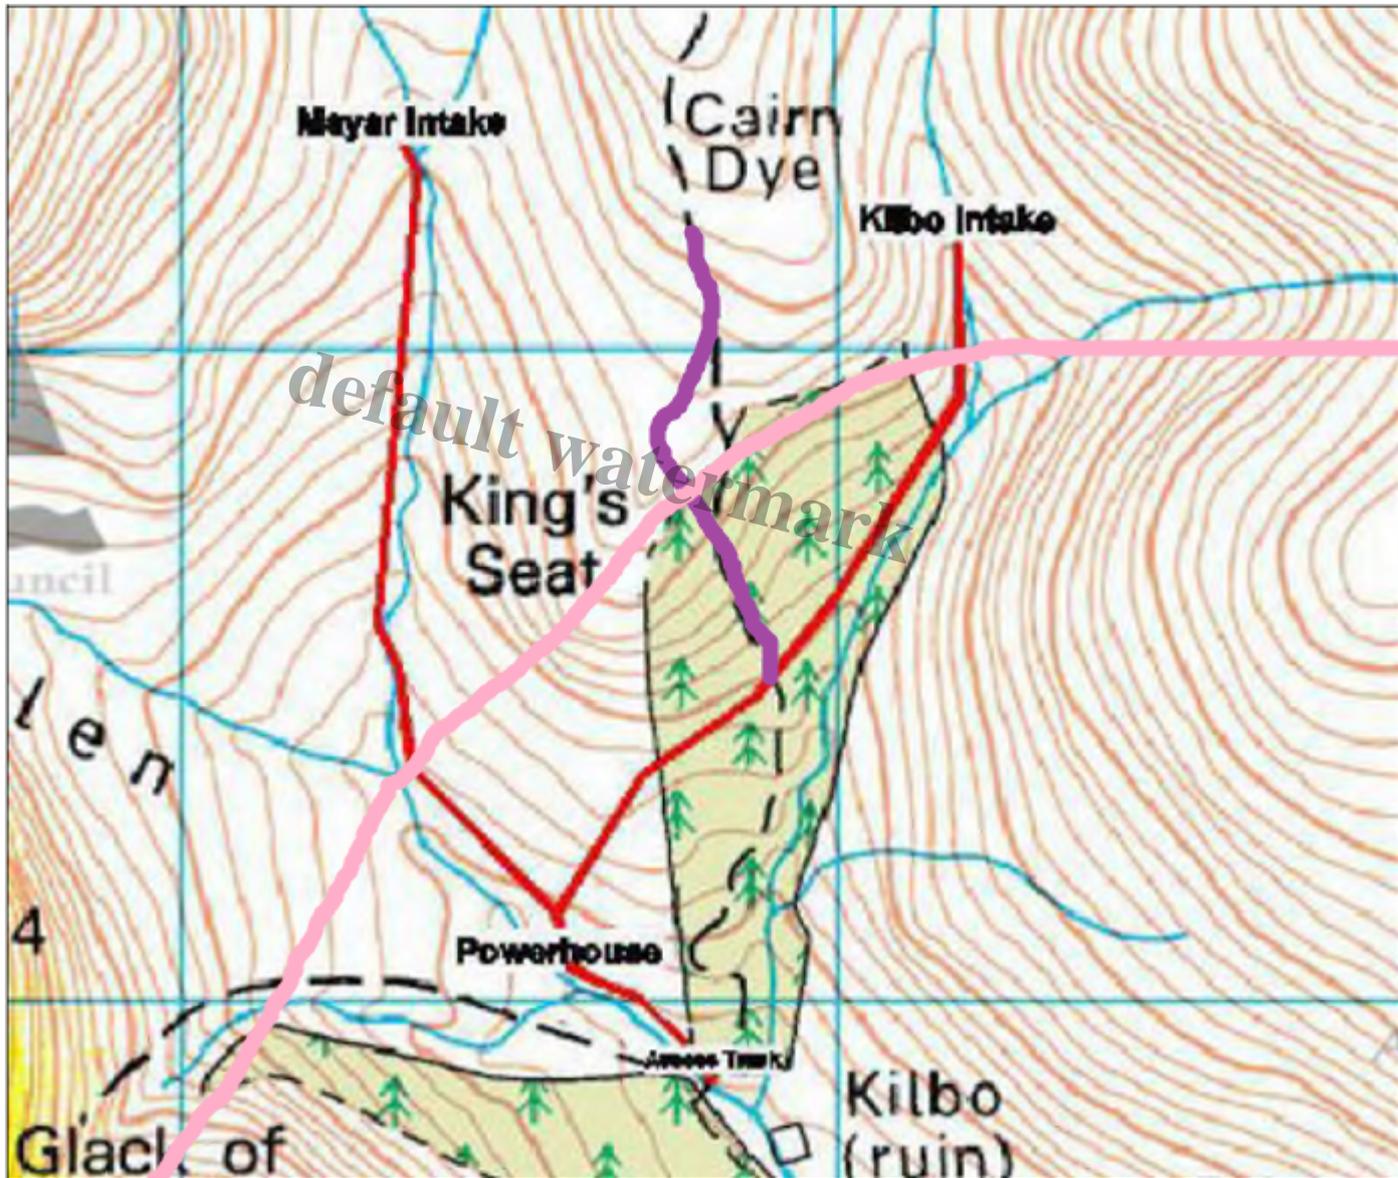
Figure 2. Site Plan

Extract from Planning Report, with the red denoting the two pipelines/construction tracks. I have added two further lines: the purple demarcates the approx line of the track constructed without planning permission; the pink the approx boundary of the Lochnagar-Mt Keen Wild Land Area which came into affect in 2014 (after planning permission was granted).

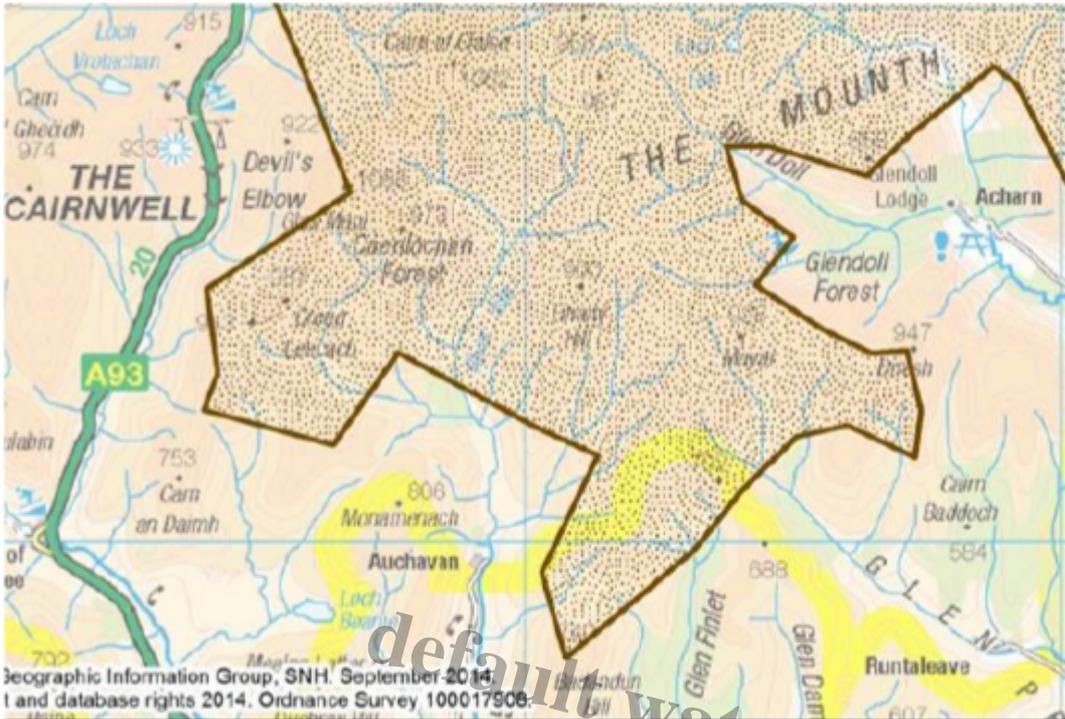
The consequences for the landscape have been significant and the track is highly visible from the high ground around the head of the glen. With two hydro roads in place on either side there can be no justification for this road. The upper part is also within the Lochnagar-Mt Keen Wild Land Area and seems likely to have been constructed after SNH's maps and descriptions of Wild Land Areas were published in 2014:

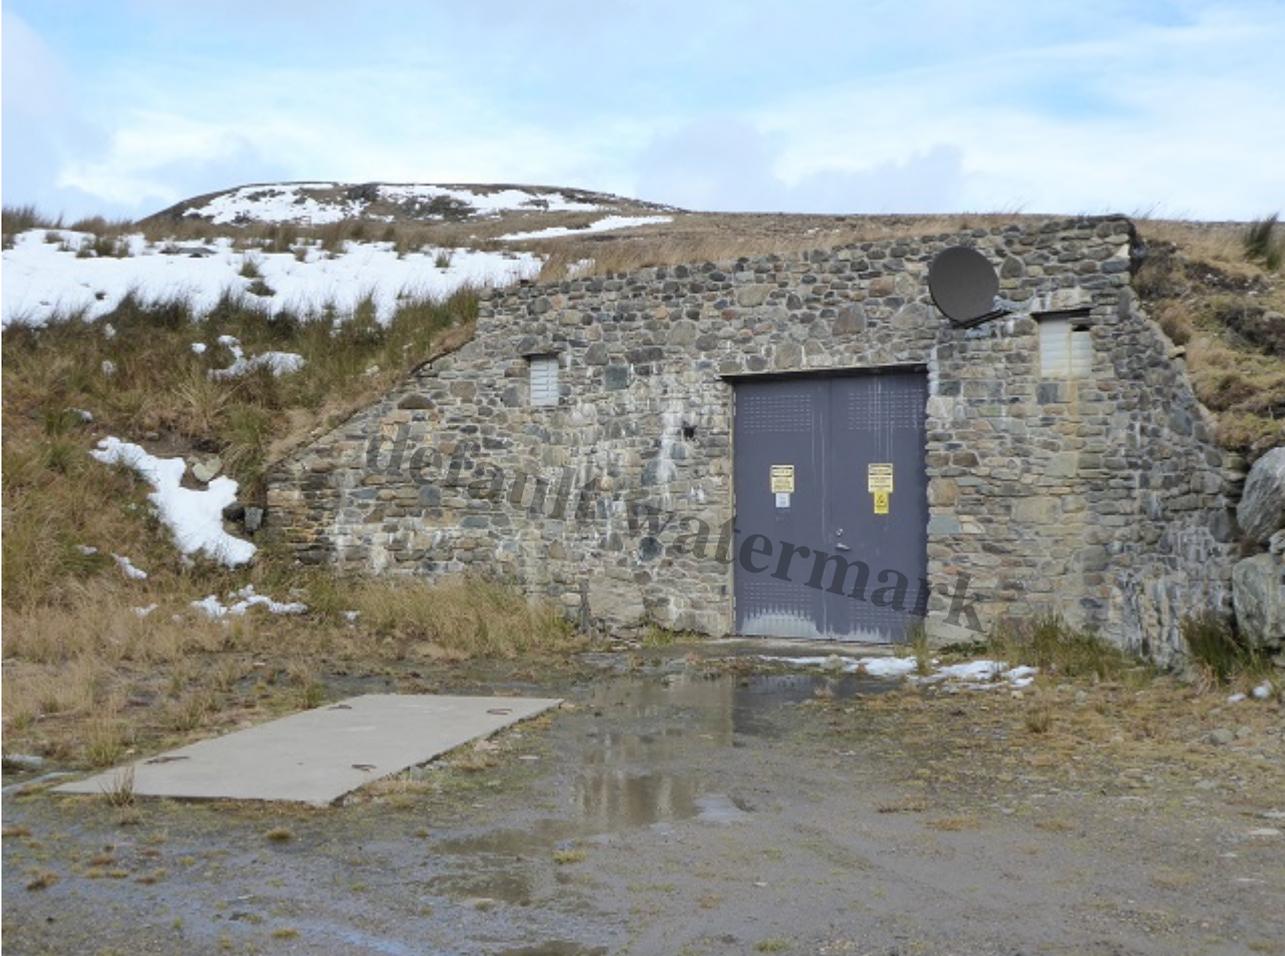
Apart from the new roads, the other elements of the Glen Prosen hydro scheme have been well done. The 3.2 km powerline from the powerhouse to Old Craig has been buried and the line of this barely discernible. The powerhouse itself has also been buried and is one of the best examples of this I have seen.
