## The hill and hydro roads disaster at the head of Glen Prosen

**The landscape impact of the two new hydro roads**

## **The new grouse moor track**

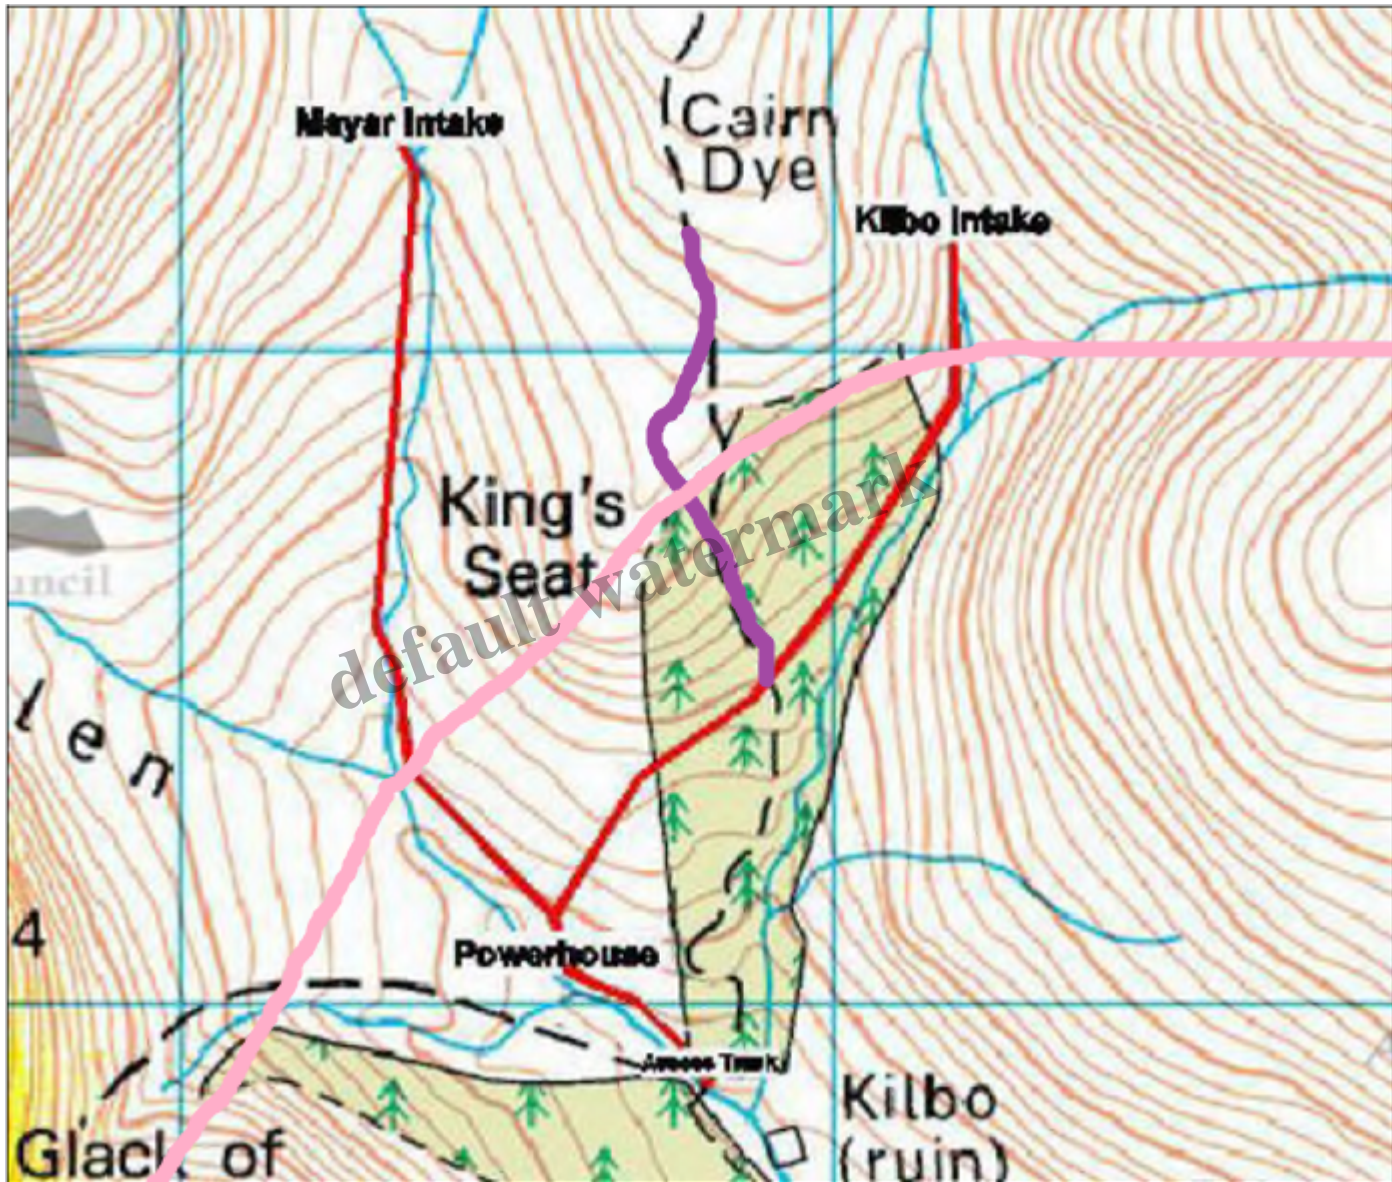
**Figure 2. Site Plan**

Extract from Planning Report, with the red denoting the two pipelines/construction tracks. I have added two further lines: the purple demarcates the approx line of the track constructed without planning permission; the pink the approx boundary of the Lochnagar-Mt Keen Wild Land Area which came into affect in 2014 (after planning permission was granted).

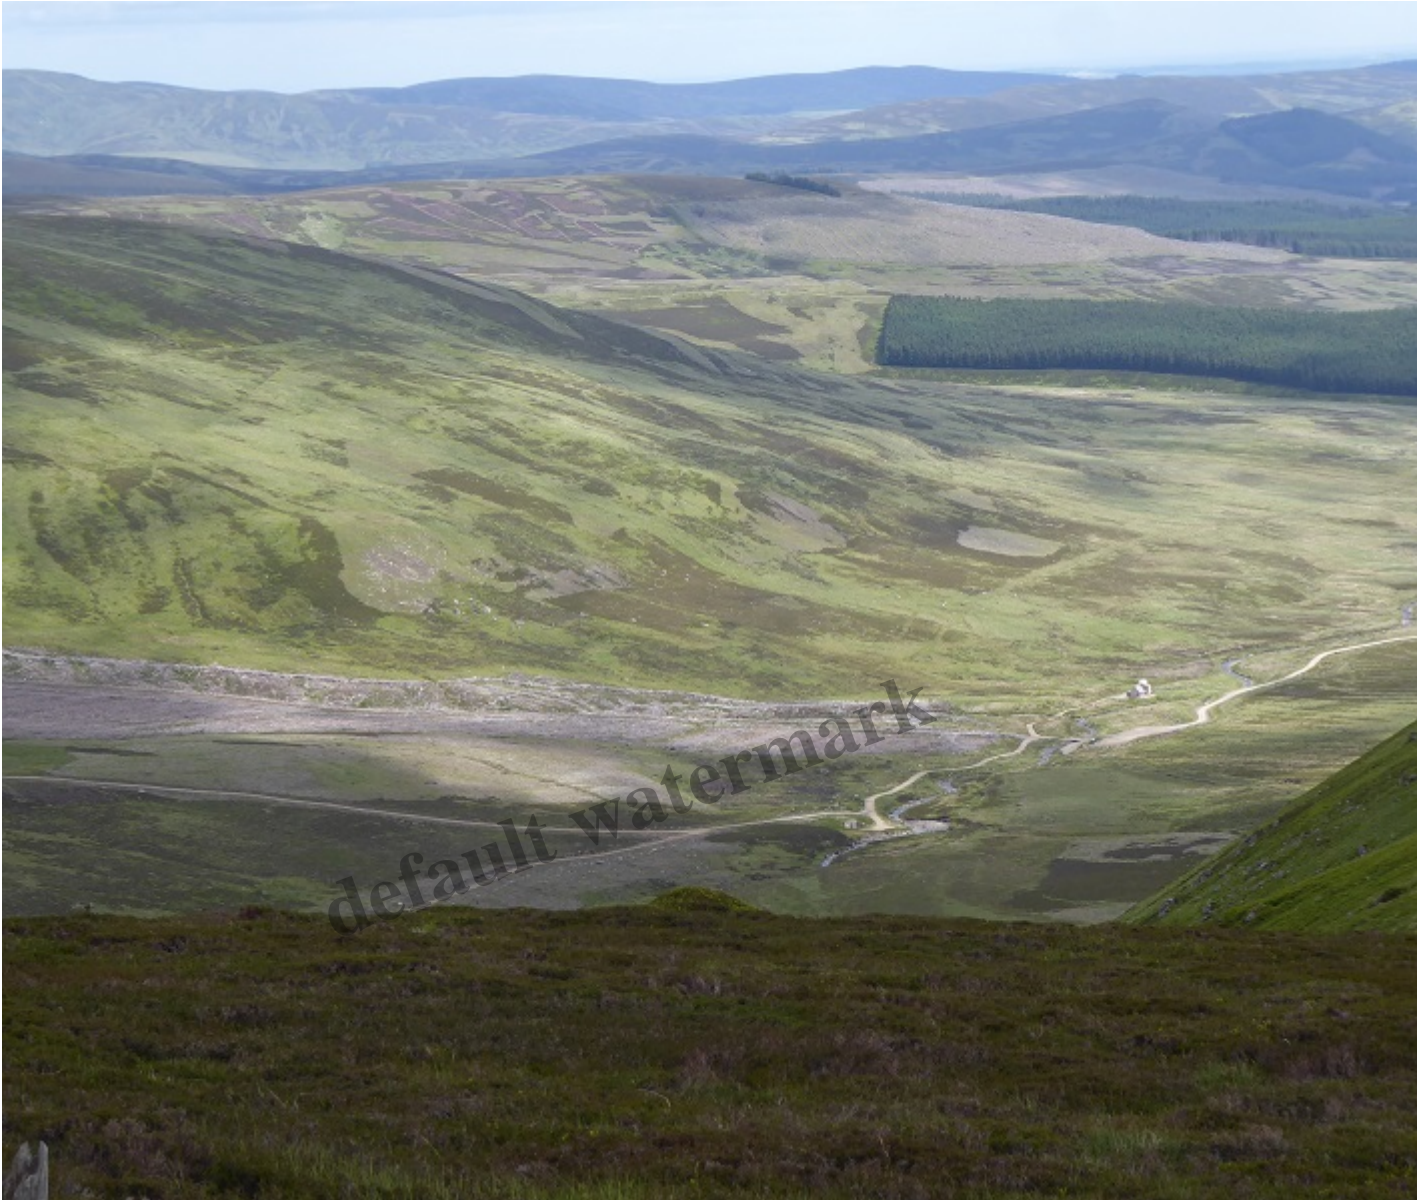
Looking down on the start of the two new hydro roads – the fork marks where the two pipelines meet head of Glen Prosen in June 2016. The location of the powerhouse can be seen just right of centre

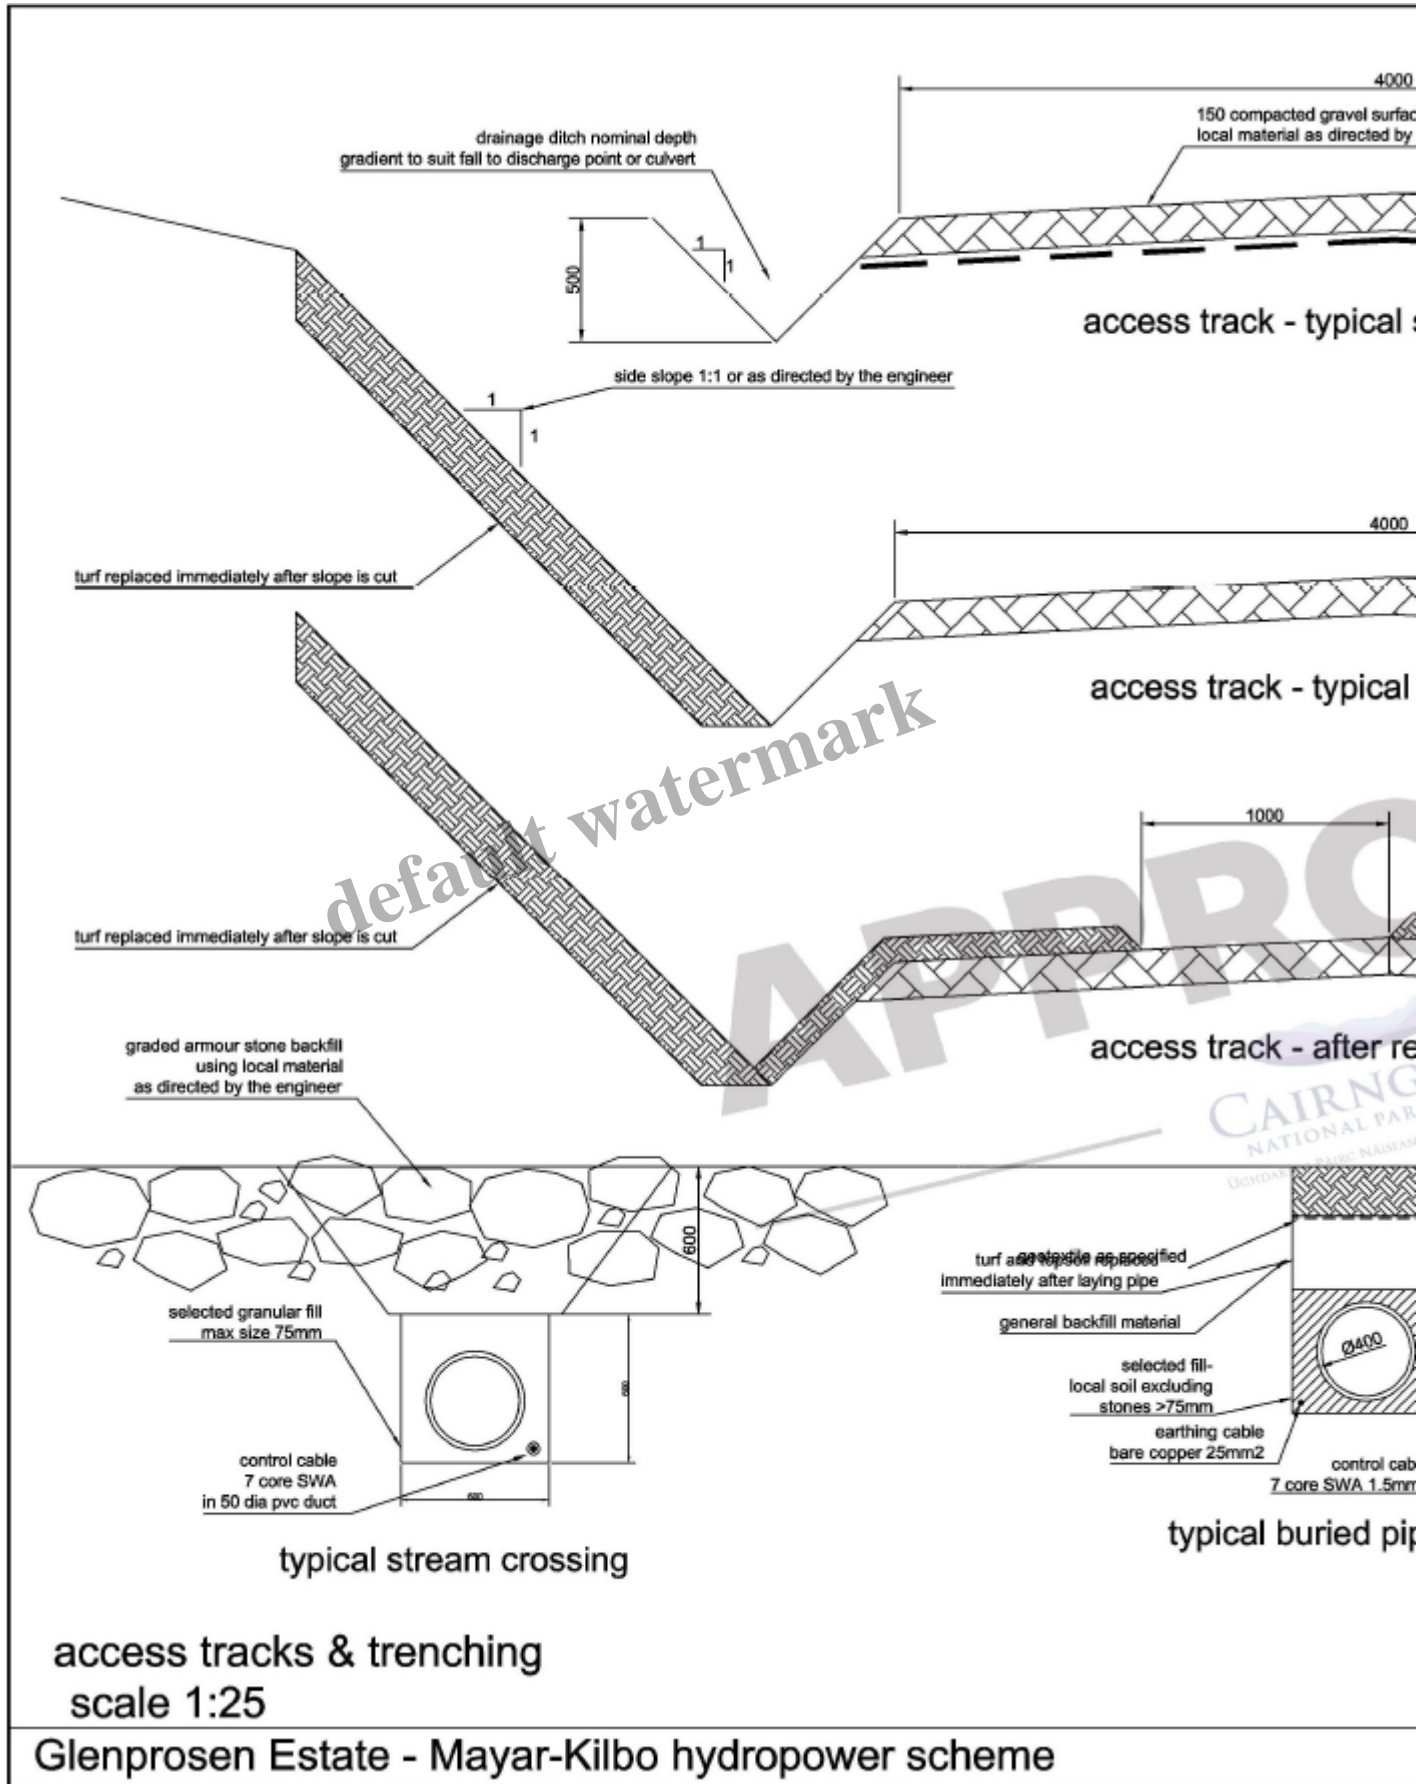
access tracks & trenching  
scale 1:25

The first diagram shows the hydro construction tracks being four metres wide and the surface being being reduced to 1m wide for quad bike use after construction.

The specification has been ignored, with more imported material than that originally proposed and far more limited restoration of the track width:

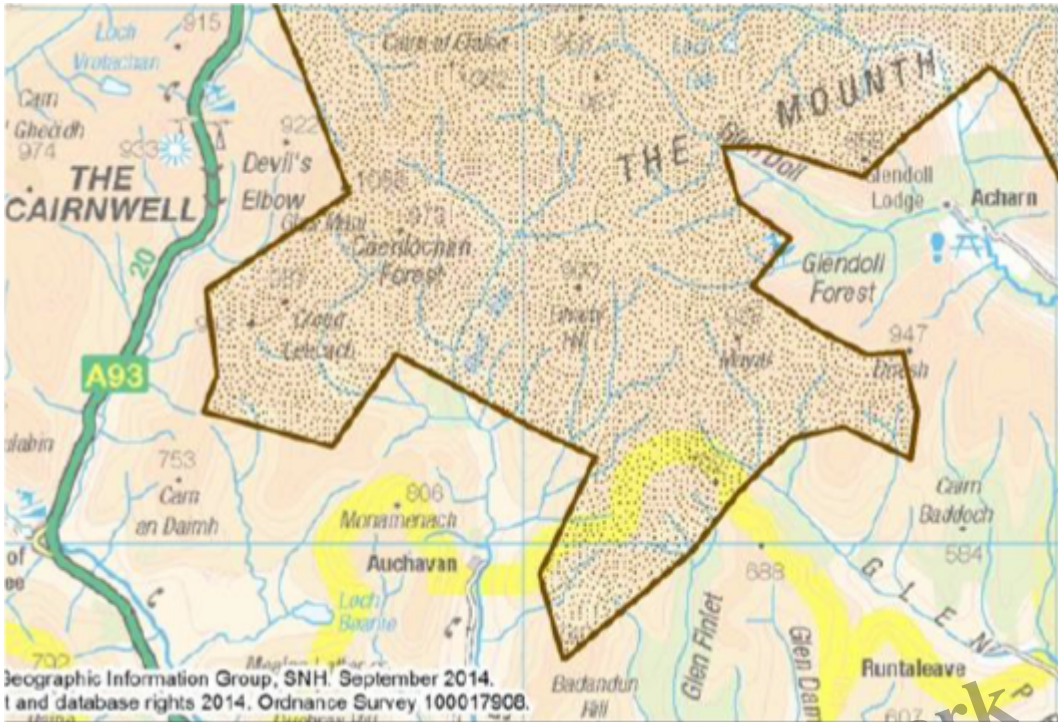
The consequences for the landscape have been significant and the track is highly visible from the high ground around the head of the glen. With two hydro roads in place on either side there can be no justification for this road. The upper part is also within the Lochnagar-Mt Keen Wild Land Area and seems likely to have been constructed after SNH's maps and descriptions of Wild Land Areas were published in 2014:

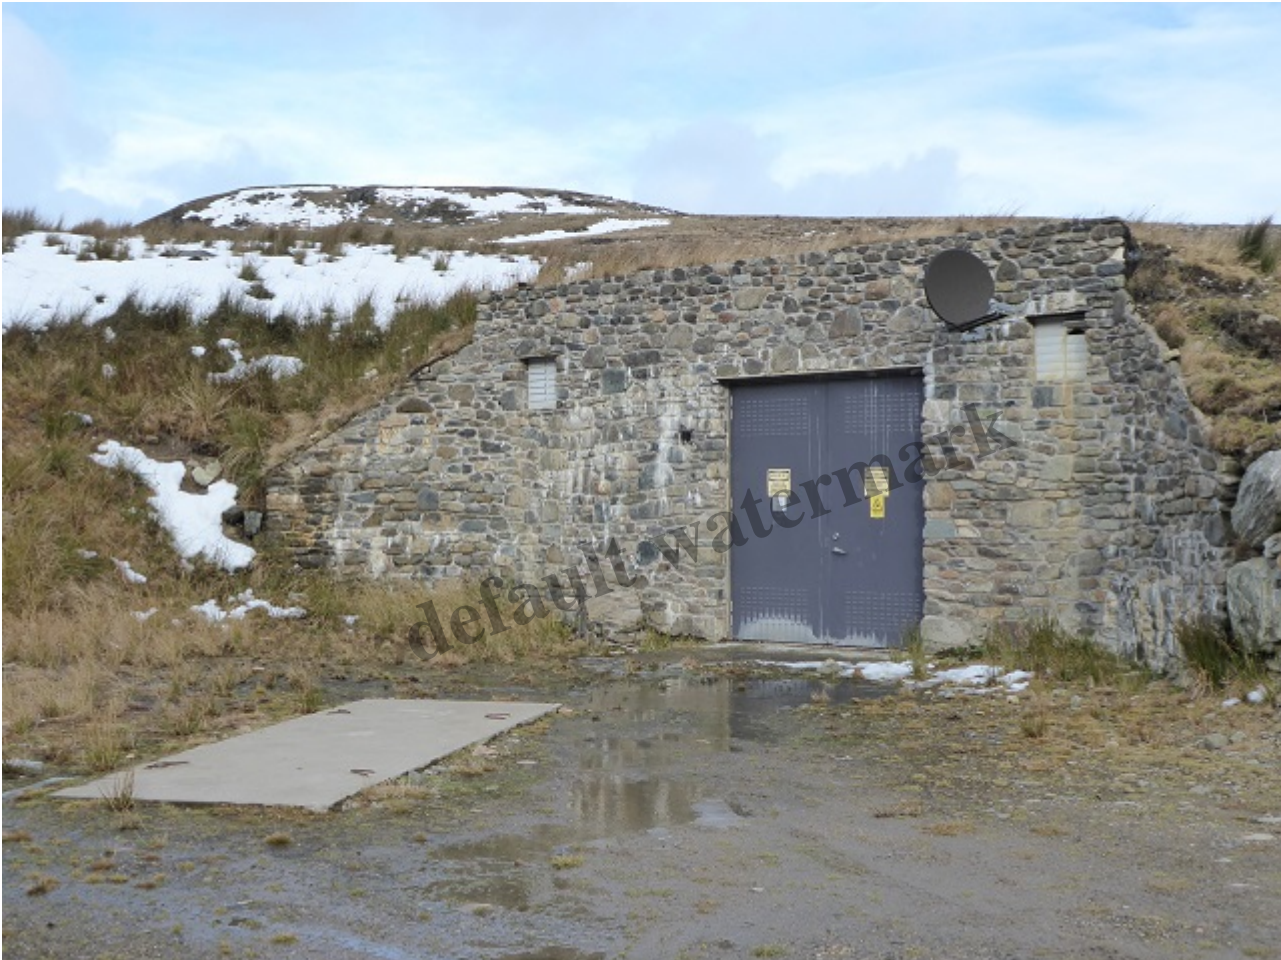
Apart from the new roads, the other elements of the Glen Prosen hydro scheme have been well done. The 3.2 km powerline from the powerhouse to Old Craig has been buried and the line of this barely discernible. The powerhouse itself has also been buried and is one of the best examples of this I have seen.
