Hydro schemes and the failure of the planning system in the Loch Lomond and Trossachs National Park

The Upper Glen Falloch hydro scheme

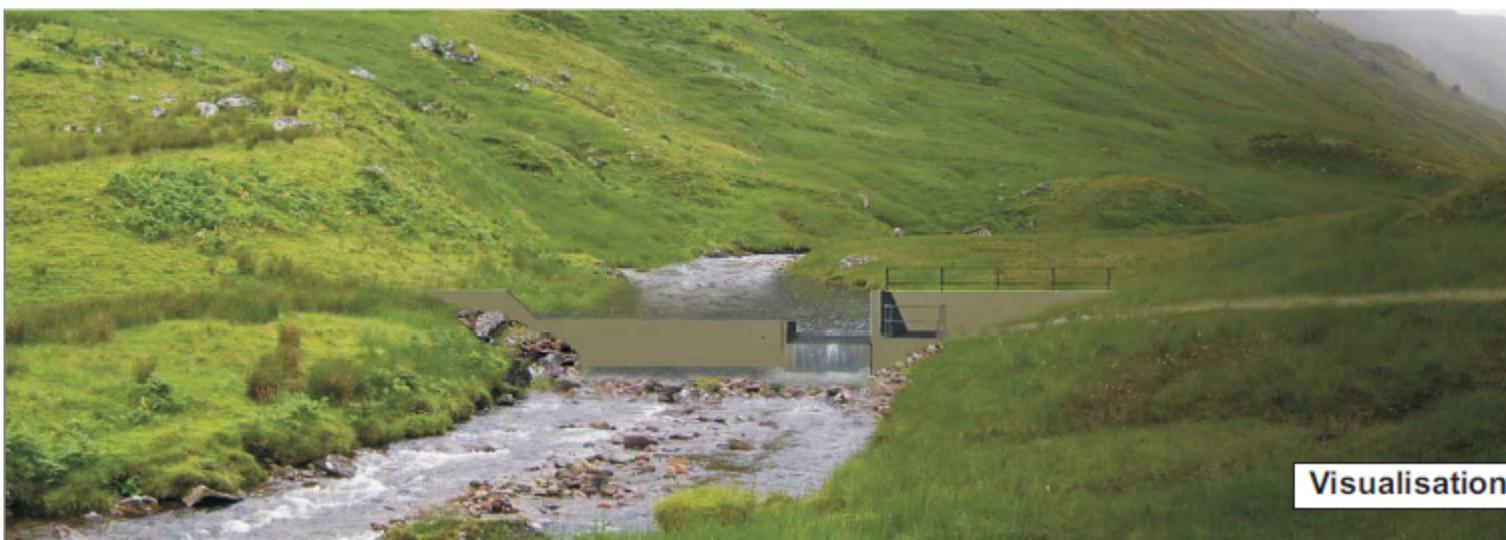
This is not, strictly speaking, a run of river hydro scheme at all but a small new reservoir that has been constructed without any regard for the landscape. Here is a graphic, from the Planning Application, of how it was meant to look:

The LLTNPA’s much vaunted planning system has clearly failed to deliver what was promised.

In my view, unless ways can be found to construct run of river hydro schemes in sensitive areas without the use of rip rap bouldering they should be refused. Why didn't the LLTNPA put a halt to this hydro scheme when the extent of its landscape impacts became apparent?
