Hydro schemes and the failure of the planning system in the Loch Lomond and Trossachs National Park

The Upper Glen Falloch hydro scheme

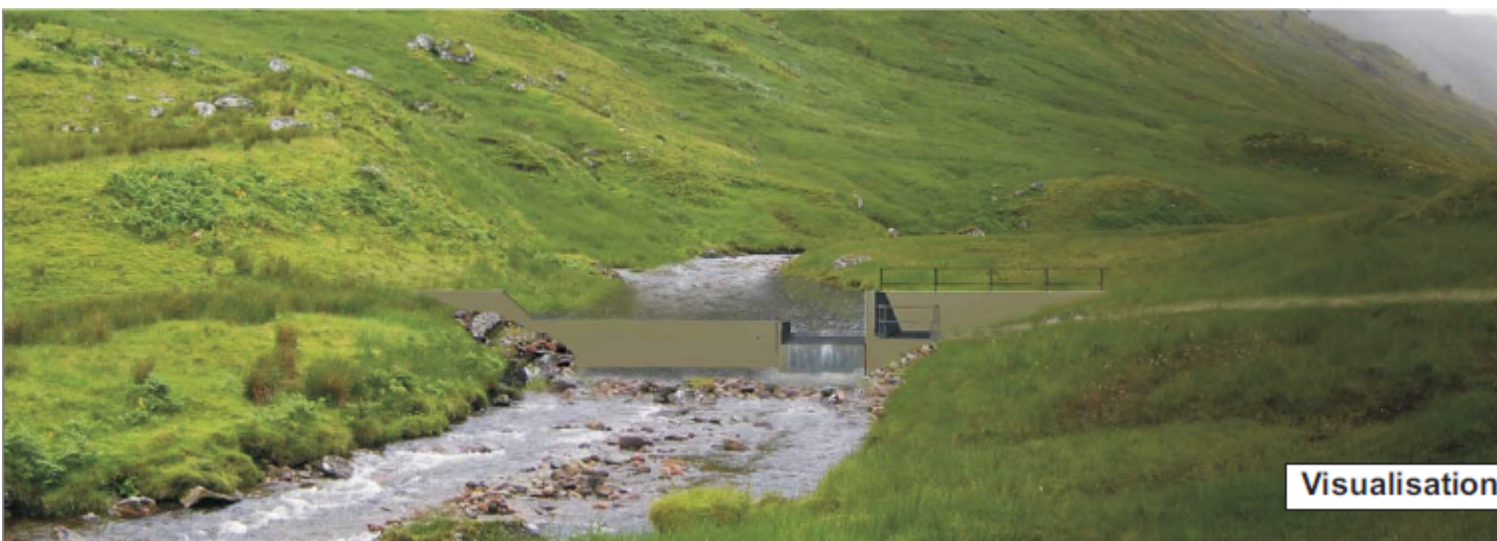
This is not, strictly speaking, a run of river hydro scheme at all but a small new reservoir that has been constructed without any regard for the landscape. Here is a graphic, from the Planning Application, of how it was meant to look:

The LLTNPA's much vaunted planning system has clearly failed to deliver what was promised.

In my view, unless ways can be found to construct run of river hydro schemes in sensitive areas without the use of rip rap bouldering they should be refused. Why didn't the LLTNPA put a halt to this hydro scheme when the extent of its landscape impacts became apparent?
