The Donich Water hydro scheme and industrial forestry – out of sight, out of mind?

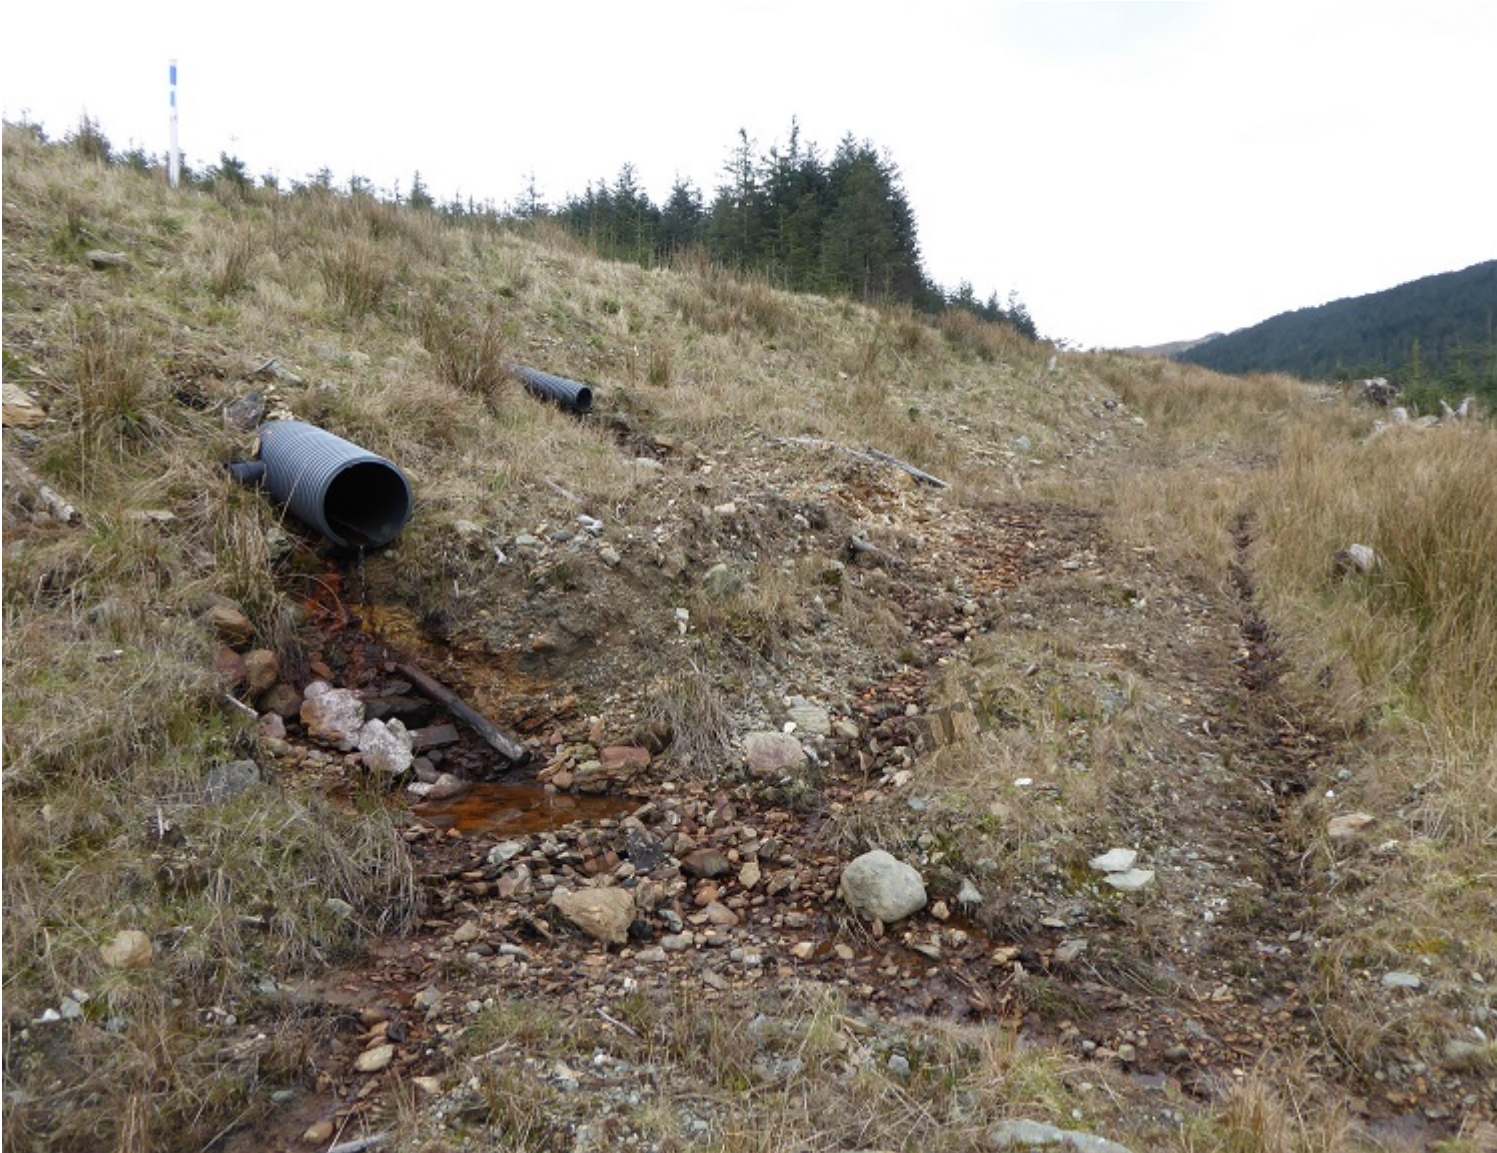
The National Park has simply been treated as industrial wasteland. What's clear is that the LLTNPA has abandoned any attempt to enforce its normal standards on land owned by the former Forestry Commission.

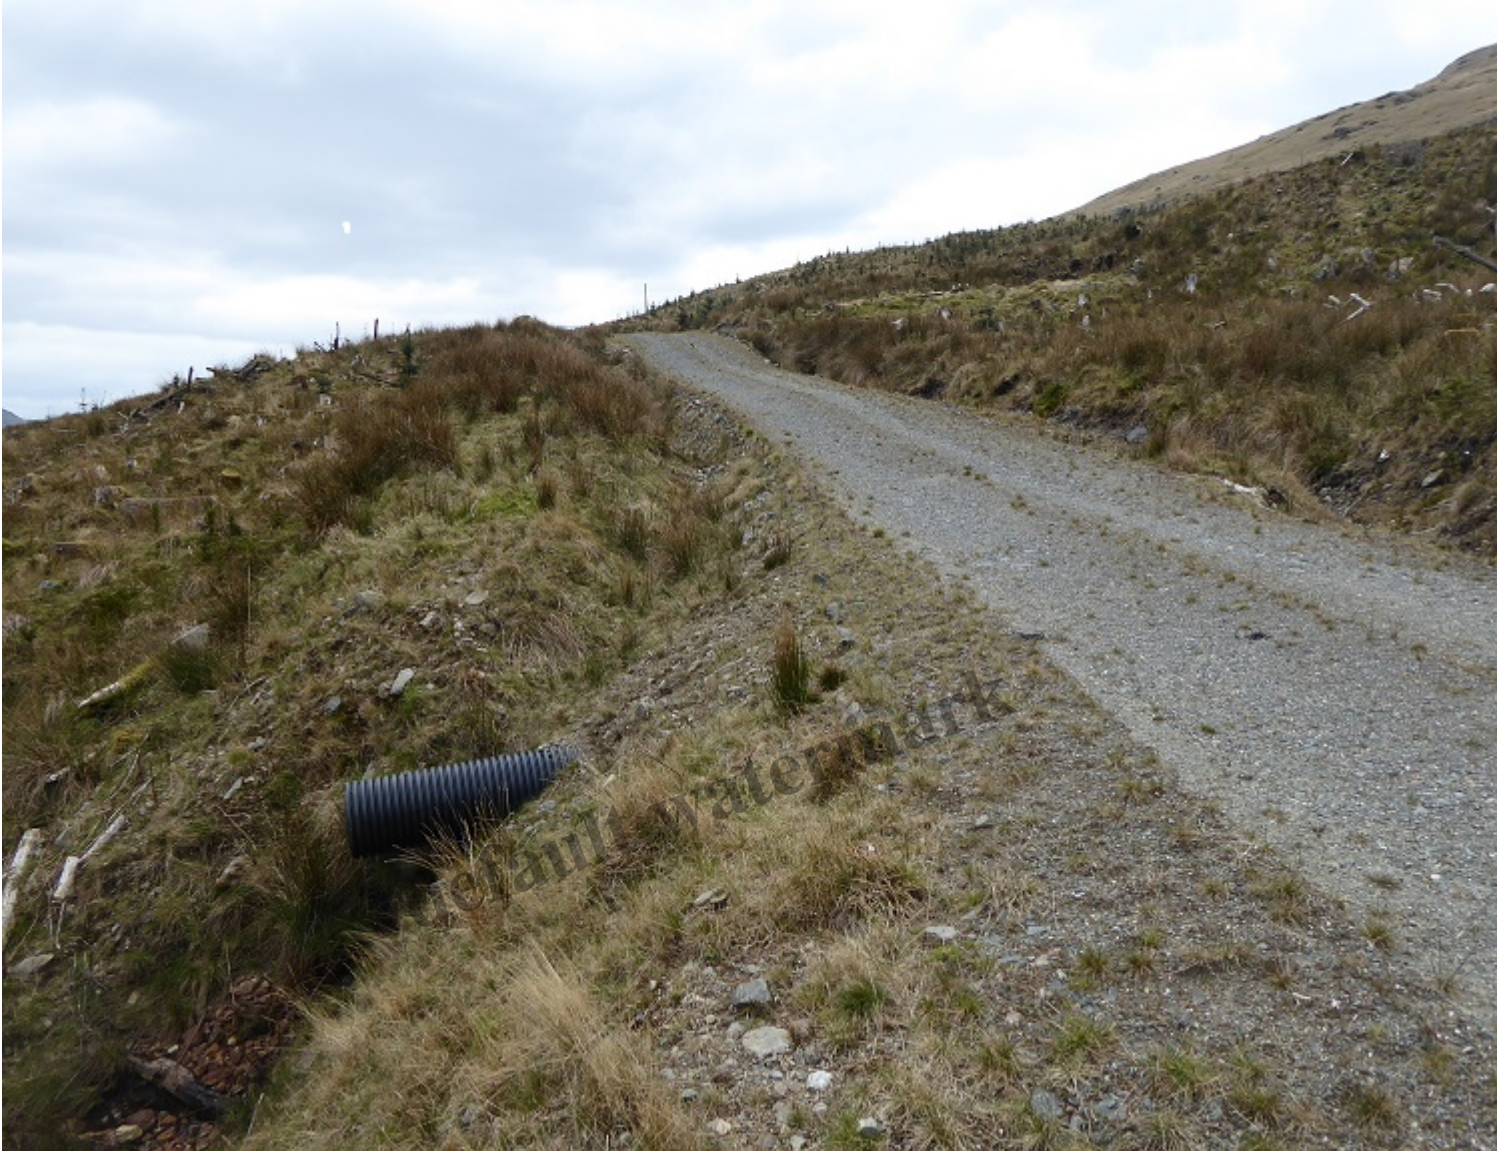
It was a relief when I eventually managed to escape both the hydro and the forestry. The LLTNPA Board should take a visit and see for themselves the issues.
