The Donich Water hydro scheme and industrial forestry – out of sight, out of mind?

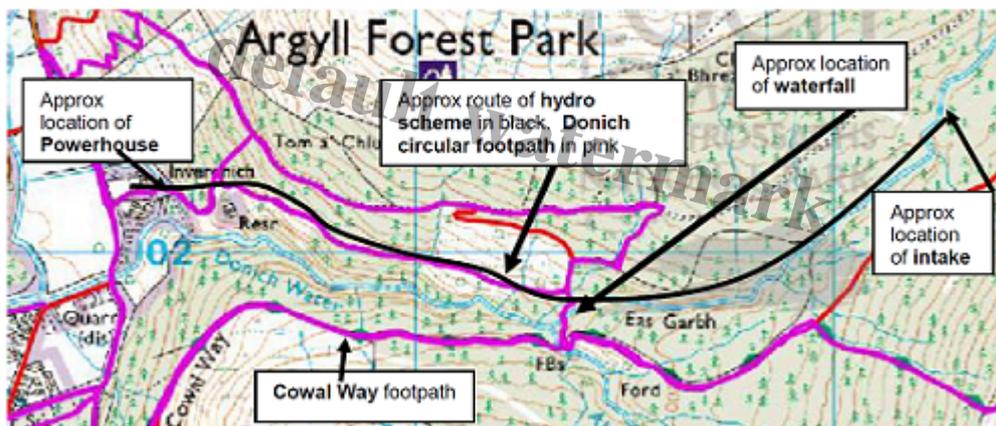
Fig 2: footpaths, waterfall and hydro scheme

3.3 **Figure 2** below illustrates the relationship/proximity of the local footpath network and the location of the waterfall and the hydro scheme. The waterfall can be best viewed from the footpath/bridge that crosses the Donich Water.

Extract from planning application showing paths, waterfall and pipeline

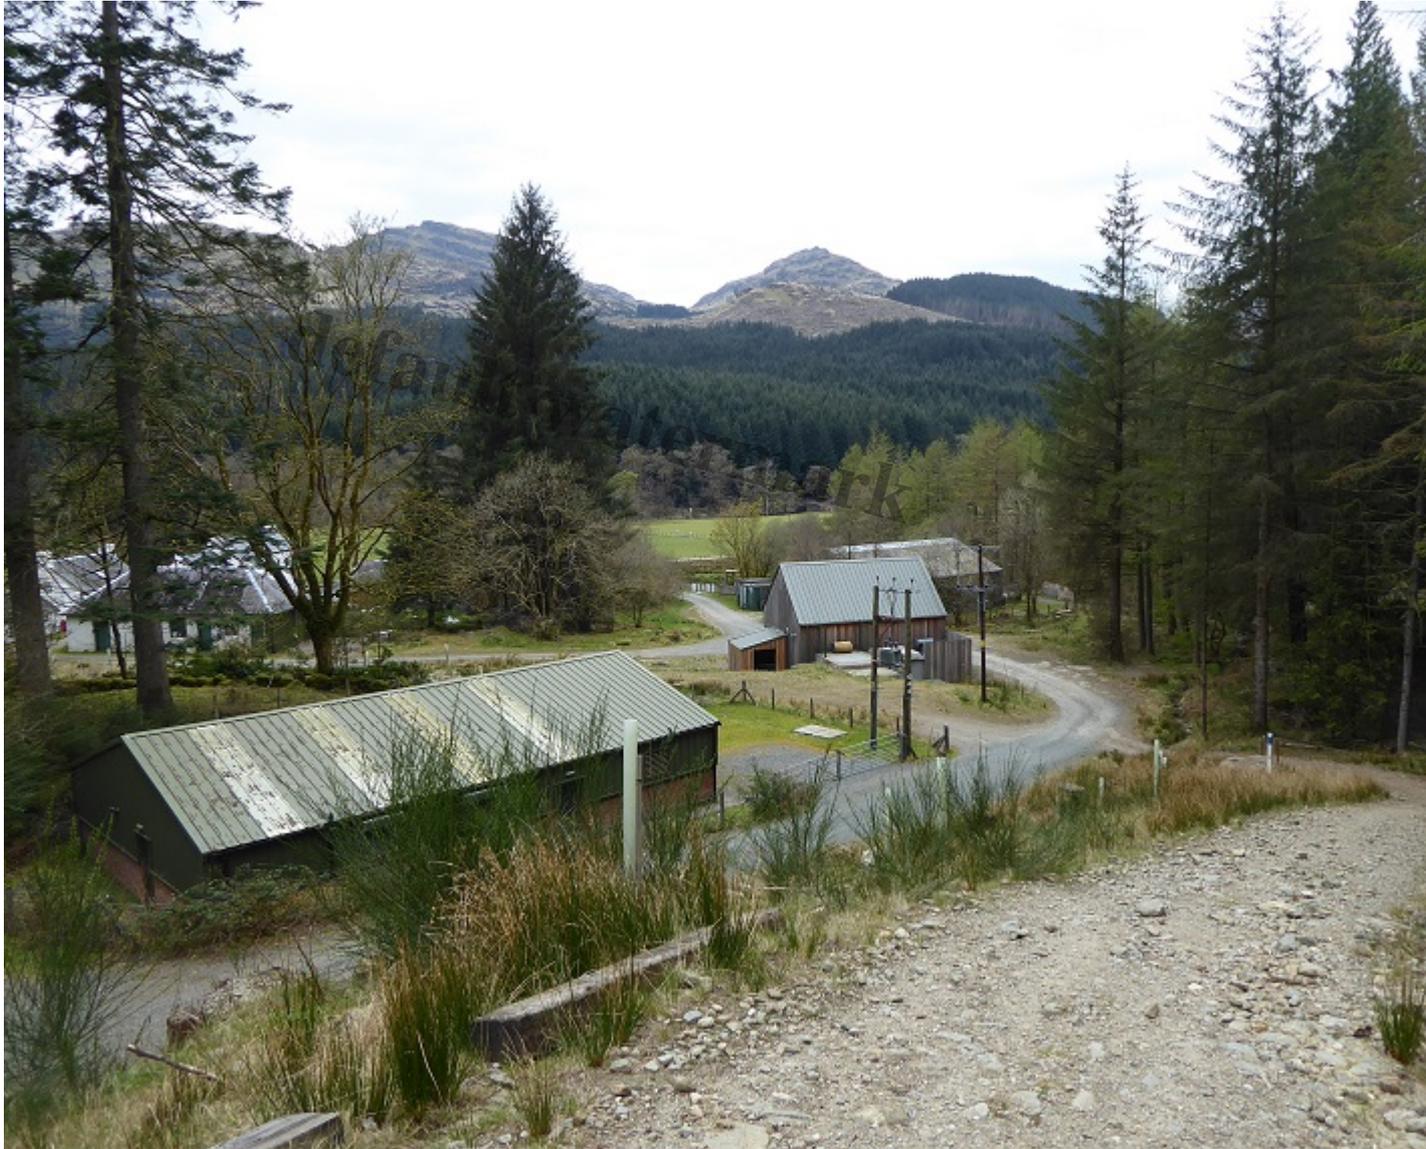
Powerhouse just right of centre, Beinn Bheula behind on left

Local residents had also expressed concerns about the noise that would be emitted from the powerhouse and subjected the specification of the building to detailed scrutiny. Their concerns were dismissed by Environmental Health and Planning Staff:

However, by 2018 the Public Authorities involved were forced to accept they had been wrong when the Developer submitted a further planning application to extend the power house building to reduce noise levels. Here is the explanation in the words of LLTNPA staff:

“The extension has been proposed to reduce noise levels from the powerhouse of the Donich Water hydro scheme. The hydro scheme was approved under planning reference 2013/0120/DET. Condition 13 of this permission requires the hydro scheme to keep within prescribed noise levels for perpetuity. The condition also required the applicant to undertake monitoring and assessment to demonstrate that noise generated by equipment is within these levels. A noise report was provided to the NPA and the condition subsequently discharged after input from Argyll & Bute Council Environmental Health.

Following the discharge of the condition, residents living adjacent to the powerhouse building wrote to A&BC Environmental Health expressing concerns that the findings of the report were not representative of actual noise levels. The letter contested that noise levels generated by the powerhouse were in excess of what had been recorded for the report and deemed acceptable in line with Condition 13.

The applicant has submitted this application in response to concerns from neighbours. The extension has been designed to direct noise from the powerhouse away from nearby properties into an uninhabited area. The principle of the extension is supported by Overarching Policy 2 of the Local Development Plan as it has been designed to improve the amenity of residents.”

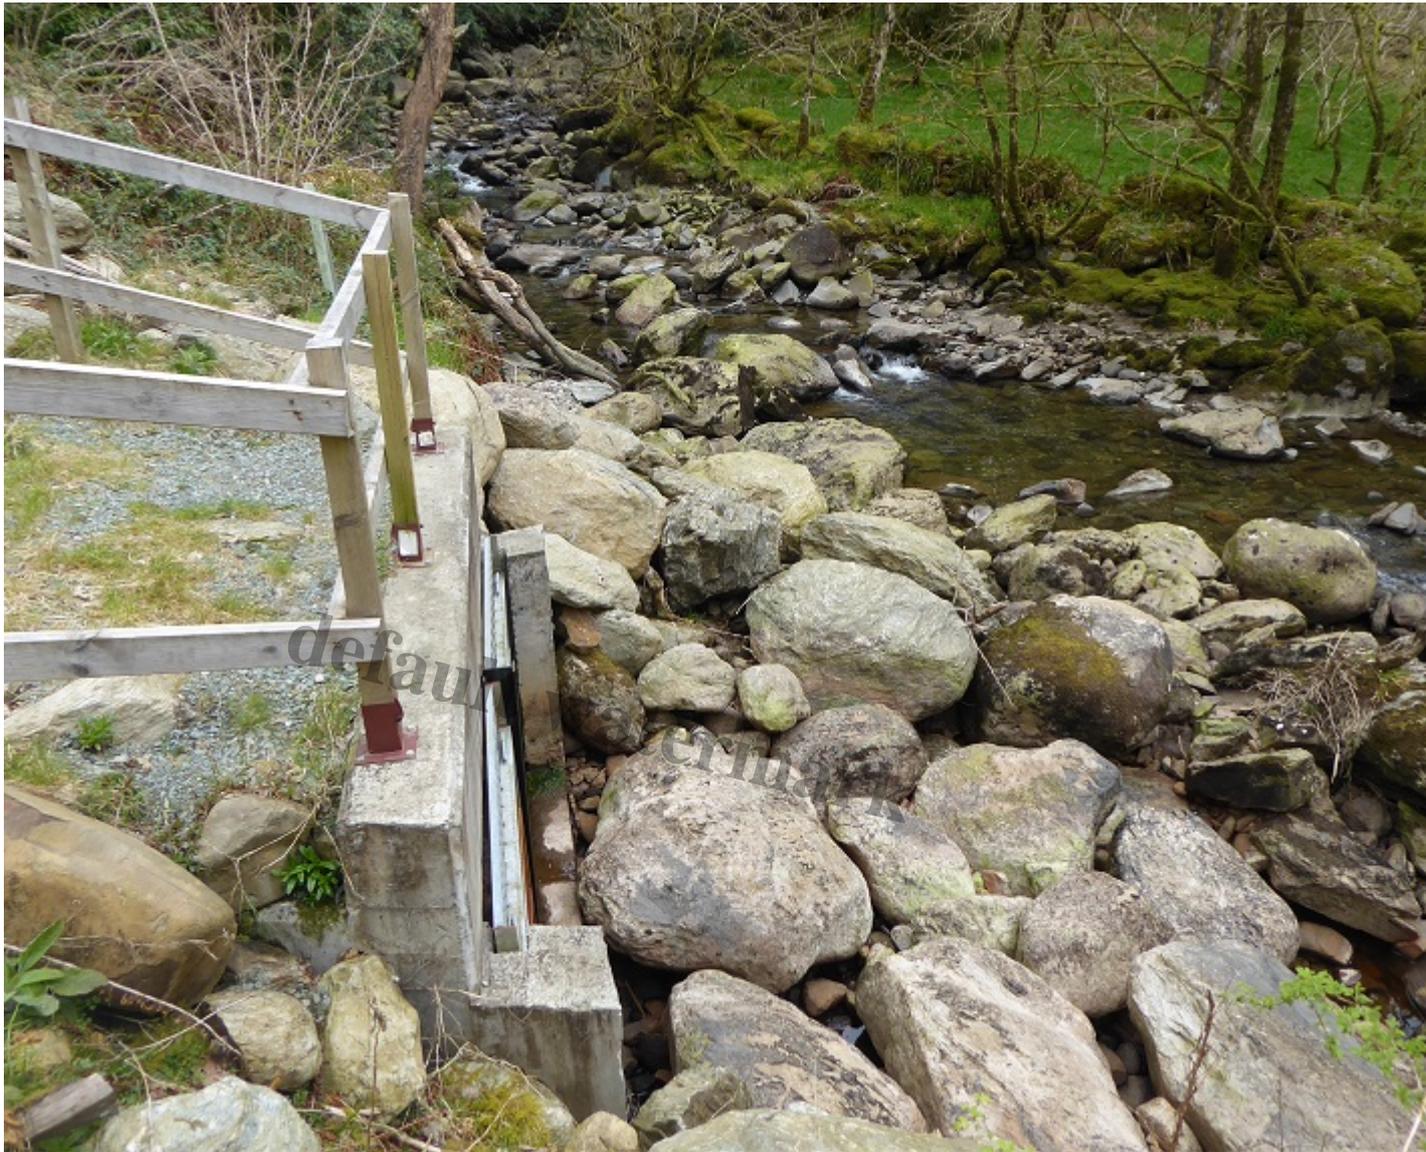
Tailrace – where the water from the powerhouse would re-enter the river if the scheme was opera

Unfortunately on the day I visited it was impossible to judge whether noise was still an issue because, as is quite common with our ‘flashy’ west of Scotland rivers, the river flow was too low to produce any electricity.

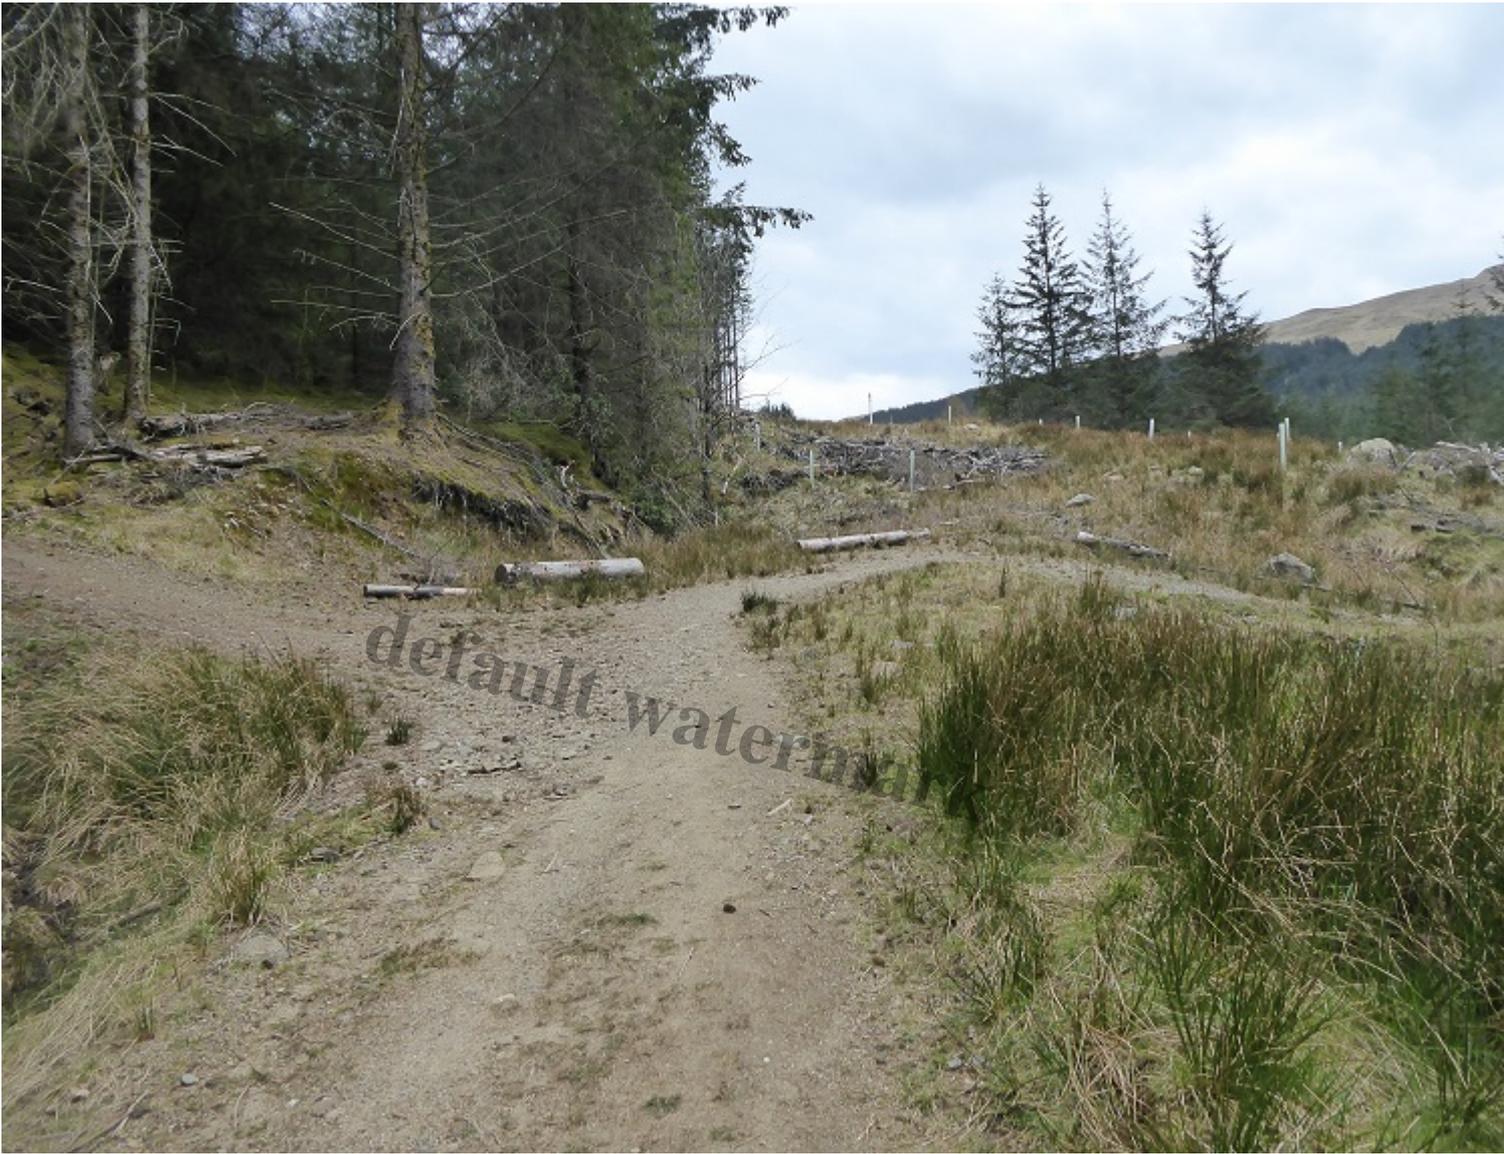
The pipeline then diverges from the path, taking a fairly direct line to the intake through a felled forest plantation while the core path bends to the right and descends to the Eas Garbh.

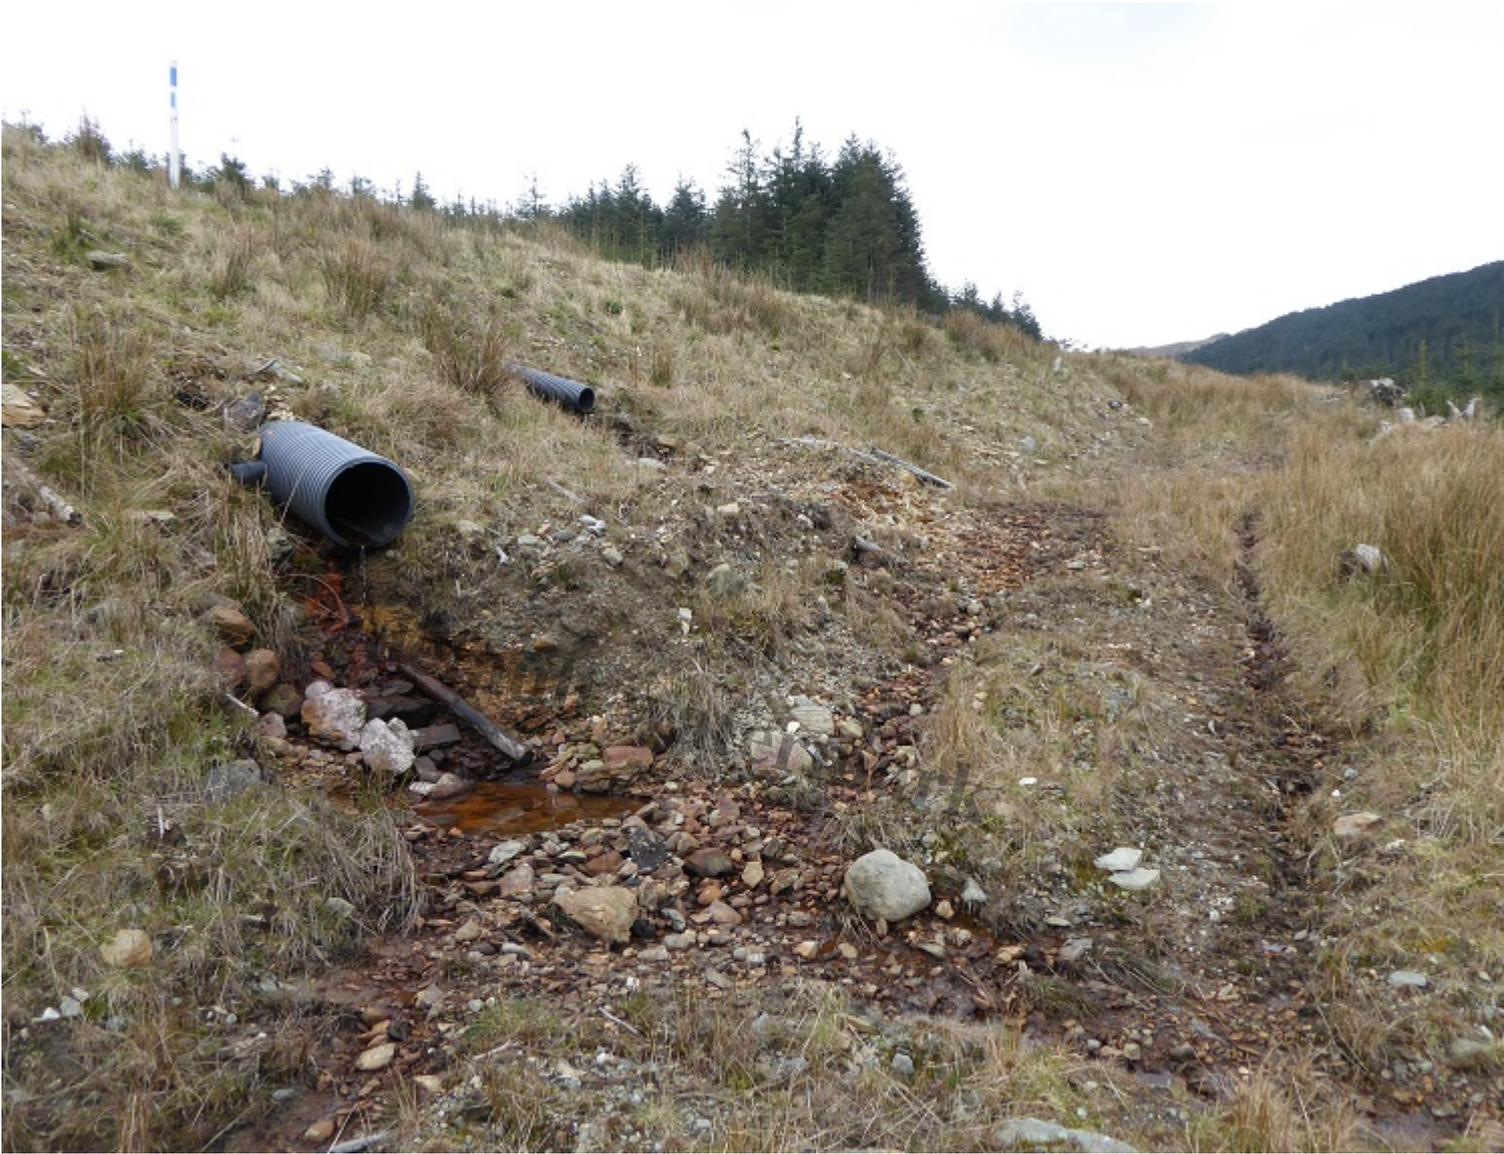
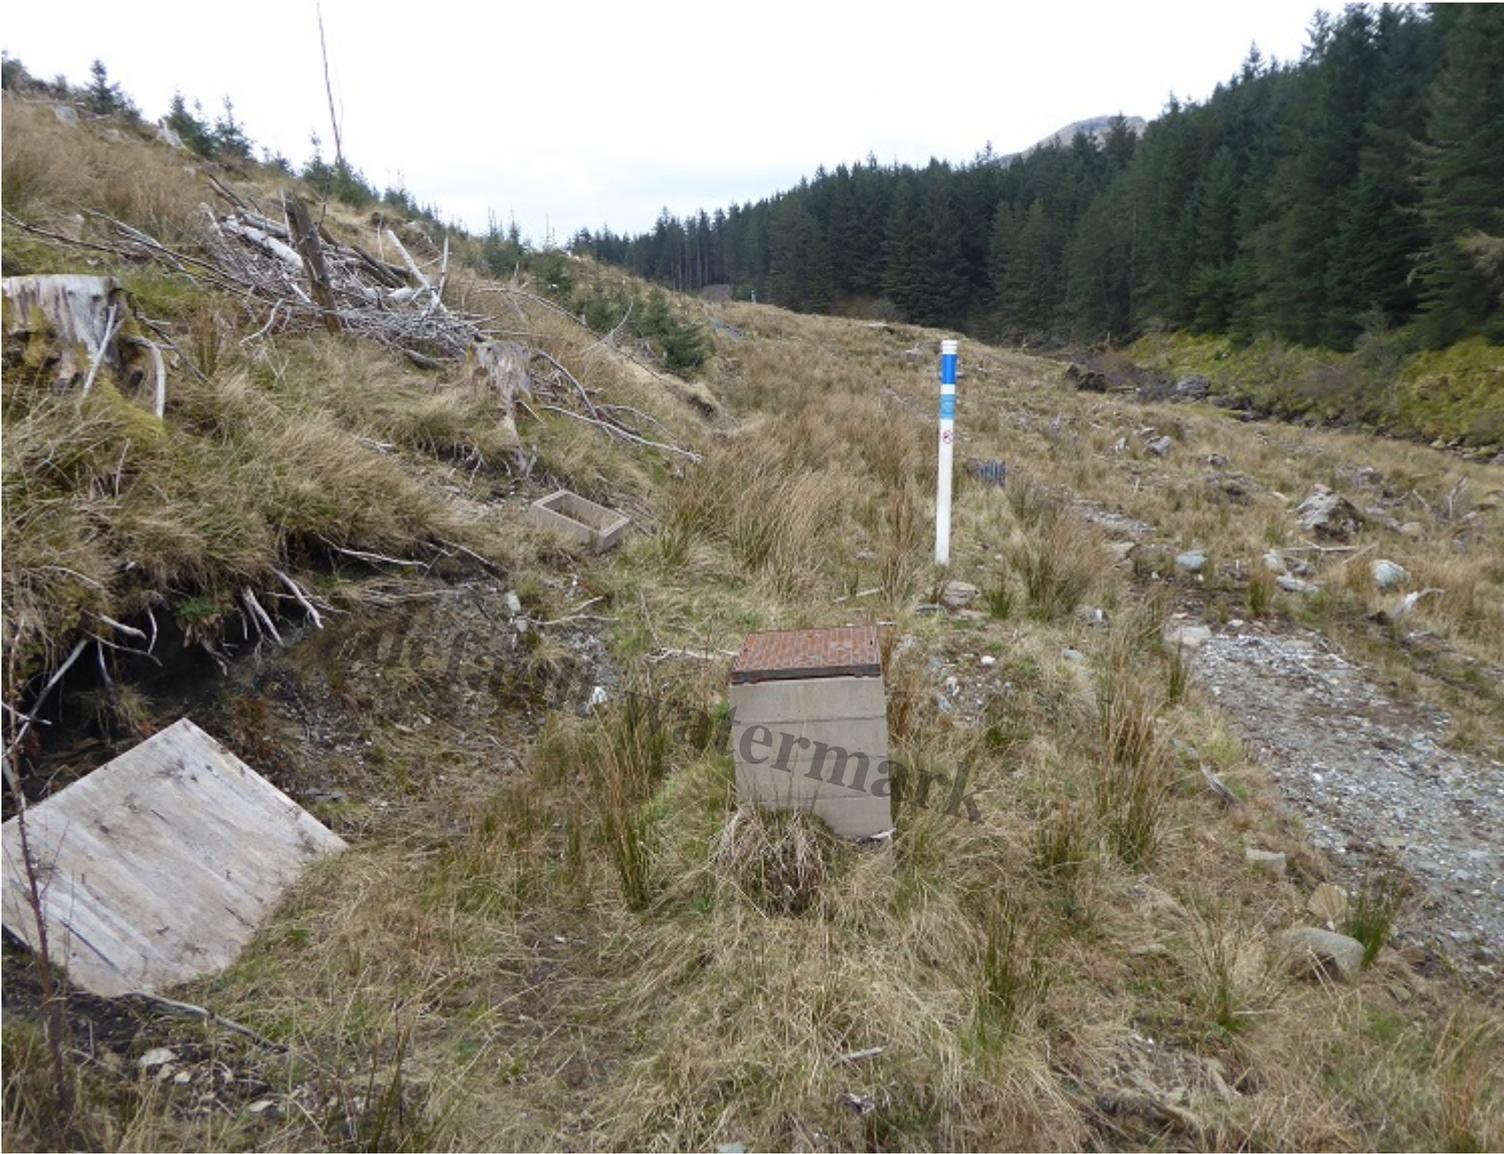
The National Park has simply been treated as industrial wasteland. What's clear is that the LLTNPA has abandoned any attempt to enforce its normal standards on land owned by the former Forestry Commission.

The hydro scheme could have provided an opportunity to rescue the west bank of the Donich Water from the ravages of industrial forestry but has instead has made it worse.
