## Climate Change and Glen Falloch (4) – hydro failures and their impact

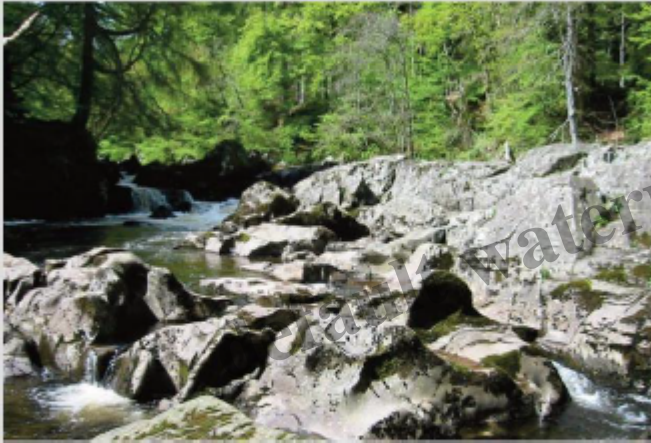
Figure 32 A Bedrock river

Natural features such as bedrock lined channels / pools are common in high energy upland areas (see figure 32 above). As these environments are very stable and not prone to erosion then little or no erosion protection may be necessary. These features can be chosen as an appropriate location for an outfall to reduce the need for erosion protection.
